ALDENHAM HOUSE - FORMAL GARDENS PLAN - WITH LOCATION OF EXISTING STEPS: 1:200@A3

Project and Project No: **HABERDASHER'S SCHOOL**

Drawing No:
9756-1 P(0)001

Title:
AH - FORMAL GARDENS - PLAN WITH LOCATION OF STEPS

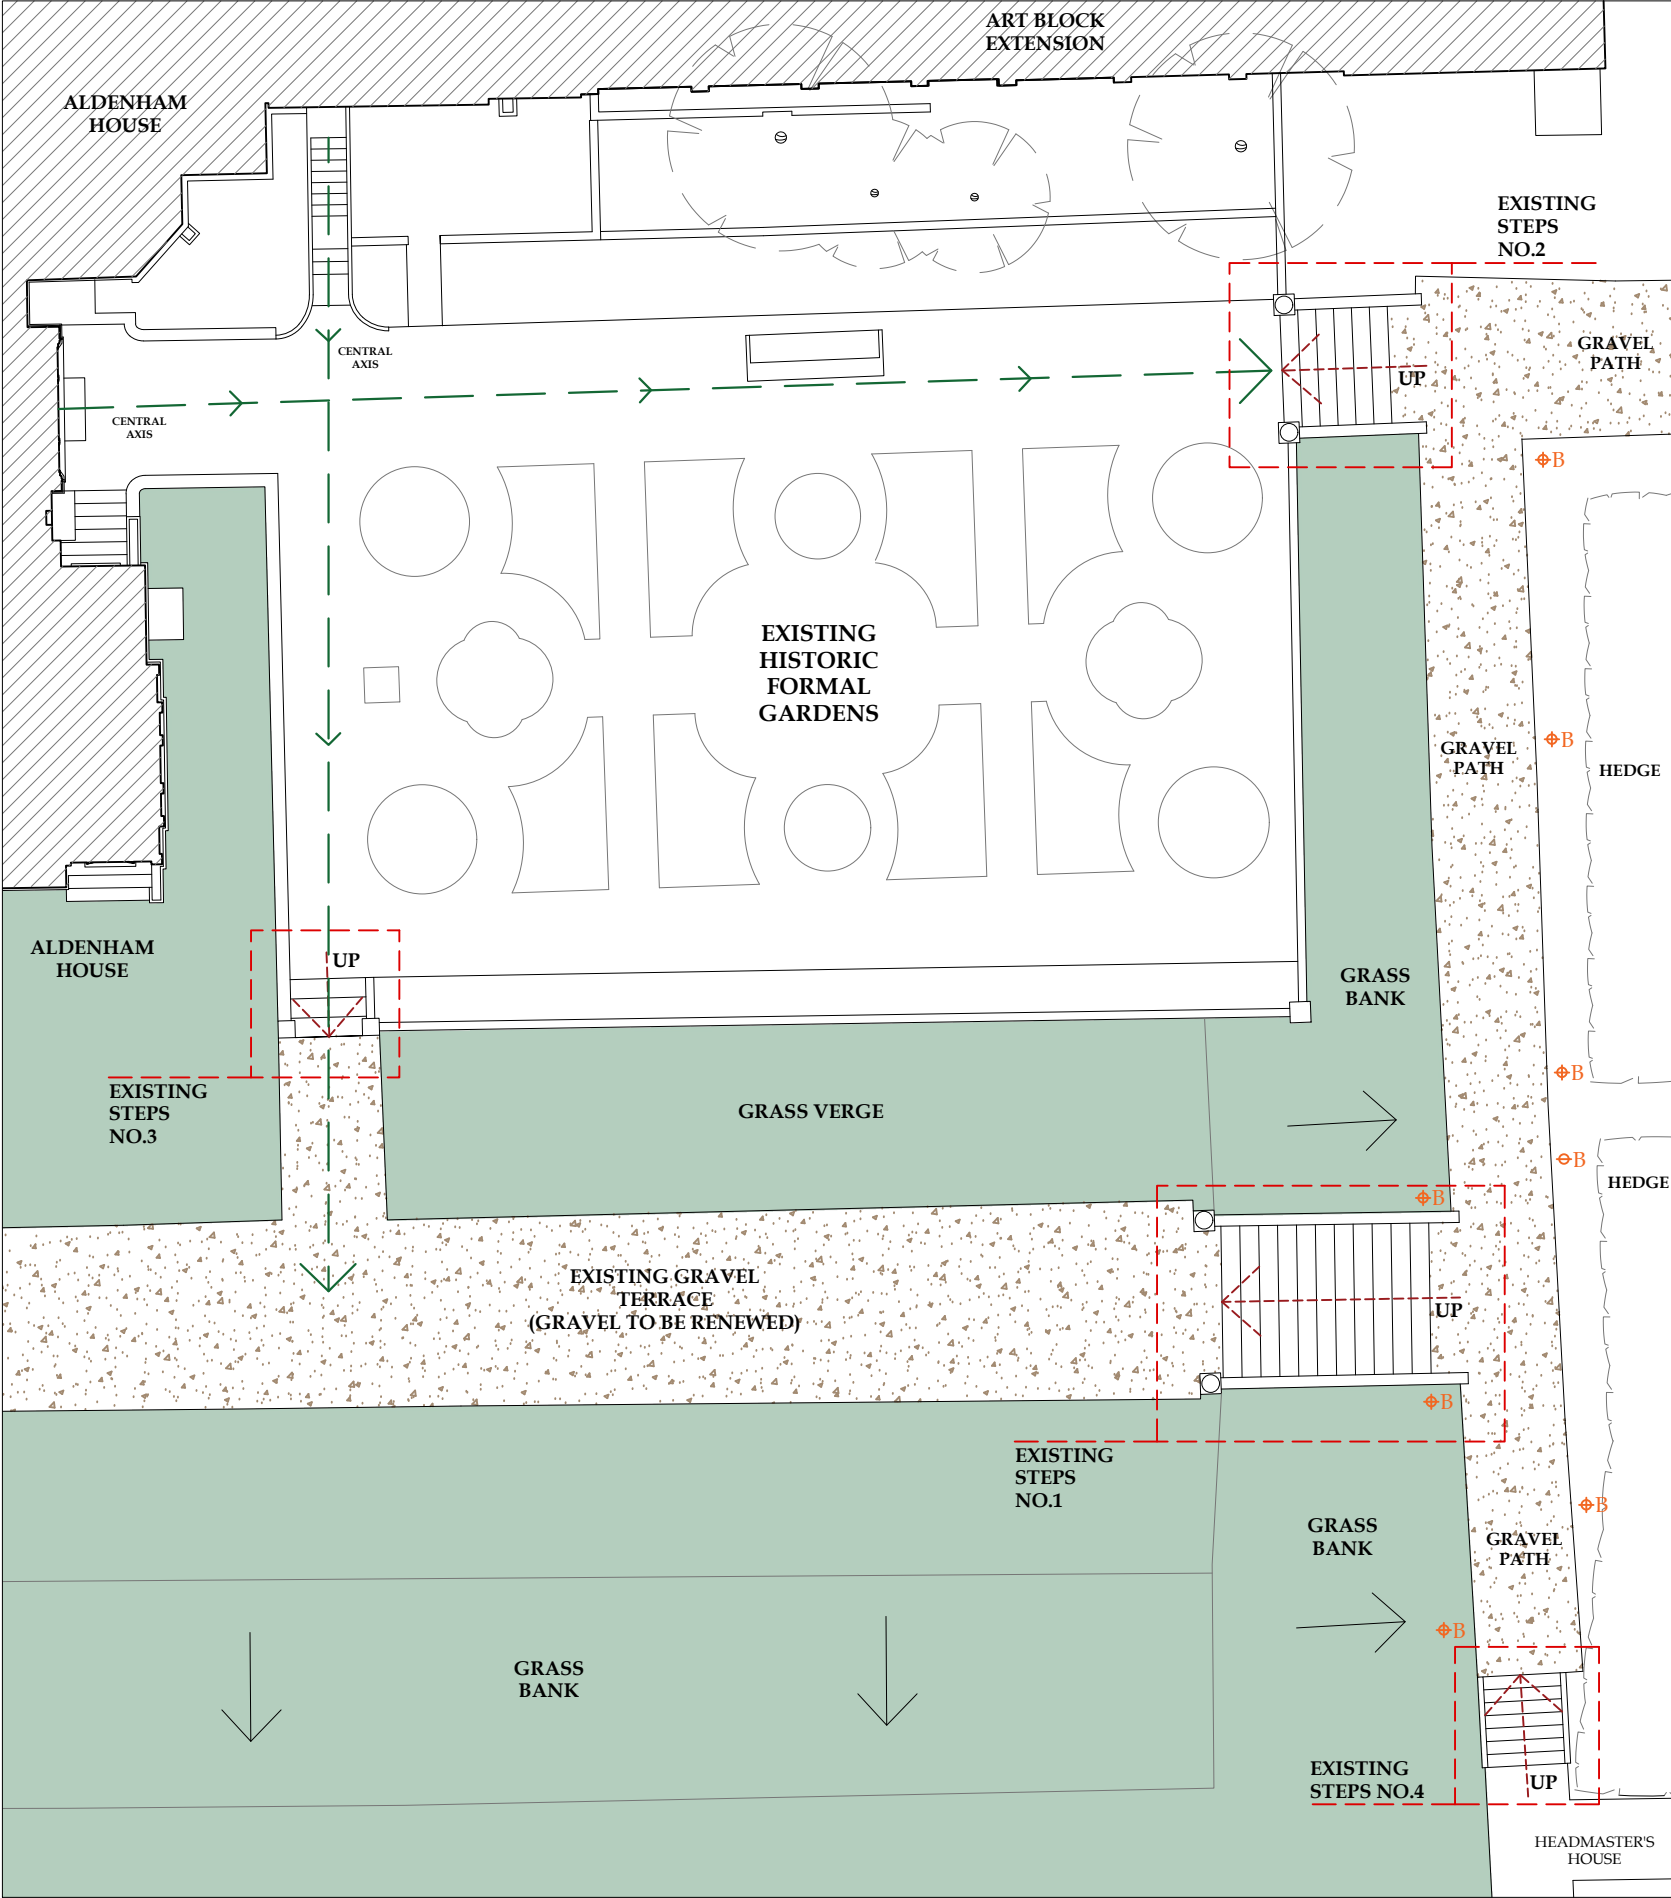
3. The four sets of existing, historic steps all form part of the historic formal gardens that surround Aldenham House, now Haberdashers' Aske's Boys' School. They date from the late 19th Century and are likely to the design of A. Blomfield who modified Aldenham House for Baron Gibbs and also designed the terracotta wall that formed the boundary to the formal gardens;

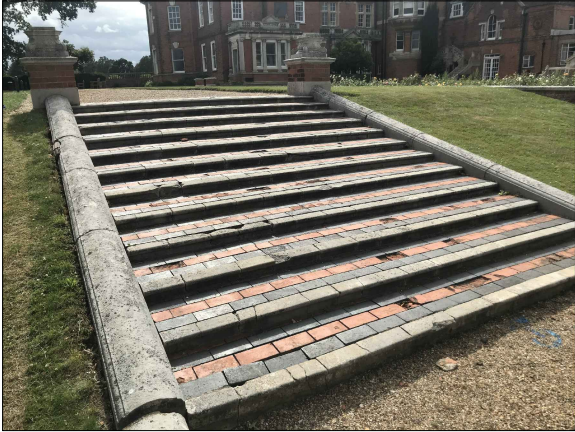
EXISTING STEPS NO.1

4. All existing steps are constructed from both black and red engineering bricks, with limestone kerbs, nosings, trims and other dressings.
5. Existing Steps 01: Principal steps to terrace formed from 12 treads, with limestone kerbs, nosings and dressings to 2x brick piers. The steps are generally in poor condition with evidence of settlement that has caused them to split roughly in two. along the middle axis. The treads and nosing are also badly spalled and cracked and therefore require complete replacement with new sections. The structural engineer has recommended that the steps are rebuilt on a new foundation in order to mitigate future movement. The limestone kerbs and piers (with inverted capital finials) can be retained in their entirety and reinstated once the foundation have been installed.

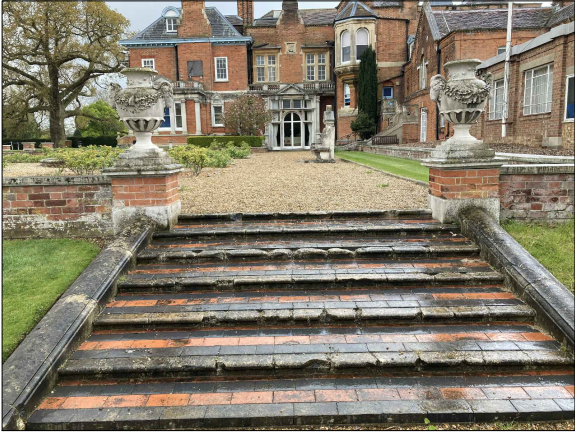
EXISTING STEPS NO.2

6. Existing Steps 02: Steps to formal rose gardens formed from 6 treads, with limestone kerbs, nosings and dressings to 2x brick piers. The steps are in a better condition than Steps 01, with no evidence of structural cracking or movement. However, localised areas of replacement to the limestone nosings and the treads are required. Complete repointing is required in lime mortar and the decorative urns are to be carefully taken down and securely reinstated.

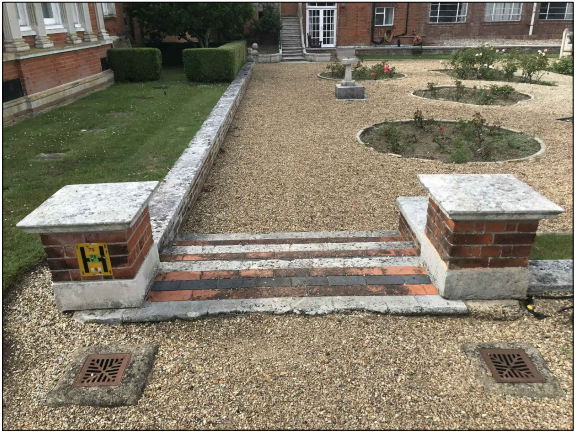
EXISTING STEPS NO.3

7. Existing Steps 03: Steps to formal rose gardens formed from 3 treads, with limestone nosings and dressings to 2x brick piers. The steps are generally in good condition, with no evidence of structural cracking or movement. Localised repointing only is required.

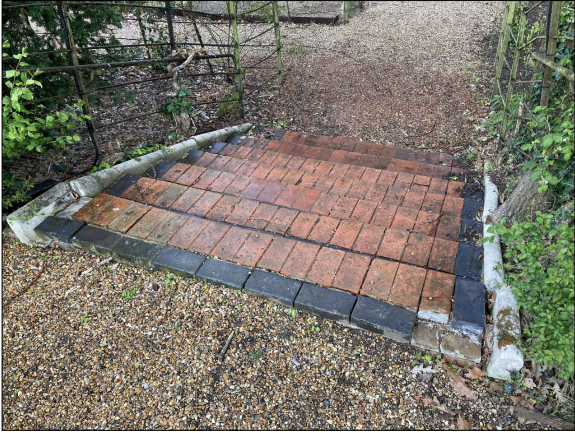
EXISTING STEPS NO.4

8. Existing Steps 04: Steps leading to Headmaster's House and garden. The top pair of limestone kerbs require resetting with 2x replacement black engineering bricks where they are missing. Complete repointing is required.
