FRITH:BLAKE
CONSULTING LTD

**PROPOSED CONVERSION OF BARN ADJACENT TO:
White House, Long Road, Silfield, Norfolk. NR18 9NT
STRUCTURAL APPRAISAL**

Report Title: Structural Appraisal
Project: 3203 – Barn adjacent to White House, Long Road, Silfield, Norfolk.
Client: Mr Rupert Baker
Date: May 2021
Revision: V1 – 19.05.21 – First Issue

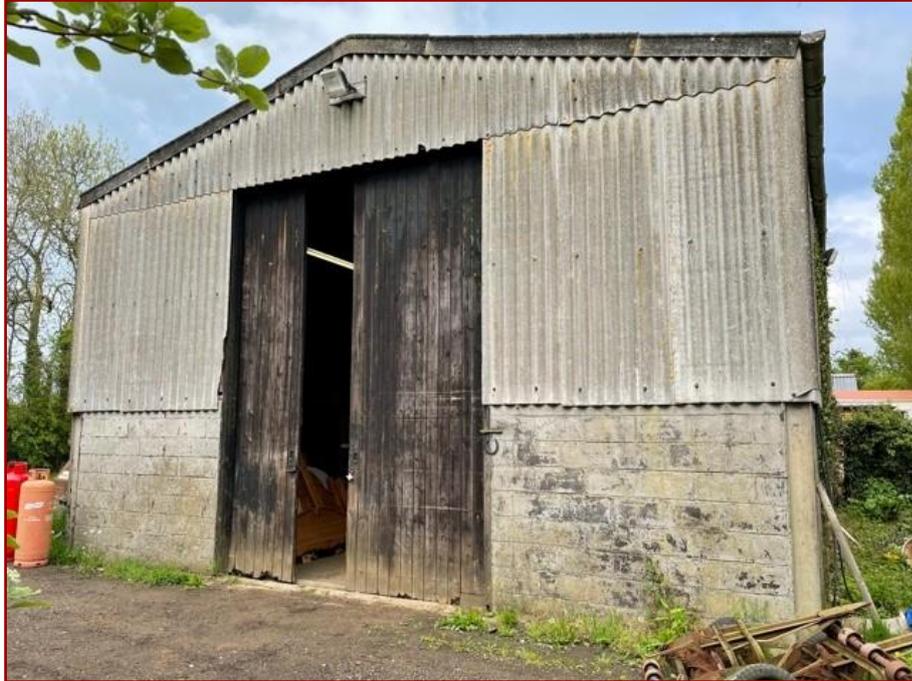
Figure 4.1 - Existing Agricultural Building

The existing barn comprises a duo-pitch steel frame building, a ground bearing concrete slab with block walls built between the columns to mid-height. Above the walls consists of timber cladding rails supporting asbestos/cement corrugated sheeting. Timber eaves beams and purlins spanning between the rafters support corrugated asbestos/cement roof sheeting forming the roof structure.

The barn is accessible via large sliding timber doors to the front gable on the eastern elevation pictured above in Fig 4.1.
