# JON SLOAN Ecological consultants

GATE FARM, CAERSWS, POWYS

## PRELIMINARY ECOLOGICAL APPRAISAL MAY 2021

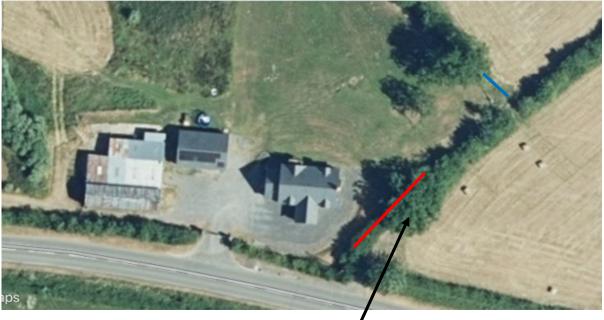
## Proposed Hedge Removal Sites

Area of hedgerow to east to be translocated (red)

Oak tree

Site for translocation (blue)

The Oak tree at the northern aspect of the section of this hedgerow which is to be removed will have to be felled to make way for new driveway. The ecologist will need to be on site when this is being undertaken (see Appendix 1 "Proposed Tree Felling").

The eastern hedgerow which is being removed is to be translocated to the northern boundary which will connect the existing northern & remaining eastern hedge (see Appendix 3 "Methodology for hedge translocation"). The time for this would be between November – March.

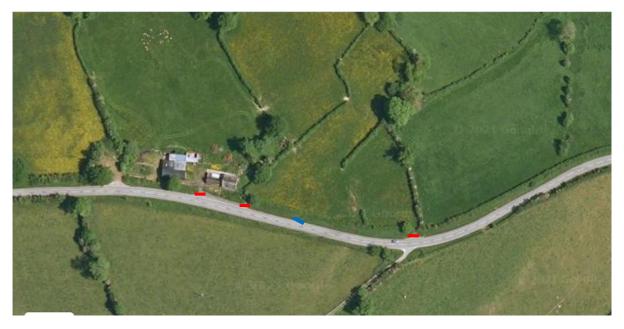
Existing access points to be "stopped up" (red)

New access site(blue)

A further section of hedgerow will be removed on the roadside to create a new, safer access to the site. This will measure approximately 4.5m & is predominantly Hawthorn. The existing 3 access points within this boundary will be "stopped up" by new hedge planting (total length of new planting in these areas will be 17m), this will connect the existing hedgerows (see Appendix 2 "Proposed hedge removal").

The 3 existing access gaps within the hedgerow to the southern boundary/roadside of the site will have additional native planting to enhance the hedgerows for wildlife & to alleviate any fragmentation. A more sympathetic hedge cutting regime allowing the hedges to grow taller and thicker will be implemented. A 2m buffer zone will also be created on the field side of all new/translocated hedgerows.

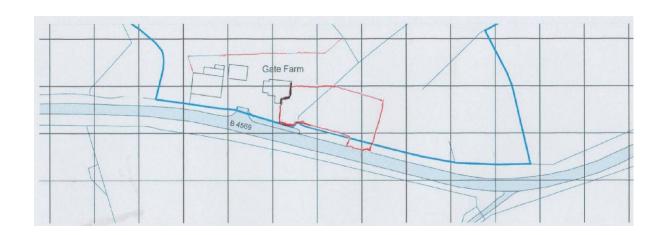
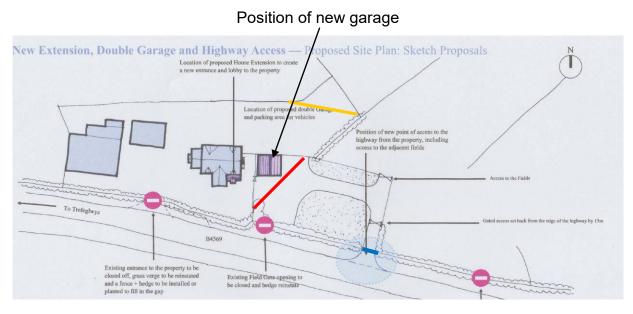
## Appendix 4 Site plans

- gateways to be blocked with new hedge planting
- Area of hedgerow to be removed/translocated
- Position of translocated hedge
- Proposed new access

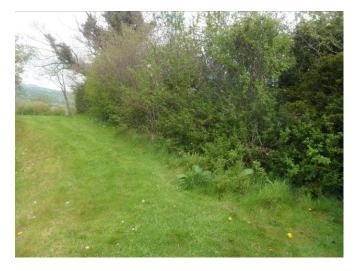
Eastern hedgerow looking south to north

Inspections of the hedgerow to the east of the dwelling were undertaken given that approximately 25m of this hedge is proposed to be removed & translocated to the northern aspect of the site, thus connecting the eastern & northern hedgerows (see Appendix 1 "Proposed hedge removal sites"). This hedgerow is dominated predominantly by Hawthorn with some Holly, Ivy, Dog Rose & Sycamore with Douglas Fir to the far southern aspect. The understorey consists of Foxglove, Nettle, Greater Stitchwort, Celandine, Dandelion, Speedwell, Common Vetch, Primrose, Dock, Daffodil, Ladies Smock & Cleavers.

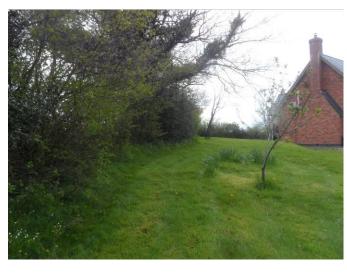
Eastern hedgerow looking north to south

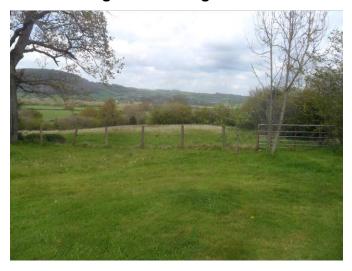
Location of site for translocated hedge

A trench will be dug at the receptor site approximately 1m deep and 1m wide in the middle, with side/s shallow tapered.

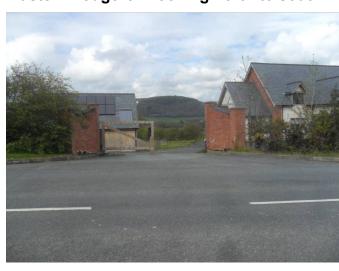
Existing access to be closed with new hedge

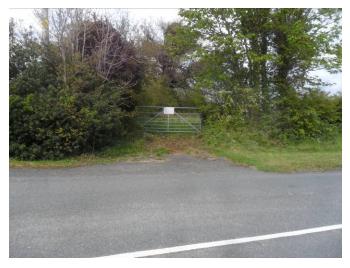
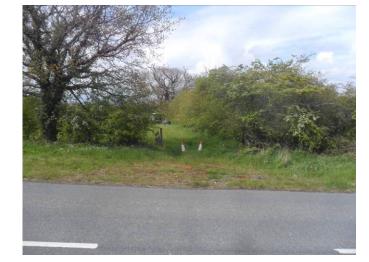
Existing gateways to be closed with new hedge

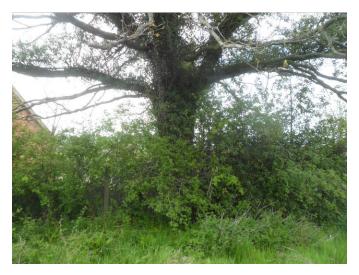
The Oak tree within the hedgerow to the east of the dwelling was also assessed for its potential for bats, this was deemed to have low/ negligible potential for bats to roost but could be used for foraging.

Oak tree

The Oak tree proposed to be felled will be subject to an inspection by the ecologist from the ground immediately prior to any works being undertaken. This will involve checking for any bat roost features & inspecting any crevices or foliage (i.e. ivy) with an endoscope where possible. Once the inspection surveys confirm the tree has a low suitability for bats or birds, the tree will be felled taking reasonable avoidance measures. In particular the following methodology will be employed:

- The tree will be felled during September/October to avoid maternity and hibernation seasons when bats are most vulnerable to disturbance & avoiding nesting birds.

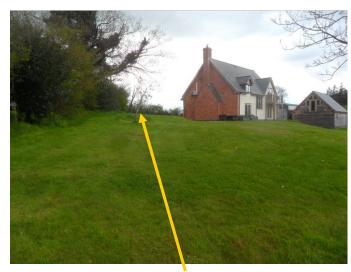
Site for proposed new garage

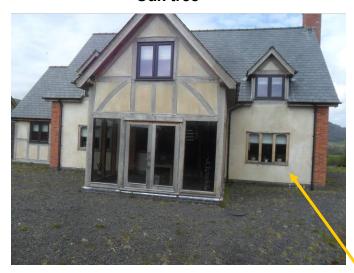
A Preliminary survey of the dwelling was undertaken to inspect for evidence of or potential for bats to roost, in particular the area where the new lobby is proposed. Inspections were carried out with the aid of surveyor's ladders, endoscopes, binoculars & 1.5 million candle power lamps. The roof void was accessed via a loft hatch on the first floor landing, no evidence of bats or potential for bats to roost was found. The exterior of the dwelling was also inspected closely, with the area at the south-eastern aspect where the new lobby is proposed being inspected closely. No evidence of bats or potential for bats to roost was found. All gable end slating, soffits, fascias & roof slating was sealed/tight fitting.

Proposed location of new lobby

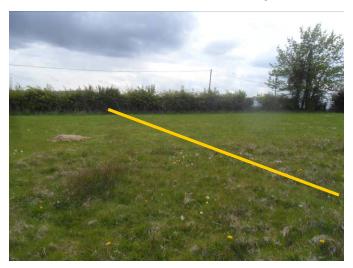
Approximate location in field where new access drive is proposed
