Heritage Statement

Charehead Barn, Acomb

Project No.	201018
	201018-NAP-ZZ-XX-RP-A-00002
Revision	2
Issue Date	1st September 2021
Checked	GD
Produced By	CD

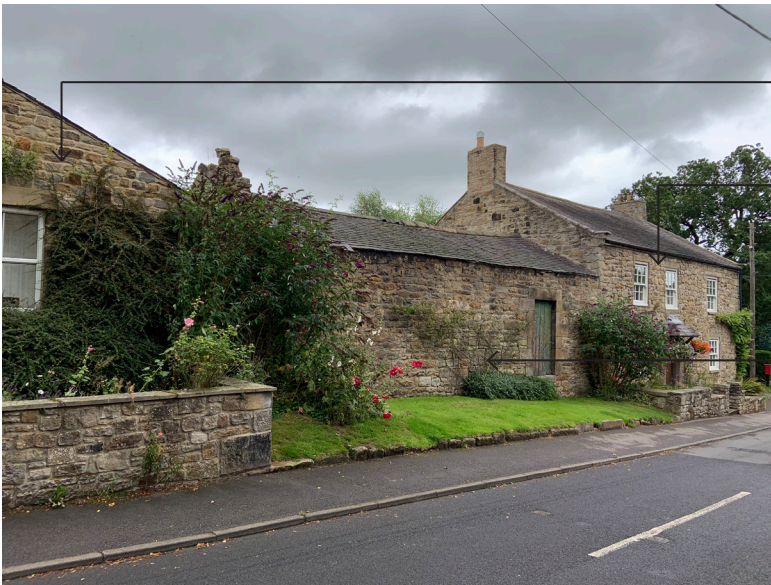
Figure 4

Townhead House - new build within the footprint of the previous barn

Charehead House (owner's home), built on the footprint of the previous barn.

Charehead Barn. Existing stone barn which is the subject of this application.

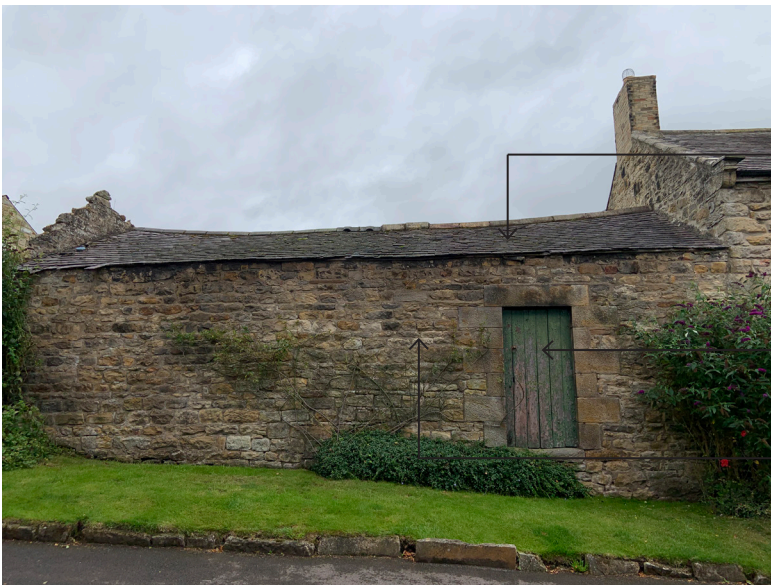
Figure 5

Existing slate roof in a state of disrepair. The ridge line is sagging badly and there are no rainwater goods remaining.

Existing timber entrance door

Random roughly coursed rubble walling. Removal of vegetation and soft mortar is required and re-pointing in lime mortar.

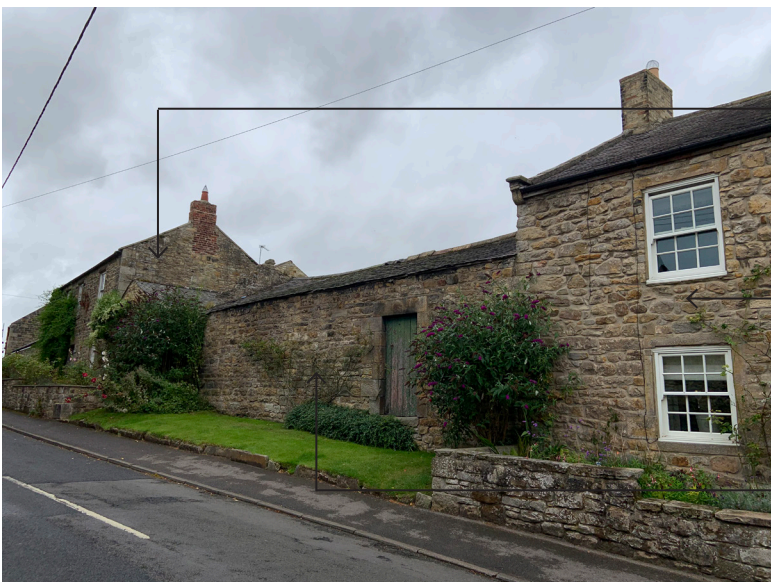
Figure 6

Townhead House; note the remnant of the barn gable to the single storey extension to the property.

Charehead House

Charehead Barn

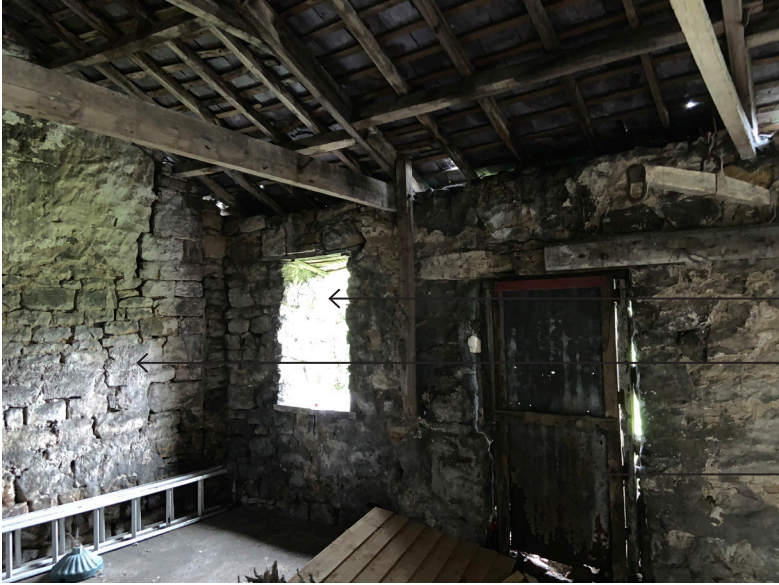
Figure 7

Existing rear window with collapsed internal lintel.

Stone walling to be repaired with stainless steel "stitching" to areas of significant cracking.

Existing rear door opening

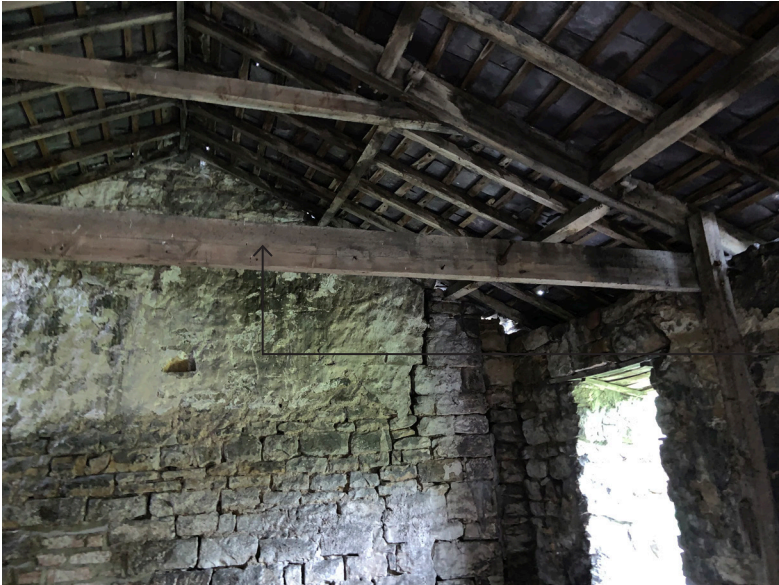
Figure 8

Existing timber roof structure showing previous roof member replacement. The timbers are to be salvaged, treated and dressed for use in the new construction.

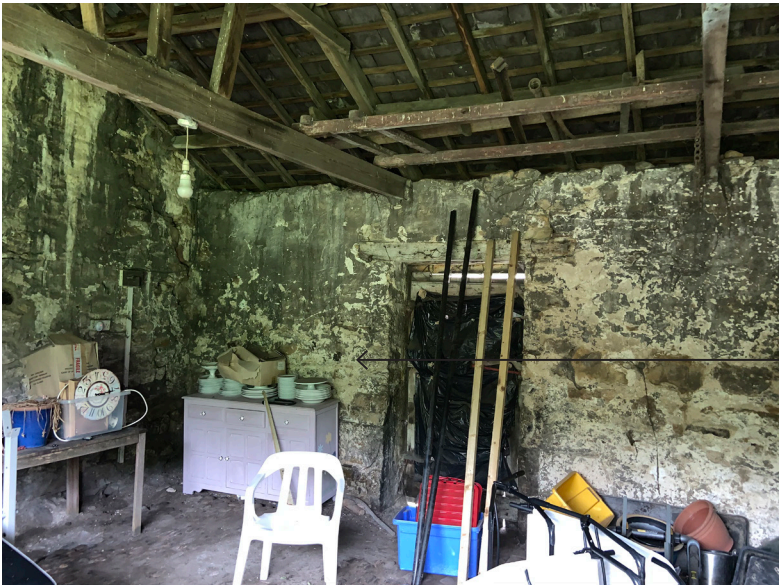
Figure 9

Interior currently used as storage. The internal walls are to be cleaned and sand blasted to remove the old limewash and prepared for re-pointing in lime mortar

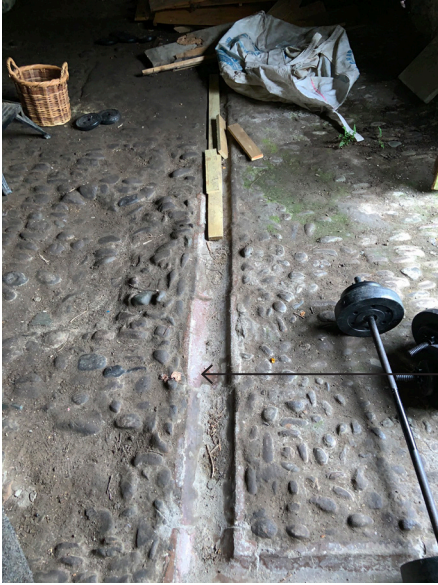
Figure 10

Existing channel and cobbles are to be lifted and relaid as part of the new external work to the front of the property.

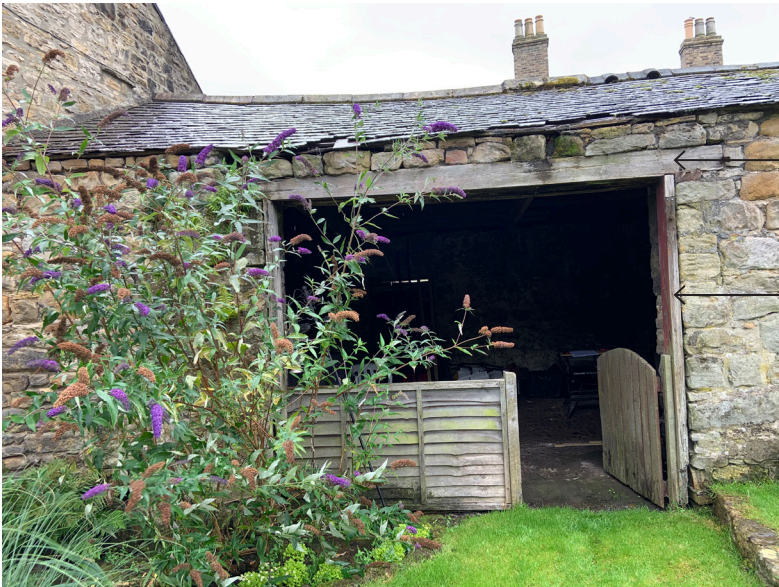
Figure 11

Rotten wooden beam (4 number timbers with blocking between) with woodworm infestation. Requires replacement.

Rear Opening - doors no longer present.

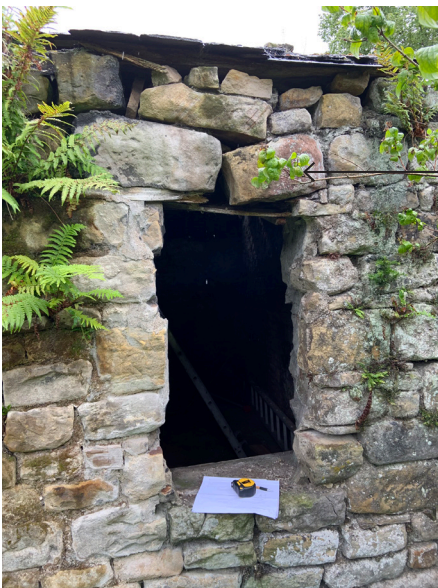
Figure 12

Existing collapsed stone supported on a rotten timber lintel. Opening to be adapted and made good.

Existing rear door opening. Jamb to be made good and stone head raised.
