**Land at Draycott, Cam
Preliminary Land Contamination and
Geotechnical Risk Assessment**

On behalf of Persimmon Homes Severn Valley and Robert
Hitchins Limited
Report 01-12-104884 /DSR1

June 2021

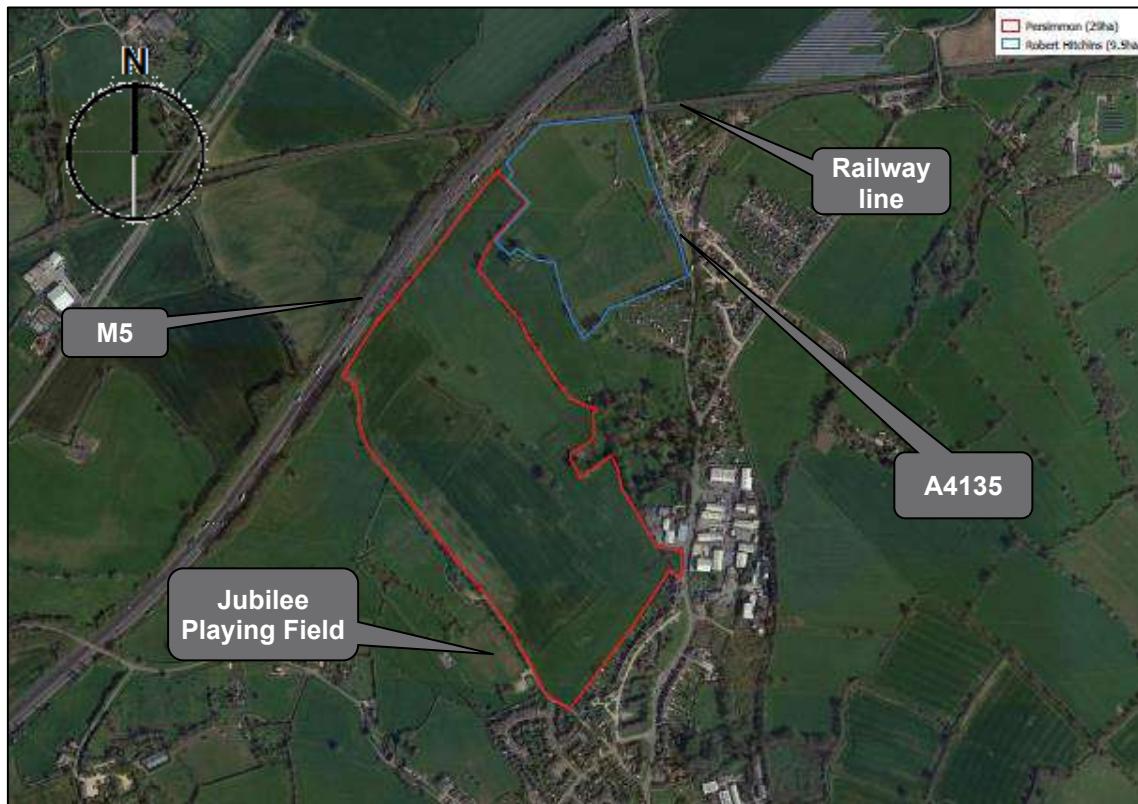
Figure 2 Site layout and land allocations (Red = Persimmon / Blue = RH)

Figure 2 shows the site setting and land allocations.

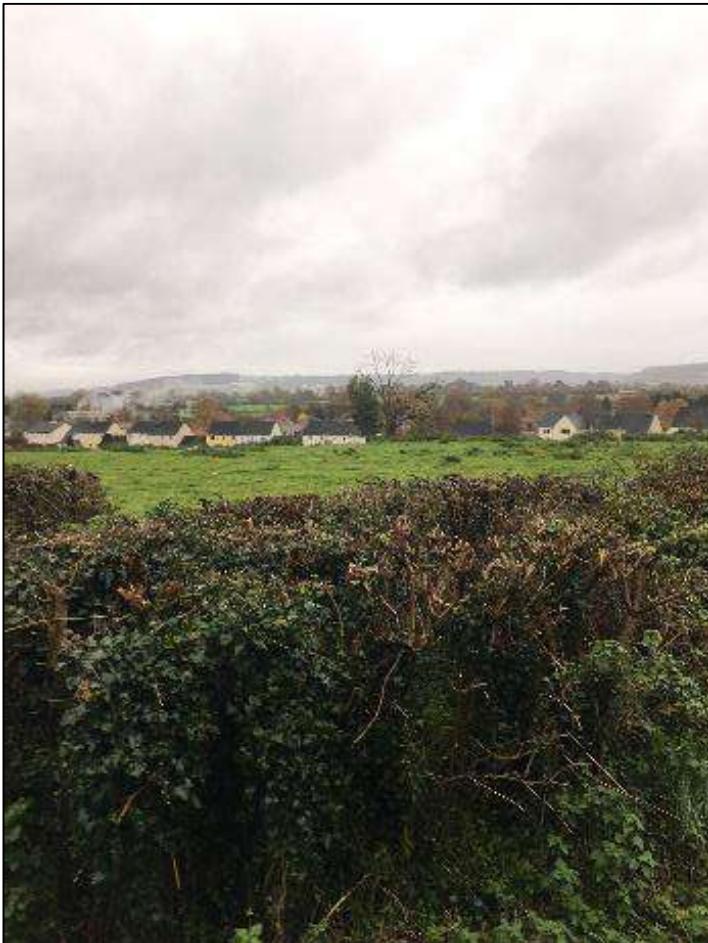
Plate 1 – Undulating Ground in South West Corner (Persimmon land)

A section of field in the south west corner of the site (Persimmon land) had not been ploughed, it was noted that that this section of the field undulated unnaturally (Plate 1). This may indicate that earthworks have been completed in this area and or that the area has been affected by filling.

Deep Made Ground resulting from infilling or significant raising of levels is considered unlikely. However, localised areas of deeper Made Ground may be present in the Persimmon lands, associated with potential landfilling on northern boundary, the infilling a former pond and gravel pit and with earthworks in the south corner of the site, where undulating land is noted.

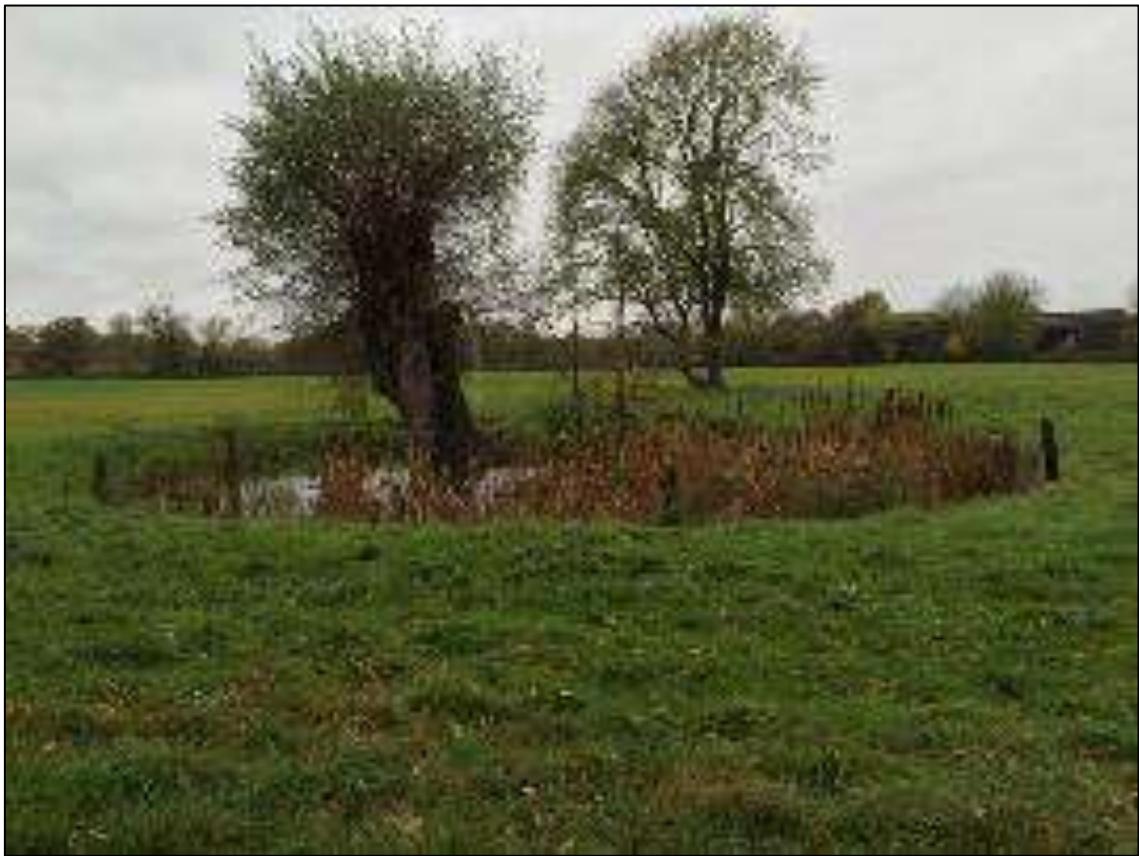
Plate 7 View west of pond in Robert Hitchins Land

A small pond (Plate 7) is present within the north east corner of the site (Robert Hitchins land). In this area, a small stable block is also present, along with a number of outbuildings that are used for the storage of agricultural materials and firewood.

At the time of the walk over extensive surface water was present across the site and water was present in the pond in the north east of the site at circa 0.3m bgl. It is therefore envisaged that shallow groundwater may be present.

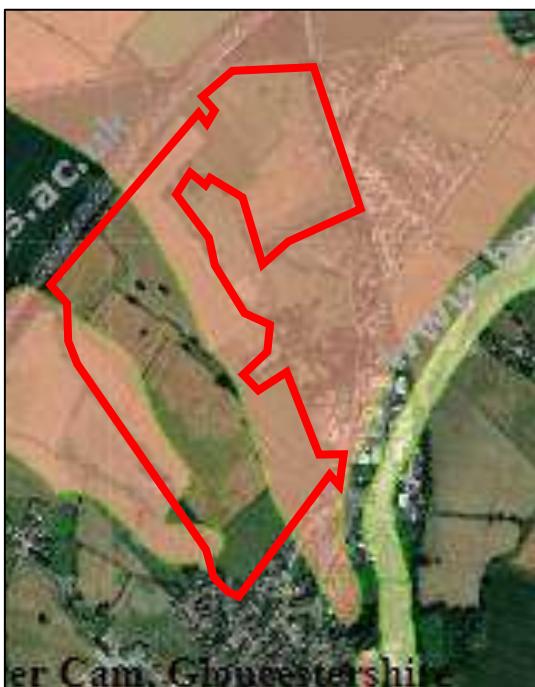
Figure 3 Extent of mapped Superficial Deposits (coloured orange)

The superficial deposits are absent from a north south running strip in the centre of the Persimmon lands, here the Blue Lias Formation and Charmouth Mudstone Formation is mapped as present. The mapped extents of the Sand and Gravel deposits are shown below in Figure 3.

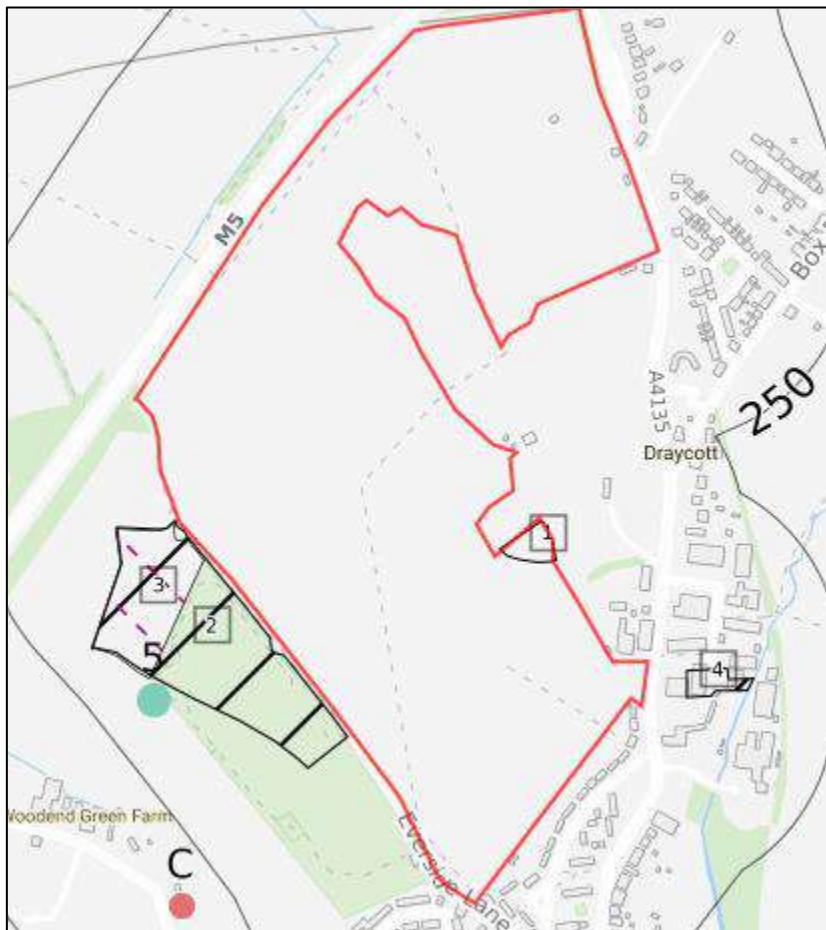
There are two recorded areas of landfilling within 250m of site boundary. The locations are shown in the extract from the Groundsure report below.

The first is located on the eastern boundary of the Persimmon land. It is recorded as Everside Lane Refuse Tip, Cam, Dursley, Gloucestershire and was operated by Dursley Rural District Council. Waste type is recorded as Inert, Industrial, Commercial and Household. The site was active from 01/08/1963 with the last recorded waste received on 30/10/1975.

The second is located near to the south west boundary. This records for this area are the same as those recorded on eastern boundary.

Given the proximity to the site, the potential for the generation and migration of ground gas / leachates on to the site cannot be discounted.
