Heritage Statement

Old Foxcote Farm Site
Foscot, West Oxon

November 2019 | Project Ref 4988A

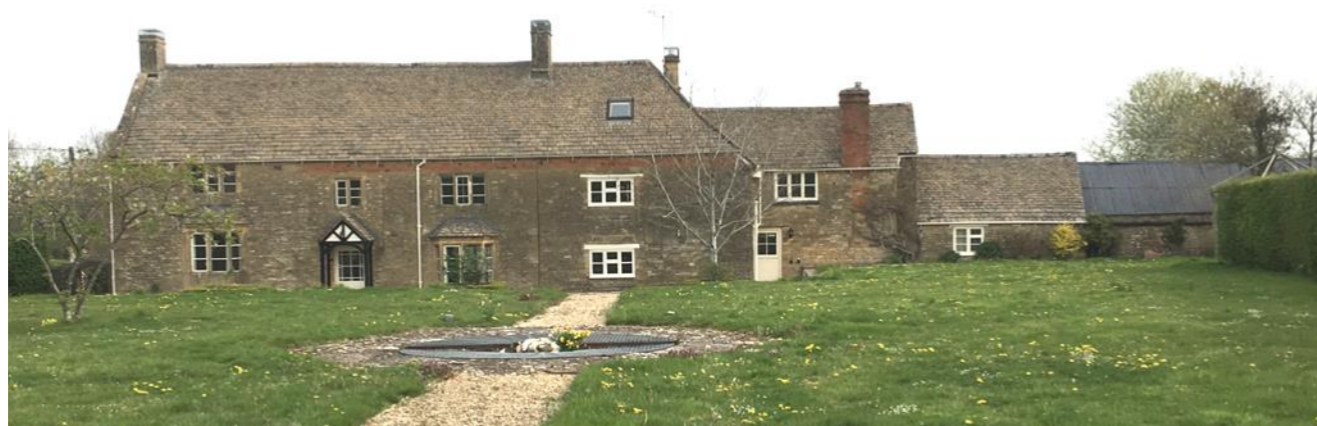
Plate 1: Old Foxcote Farm southern garden elevation.

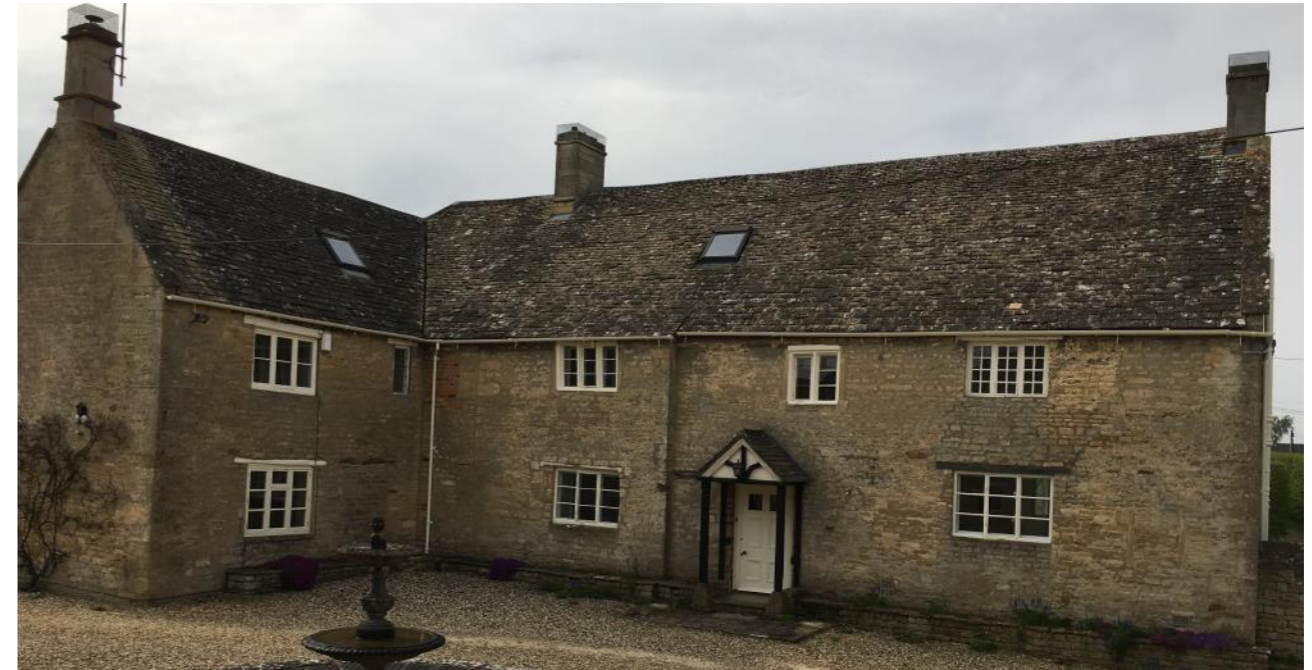
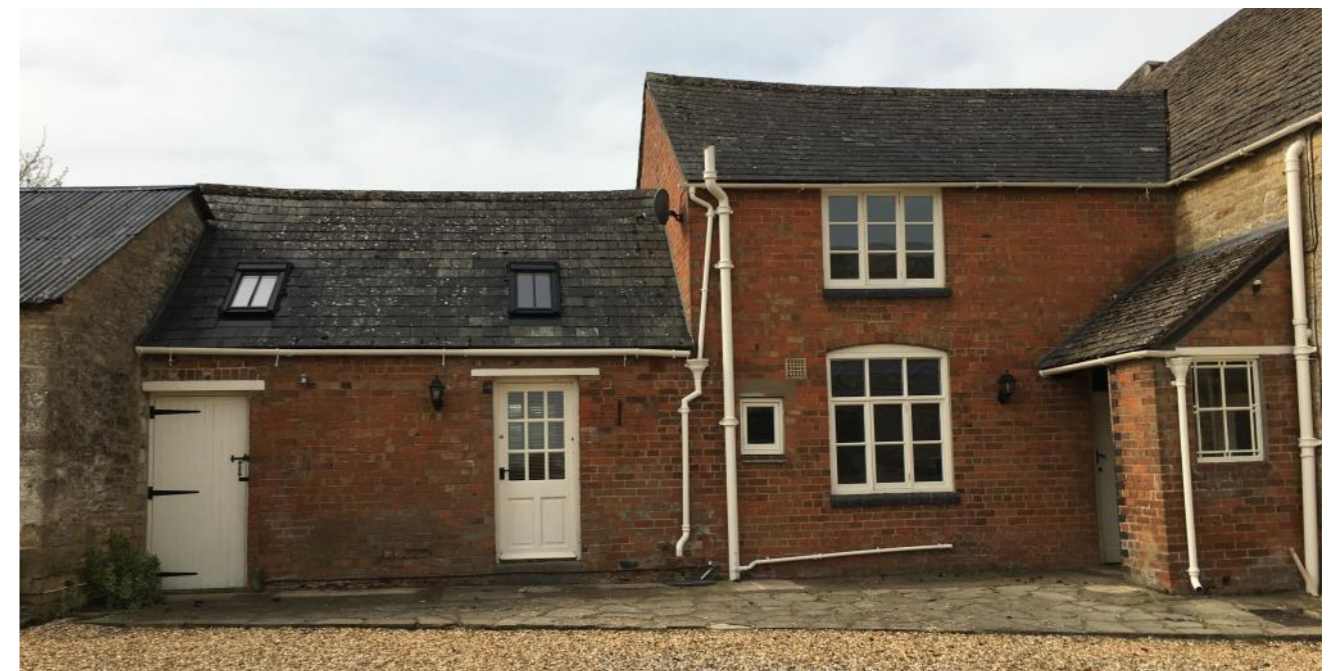
Plate 2-3: Old Foxcote Farm northern yard elevation (above) and extended Victorian range (below). The elevations on all sides of the building show evidence of extension in an easterly direction with the red brick elements being the latest. The single storey red brick structure below features only modern features (doors and skylights and all interiors) and the brickwork also appears less consistent with the two storey section to the right. It may be that this portion was rebuilt or added more recently though we have assessed it as broadly Victorian in overall date based upon the map evidence.

29. The rear of the building is distinct in the use of red brick in the construction of Victorian extensions and a porch. They abut a stone cart shed of unknown date. This structure is open to the west and has no real diagnostic features to enable a closer dating. It does appear to be earlier than the brick extensions which abut it. The use of brick on the southern elevation at eaves level suggests that the farmhouse was re-roofed at this time and the eaves all levelled up in brick. The roof structure has been very altered with principal members and timbers relocated, replaced with different structural pieces and many of the common rafters replaced. The date for these changes is unknown but the farmhouse was re-roofed in concrete slates in the mid 1990s (W96/1065) and this may have been when common rafters at least were replaced.

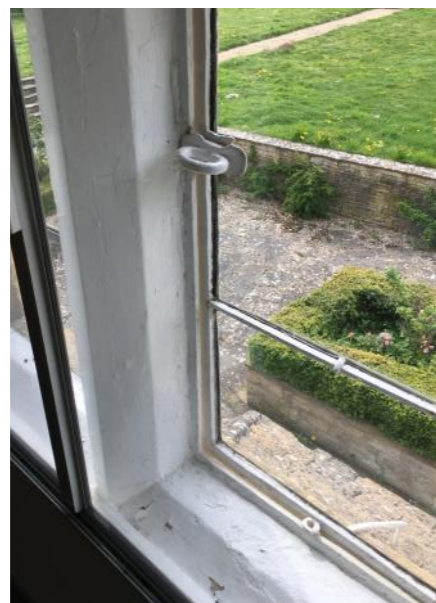
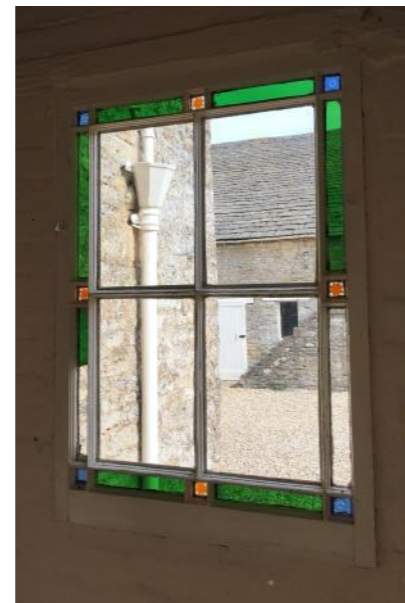
Plate 4-5: (left) early casement set into the stone mullion at first floor, simple turnbuckle catch and loop on the bottom of the casement to take the twisted stay just visible externally. (right) typical mid 19th century window with brightly coloured glass within margin lights; rear porch.

- 32. The historic windows (the eastern end of the building feature several modern timber units of no heritage value) are metal framed with some opening casement sections. These fit into the earlier mullioned stone surrounds as well as into the Victorian bays on the south front. The opening sections on the garden front feature twisted hook stays at the base, a single quadrant stay is seen on the northern elevation. Internally the turnbuckle catches are simple rounded shapes with a loop. These window features (twisted stays and simple turnbuckle catches) are typical of windows from the late 17th and certainly throughout the 18th century (Hall 2005, *Period house Fixtures and Fittings 1300-1900*; 90-92). They are good early survivals on this building though the glass of these metal windows appears later.

- 33. Other windows in the building are much more typically 19th century, including that lighting the back kitchen/scullery with its large frame with canted head and the front door, and back porch window, with coloured margin lights.

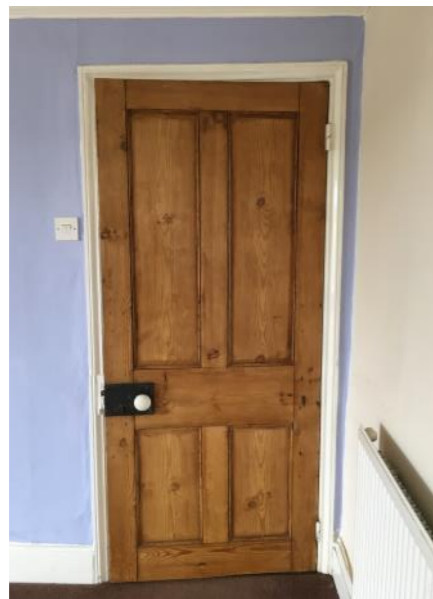
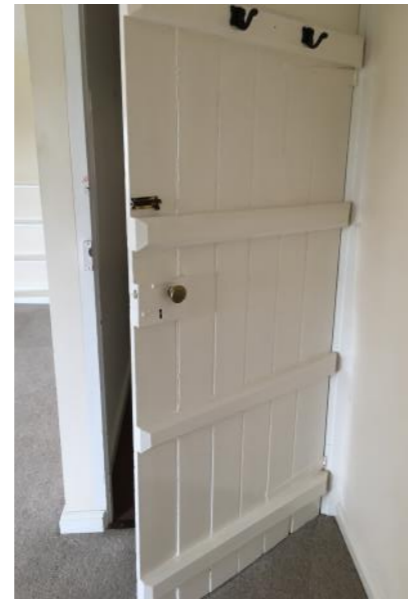
Plate 6-7: (left) Victorian four panel door. (right) typical plank and batten door, of which there are several in the building, with long strap hinges, these with rounded ends.

- 34. Doorways within the farmhouse are similarly varied with examples of older, probably 18th century plank and batten doors, with more typical Victorian panelled doors also in evidence.

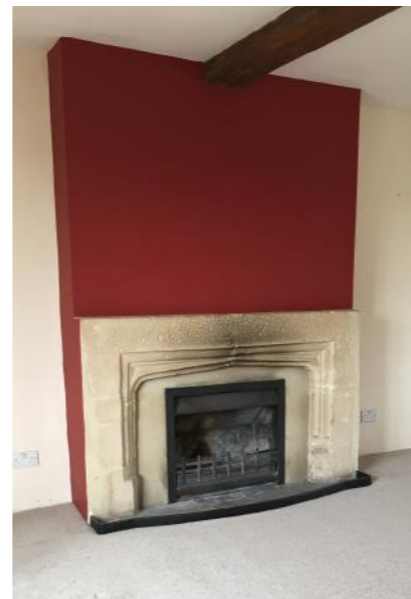
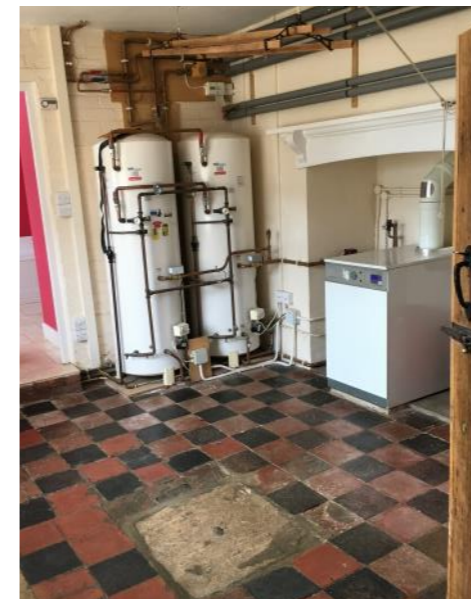
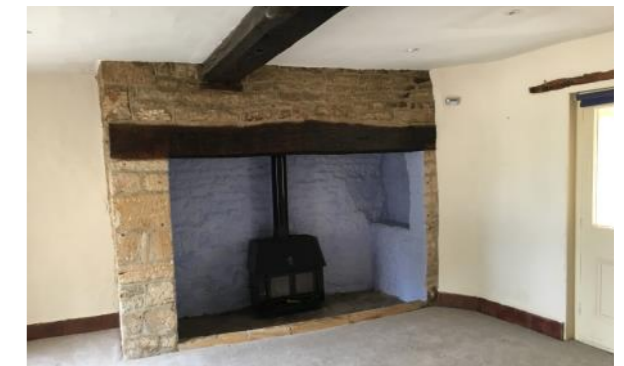
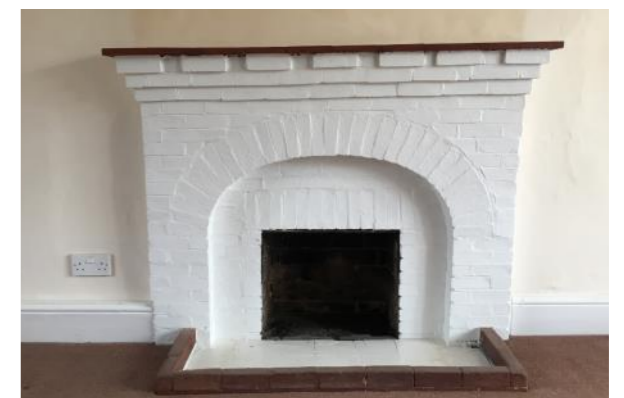
Plate 8-11: (left) Ostensibly early surround but thought to be salvaged and relocated here; (right) Victorian mantel and opening for a range in the extension; (right above) 18th century fireplace with bressumer; (right below) early 20th century brick surround.

- 35. The house retains chimney stacks with some fireplaces at ground floor level only. Aside from the large open fireplace in the northern return range the actual surrounds have been adapted and changed later in the building's history. There is one ostensibly 15th or 16th century stone surround with a Tudor arch, recessed spandrels and moulded stops within the western sitting room, however, this fireplace sits awkwardly in the stack and appeared at first inspection likely to have been relocated or salvaged from elsewhere. Investigative opening up confirmed that it is set into and bonded to the wall with very hard cement, which extends over the chimney breast. It has a much later 20th century grate and hood set within it, also within cement render. The central room features a brick surround typical of the early-mid 20th century. The north return to the building retains a large open fireplace with timber bressumer and some evidence for a former bread oven. A similarly large fire surround with typical 19th century mantel is located in the Victorian extension, this probably contained a range or enclosed stove, now replaced with a boiler.

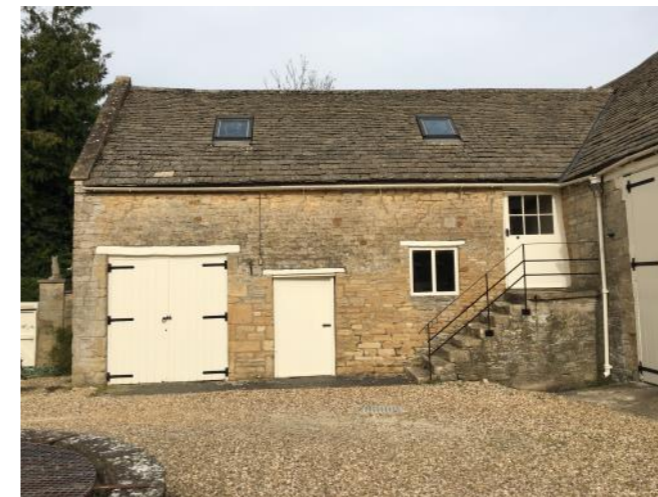
Plate 12: Stable range, southern elevation, with gate into yard on left.

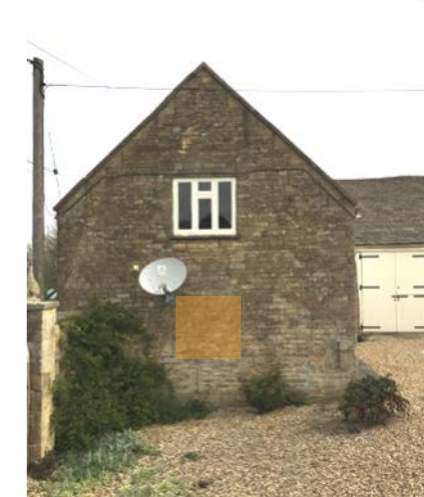
Plate 13: Stable range western gable with position of blocked window shaded.

45. The smaller stable block on the western side of the yard shows evidence in its southern gable for a former window at ground floor level. A WC has been inserted into the store (probably a former tack room, or perhaps a small cart shed) on the left of the building. The northern right hand part of the building has a blue brick floor, and path externally, and is divided into two loose boxes with wooden board construction inserted into the building and wooden troughs and feed mangers internally. A lead lined trough is located beneath the stair to the loft which intrudes into the internal space. There us some uncertainty as to the original function of this building, the presence of a doorway leading into the door suggests a different arrangement in the past.

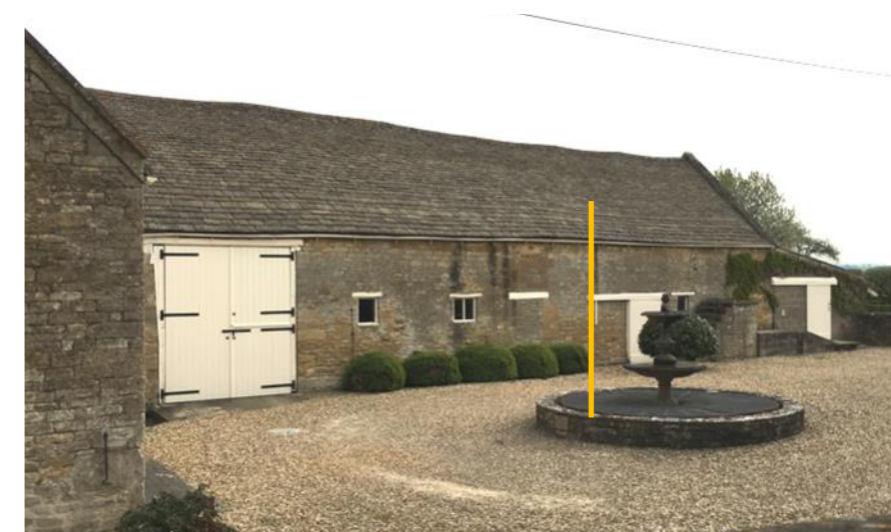
Plate 14: The main barn, the added three bay southern structure is marked with a straight joint just right of the blocked door (marked)

47. The barn comprises two halves, a larger five bay barn on the west (Plate 13) with double threshing doors centrally on either side. On the east a slightly smaller three bay barn with

smaller doors and clear evidence internally and in the raised steps within the yard that it had originally featured a loft or first floor, now removed (Plate 14). The barns both feature in line purlins joined through the principal trusses with loose tenons, the later barn on the east appears only to have had raised collars (Plate 15) with the first floor beams providing the necessary tie between the walls; the walls have splayed somewhat with the removal of the floor.

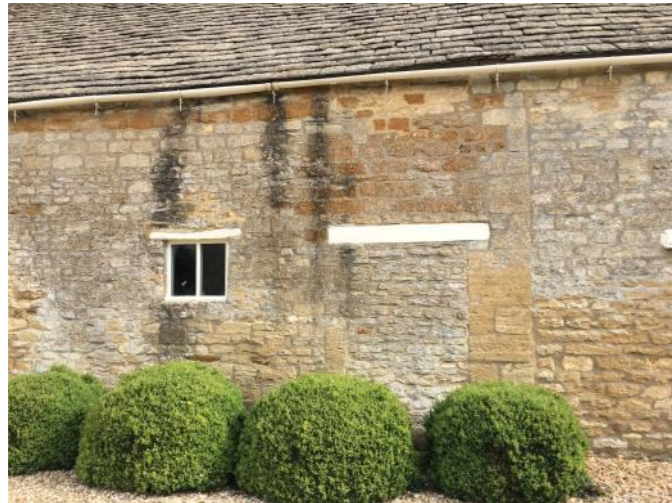
Plate 15: The main barn, blocked door and straight joint showing extension point to east.

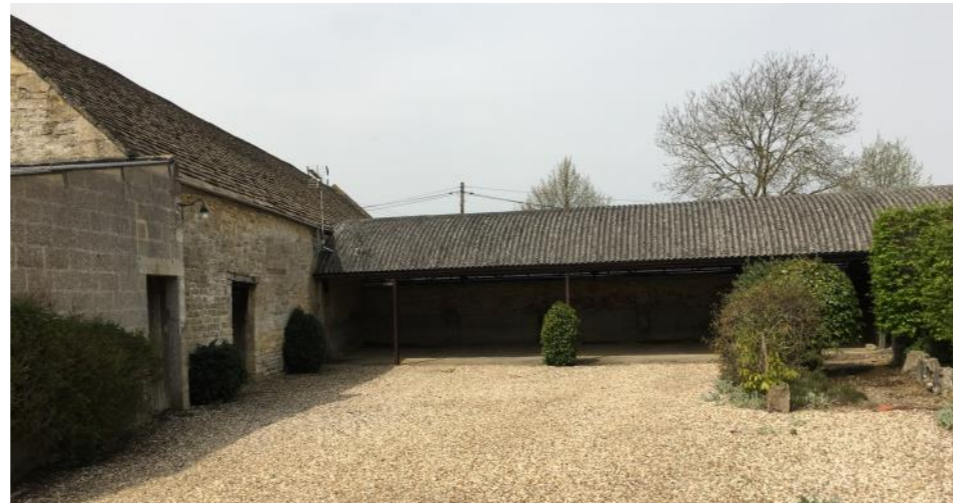
Plate 16: The main barn north elevation of the eastern three bay portion and later concrete block construction, also metal roofed structure behind on footprint of former shelter sheds.

(Plates 16 and 23), is a long timber range constructed of wide planks and some reused railway sleepers, with internal wooden troughs and mangers. The doors are mounted on long strap pintel hinges and all the ironmongery is matched.

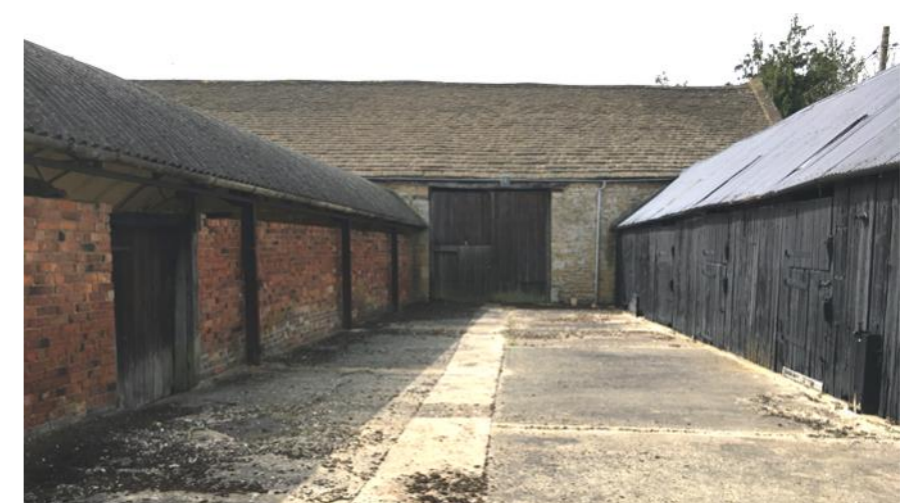
Plate 17: The main barn northern threshing doors, later stables on right and metal roofed shed on left over earlier brick wall occupying footprint of former shelter shed.

41. The first is a long timber structure adjacent to the road with corrugated sheet metal roof comprising stables opening into a narrow yard on its eastern side. The second includes low standing walls in brick with some stone defining generally open area with a curved corrugated roof supported on steel posts and trusses (Plate 17-18).

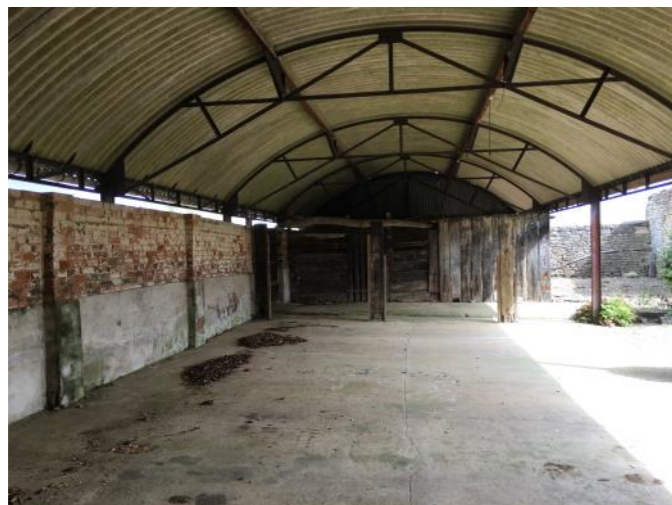
Plate 18: Bow roofed and steel supported storage shed at the rear of the main barn. Formerly location of shelter sheds for animals.

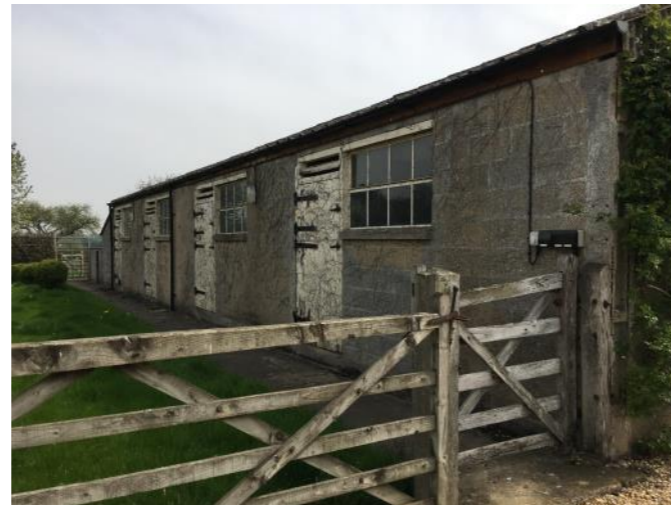
Plate 19: Building 17 concrete block structure to the east of the main yards. Doors and windows suggest possible stabling.

43. A concrete block building with metal truss and concrete beam roof (Plates 19-20) and a modern corrugated Dutch barn (Plate 21) are located outside the primary yard areas on slightly higher ground to the east.

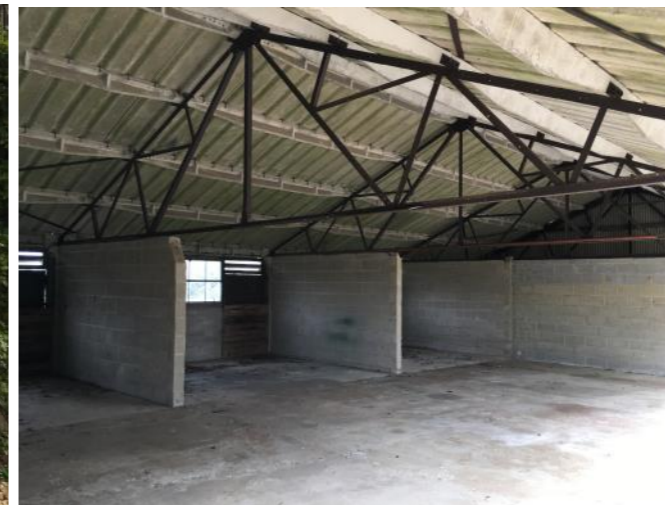
Plate 20: Building 17 interior showing steel truss, modern roof and concrete block walls. Vehicle storage has been most recent use and there remains no evidence or clues to any former animal accommodation function.

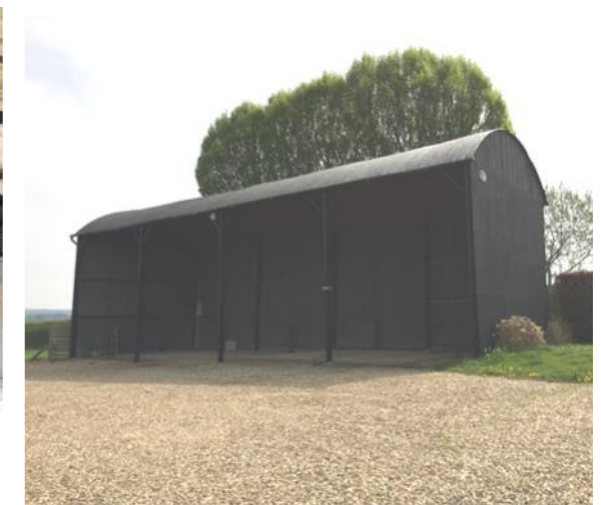
Plate 21: Modern Dutch barn on eastern edge of the site..

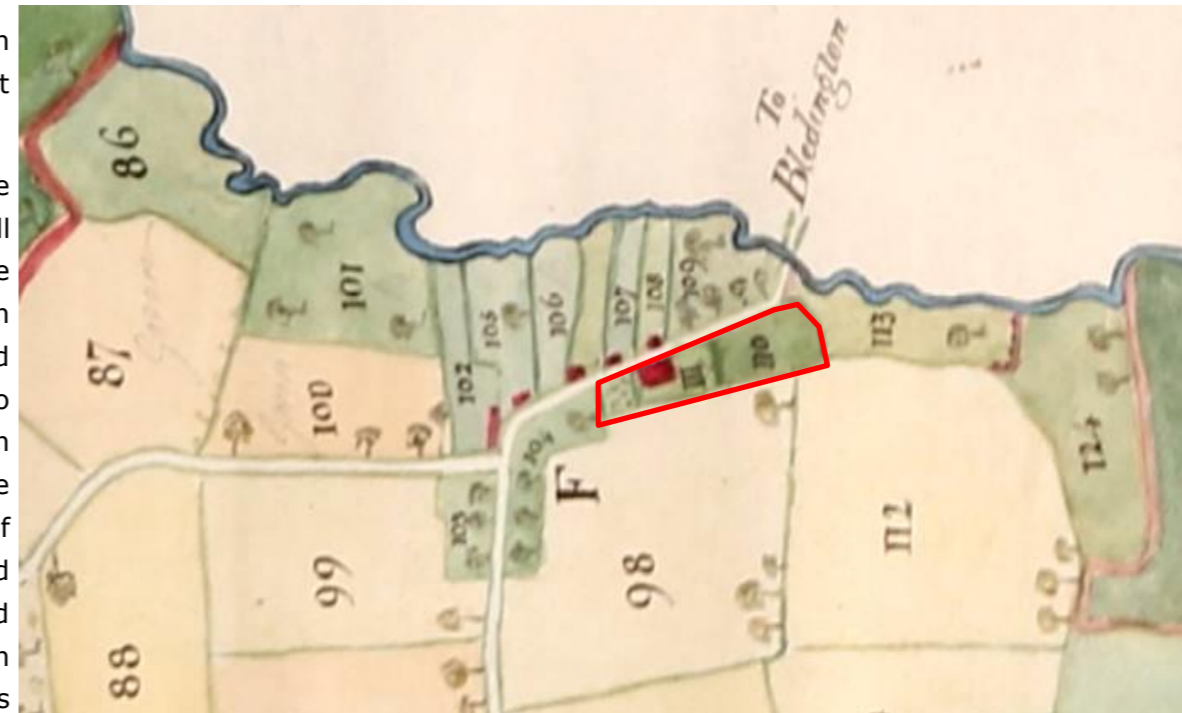
Figure 3: Extract from Estate map of 1778-9 (turned and reproduced with the permission of Leicestershire, Record Office, Ref: DG39/904 1779, Map of the Manor of Idbury, Bould and Foxcote surveyed by Wm Reeves (following enclosure)

51. Following the joining of the Idbury estate to the Turville Constable-Maxwell family estates in the second half of the 18th century a number of estate maps and valuations were prepared in 1768, 1780, 1799; that last mentioning Foxcote Farm specifically. The map (Figure 2) accompanying the valuation shows a single large square 'building', the valuation document identifies 'Foxcote Farm house, garden copse and yard'. The accompanying map is only indicative but from the scale of the red square in the location of the house it is considered that by this point at the end of the 18th century the farmhouse and stone range of buildings were constructed. The similarities in roof structure suggest that the house included its northern return range by the early 1800s.

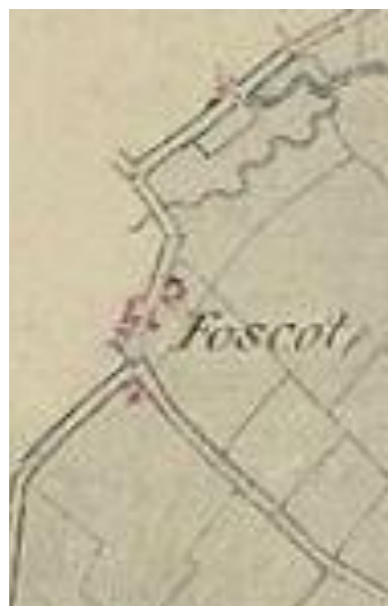
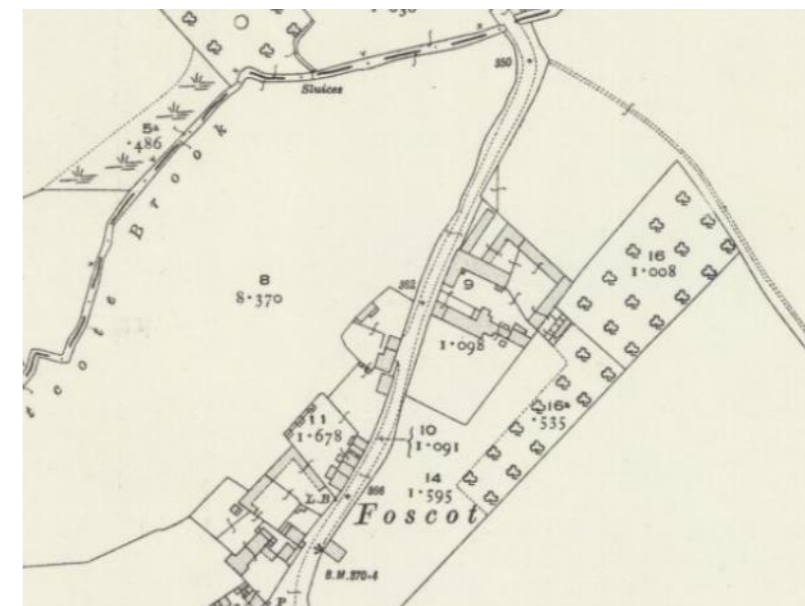
Figure 4-5: Map regression from left: **4: 1815** Ordnance Surveyor's Preparatory drawing does show a single yard (© British Library); **5: 1880** Ordnance Survey Gloucestershire XXIX.8 25 inches to one mile showing the extension of the farmhouse and secondary yard to the north east; **6: 1919-22** 25 Inches to one mile showing the addition of a structure adjacent to the road and a building on the current location of the vehicle store (possibly pig sties at that time).

52. The Ordnance Surveyors Drawing (1815, Figure 3) and viewed via the British Library's online collection shows the farm with a single yard enclosed on four sides. However, the detail is poor. The House, stables and barn appear to be in existence, along with a further building to the east enclosing the yard. None of the long ranges running to the north at the back of the main barn, or enclosing the secondary yard to the north east are depicted.

(Figure 4; though the bay windows are not shown and the 'tractor shed' is depicted as a timber structure infilling the northern angle of the building). The eastern extensions are shown with a slight step in the southern elevation line. The stable and long barn range are also present in their current form. To the north and east the current access and parking area was a fully enclosed yard with buildings (grey= timber or iron structures) on three sides and a wall or other boundary dividing it from the yard outside the house.

54. The 1922 OS edition (Figure 5) shows the addition of a narrow built range running adjacent to the road and north of the main barn. The structure on this footprint today

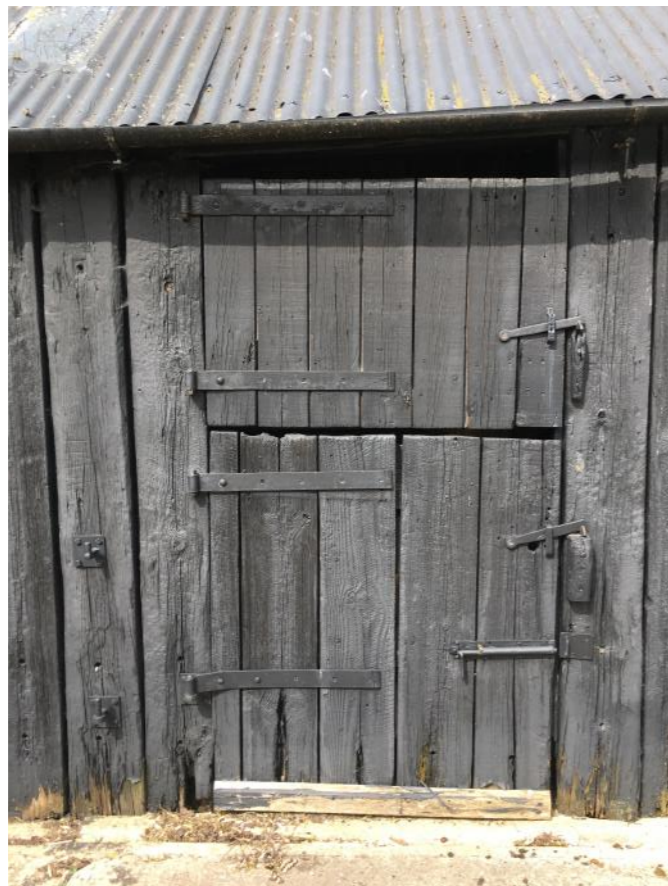
Plate 22: Stables doorway with typical mass produced ironmongery, matched elsewhere on the farm.

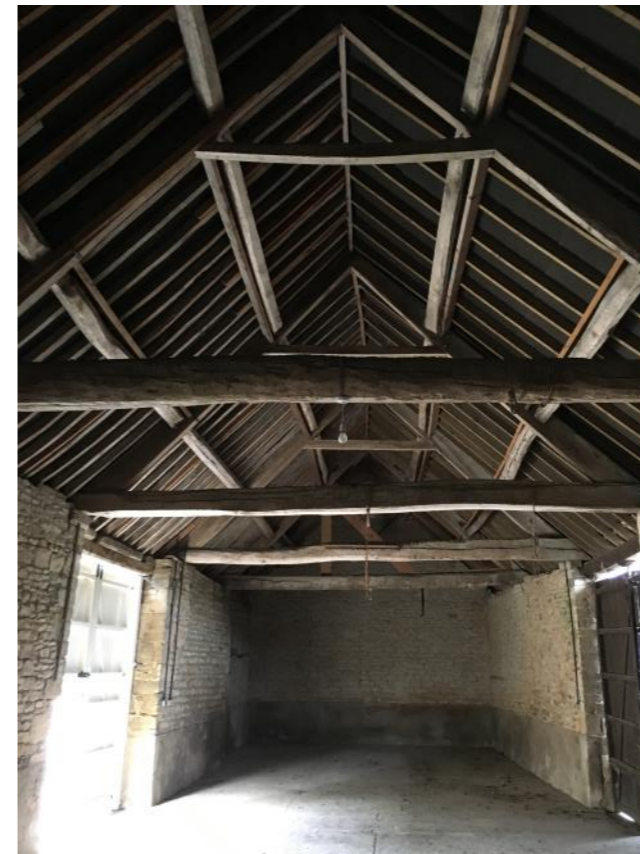
Plate 23: Main barn interior with tie beams and collars set beneath the upper tier of through purlins. All common rafters are replaced.

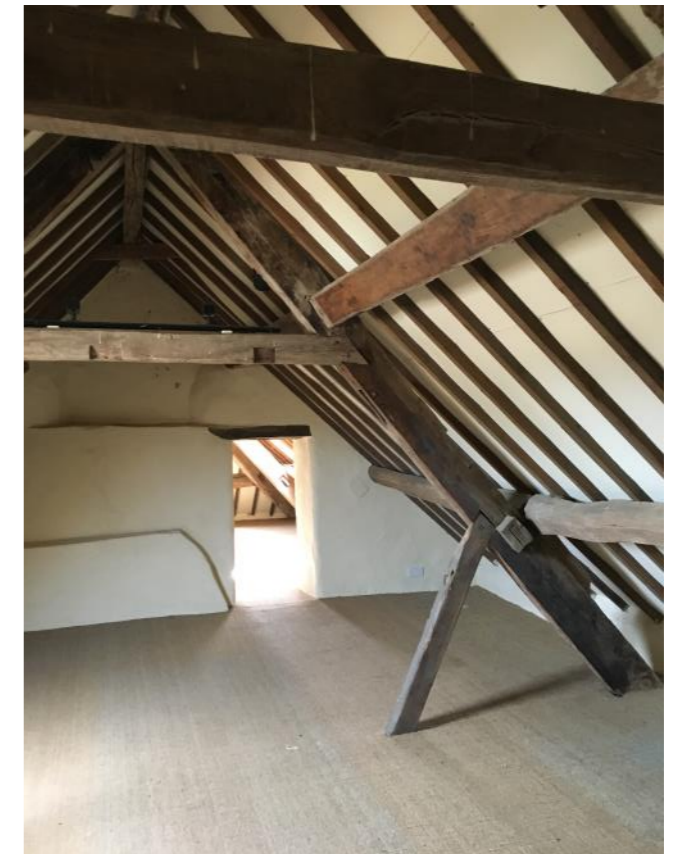
Plate 24: Main roof over the historic core of the farmhouse. Structure shows frequent new rafters associated with the re-roofing, evidence of removed, relocated and raised collars and braces and the re-positioning of the purlins to be lying over instead of butted up to the principal rafters.

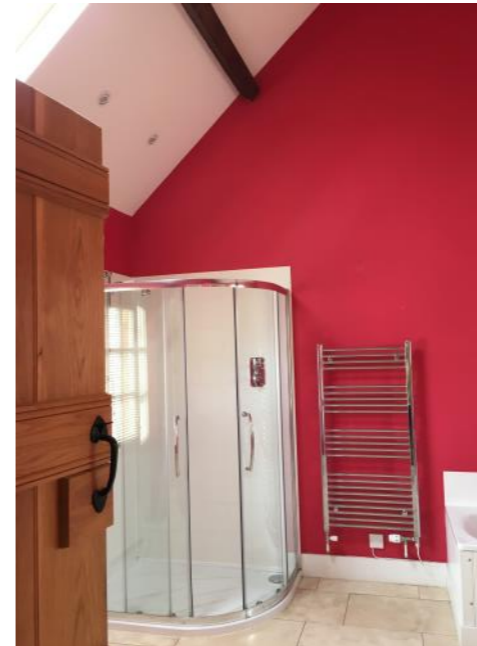
Plate 25: Modern bathroom inserted into eastern portion of the Victorian Extension and removing any heritage character or evidence of function.

68. The easternmost portion of the building, part of the Victorian extension, has been converted to form a bathroom and has lost all aspects of historic character or illustration of its original use. It has entirely modern fittings, doors and windows. This portion of the building now makes a very limited contribution to architectural values.

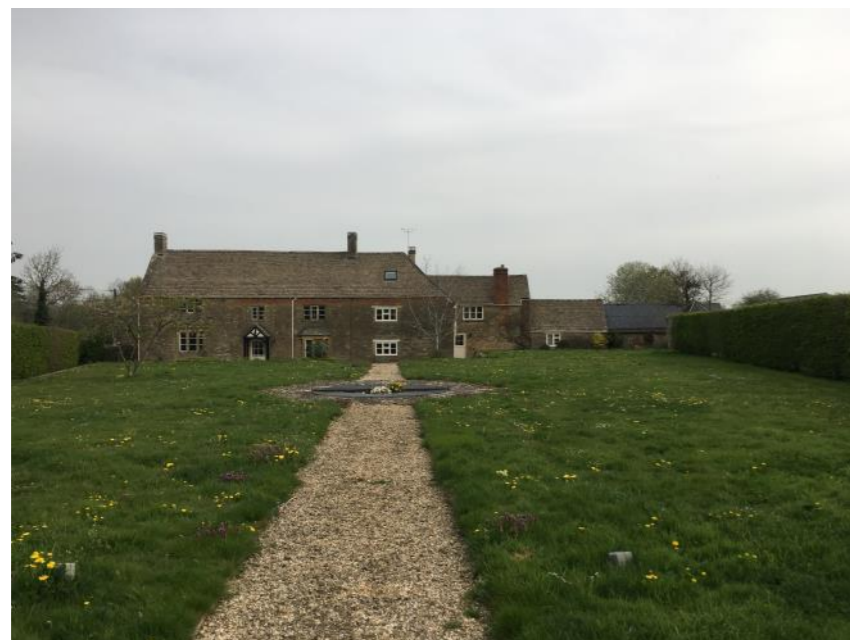
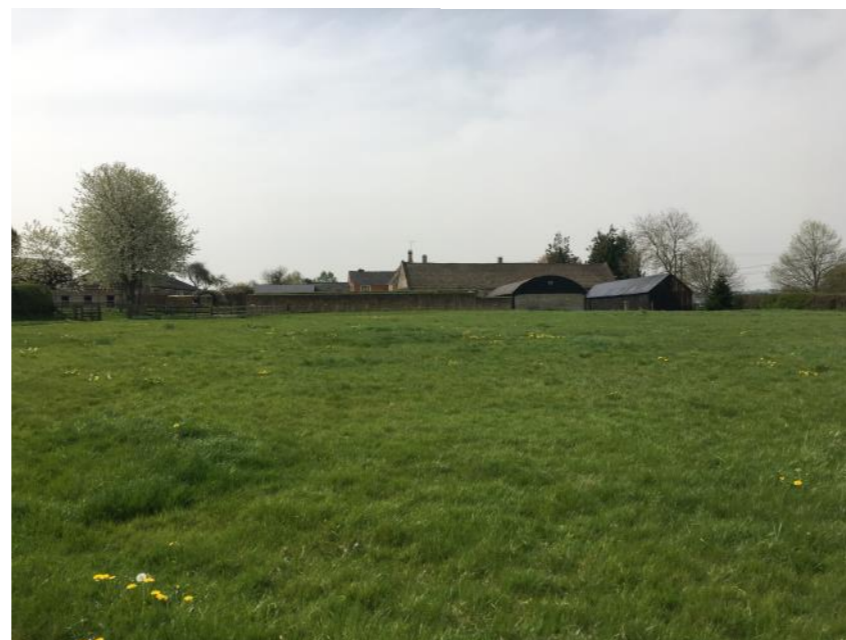
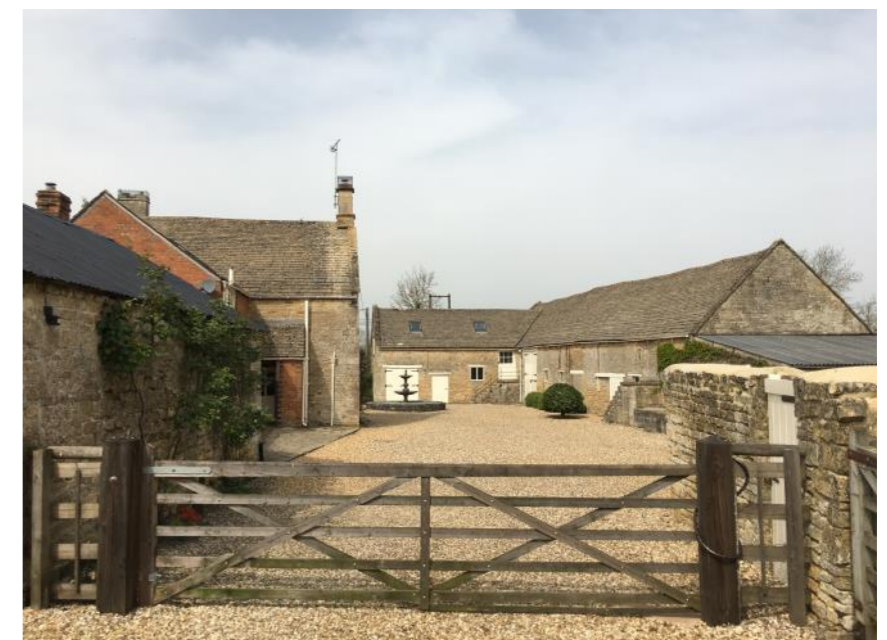
Plate 26-28: The setting of Foxcote Farmhouse. From left: the garden front of the farmhouse with the farm buildings not really visible behind. The farm buildings from the entrance to the north, farm house not really appreciable until approached; Looking into the main farm yard from the south where the close proximity and shared characteristics of the group is more directly experienced.
