## Cushenquarters Farm, Stirling, Bat & Breeding Bird Survey

A REPORT PREPARED BY THE  
WILDLIFE PARTNERSHIP  
JUNE, 2021

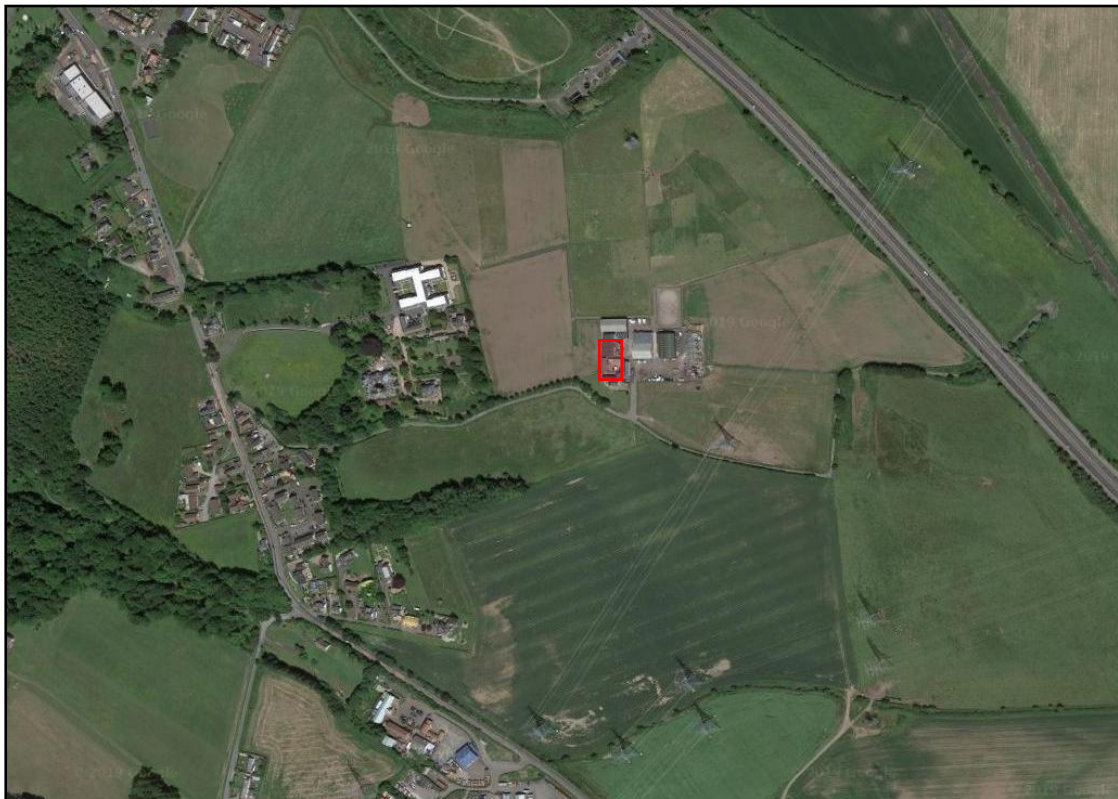
**Figure 1.** Aerial photograph showing the location of the building to be impacted at Cushequarters Farm; outlined in red and shown in more detail in Figure 2.

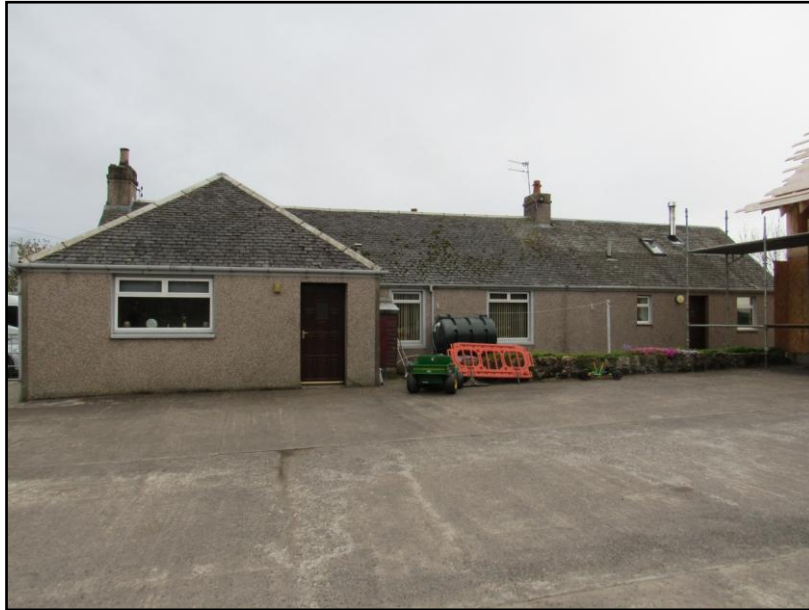
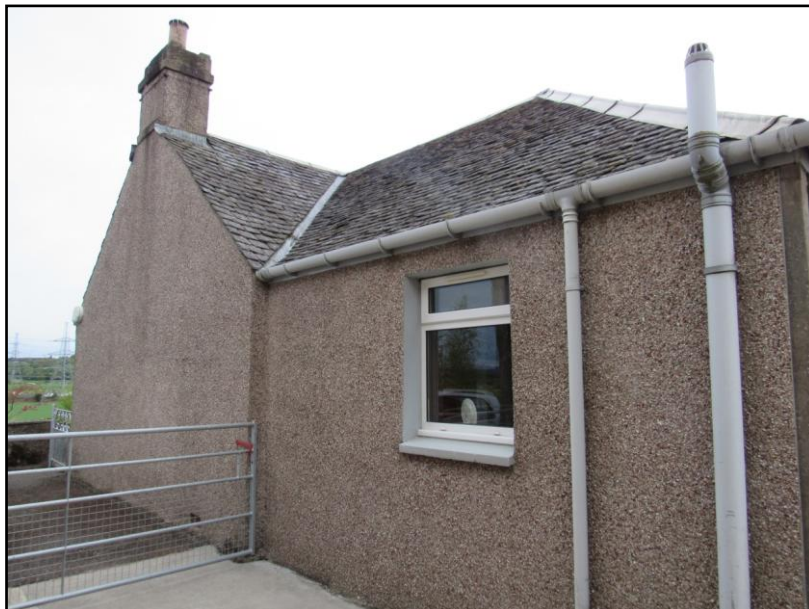
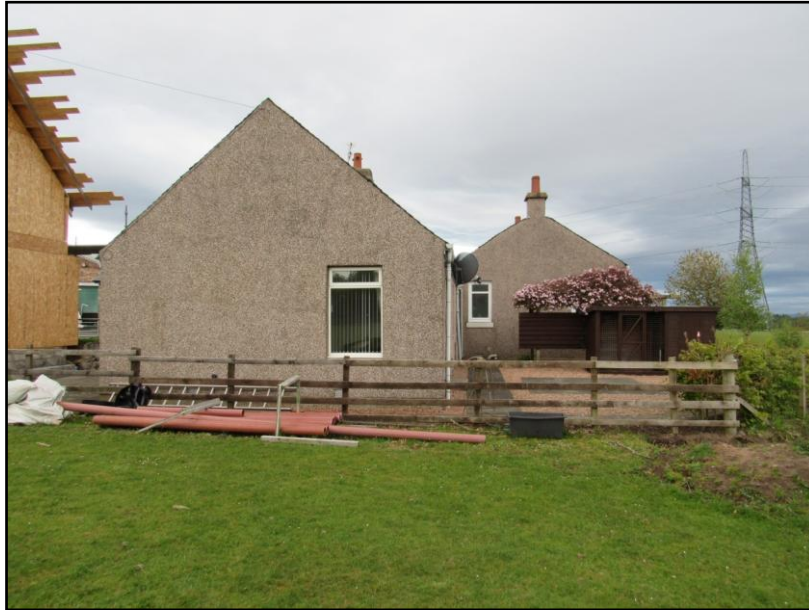
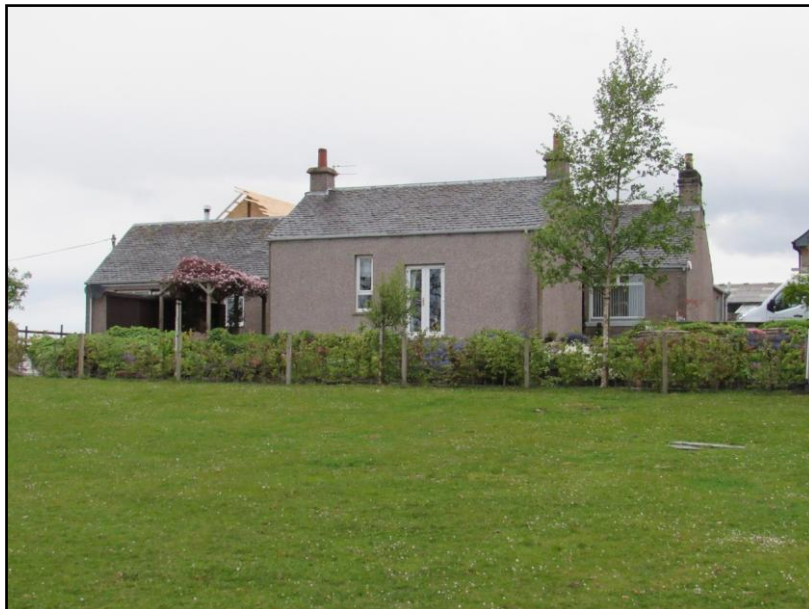
The farm cottage is a single-storied building constructed from concrete masonry units and coated in roughcast render throughout (see Figures 4-7). The pitched and hipped roofs of the cottage are all lined with grey slate with lead flashing along ridges and valleys. The building is in reasonable condition and the external render is tightly sealed with no cracks or crevices that could be exploited by bat species (Figure 8). Similarly, the building is well sealed around the eaves leaving no points of access to the space above the wallhead (Figure 9). However, there are an abundance of gaps between and beneath the slates (see Figure 10) providing direct access to the space between slates and sarking. There are also several sections of raised flashing providing access to the void beneath (Figure 11) this is a common roost site for crevice dwelling bat species. However, following a thorough inspection there was no evidence, across the external fabric of the building, to indicate the presence of bats. There was also no evidence, either current or historic, to indicate that birds have ever nested within the property.

**Figure 4.** Farm Cottage – northern elevation.

**Figure 5.** Farm Cottage – eastern elevation.

**Figure 6.** Farm Cottage – western elevation.

**Figure 7.** Farm Cottage – southern elevation.

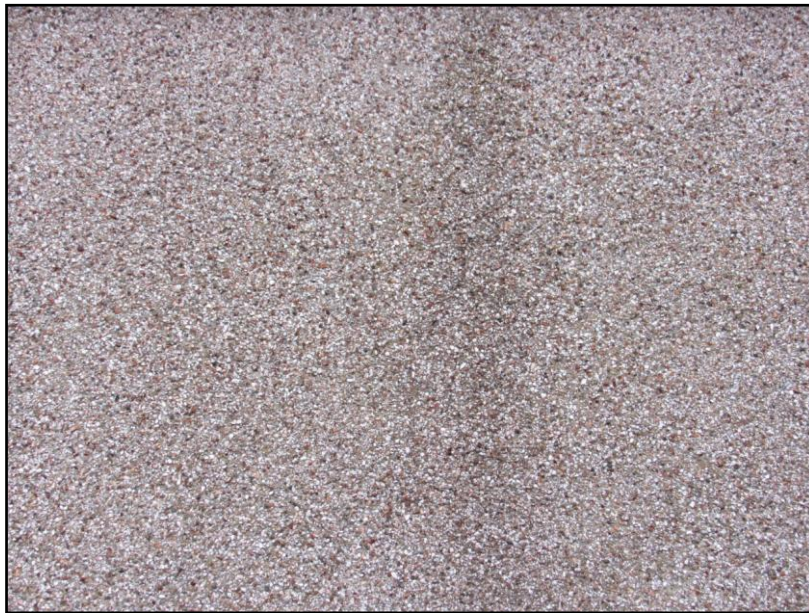
**Figure 8.** The external render is tightly sealed offering no points of access for bat species

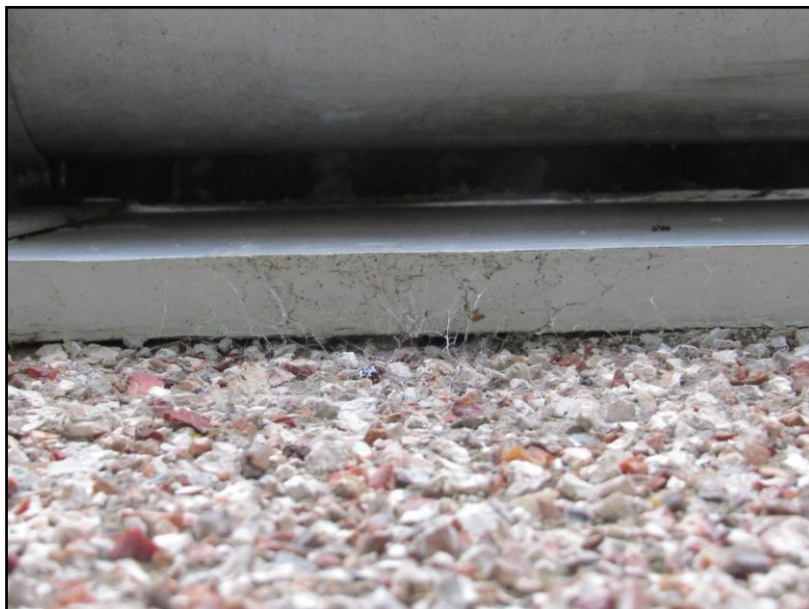
**Figure 9.** The fascia is tightly fitted to the render leaving no points of access for bat species around the eaves of the cottage.

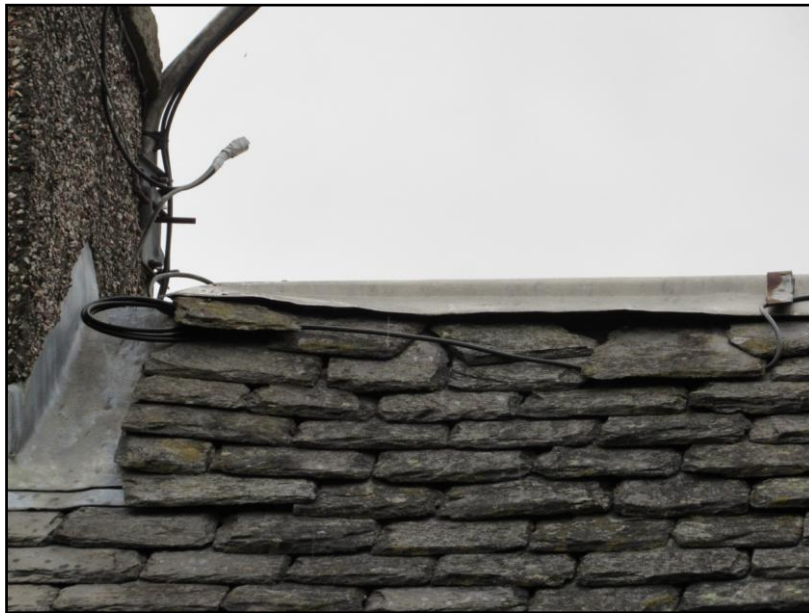
**Figure 10.** There are numerous gaps between and beneath the slates across the roofs of the cottage.

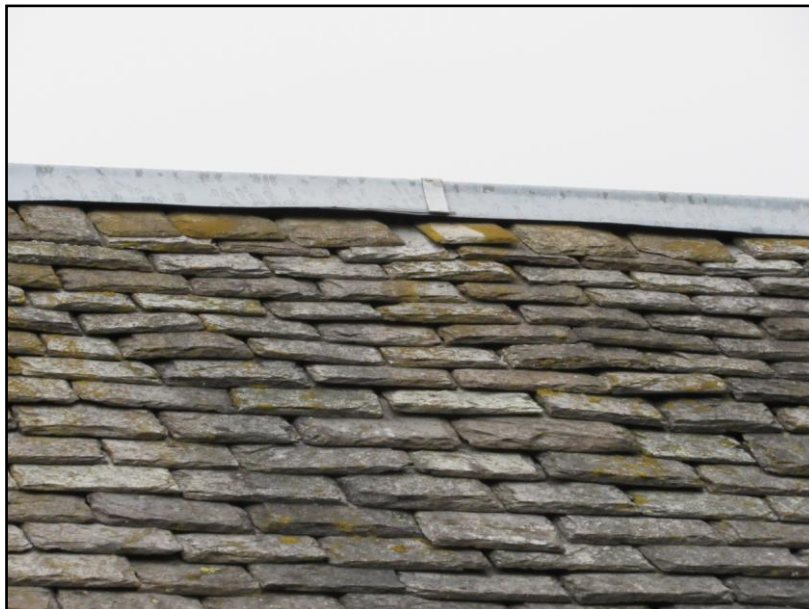
**Figure 11.** The void beneath ridge flashing is a common roost site for pipistrelle bats.

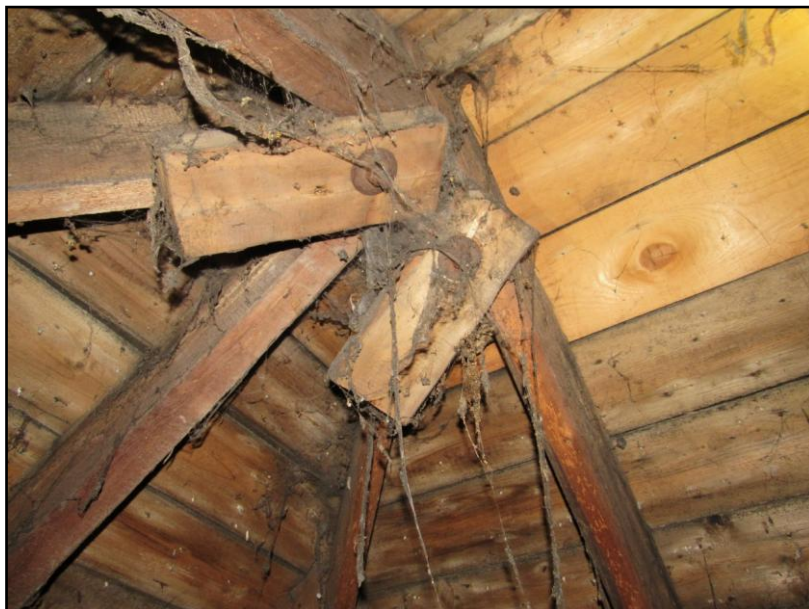
**Figure 13.** Potential roost sites across the roof are obscured by cobwebs.

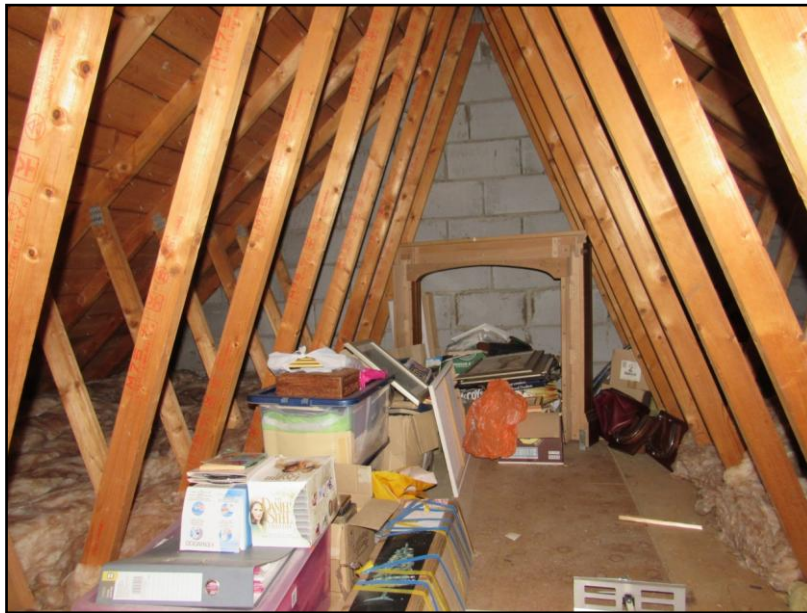
*Roof Void B* - This is a small, linear, roof void cluttered by a variety of supporting struts and lined with wooden sarking throughout (Figure 14). The roof void has a floor to apex height of approximately 2m and is currently used for storage. Despite a thorough inspection there was no evidence to indicate the presence of bats and potential roost sites across the roof coverings were coated in cobwebs (Figure 15).

**Figure 14.** Roof void labelled B in Figure 3.

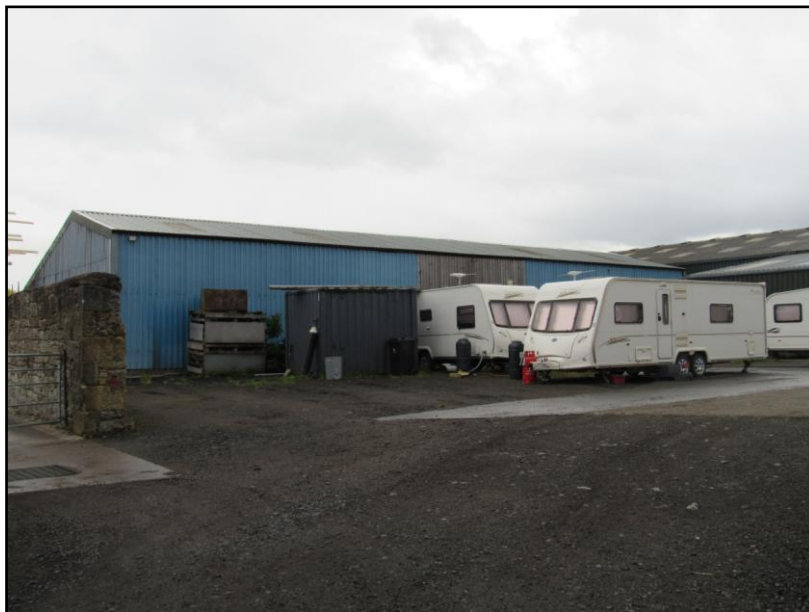
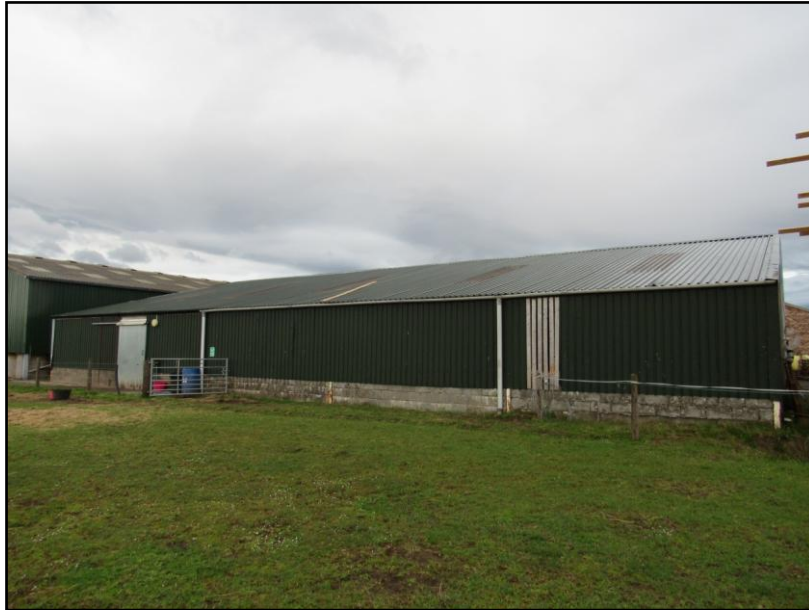
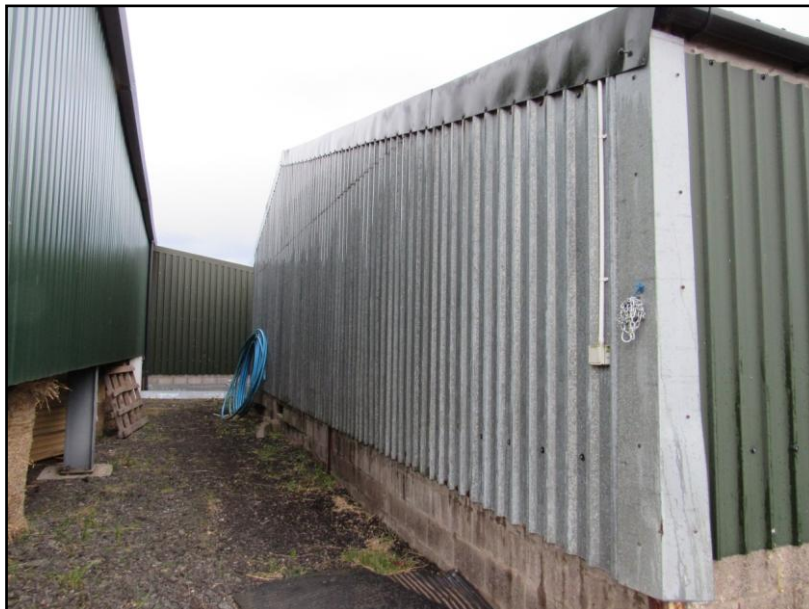
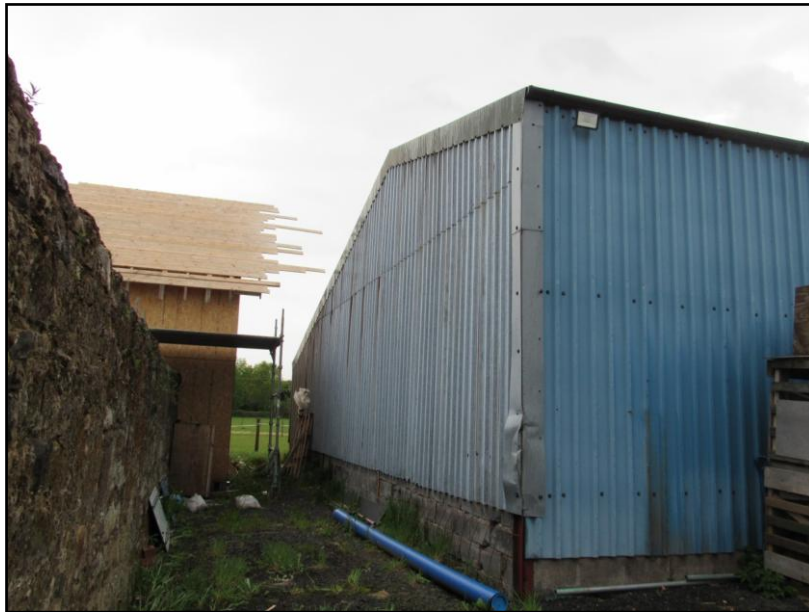
This is a large, agricultural shed constructed entirely from single-skinned, folded steel panels on a base of concrete masonry units (Figures 16 – 19). The steel panels are tightly sealed and present a smooth surface that would offer no purchase for bat species and is considered to be wholly unsuitable for roosting bats. The presence of regularly spaced security lights around the eaves of the shed makes the presence of bats even more unlikely (Figure 20). In buildings of this type potential roost sites can often be found at the junction between the base and steel panels; however, all of the locations were tightly sealed and no potential roost sites were identified anywhere across the external fabric of the building.

**Figure 16.** Agricultural shed – eastern elevation.

**Figure 17.** Agricultural shed – western elevation.

**Figure 18.** Agricultural shed – northern elevation.

**Figure 19.** Agricultural shed – southern elevation.

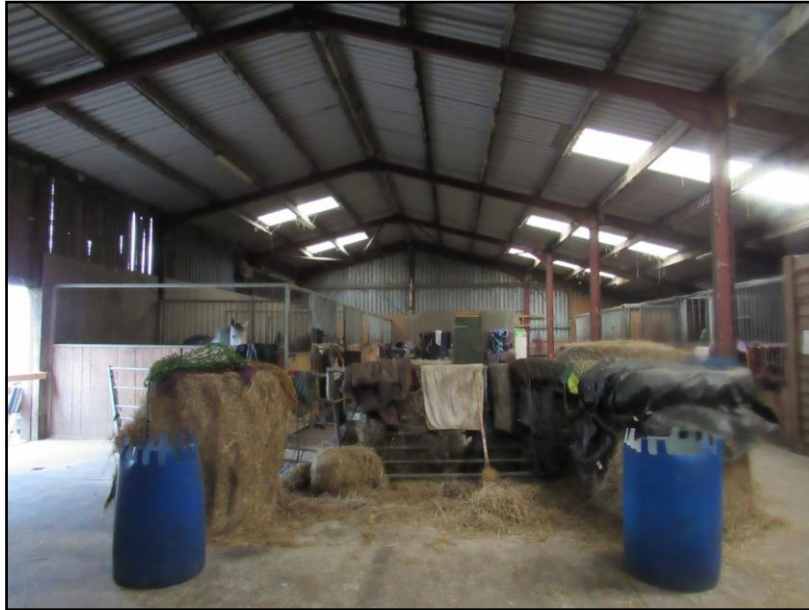
Internally the shed is currently used to stable horses and is brightly lit by a series of regularly spaced roof lights creating a light regime unlikely to be suitable for roosting bats (Figure 21). Despite a thorough inspection there was no evidence to indicate that bats have ever been present within the shed and no potential roost sites were identified. However, although, there was no evidence of bats within the shed the steel framed roof provides an abundance of nest sites for swallows and at least three active nests for this species were identified. A solitary pigeon nest was also present but no birds were seen accessing this nest throughout the current survey.

In summary, there was no evidence, either internally or externally, to indicate that bats have ever been present within the shed and it is considered to be wholly unsuitable for roosting bats.

**Figure 21.** The interior of the shed is brightly lit and wholly unsuitable for roosting bats.

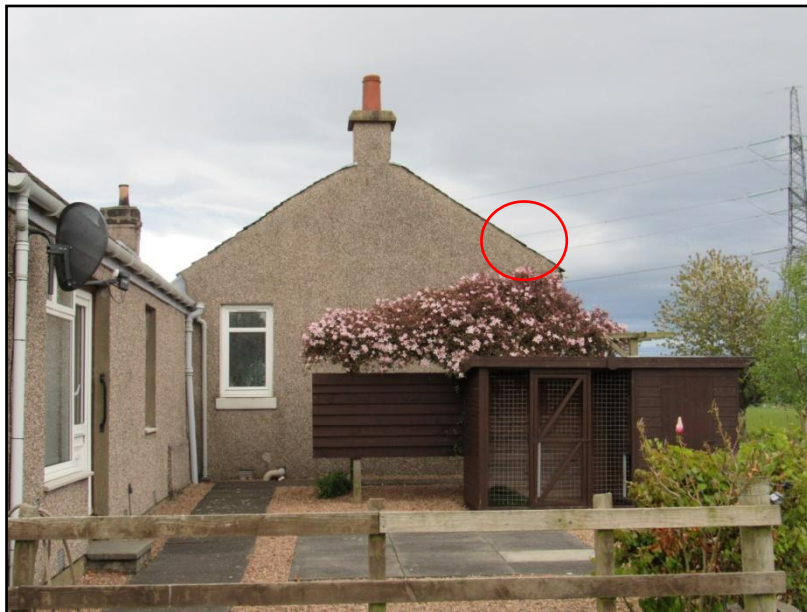
Bat activity was very low throughout the dawn survey and comprised a total of two soprano pipistrelles foraging intermittently across the site. At 03:45 one of these bats were clearly observed commuting out of the site to the west leaving only a solitary bat which surveyors were easily able to maintain contact with. This bat (soprano pipistrelle) began to swarm around the southern elevation of the cottage at 03:51 and was observed entering a roost site beneath a slate on one of the western gables at 03:54 (roost site shown in Figures 22 & 23 and labelled Soprano pipistrelle roost A in Appendix 2).

**Figure 22.** Soprano pipistrelle roost identified on the western gable of the farm cottage – roost site shown in more detail in Figure 23 and labelled A in Appendix 2.

A mitigation plan which would ensure no net loss of roosting habitat and provide protection for bats currently roosting within the site is outlined in Appendix 4. It should also be noted that this site only provides small non-breeding roosts for soprano pipistrelle bats and would; therefore, fulfill the criteria for a Bat Low Impact Licence or BLIMP (see below).

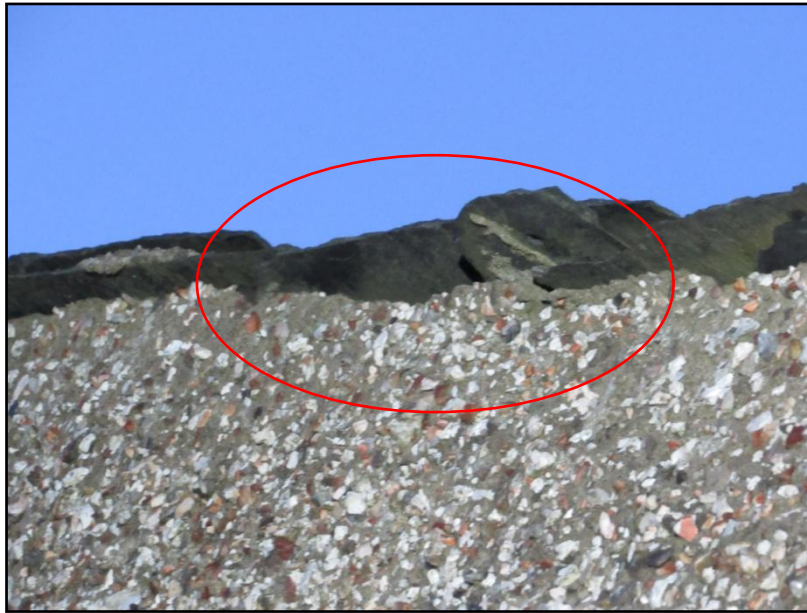
**Figure 23.** Soprano pipistrelle roost labelled A in Appendix 2 - only a solitary bat was ever recorded within this roost.
