**RESULTS OF FURTHER BAT SURVEY WORK
(1st Emergence survey only)**

**No. 2 THE PARADE, MALPAS ROAD,
TRURO, CORNWALL**

August 2021

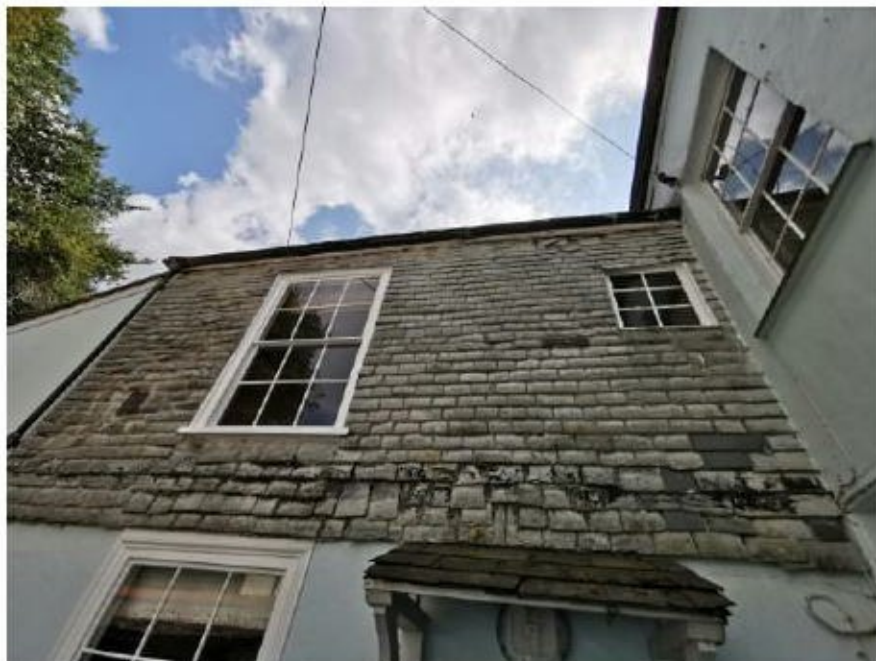
The building subject to this survey is a large two storey early 19th Century terraced house with a two-storey extension to the north. The terrace of houses sits on a high terrace raised above the road to the west looking out over the City of Truro and the river. The main part of the house is rendered with the western face having the finer finish with a cast iron glazed veranda and the properties garden being to west. The roof on this part of the building is pitched and covered with slate and has a glazed light well built into the roof. To the east is a small, paved courtyard with the extension forming the southern side and contains a small outbuilding with a slate covered mono-pitched roof. The roof on the rear extension is hip ended and there is a lean-to on the end with a glazed side. The upper part of wall facing into the courtyard on the extension is clad with hanging slates which is in poor condition, see photos 1 to 4.

Photo 3. Showing the wall hanging slates on the rear extension

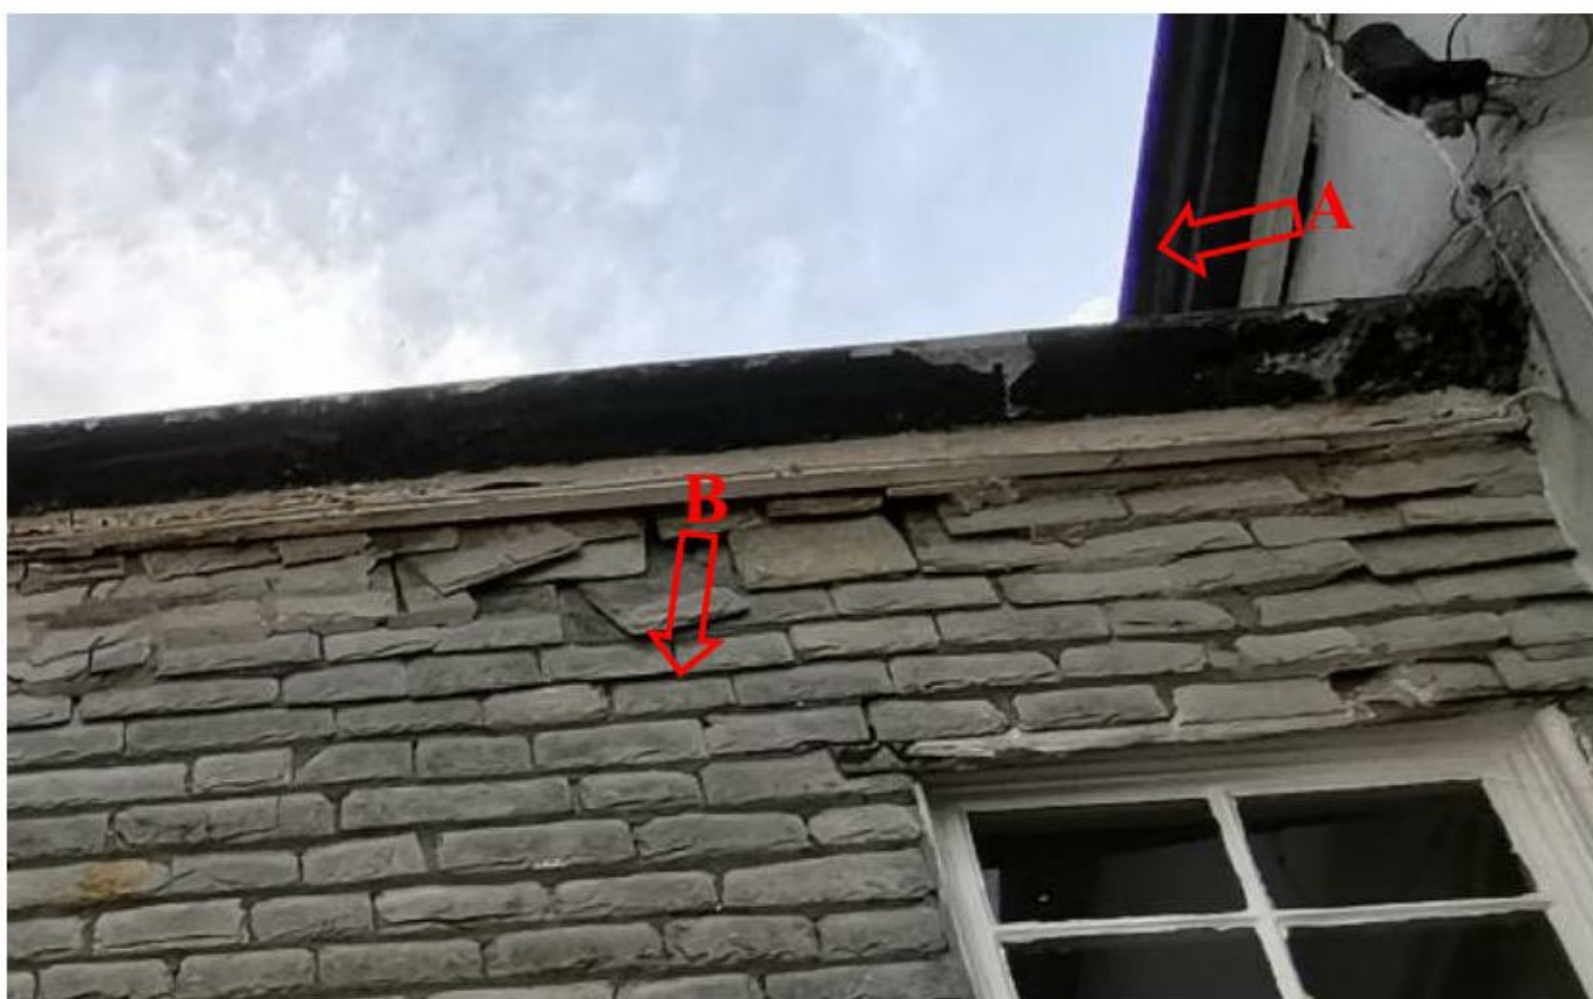
The first bat activity noted was from a Common Pipistrelle which emerged from behind a fascia board on the main house at 20.36 (A). Then at 20.39 a further Common Pipistrelle was seen to emerge from the gap between the hanging slates and the fascia close to the main house on the extension (B), see annotated photo figure 1. Single occasional passes by Common Pipistrelles along the treelined lane to the east of the house were noted throughout the survey along with a single Noctule pass.

Figure 1. Annotated photo showing the location's bats were seen to emerge from, letter showing location bat emerged from

The proposed works should not impact access point and roosting site A but access point B is near certain to be impacted when the slates are repaired or replaced, see figure 1. Individual bats could also be disturbed or injured if present when the works are undertaken.

In this instance, the existing roosts can be retained or recreated with minimal disturbance. Access point/roosting site A can be retained with access point/roosting site B being recreated by retaining a crawl-in access point in between the hanging slates and fascia at the same location, see figure 1. The works can be undertaken at any time of year.
