Melendo, Congresbury
Bat Scoping Survey Report

On behalf of Julia Stuckey

Avondale Ecology

AE322
Revision: 1
September 2021

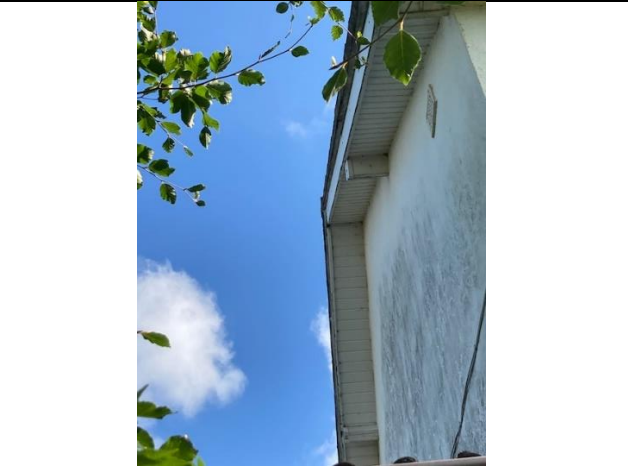
The detached house appears to date from the 1960/70s and is constructed of concrete block and brick with intact render. Externally, the building is in excellent condition. uPVC soffits are intact and flush to the wall with no access for bats or nesting birds under the eaves or on gable ends. Brickwork and flashing around the chimneys is intact. Interlocking concrete tiles are in good condition with no obvious slipped tiles and mortar under ridge tiles appears to be entirely intact. There were no obvious accessible features suitable for roosting bats on the exterior. The roof on the extension is in excellent condition.

A.4 Sealed soffit on eastern gable

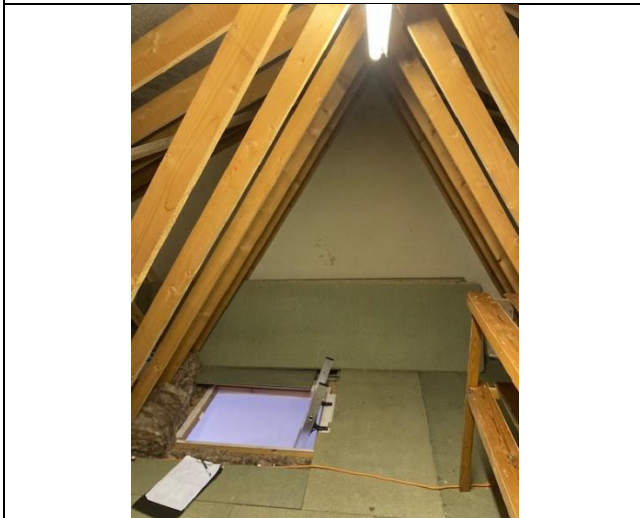
Internally, there are two lofts. The loft above the single storey extension is approximately 2m high (maximum), 3.5m long and 6m wide. The trussed construction using softwood timbers is cluttered. Bitumen underlay appears entirely intact. End rafters are flush with the block wall and the loft appears to be entirely sealed to bats, particularly as there is thick insulation under the eaves. A vent on the eastern gable end has a grill with 5mm x 5mm holes which is too small for bats to access. There was no evidence of use by bats, although there were occasional mouse droppings.

A.5 Loft above single storey extension

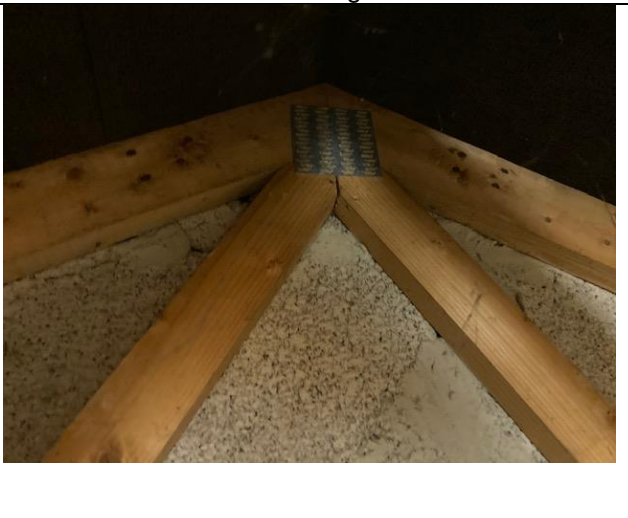
A.6 Sealed end rafter in extension loft

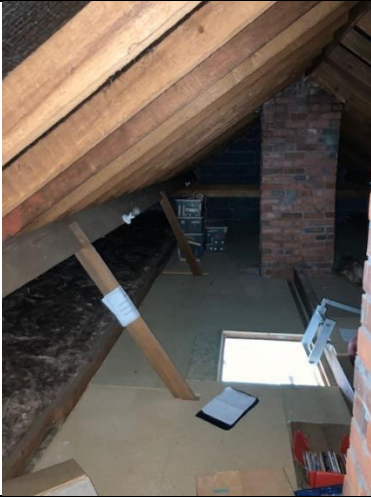
The main loft above the two storey section of the house is approximately 2.5m high, 11m long and 6m wide. The loft was noticeably very warm at 24°C (5°C above the outside temperature). The two chimney stacks constrain the space but otherwise, the loft is open and uncluttered. The roof is lined with bitumen underlay which is intact except for one small tear around the western chimney. There was no evidence of recent use of this feature by bats accessing the loft as thick cobwebs were evident around the feature and chimney. There were possible gaps around brick and block at the gable ends, although expanding foam was present in some areas. Access at these locations would be prevented by the intact and sealed external soffits in any case. There were 4 old (>6 months) mid-sized bat droppings, typical of long-eared species, close to the western gable. The most likely location for access would be around the western chimney. There were insufficient droppings to gather to send off for DNA analysis.

A.7 Main loft above two storey section

- A Toolbox Talk by a suitably qualified ecologist to any contractors and pre-works inspection of the main loft before removal of the eastern chimney;
- Eastern chimney to be removed when bats are unlikely to be present during October to April inclusive;
- Potential bat access to loft to be retained around western chimney;
- Work to be completed as quick as possible (within 1-2 days ideally) and roof to be reinstated; and
- If a roosting bat(s) is unexpectedly present at the time of works or if evidence has substantially increased, the licensed ecologist will agree a revised methodology which may require a Natural England licence.

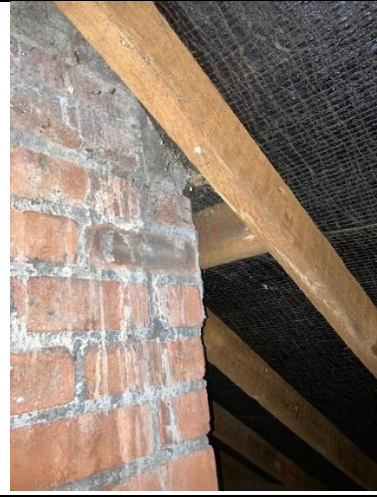
The building is in a good condition, with the roof intact and in excellent condition. In the main loft over the two storey section, four old mid-sized bat droppings (likely long-eared species) were found by the western gable end. The only obvious bat access was via a tear in underlay by the western chimney, although the entrance was cobwebbed and there was no evidence of recent use. This feature will be retained. There was no evidence of use by bats and no obvious bat access into the smaller loft above the north-east extension. There was an intact uPVC soffit on the eastern gable with no potential bat access at this location.

A.8 Small tear beside chimney
