## 209 Gilesgate, Durham City DH1 1QN

### Heritage Statement

### Proposals

The proposed works consist of removing an unsafe brick skin to the gable wall and rendering the wall in a sand, cement, lime render

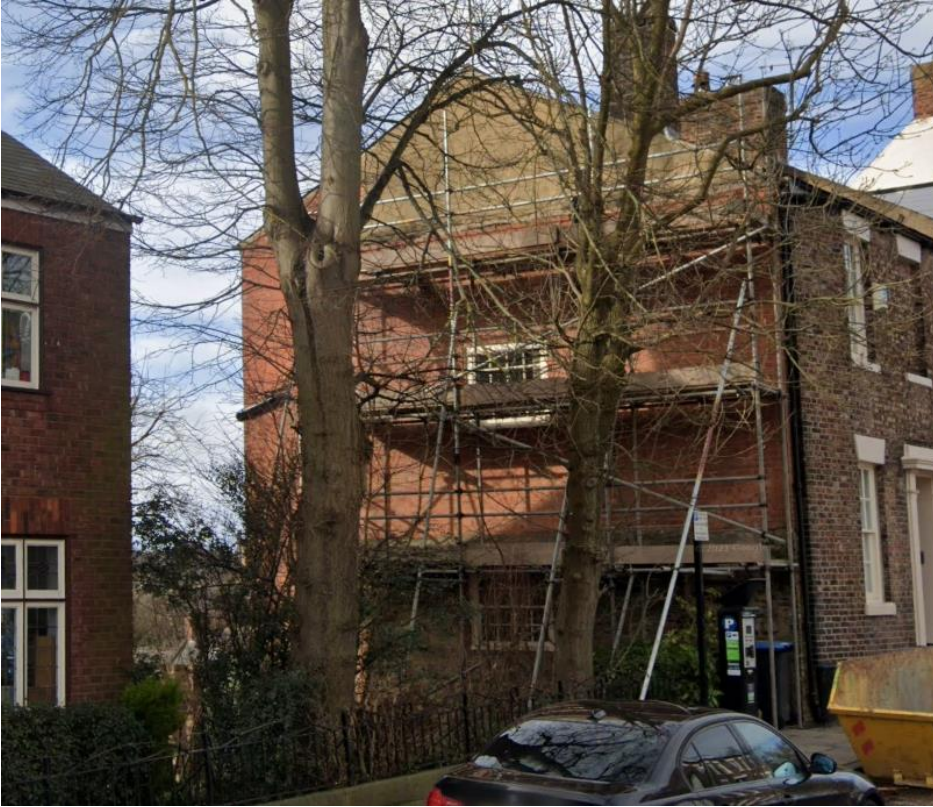
Gable elevation

The gable had an extra brick skin added in the 1960's which is not tied into the main building. This has resulted in the new brickwork curling away from the building to the extent that it is now unsafe.

The proposals will remove an unsafe 1960's addition, and provide an unobtrusive replacement.

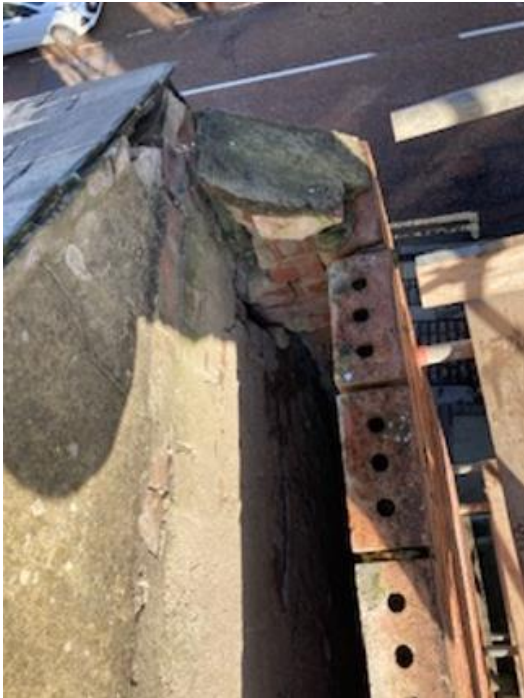
Photograph of unsafe brick skin at eaves interface

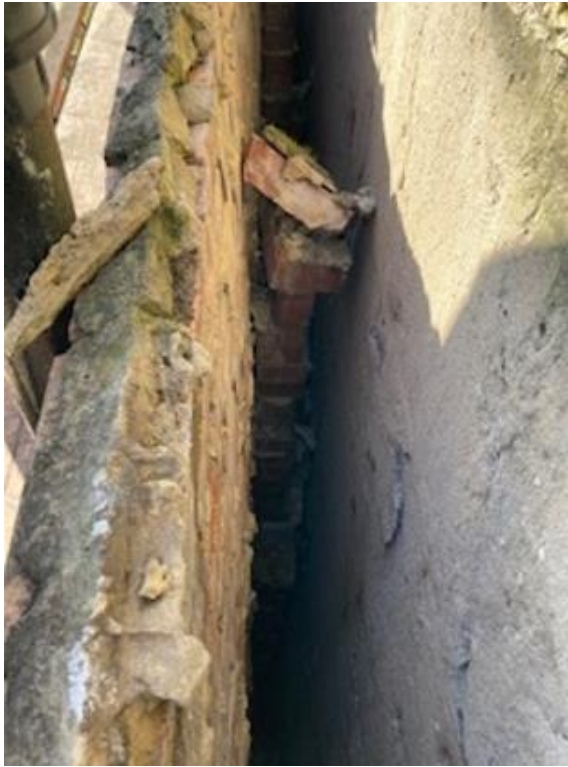
Photograph of brick skin curling away from the original house wall, also showing how it has not been tied into the original wall.
