Bat Survey: Buildings at Church House Farm, Clee St Margaret, Craven Arms SY7 9DT

Site Visit 1: 24th August 2020
Site Visit 2: 28th August 2020
Site Visit 3: 28th September 2020
Site Visit 4: 30th September 2020
Report Submitted: 30th November 2020

Report Reference: EG/2430/20.1

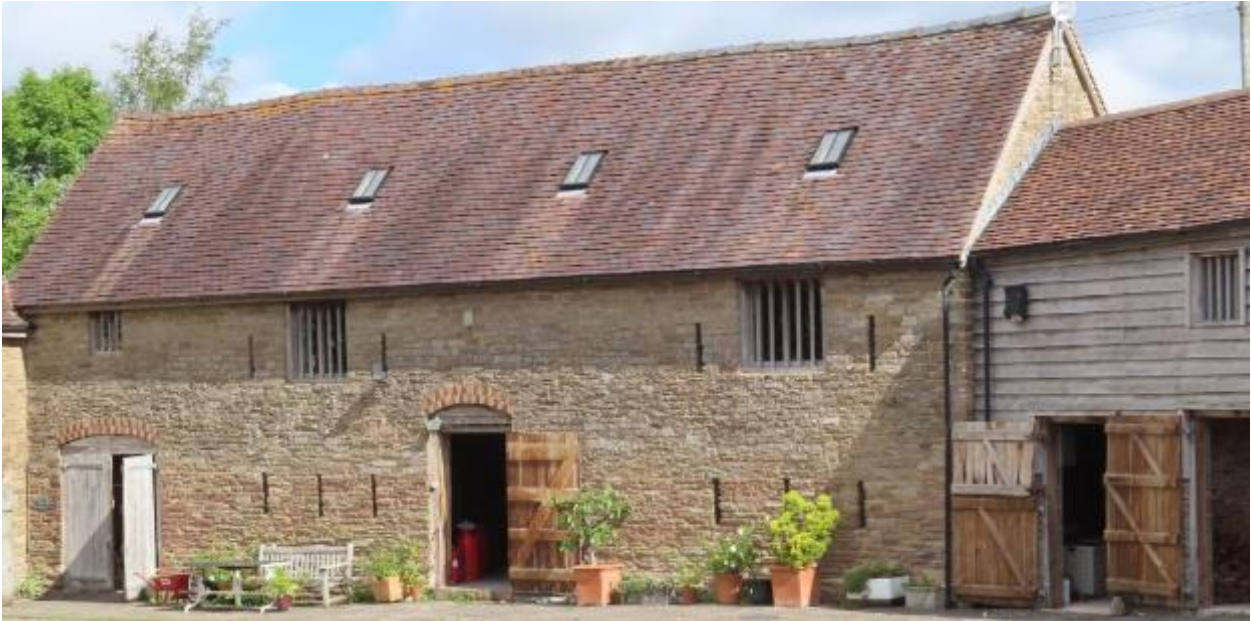
Photograph 1. Buildings at Church House Farm. Exterior.

Left and centre: Building 1 South elevation.
Upper right: part of the Building 1 East elevation (gable).
Lower right: part of the Building 2 Southwest elevation.

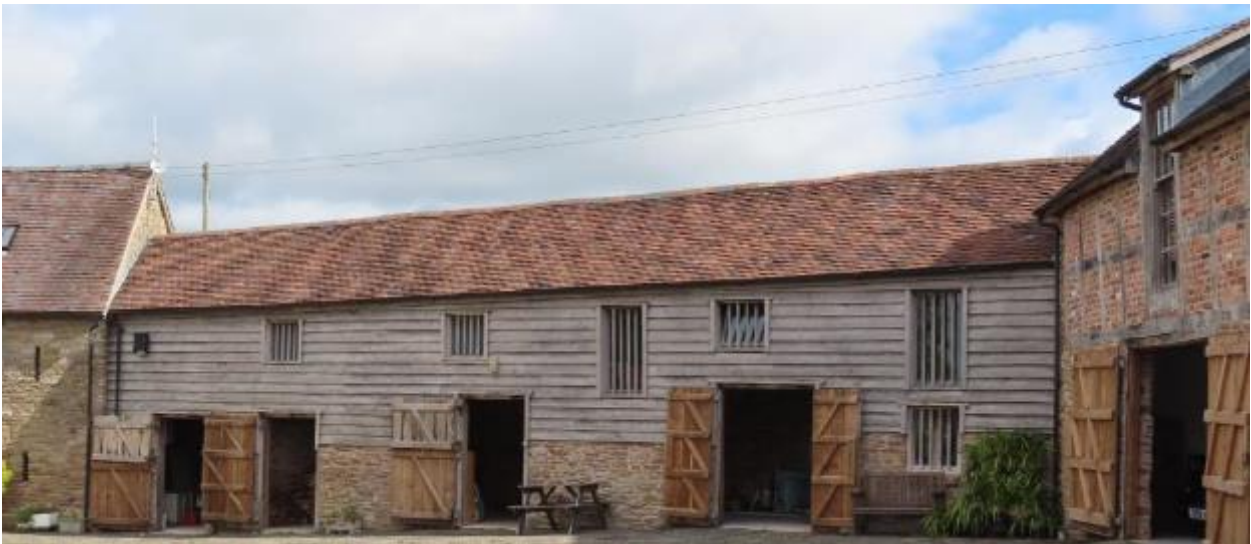
Photograph 2. Buildings at Church House Farm. Exterior.

Left: parts of the Building 1 East and South elevations.
Centre: Building 2 Southwest elevation.
Right: part of the Building 3 West elevation.

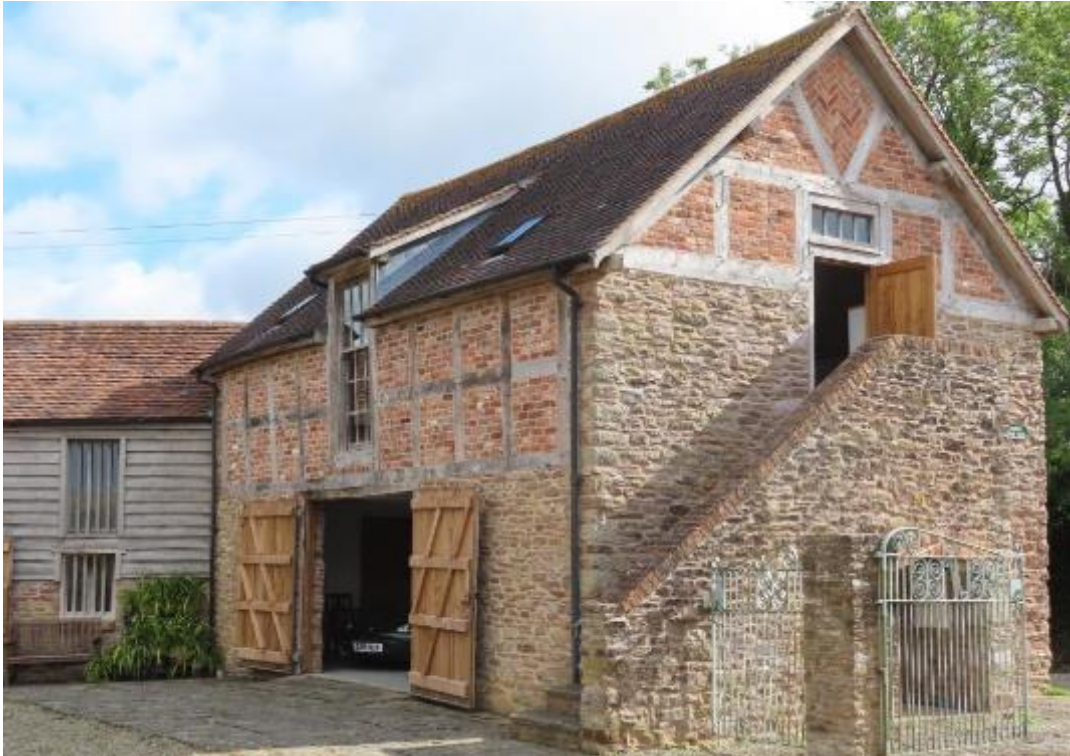
Photograph 3. Buildings at Church House Farm. Exterior.

Left: part of the Building 2 Southwest elevation.

Centre: Building 3 West elevation.

Right: Building 3 South elevation.

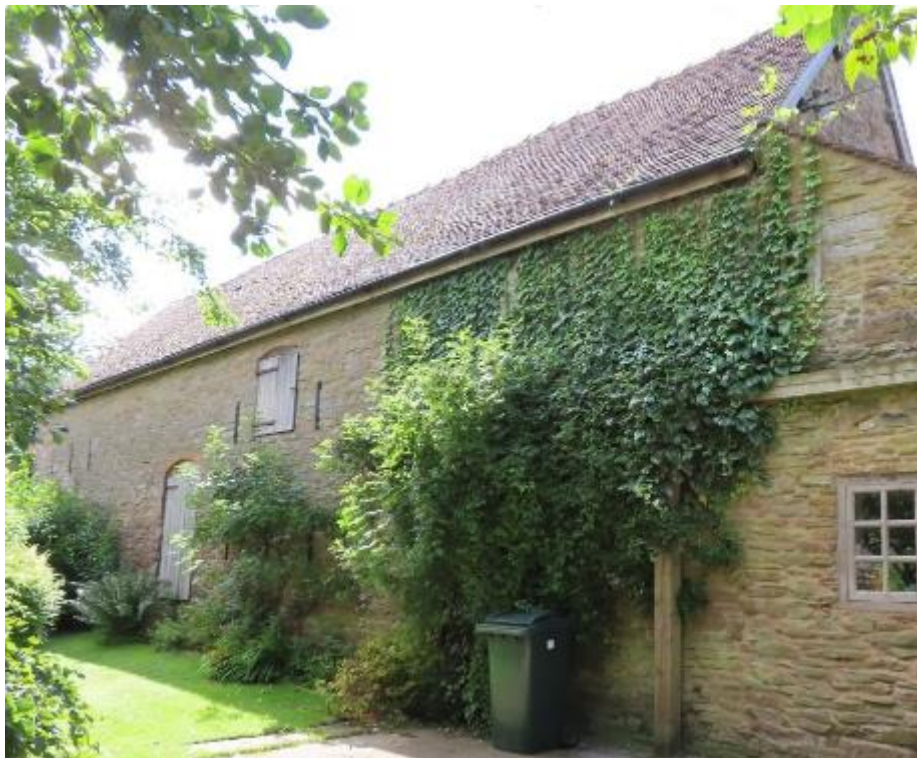
Photograph 4. Buildings at Church House Farm. Exterior.

Left and centre: Building 1 North elevation.

Upper right: part of the Building 1 West elevation (gable).

Lower right: part of the Church House house.

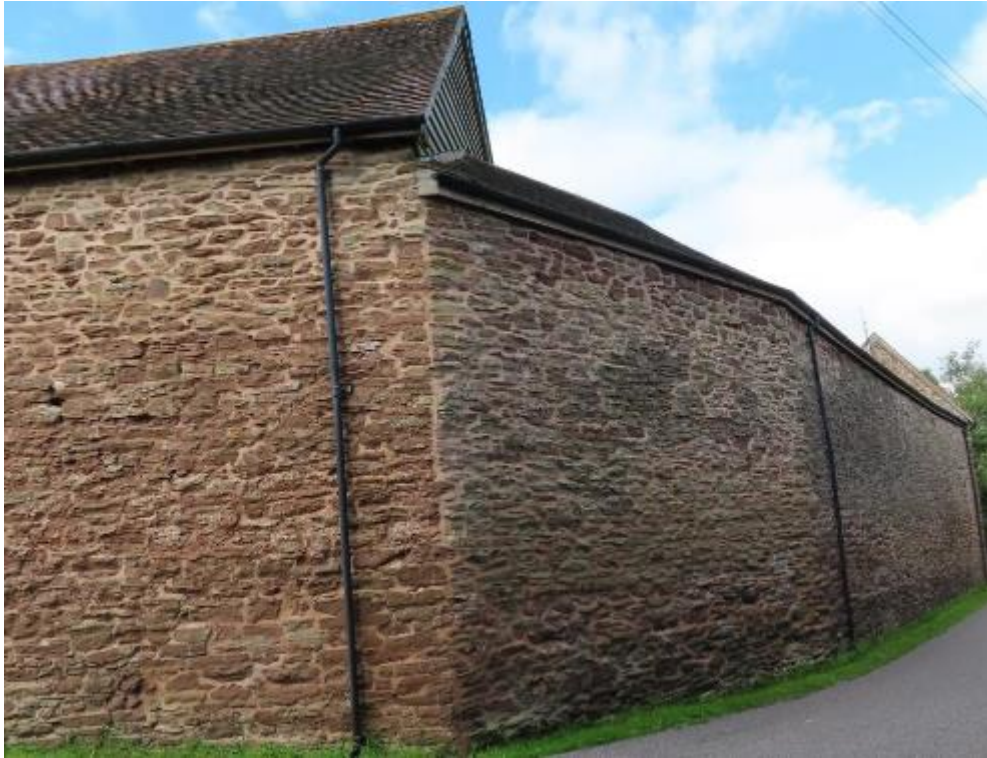
Photograph 5. Buildings at Church House Farm. Exterior.
Left: part of the Building 3 East elevation.
Centre and right: Building 2 Northeast elevation.

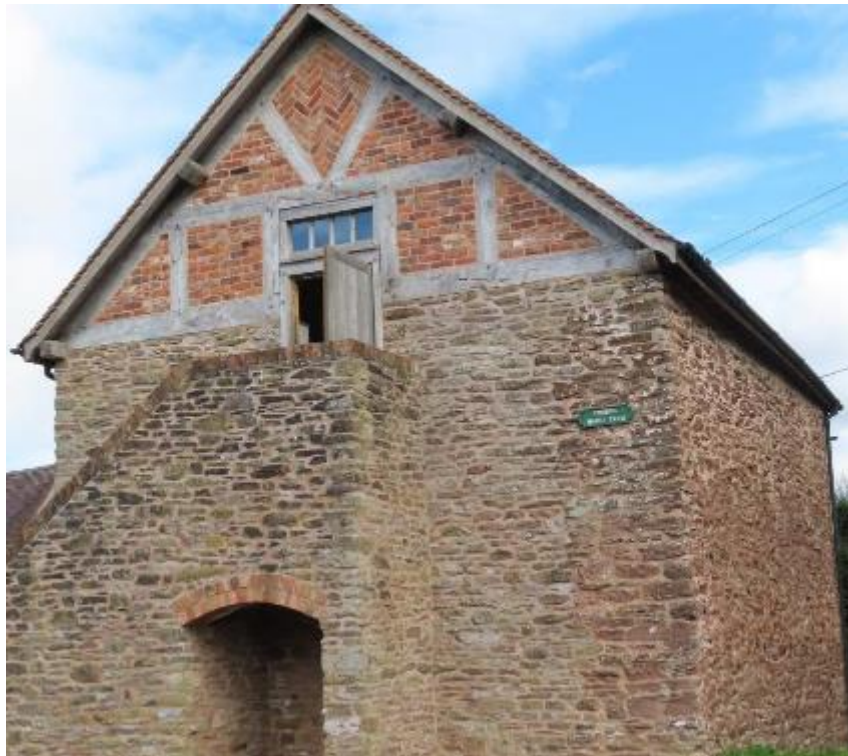
Photograph 6. Buildings at Church House Farm. Exterior.
Left and centre: Building 3 South elevation.
Right: Building 3 East elevation.

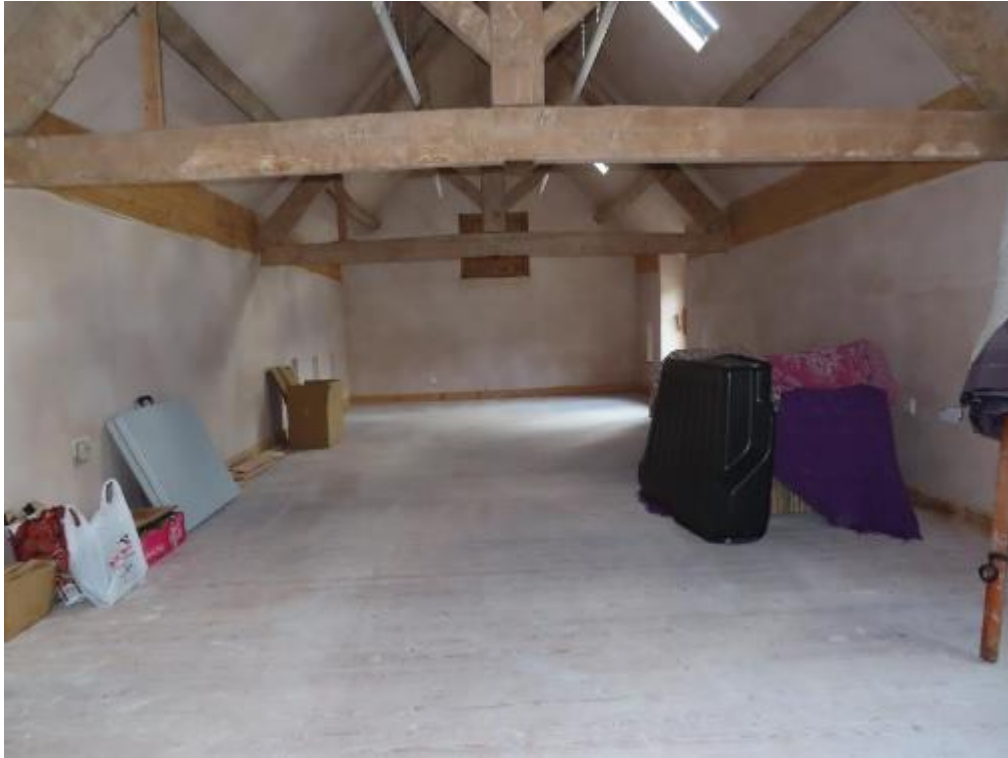
Building 1 is in good structural condition.
Building 1 does not provide bat roost habitat.
There is no potential bat access to the Building 1 roof structure or to the interior of Building 1.

Photograph 7. Buildings at Church House Farm. Interior.
View of the main (central and east-end) first-floor room of Building 1.
Looking east from west.

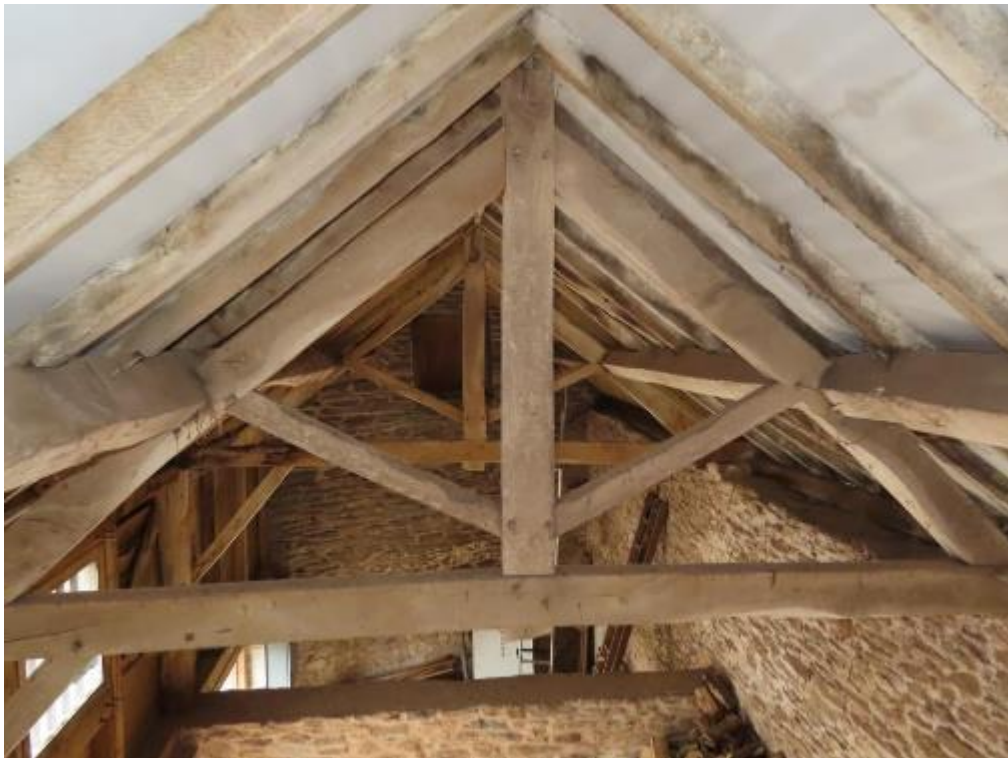
- Finding 2: a cluster of 40 (year 2020) bat droppings was found on storage items at the west-end of Building 2. The bat droppings were immediately beneath the ridge board. A sample of the droppings was collected and sent to EcoWarwicker ecological Forensics for DNA Analysis. The bat species identified as depositing the droppings is Brown Long-eared. A copy of the result sheet from EcoWarwicker ecological Forensics is contained in Appendix 2, sample labelled 'S9'.

Photograph 8. Buildings at Church House Farm. Interior.
View within the west part of Building 2.
Looking west from east.

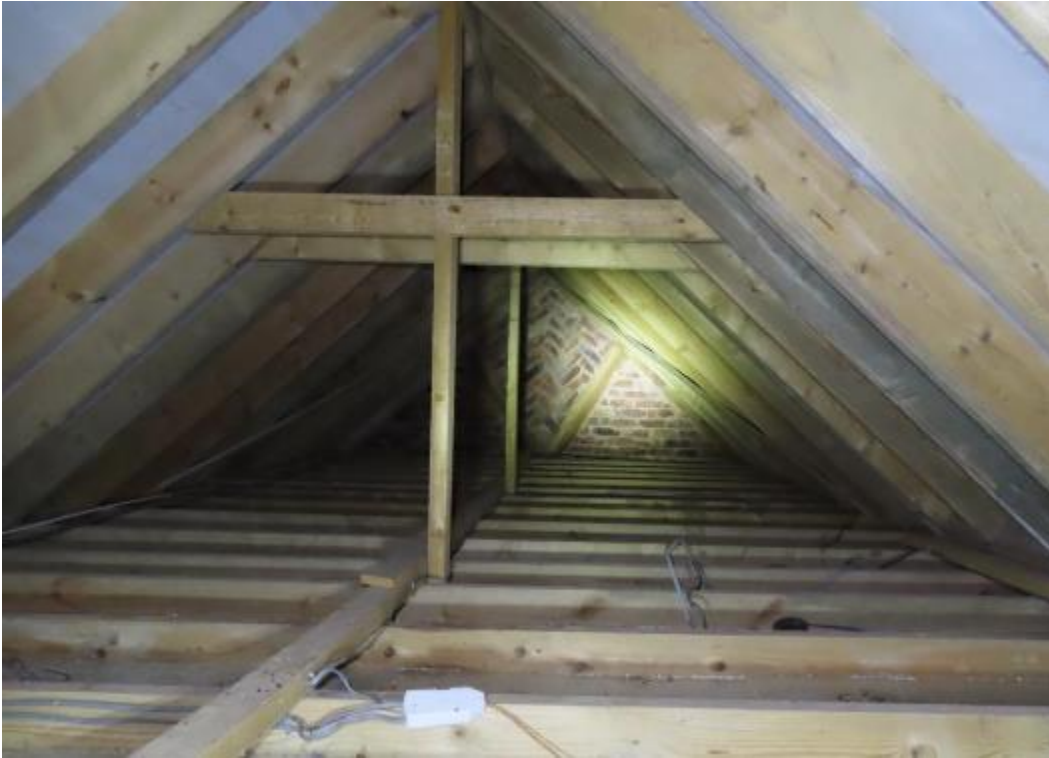
Finding 10: A group of 15 (year 2020) bat droppings was found on the floor-surface within the south area of the roof-space. A sample of the droppings was collected and sent to ecoWarwicker ecological Forensics for DNA Analysis. The bat species identified as depositing the droppings is Brown Long-eared. A copy of the result sheet from EcoWarwicker ecological Forensics is contained in Appendix 2, sample labelled 'U9'.

Photograph 9. Buildings at Church House Farm. Interior.
View of part of the Building 3 roof-space.
Looking south from north.

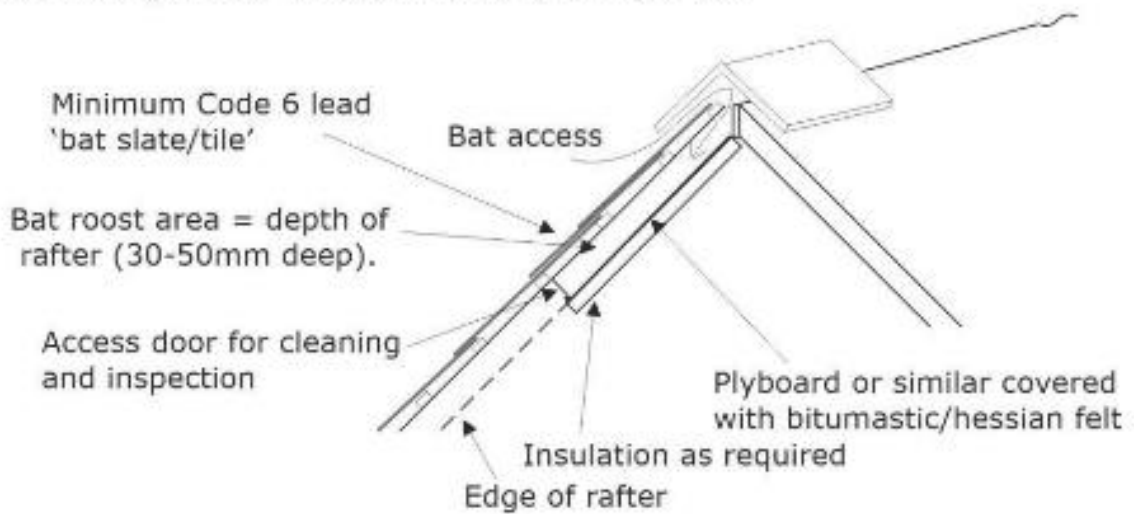
Rafter Box.

Bat roost between two roof rafters.
Access via unpointed, raised or mis-shaped ridge tile.

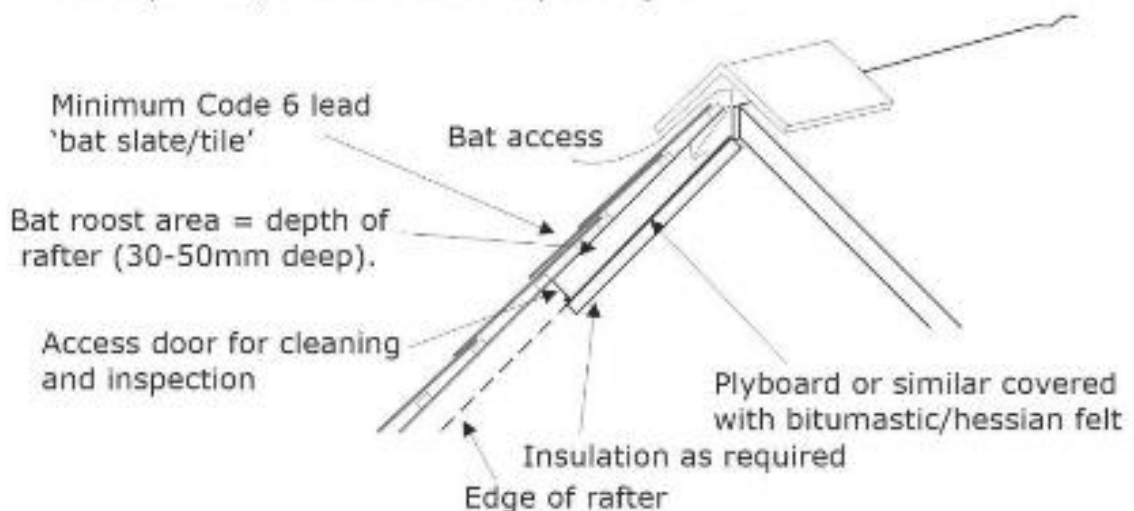
Rafter Box.

At roof apex.
Access via ridge tile.

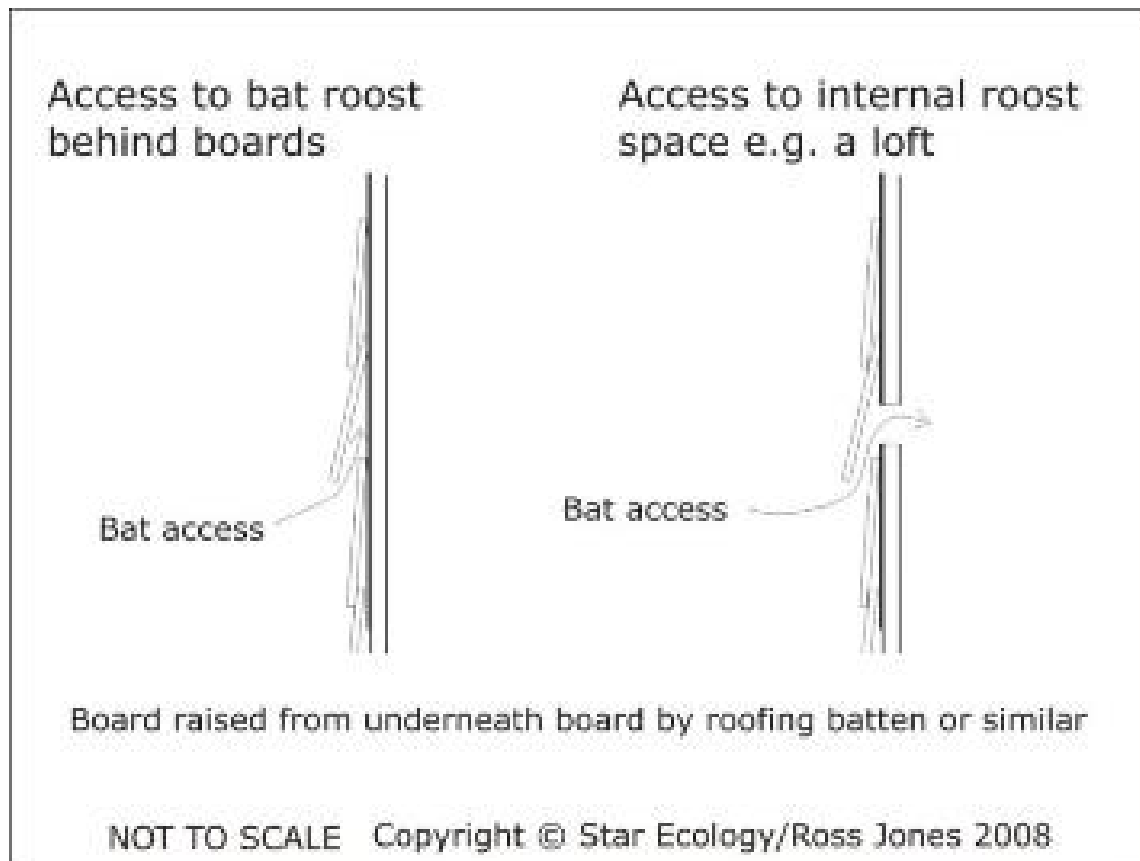
Bat roost access via external timber weatherboarding.

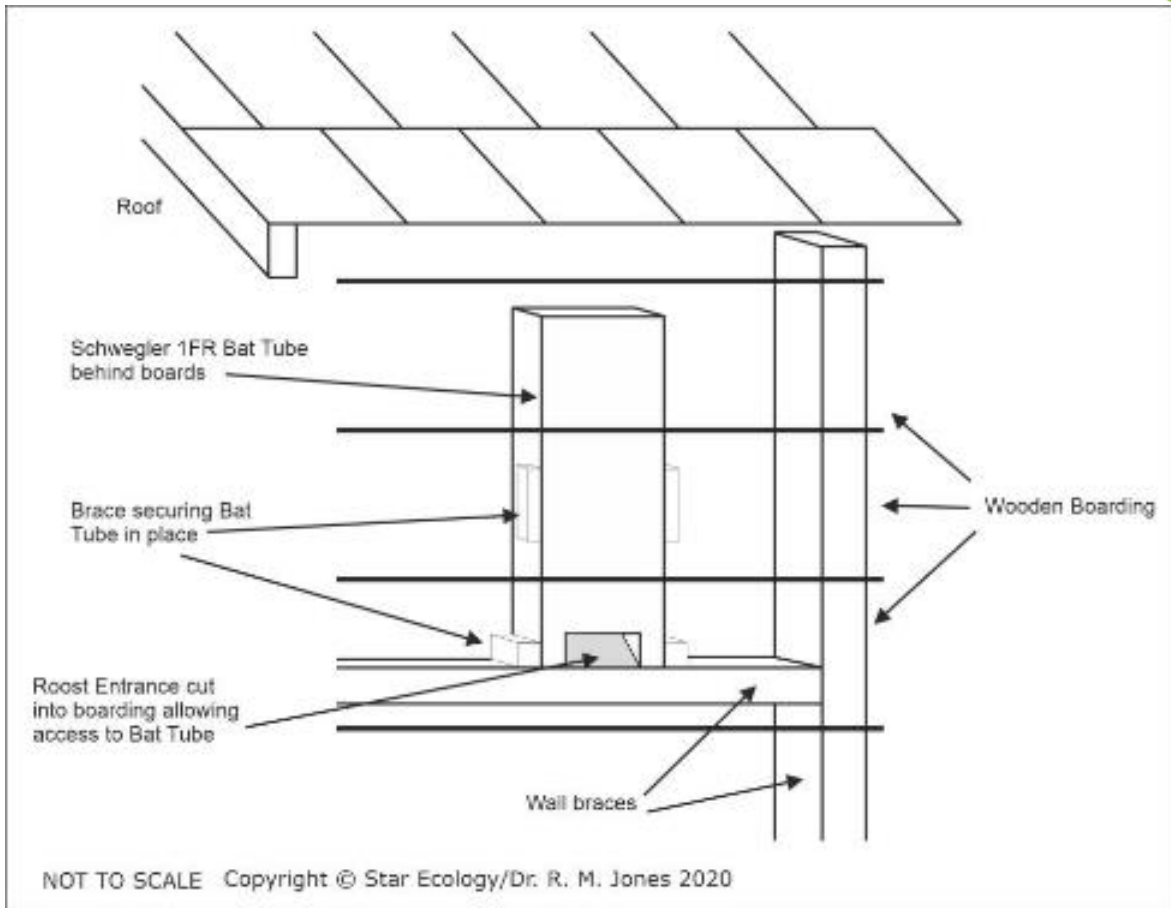
Schwegler 1FR Bat Tube incorporated into building structure of timber framed building, behind external wooden boarding.

Recommended designs are the Schwegler 1FR and 2FR Bat Tubes which provide maintenance-free roosting opportunities, Ibstock Enclosed Bat Boxes and Wienerberger Habibat Bat Boxes.

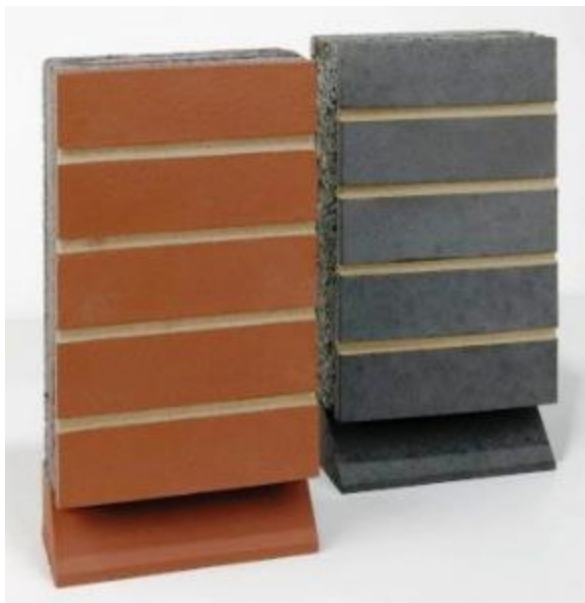
The **Wienerberger Habitat** Bat Box.

Boxes may be purchased with brick fascias to match those of existing walls or those of proposed new walls.

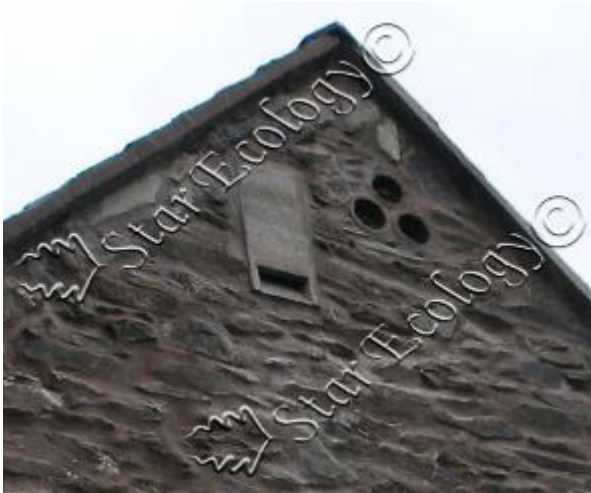
Schwegler 1FR Bat Tube built into stone gable wall.
Hay loft ventilation pipes have been retained for potential use by small birds for nesting.

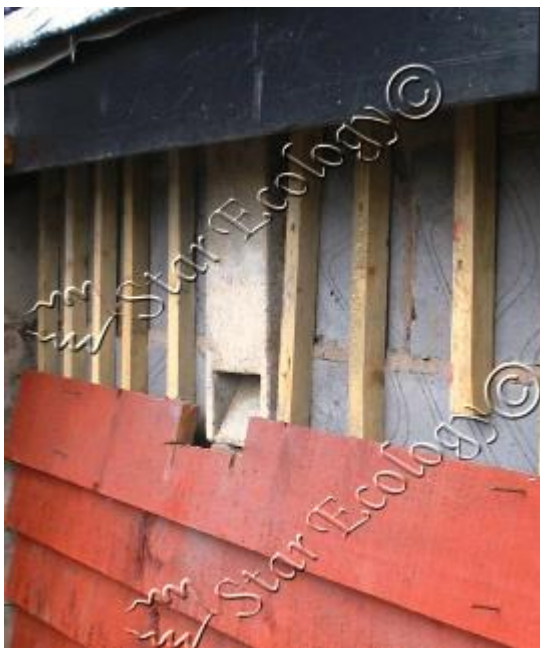
Schwegler 1FR Bat Tube built into thermalite® building block wall.
Weatherboarding will cover the Bat Tube, leaving access permanently open for bats.

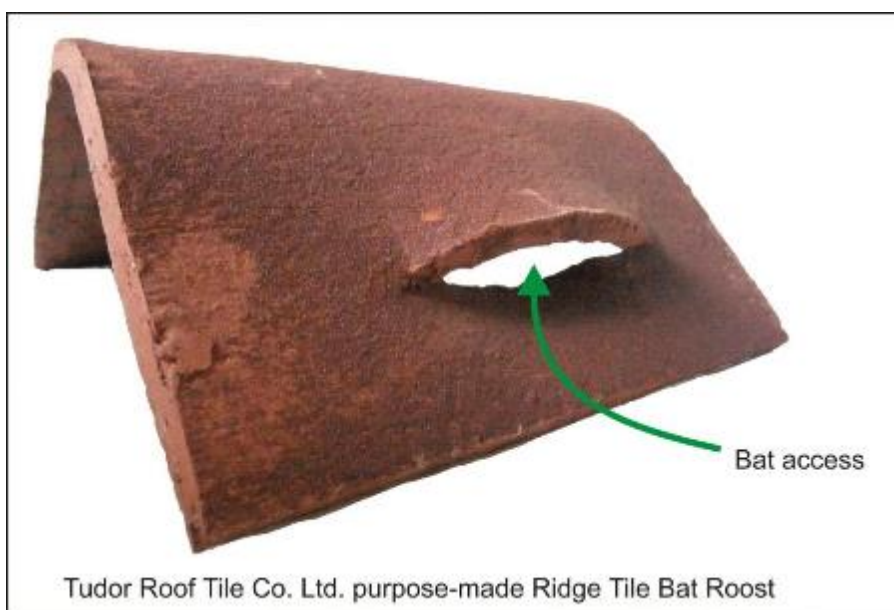
Tudor Roof Tile Co. Limited purpose-made ridge tile bat roost
