Registered Consultant Arboricultural Impact Assessment

Tree Protection Plan (TPP)

Retained Trees Shown On Proposed
Layout With Protective Measures Indicated Land At Maple Avenue,

Shildon For

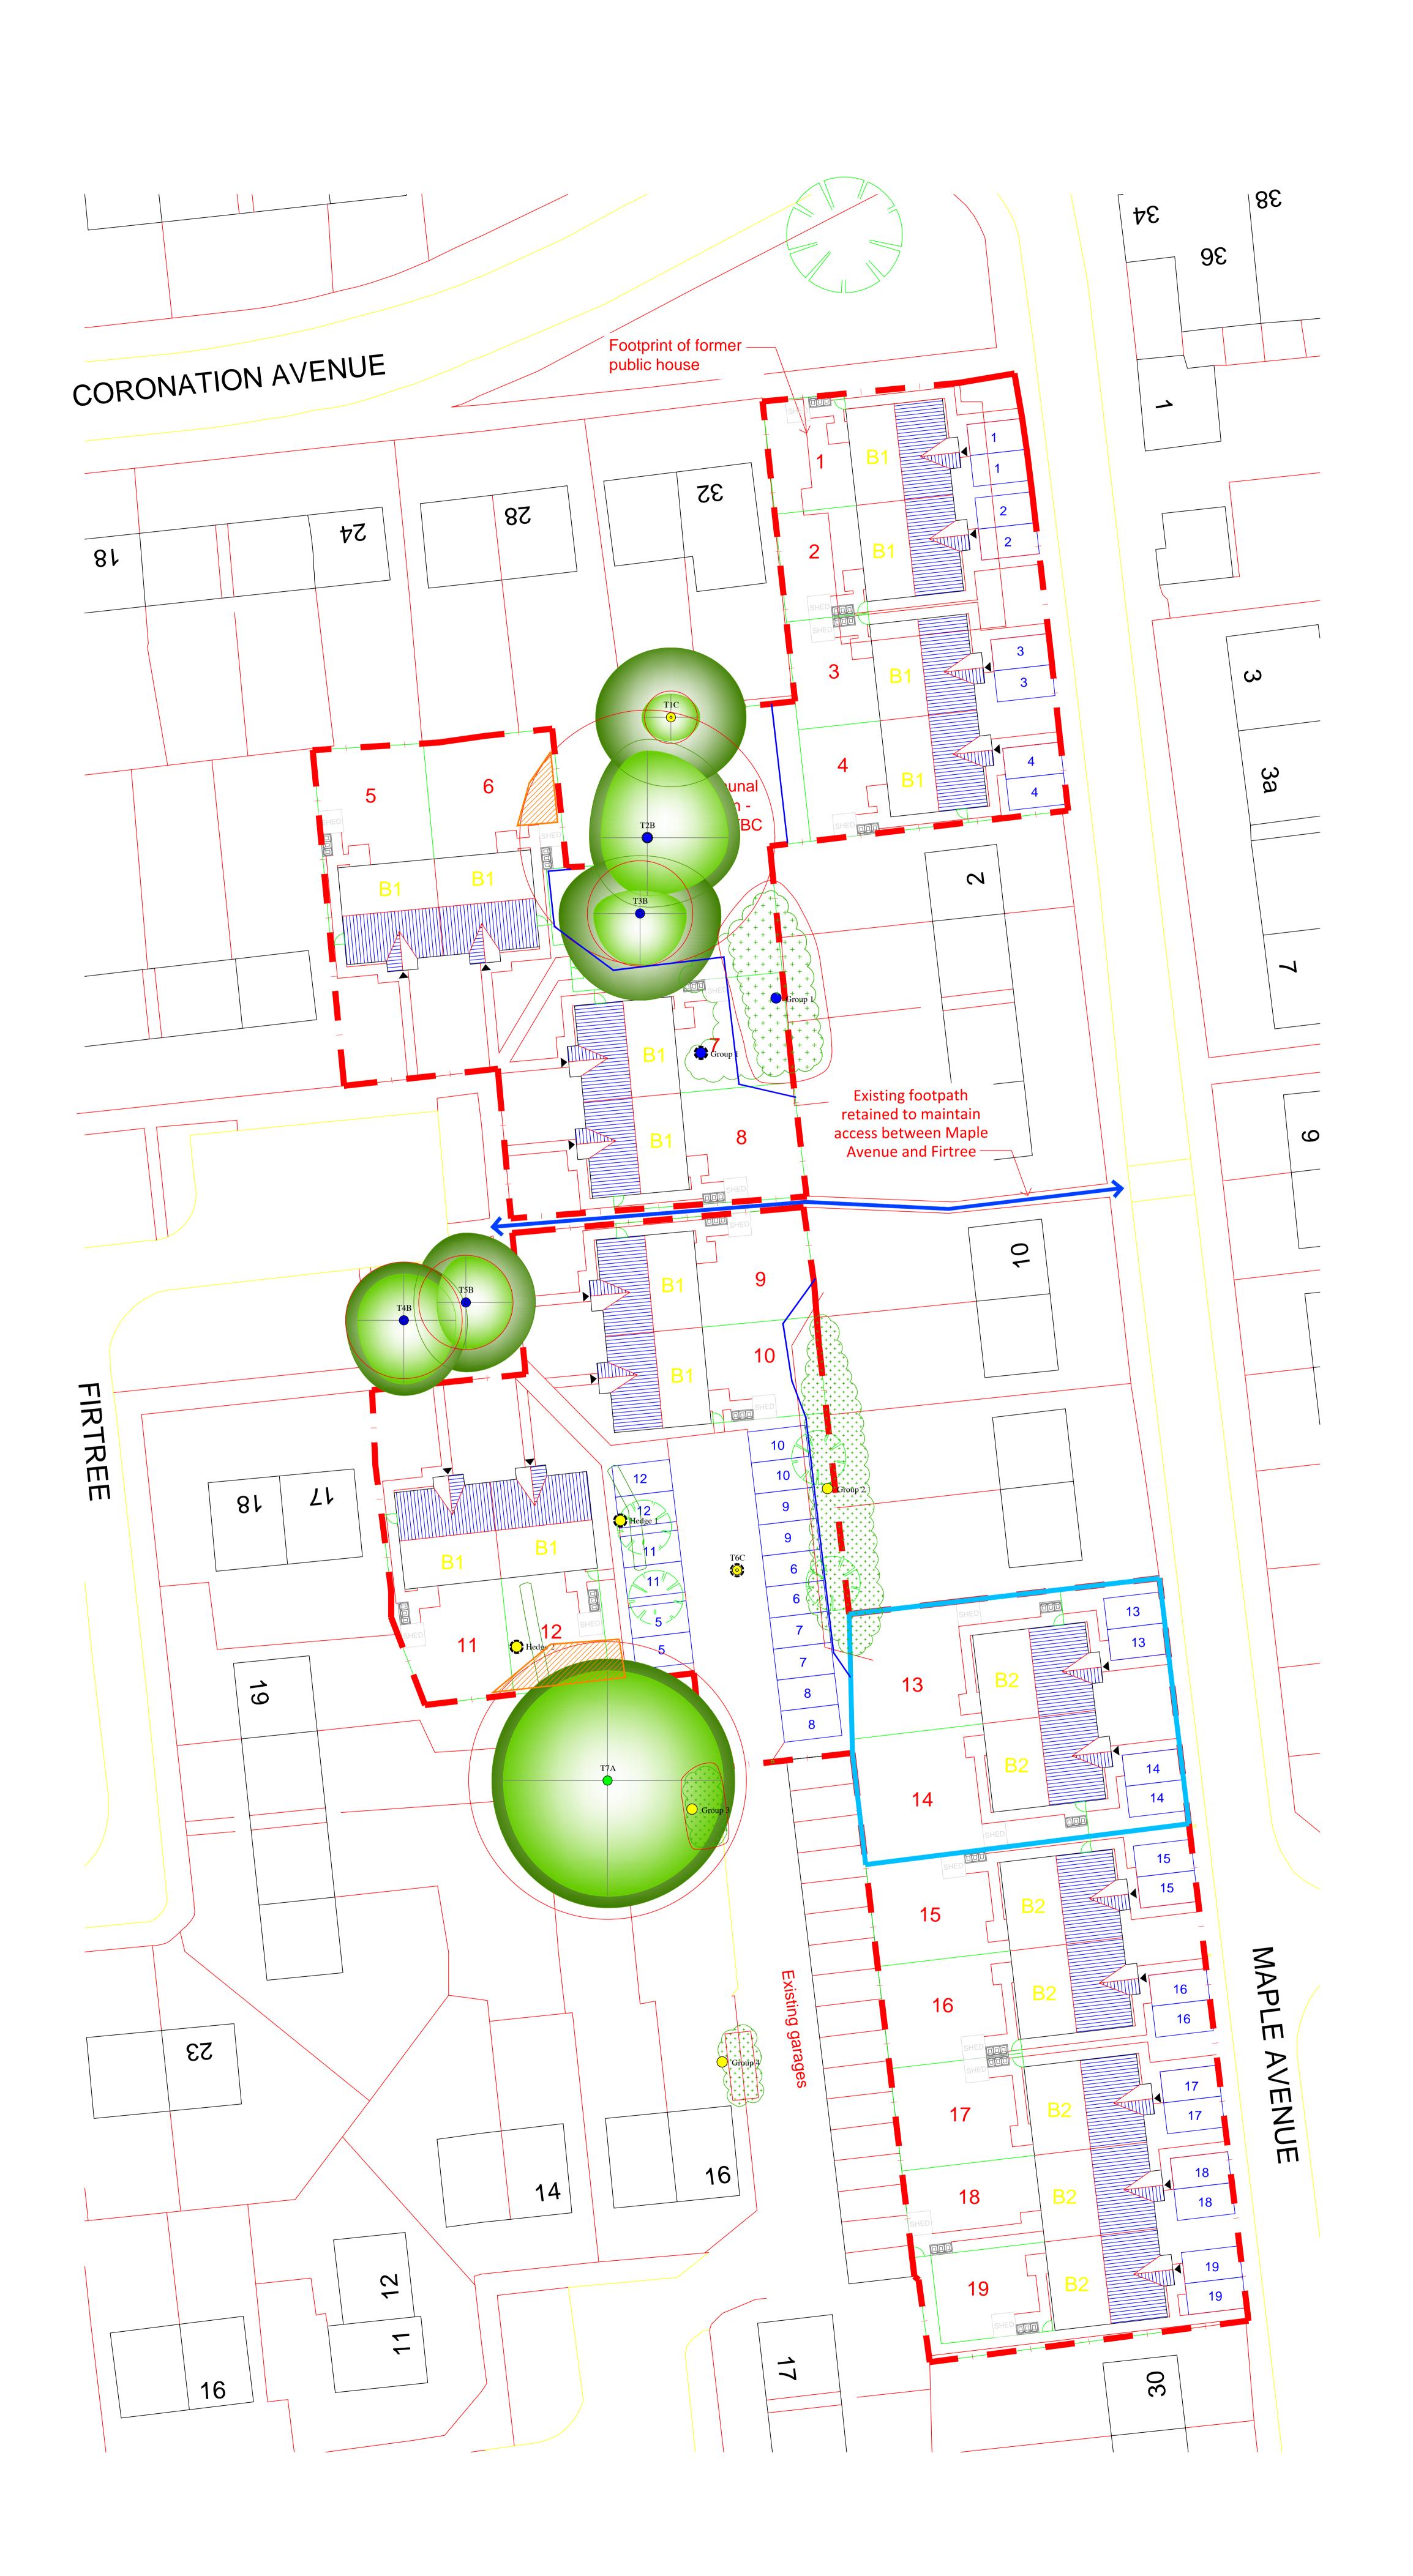
Predicted Future Growth Of Canopy (Shaded Dark Green & Surrounding Current Crown Shape) Trees To Be Removed
Broken Black Ring Surrounding

BS Root Protection Area As Shown By The Red Circle Around The Tree Tree / Woodland Groups Root Protection Area Shown By Red Outline

Position Of Protective Barrier (Continuous Blue Line) Ground Protection Required (Areas Indicated By Orange Hatching)
