Red Lion Inn, Great Bricett, Suffolk

Heritage Asset Assessment

October 2020

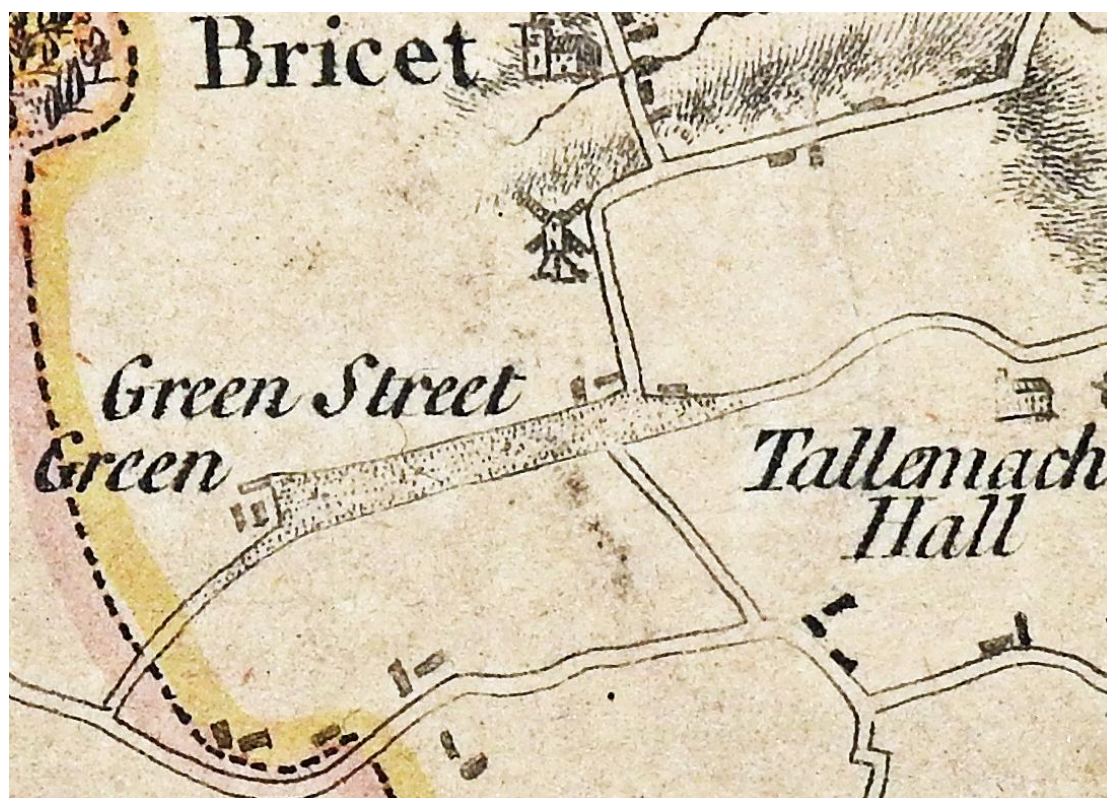
Figure 2. Hodskinson's map of Suffolk published in 1783 showing the linear 'Green Street Green' extending from the site of the Red Lion on the east to Waller Farm on the west. The Lion appears to lie within the boundary of the green and is not shown.

The Red Lion lies to the east of the B1078 in the small hamlet of Greenstreet Green approximately 750 m south of the parish church of Great Bricett. Hodskinson's map of 1783 depicts the medieval green as a linear feature extending from the site of the Lion on the east to Waller Farm on the west, and shows Red Lion Cottage at its north-eastern corner (which cottage is listed as 16th century in similar terms to the Red Lion). The Red Lion itself is not shown and its site appears to lie on the green. Many such greens were enclosed to form farm land as part of the agricultural improvements of the late-18th and early-19th centuries, and this was no exception: by the time of the tithe survey in 1838 the green had disappeared and its eastern end formed arable land that belonged to a six-acre smallholding based at the Red Lion. Taken together these two maps strongly suggest the Lion was built in *circa* 1800 on the former green to serve this new farm, but they are contradicted by the physical evidence of a 16th century house that was converted into a pair of cottages as early as the mid-17th century. Unless it was moved from elsewhere, which does not appear to be the case, the house must have been omitted in error from the 1783 map. This question may be addressed by a collection 18th century local maps in the collection of Kings College Cambridge (e.g. GBR 326 & 560 of 1721). In 1838 the building belonged to David Fayers who lived in nearby Offton and was rented to 'Faiers and Thorpe'. The entire property extended to 6.25 acres including a barn to the east of the house as shown in figure 3, but all except a yard of just under half an acre adjoining the house on the east was leased to John Scopes whom White's Suffolk Directory for 1844 describes as a shopkeeper in Great Bricett. The 1841 census return confirms that the house was shared between John Thorpe and Edward Fairs, both of whom were agricultural labourers and lived with families of three and five respectively. By 1885 it had been converted into a beer house operated in 1901 by John Proctor who was described as a 61-year old 'beer house keeper and farmer' at 'The Lion' in the census of that year, indicating that he farmed the adjoining six acres from the barn which still survived to the east.

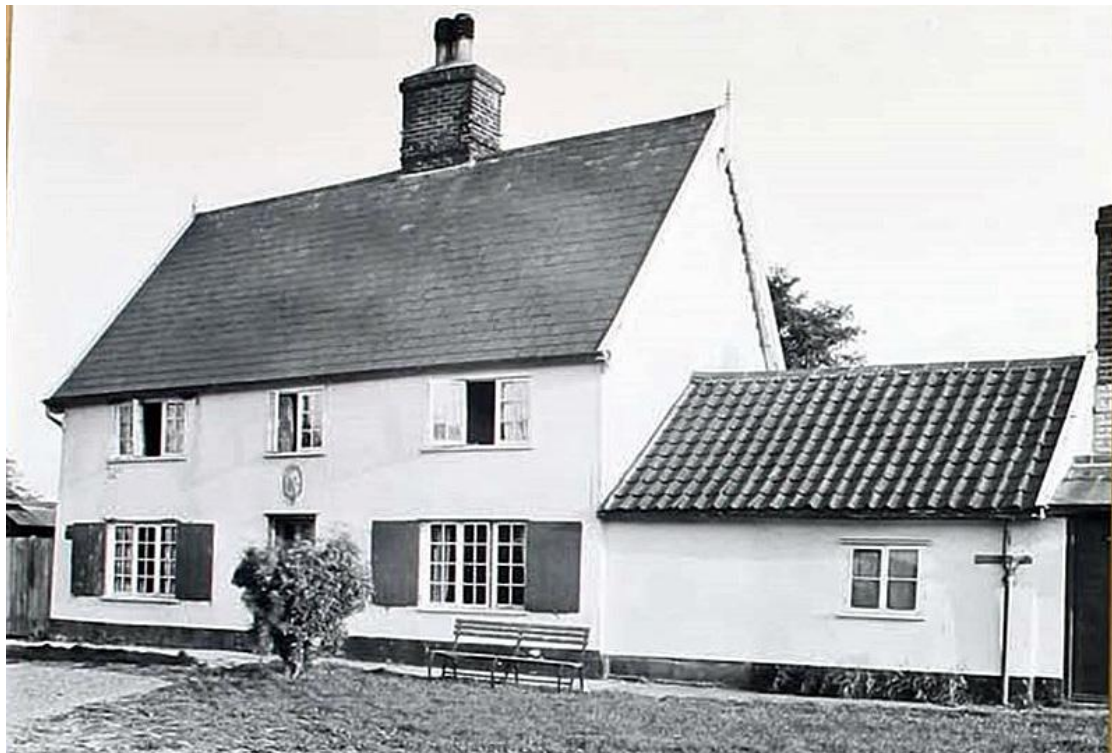
Figure 7. A photograph of 1964 (Royal Commission Archive). The single-storied shed probably dated only from the early-20th century as its facade was not indented as in figures 4-5. It has since been extended significantly and possibly rebuilt.

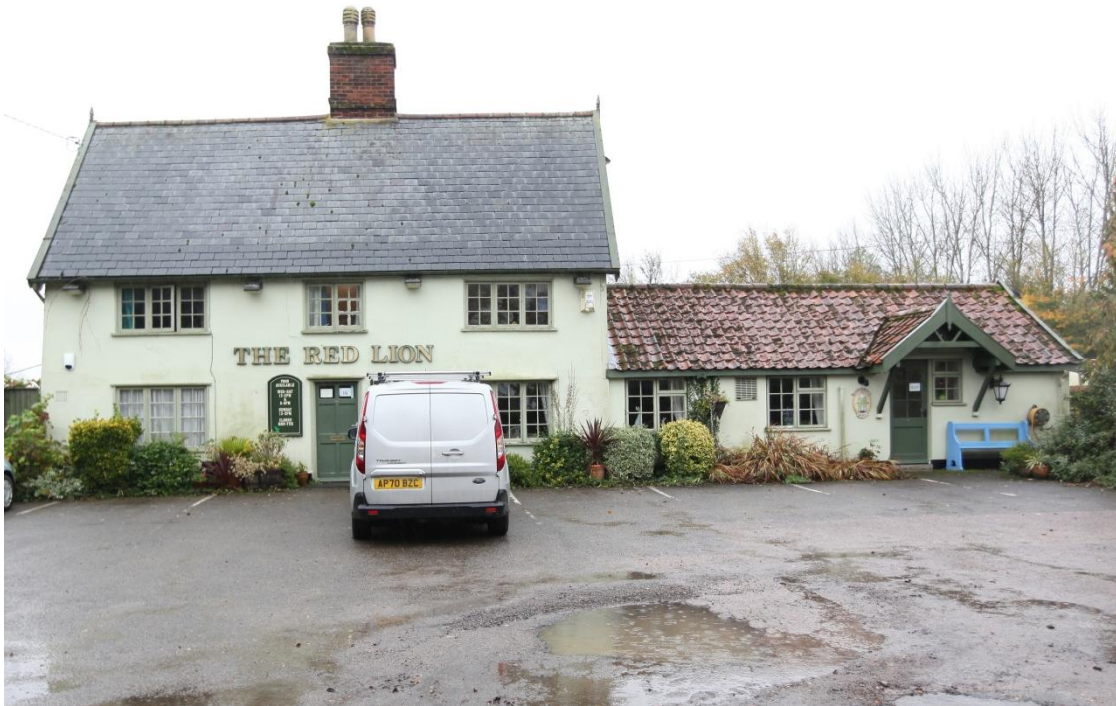
Illus. 1. The northern facade which in its present form is likely to date from the building's conversion into a public house in *circa* 1880. The decorative Mock Gothic barge boards, the brickwork of the chimney and the casement windows are typical of that period. In 1964 the single-storied range on the right terminated at a chimney in the position of its hooded entrance and has since been either extended or rebuilt (figure 7).

The existing northern facade remains almost unchanged since a late-19th century refurbishment in the Victorian Mock Gothic style that probably occurred when the building was converted from two cottages into a public house in *circa* 1880. The casement windows, shaped barge-boards and finials are typical of this period, and the former thatch indicated by the relatively steep roof pitch was probably replaced with slate at the same time. The central entrance may have served the right-hand cottage hitherto but the door to the left of the facade in illustration 8 would have been blocked. The Ordnance Surveys suggest that some form of extension existed to the west but its stepped outline is not fully consistent with the present pantiled structure shown in figure 7. Another major phase of alteration occurred in the 1980s when the small extension was lengthened and several matching structures were added to the rear. An array of false timbers was inserted in the Mock Tudor taste of the time, and the original ground-floor studs of the genuinely Tudor western gable were removed to create an open-plan layout. New windows were cut into the earlier addition and it is not clear whether its walls were entirely rebuilt or whether some 19th century fabric may remain. Other changes of this phase probably include the fireplaces, the removal of the back wall to accommodate the bar and the insertion of the main staircase along with the plasterboard divisions of the upper storey. These late-20th century alterations are not of historic interest.

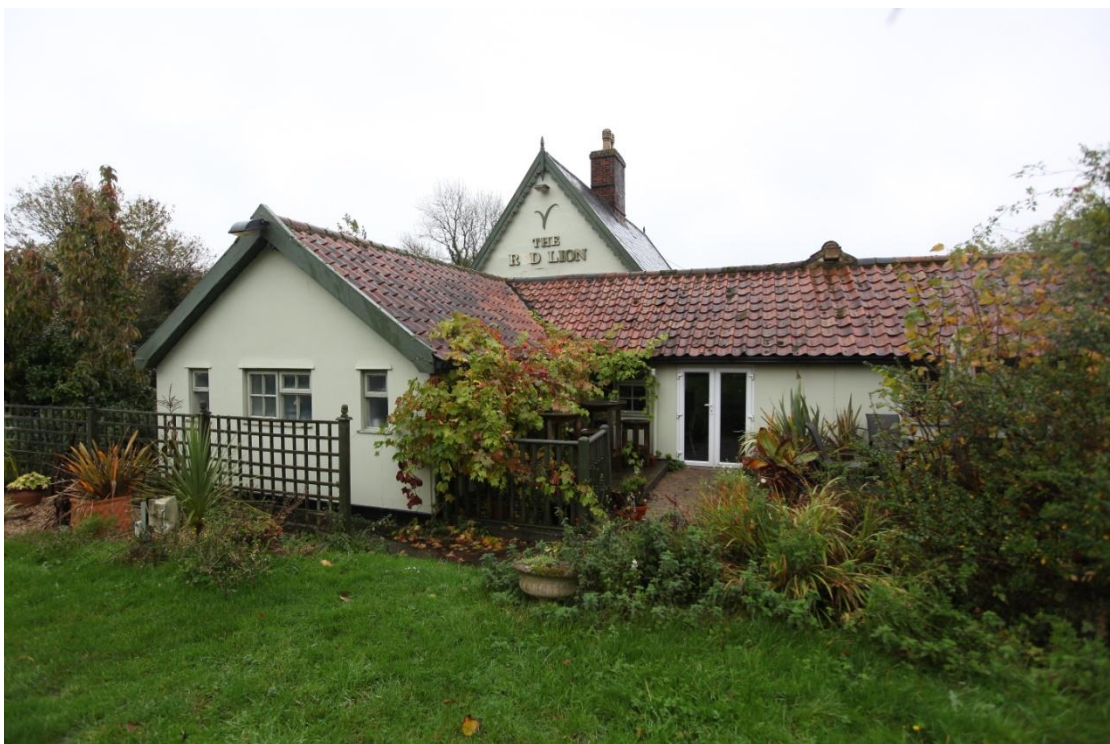
Illus. 2. The building from the west showing the modern single-storied additions in the foreground. These were not present in the 1970s and probably date from the 1980s as they appear to be mentioned in the 1988 listing description.

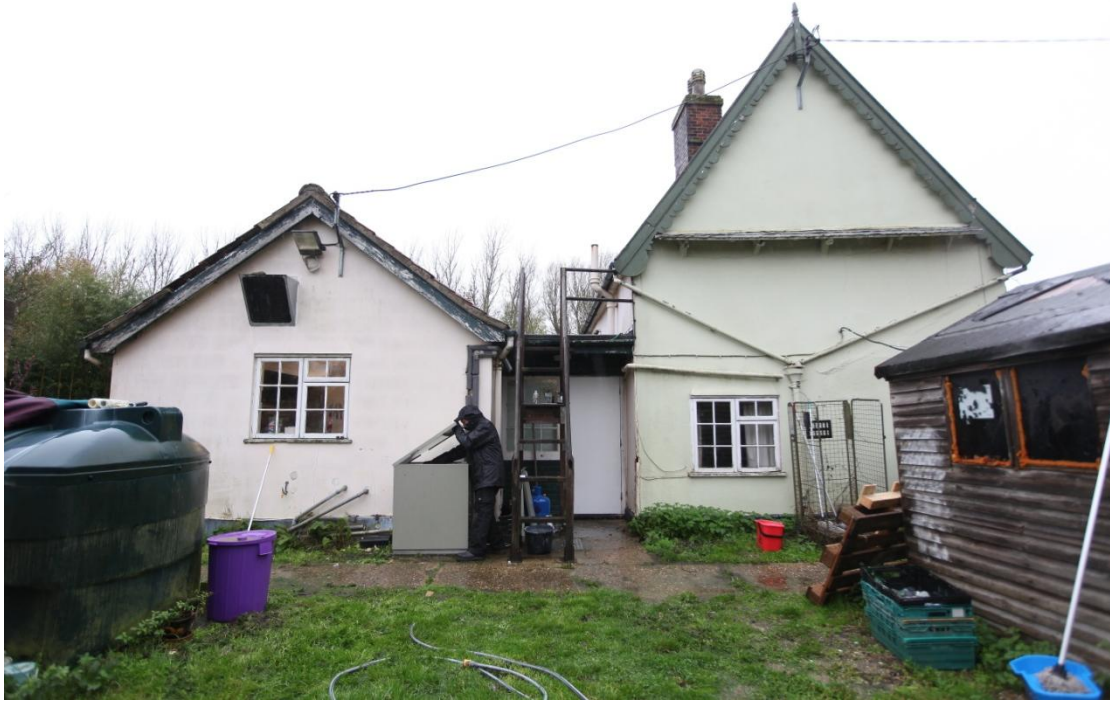
Illus. 3. The eastern gable with its traditional drip board and decorative Victorian barge-board. The steep pitch of the roof indicates it was designed for thatch and its present slate probably dates from the building's remodelling in *circa* 1880. The parallel outbuilding on the left is a recent addition that was not present in the 1970s.

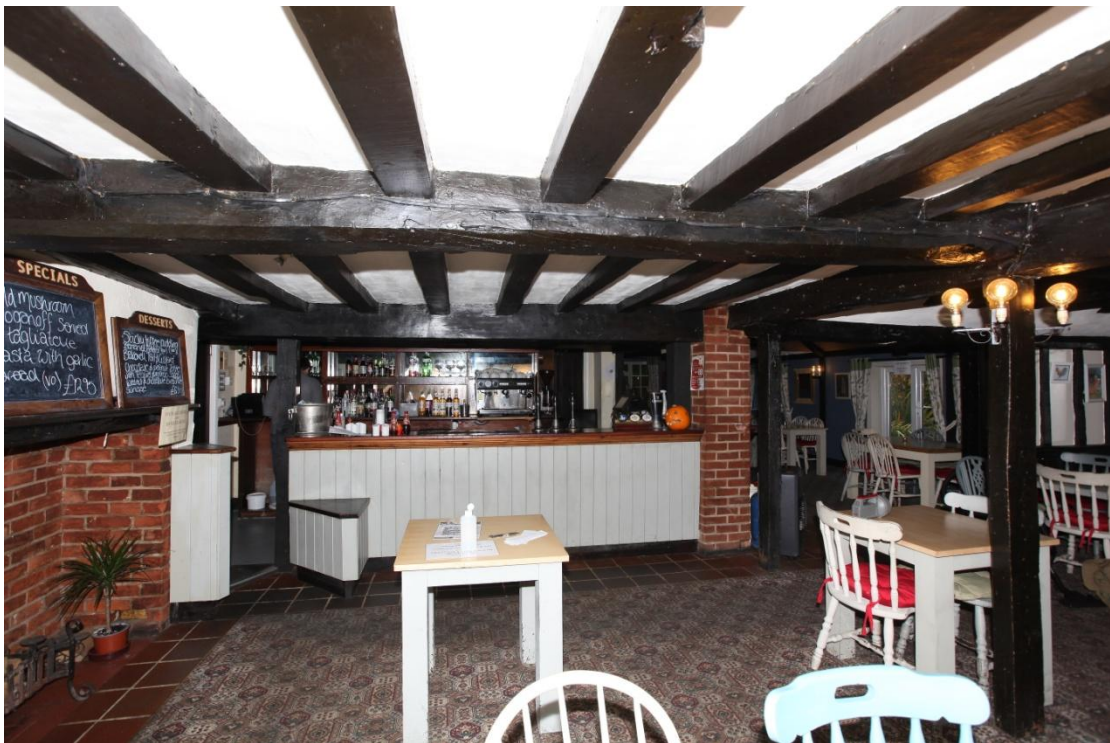
Illus. 4. The bar area seen from the north, with the rebuilt 20th century fireplace in the 17th century central stack on the left. The ceiling is a 17th century replacement supported by the chimney and there is no trace at this level of the original partition that divided the 16th century hall from its small parlour. The mid-rail to the right contains empty mortices for the western gable studs which have also been removed and the timbers in the single-storied extensions beyond are late-20th century Mock Tudor insertions.

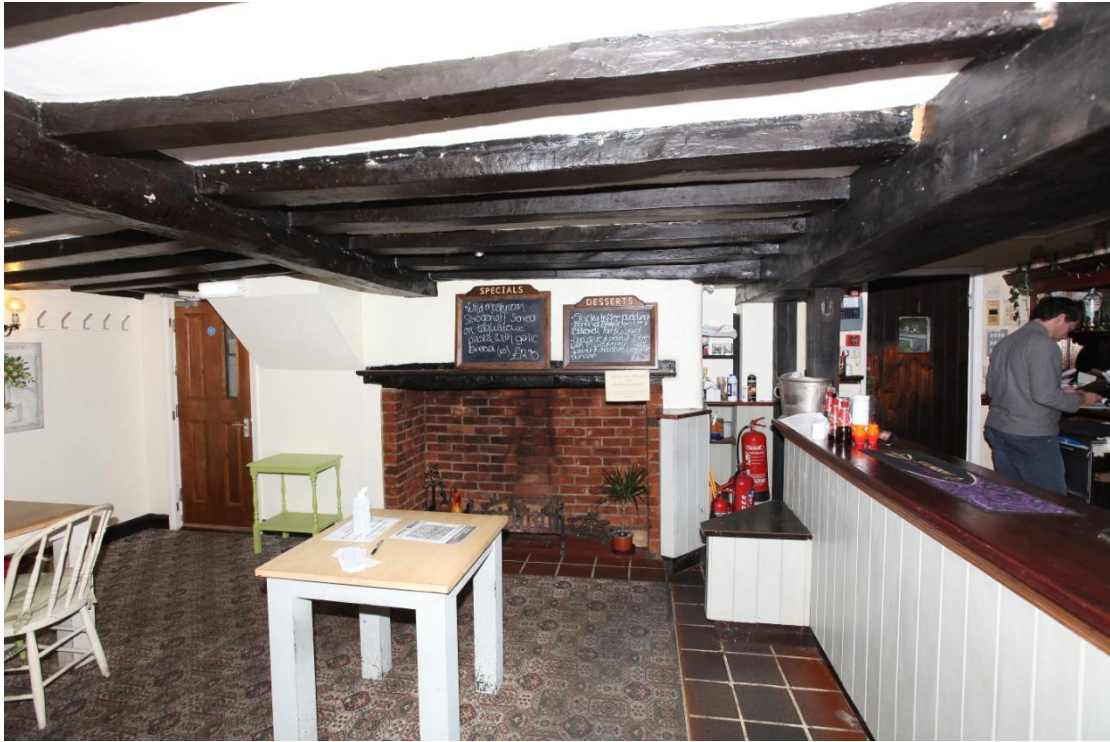
Illus. 6. The bar area from the west showing the present lobby entrance in front of the chimney to the left of the rebuilt fireplace. The structure of the front wall is hidden by plaster and the mid-rail of the back wall above the bar to the right is enclosed by modern boarding that conceals the mortices of the 16th century studs and windows.

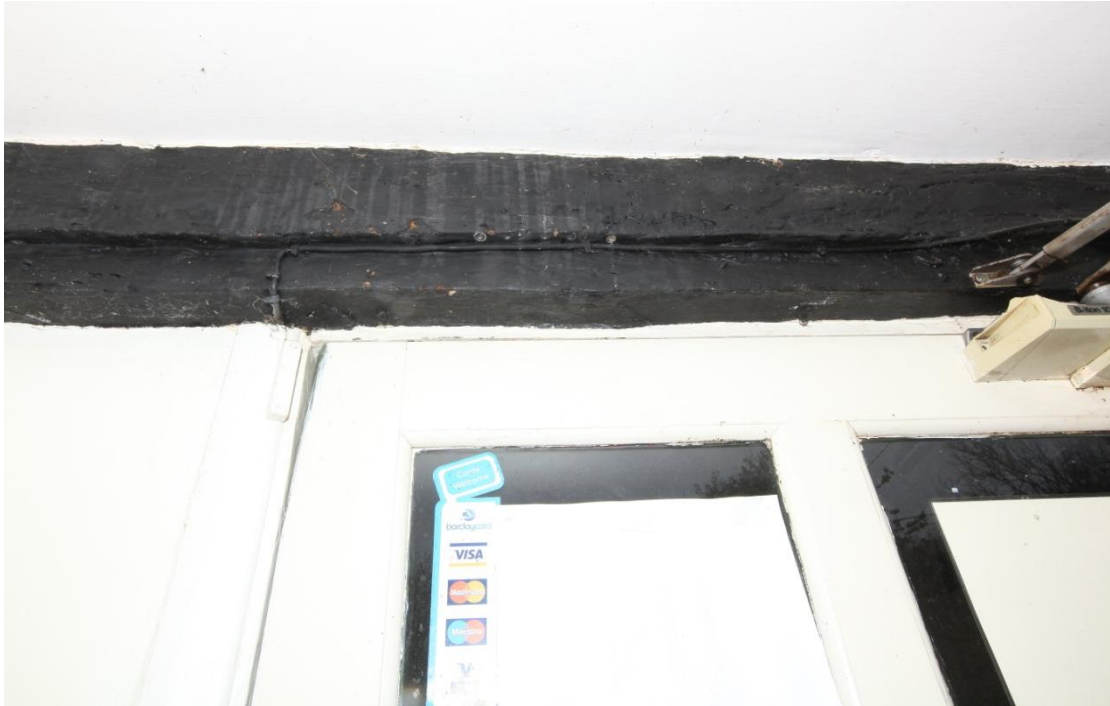
Illus. 6. The mid-rail of the 16th century structure over the present northern entrance door showing the distinctive diamond-shaped mortices of the original window mullions in its underside with a rebate for a sliding shutter above. Only the triangular inner halves of these mortices are exposed, and a fillet of timber would have been nailed over the rebate to form a groove.

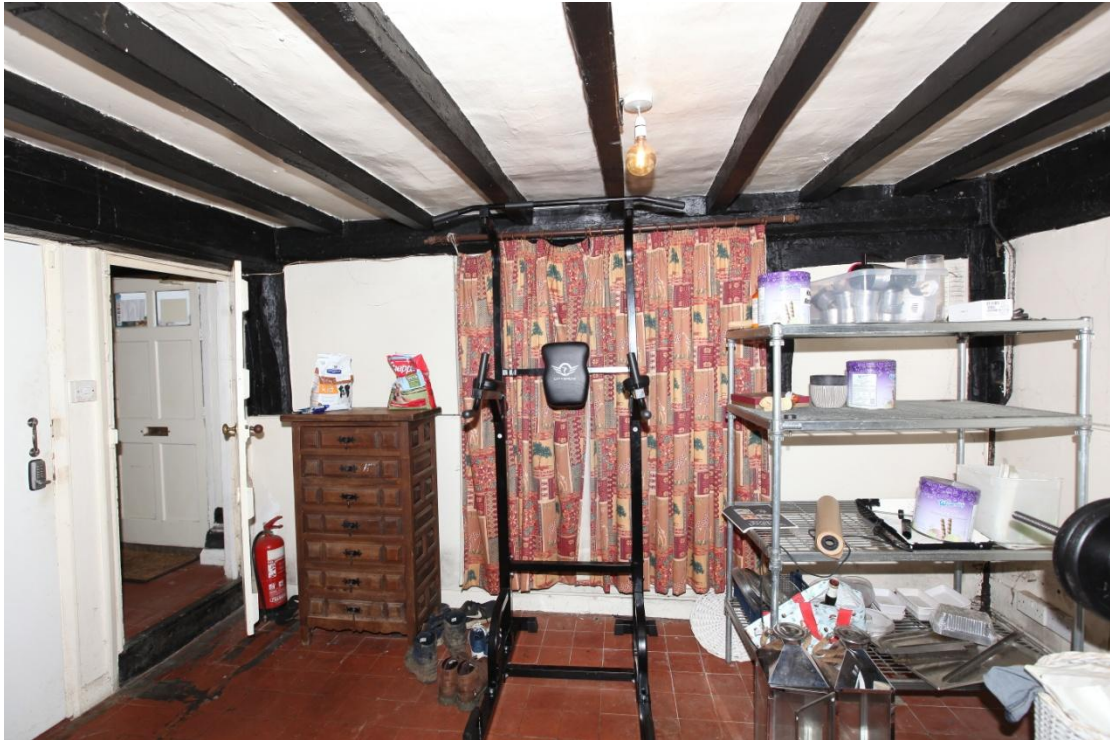
Illus. 7. The front wall of the living room (as labelled in figure 9) with the entrance on the left. As in the bar area the ceiling was rebuilt after the chimney's insertion and the 16th century binding joist above the doorway to the left contains mortices for the original longitudinal joists. The position of the 16th century entrance is indicated by the nailed lintel to the right (illus. 8). The mortice pegs in the exposed mid-rail of the eastern gable on the extreme right are hidden by thick paint and filler, but this timber is likely to contain evidence of central doors that opened into the missing service bay.

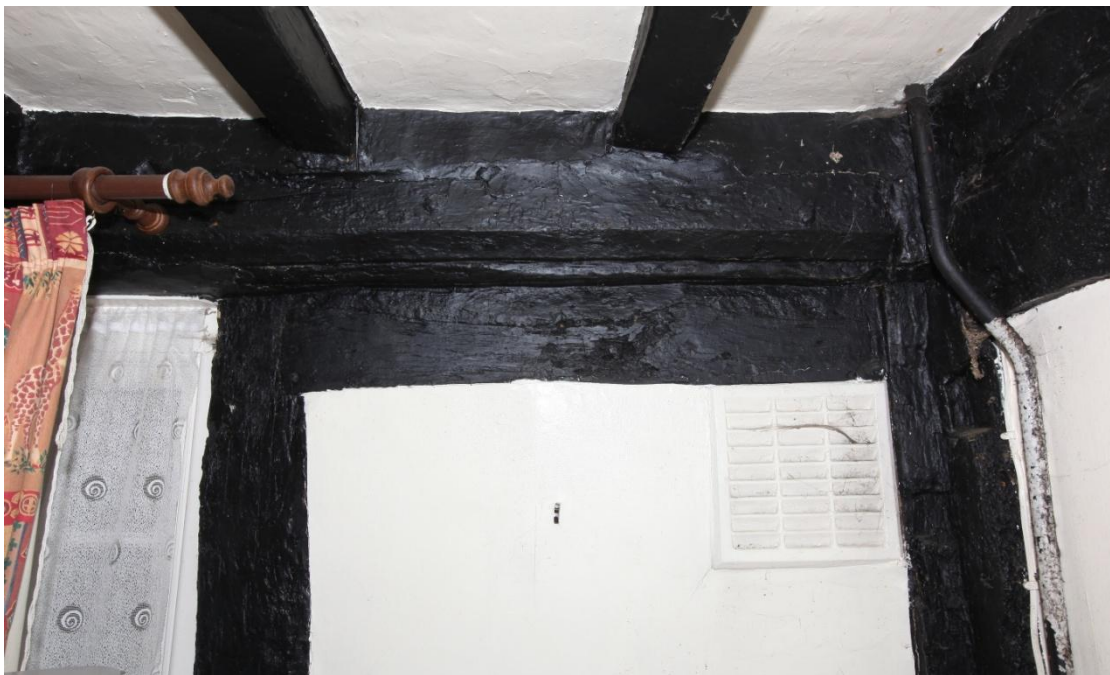
Illus. 8. A detail of the blocked door that almost certainly opened onto the original cross-passage. The lintel is a nailed insertion and the mid-rail is largely hidden by a pegged and chamfered clamp (rail) that supports the 17th century ceiling joists. This door is likely to have served one of the two cottages until *circa* 1880.

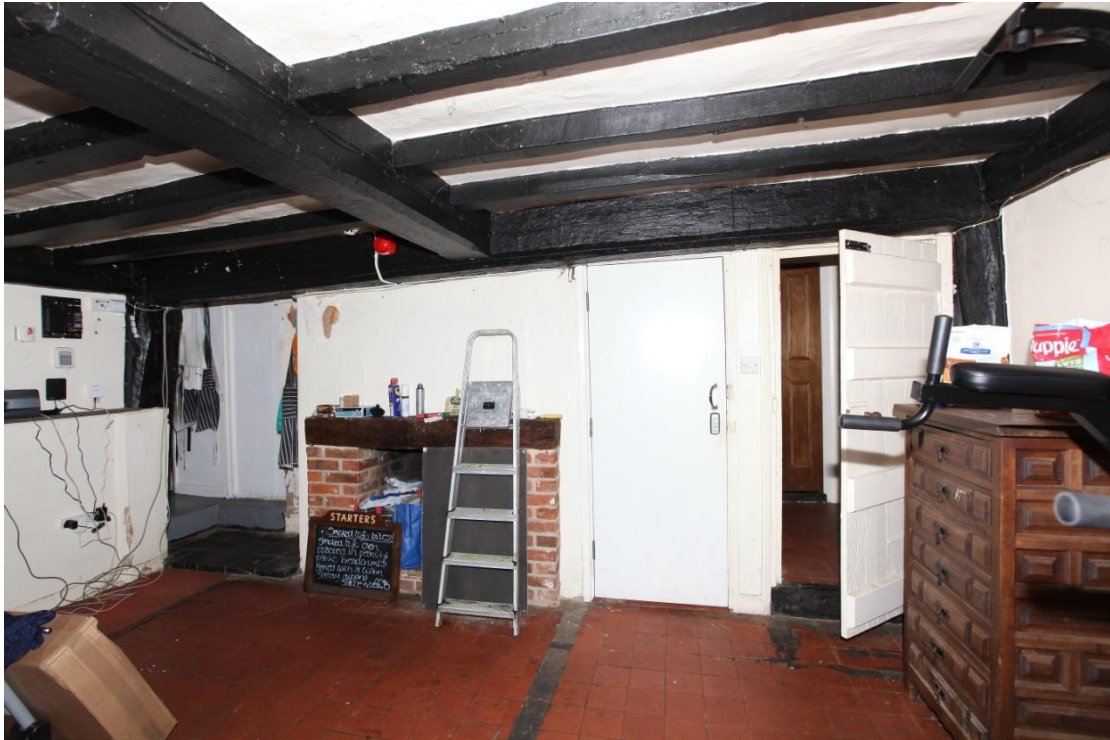
Illus. 9. The 20th century fireplace in the living room with the massive binding joist of the 16th century ceiling above. This joist spanned the approximate centre of the Tudor hall and is chamfered on both sides. Mortices are visible for large, flat-sectioned common joists at right-angles to the present joists. The storey post to the left preserves the outline of what may be a carved capital and attached shaft (illus. 11)

The hall was divided into two bays by the heavy, deeply chamfered binding joist that now adjoins the later chimney (illus. 9-11). At 4 m the low-end bay to the east was unusually longer than the high-end bay of 2.75 m (13 ft and 9 ft), but a wide gap in the framing of the latter's back wall indicates the position of an original chimney in the standard position (illus. 17). There is corresponding evidence of a cross-passage against the eastern gable, with a blocked former entrance on the north (illus. 8). The front and rear mid-rails of this low-end bay are hidden by the pegged clamps of the 17th century ceiling and that of the gable by painted filler, but the diamond mullions of a hall window are visible in the front high-end mid-rail as predicted by the standard plan (above the present entrance door in illustration 6). The eastern gable is likely to have contained twin central doors, probably with a third opening onto a stair against the back wall, and appropriate gaps in the frame are likely to be revealed if the mid-rail is stripped of its filler. Certainly a first-floor door can be seen on the upper storey as noted above. There is no evidence of the internal wall dividing the hall and parlour on the ground floor but it would have reflected its counterpart on the upper storey which was open to its rafters initially. The jowled storey posts of this first-floor partition remain visible and its tie-beam appears to have been moved eastwards to adjoin the later chimney. Hall and parlour chambers were often not directly connected in the 16th century, with the former reached via the service stair and the latter by a more private stair from the parlour, but in this instance a door may have existed against the back wall where the partition lacked the wall brace visible in the front post. The hall chamber was a storage space spanned by an arch-braced open truss in the manner of a barn, of which the rear brace survives *in situ* (illus. 12-13)

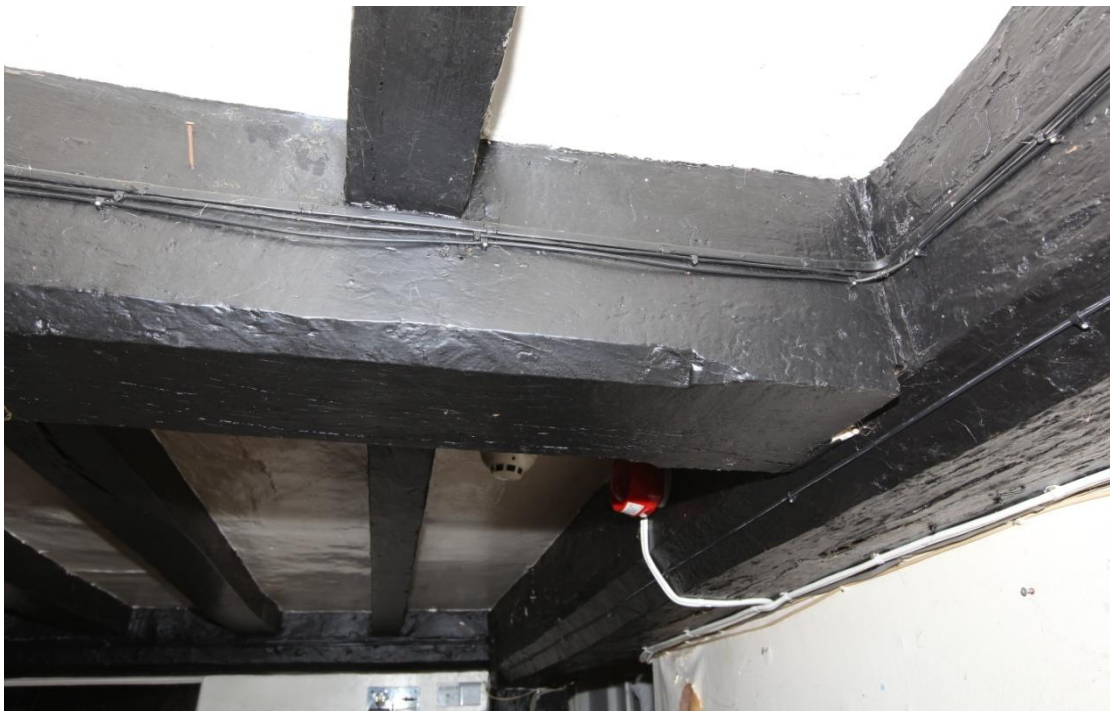
Illus. 10. A detail of the typically 17th century curled 'lamb's tongue' chamfer stop to the living room's axial joist. The square or slightly tall-sectioned common joists indicate a date in the second half of the century. The axial joist overlaps the deep chamfer on the earlier binding joist to the right which contains mortices for original flat-sectioned common joists (one of which is visible at top right).

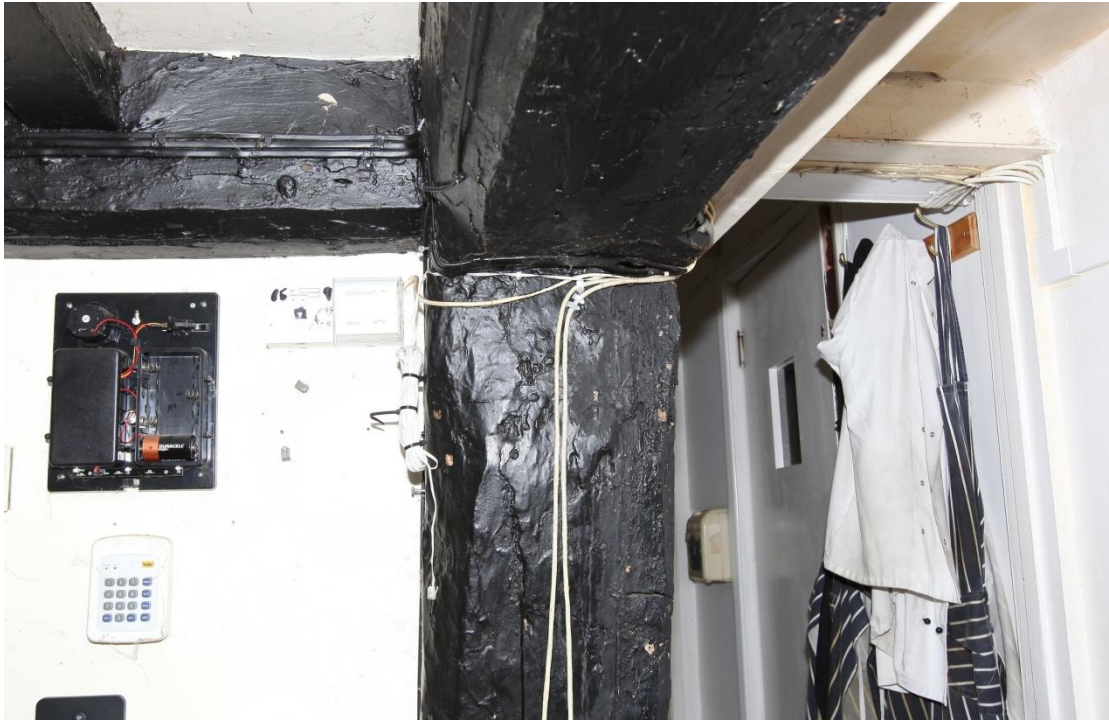
Illus. 11. A detail of the rear storey post to the left in illus. 9 showing what may be the outline of a carved capital with an attached shaft beneath. The carving has been cut away and the surface is now concealed by thick filler of some kind but it may repay careful investigation.

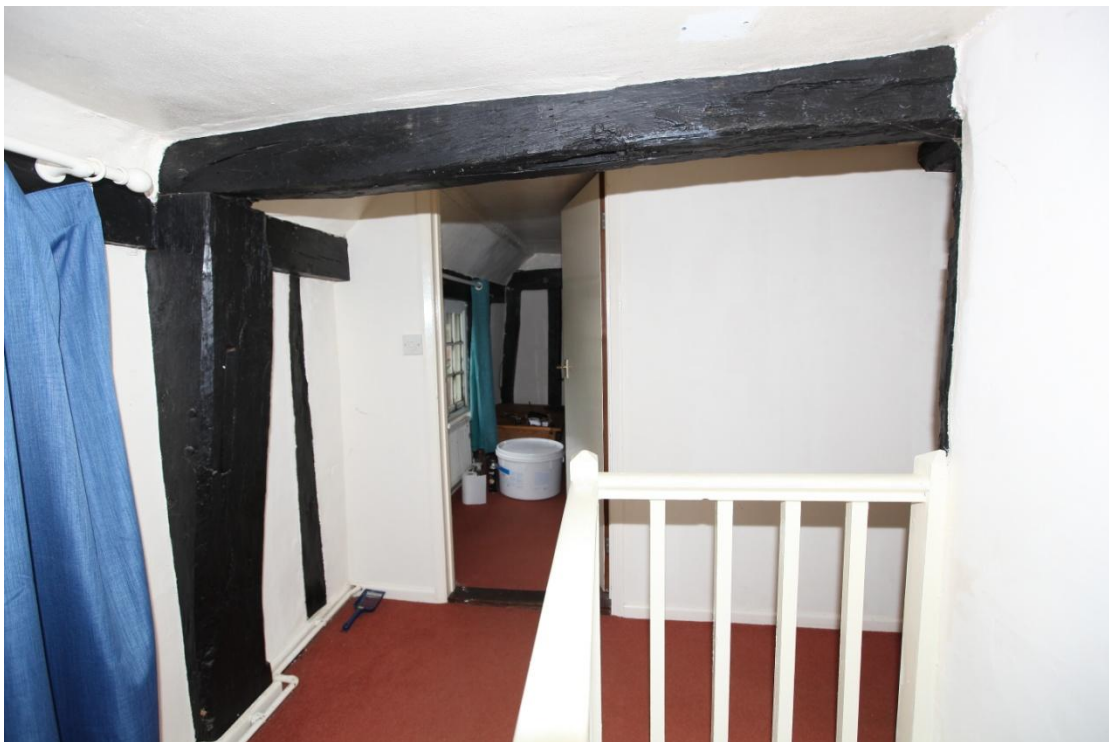
Illus. 12. The original tie-beam and heavy, jowled storey post of the hall chamber's open truss seen from the 20th century stair landing in front of the rendered chimney to the right. Both the post and tie contain pegged mortices for a missing arch-brace matching the surviving brace to the rear (illus. 13).

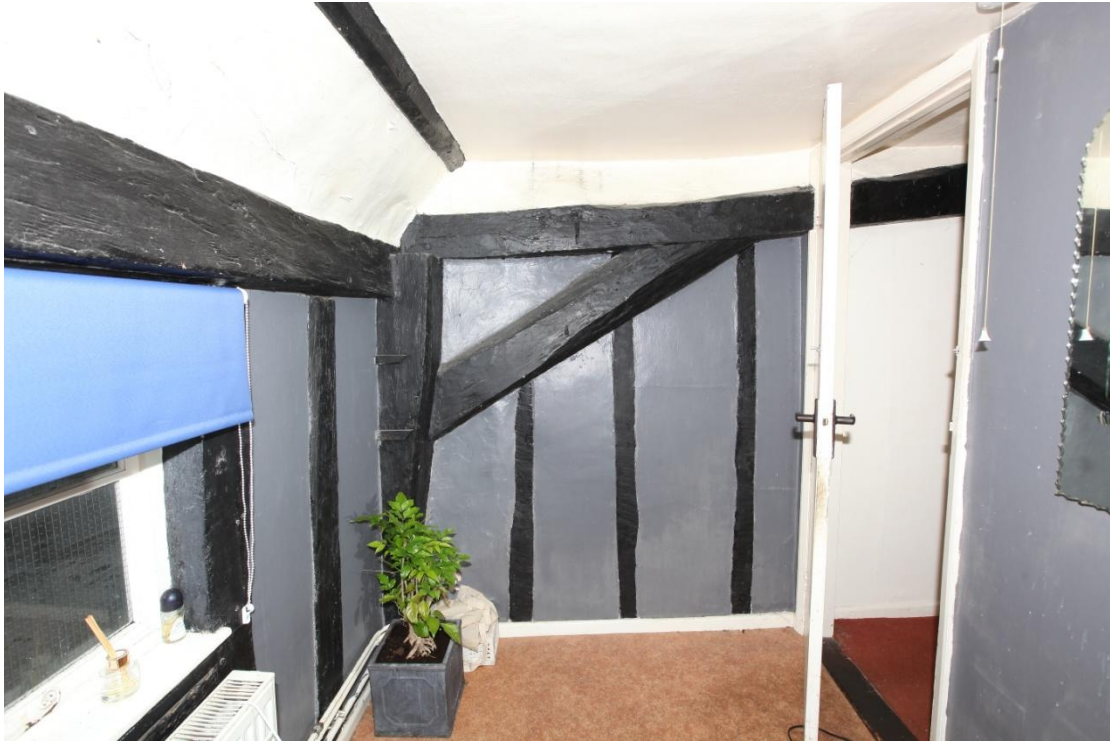
Illus. 13. The intact 16th century arch-brace to the rear of the original hall chamber's open truss, seen from the east. The narrow studs are likely to have been inserted along with the chimney in the 17th century. Mortices for diamond mullions are visible in the roof-plate above the present window to the left (illus. 13).

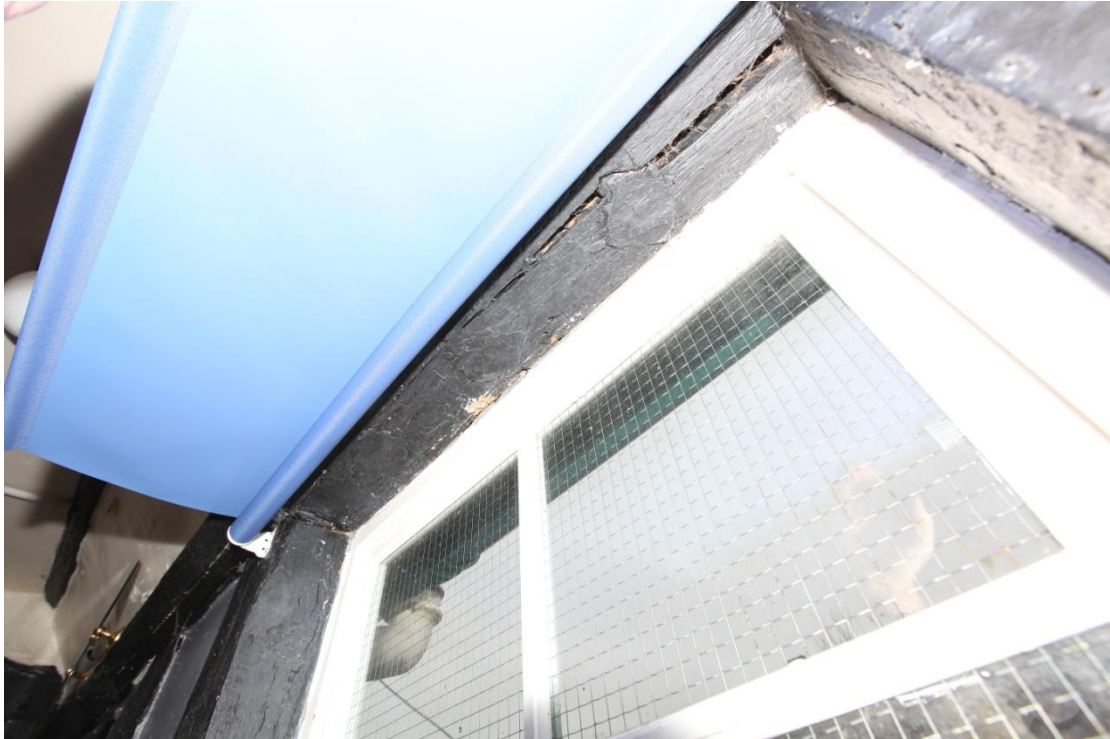
Illus. 14. A detail of the rear roof-plate to the left in illustration 13 showing three distinctive diamond-shaped mortices for 16th century window mullions.

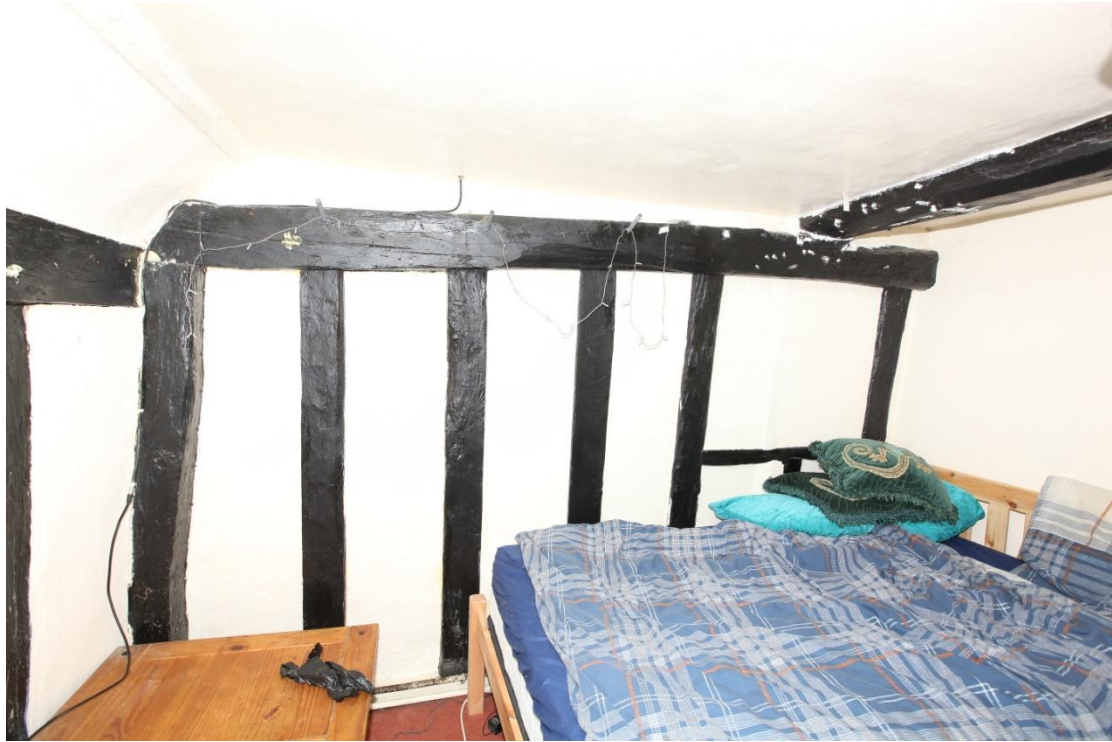
Illus. 15. The eastern gable of the hall chamber (i.e. the bedroom above the present living room). The wall studs are fully tenoned and pegged but the sill of the blocked central window is a nailed insertion and there are no mullion mortices in the fully exposed tie-beam above – because it occupies the position of an original door that opened into the missing service chamber.

Almost all Tudor domestic buildings closely reflected the standard room layout illustrated in the Appendix, especially in rural locations such as this where there was less pressure on space than in local towns. Any detailed analysis of the Red Lion's frame is hampered by the thick layers of filler and black paint which coat its ground-floor timbers, concealing the pegged joints that would reveal gaps for doors and windows. This is a particular problem in the living room, while the rear (southern) wall timbers of the bar have been removed and its mid-rail hidden by modern boarding (illus. 5-6). However the general layout can still be identified and shown to have respected the standard plan with a large hall of two bays on the east and a small single-bay parlour to the west. The hall was 7 m in length and the parlour 2.4 m, with both rooms 4.9 m wide internally (23 ft, 8ft and 16 ft respectively). These proportions are highly respectable and indicate a house of some status, well framed with substantial timber and possibly with carved capitals and attached shafts beneath the principal truss of the hall ceiling (illus. 11). The parlour was modest relative to the hall but this is typical of late-medieval buildings in which the hall remained the principal room and parlours were largely unfurnished sleeping apartments. Only with the growing demand for privacy and the advent of 'posted' beds and other large pieces of furniture during the mid and late-16th century did parlours increase in size. The structure has clearly lost the expected buttery and pantry on the eastern side of its hall as a central doorway is identifiable in the first-floor gable, later converted into a window (illus. 15). Any corresponding evidence of twin service doors on the

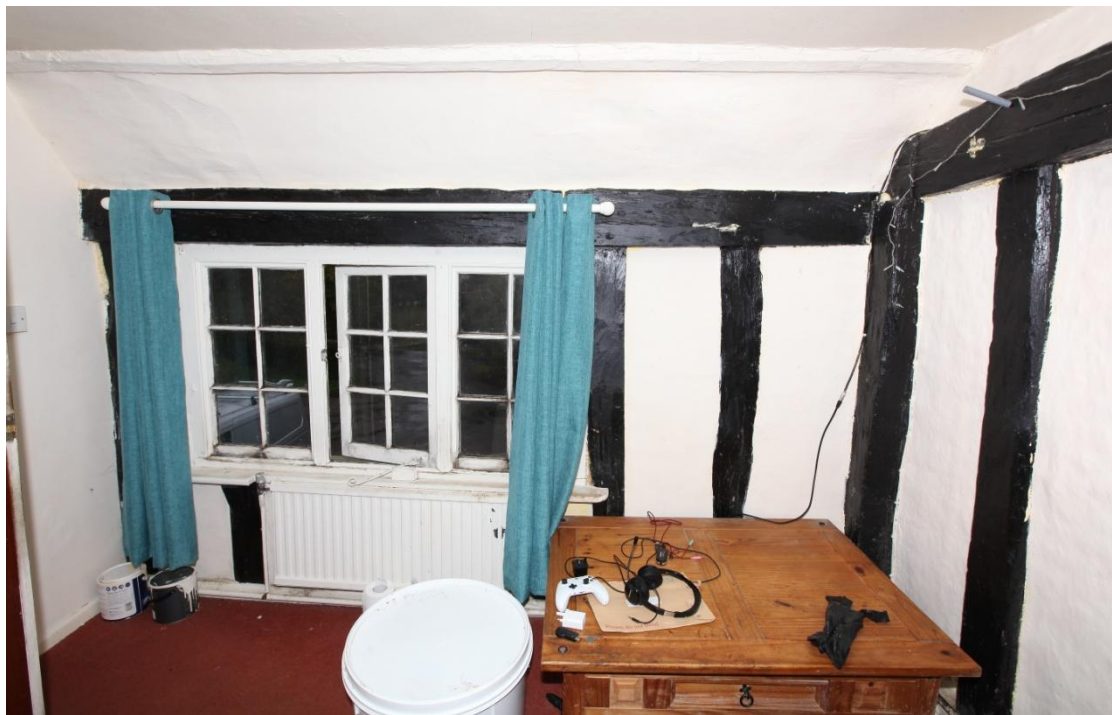
Illus. 16. The front wall of the bedroom over the living room showing a typical late-19th century casement window with mortices for the diamond mullions of a 16th century predecessor in the roof-plate above.

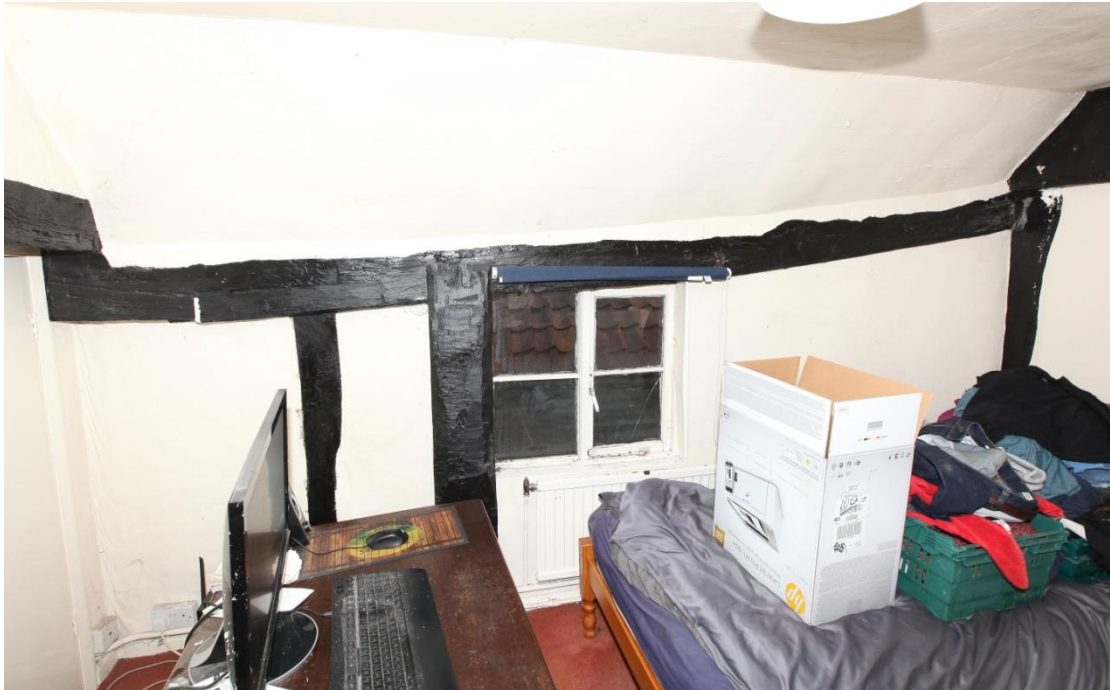
Illus. 17. The rear wall of the bedroom above the bar with the western gable on the right. The jowled storey post to the left of the present window adjoined a missing partition that divided the two-bay hall chamber on the left from the small parlour chamber on the right. The tie-beam of this partition now adjoins the chimney to the left. An identical partition would have existed on the ground floor. Note the 16th century-type edge-halved and bridled scarf joint in the roof-plate above the exposed stud. A large gap in the frame extends from this stud into the cupboard behind the chimney and indicates the position of the 16th century chimney (i.e. against the back wall of the high-end bay).

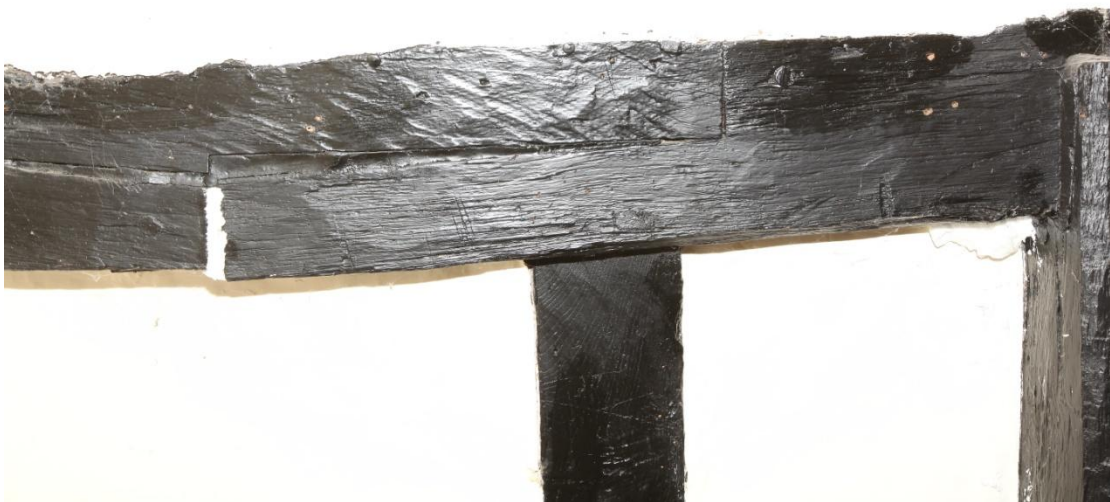
Illus. 18. A detail of the 16th century edge-halved and bridled scarf joint in the rear roof-plate (as shown in illustration 16). Joints of this kind were superseded by face-halvings around the turn of the 17th century.

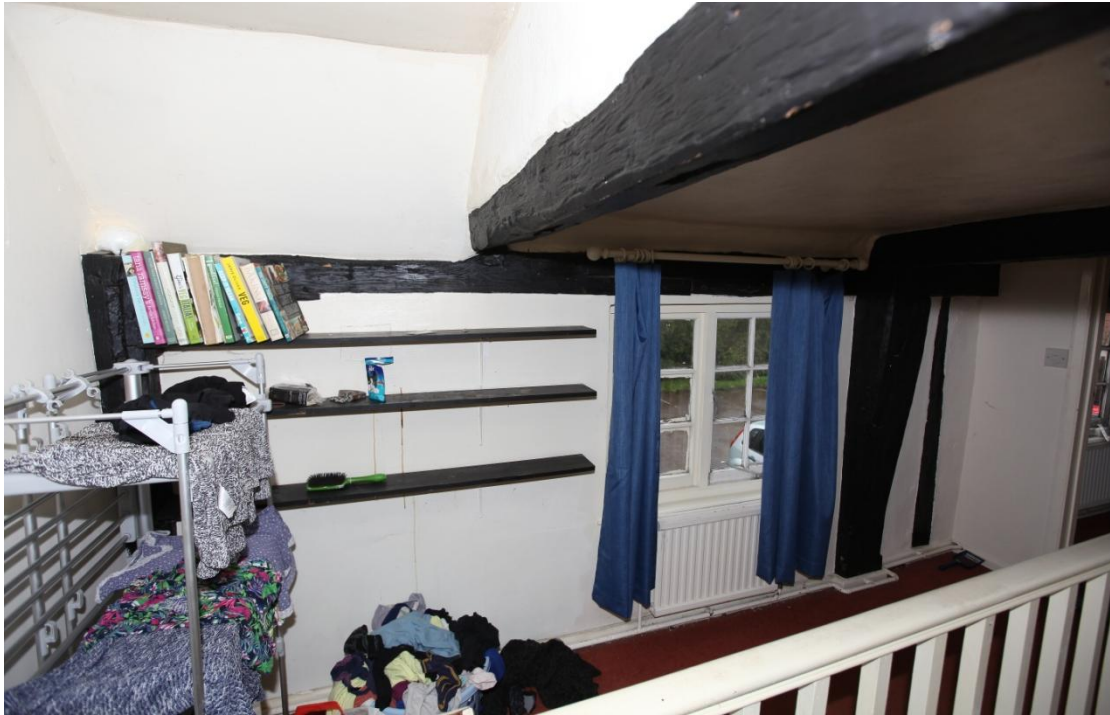
Illus. 19. The front wall showing the first-floor window above the present central entrance door with the jowled storey post of the missing partition on the left. The jowl contains a mortice for a wall brace which is lacking from its rear counterpart (illus. 16) suggesting an internal door lay against the back wall. The tie-beam in the centre contains empty stud mortices and formerly connected these storey posts.

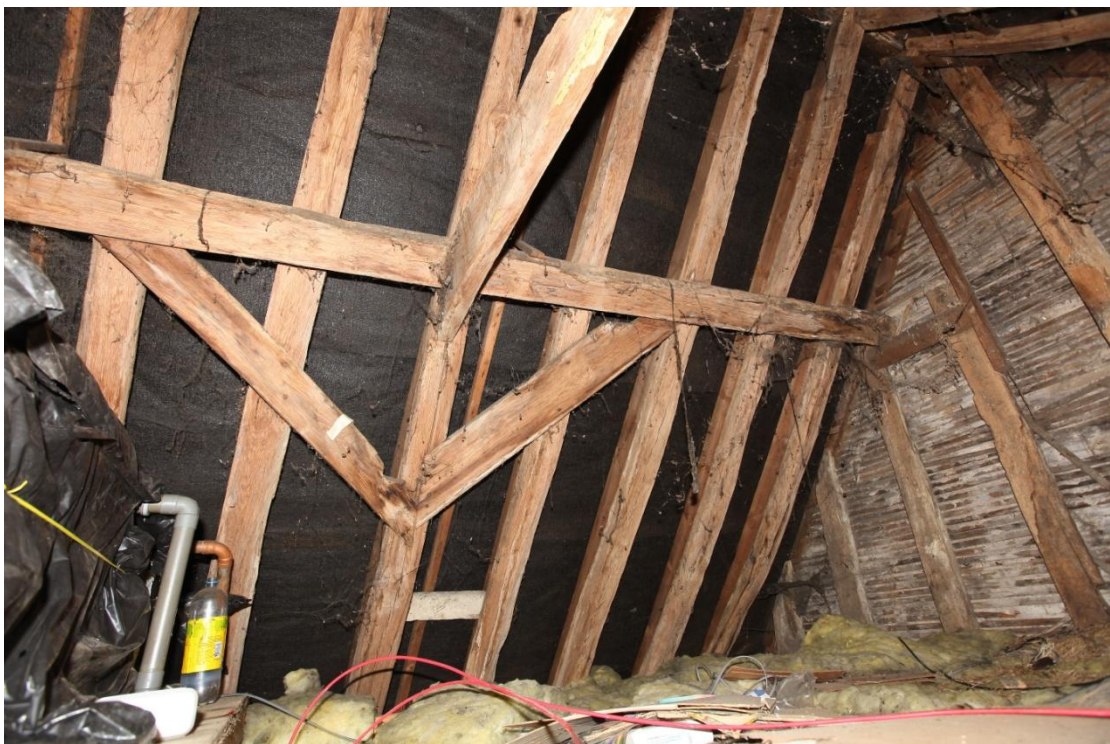
Illus. 20. The western end of the roof structure, with the gable to the right. This clasped-purlin structure could survive from the original 16th century house but its nailed wind-braces suggest it was rebuilt as part of the 17th century remodelling. Identical nailed braces survive in the front wall immediately opposite.

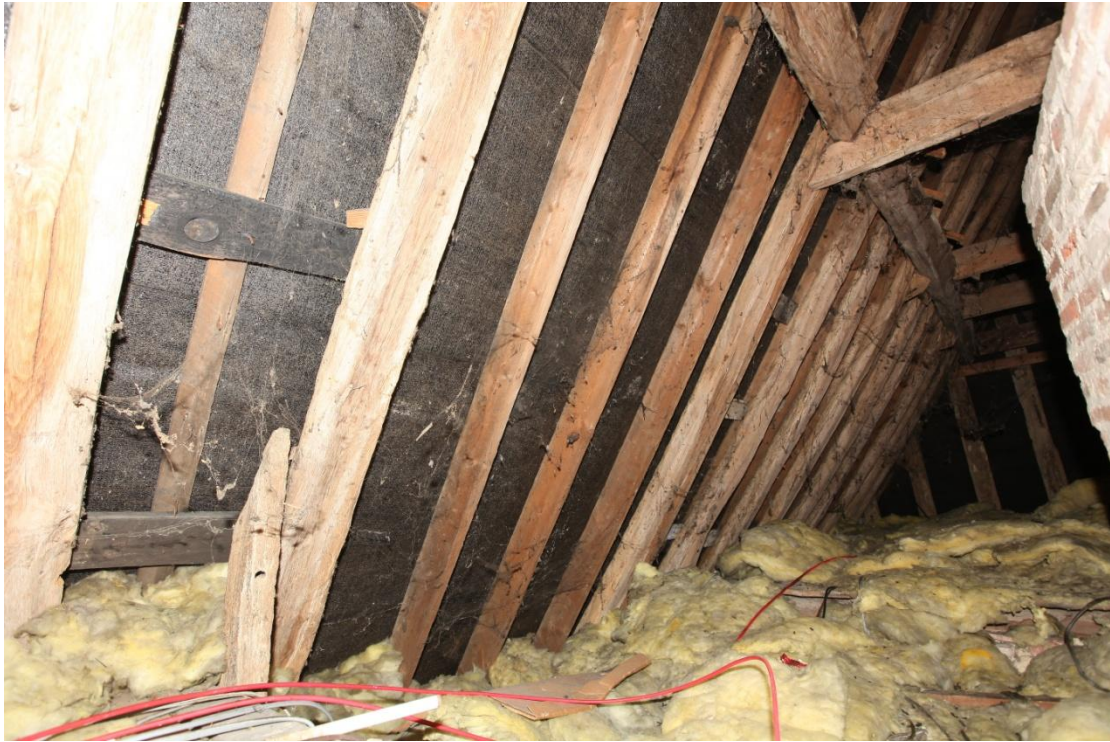
Illus. 21. The front of the roof structure with the chimney on the right. Unusually there is no evidence of any other wind bracing, whether nailed or pegged. Note the three pine rafters adjoining the stack in the centre which are late-19th or 20th century replacements.
