Red Lion Inn, Great Bricett, Suffolk

Heritage Asset Assessment

October 2020

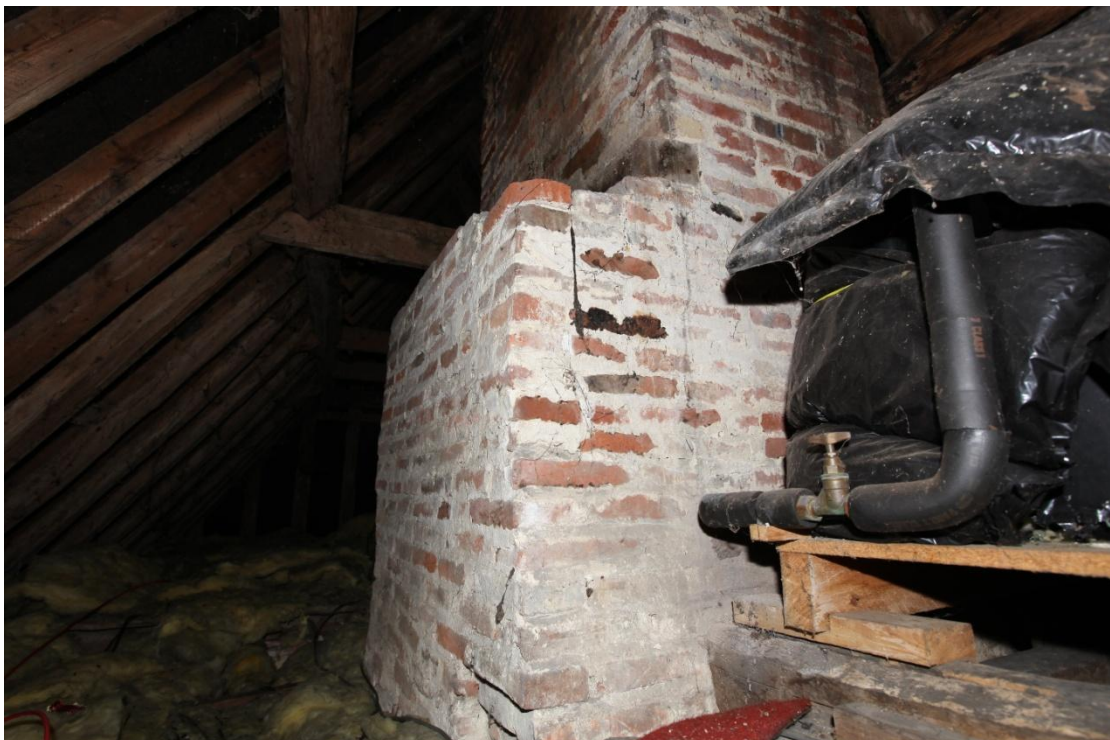
Illus. 22. The brickwork of the chimney exposed in the roof space showing its thick mortar and irregular bricks in the typical manner of the 17th century. The upper courses and external stack were rebuilt in uniform soft reds with fine mortar joints in the 19th century.
