BAT EMERGENCE AND ACTIVITY SURVEYS  
OF  
BUILDINGS AND LAND ASSOCIATED WITH  
HALL FARM  
FLAWBOROUGH  
NOTTINGHAMSHIRE

**June 2021**

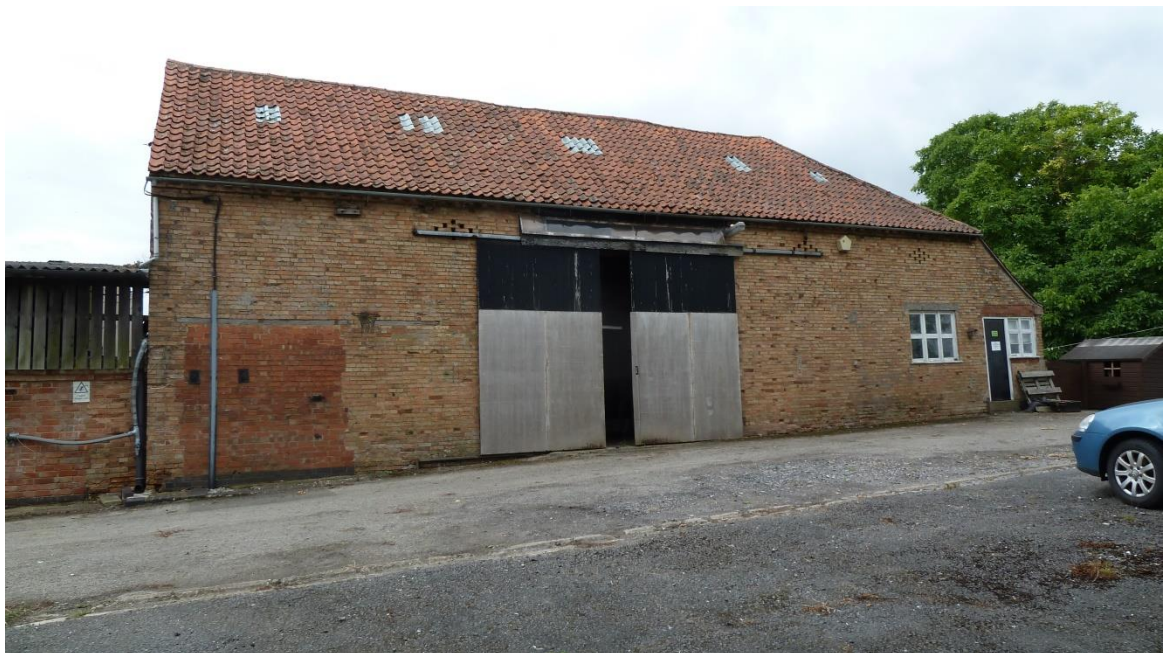
Building 3 is a two-storey traditional barn; it is of solid brick construction and covered with a pantile roof, with occasional roof lights on a timber purlin and rafter frame. The building is a two-storey construction with wall vents in the first-floor section.

Photograph 1 – Building 3, two-storey solid brick barn.

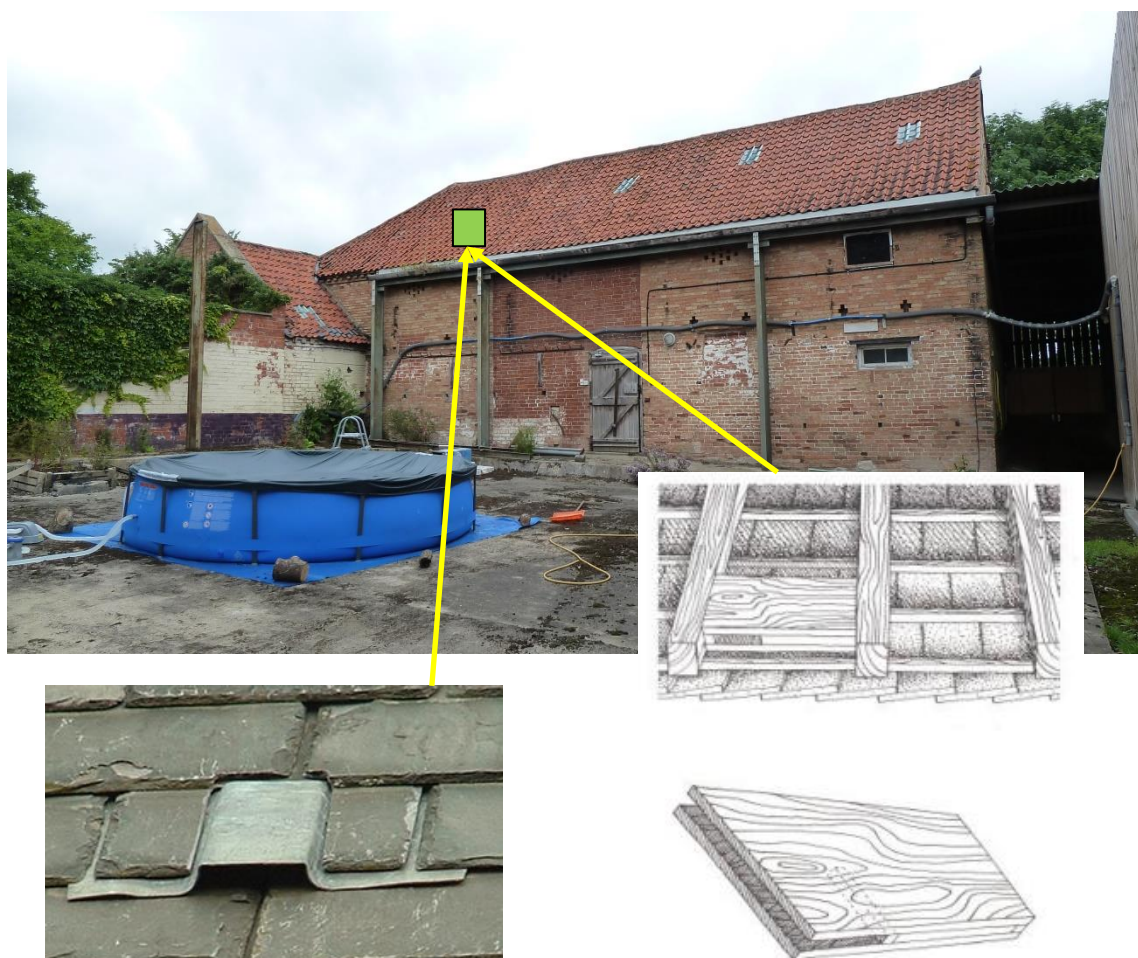
The boxes are fitted between the rafters and with the roof underlining material cut around, then covered with the roof tiles. There is a slot at the base of the tiles and box to allow access to the box. This is via a standard lead bat access tile. The specification of these is indicated in figure 3, below.

**Figure 3 - example installation for the proposed new bat box under the new roof covering of Building 3.**

Two options will be utilised during the redevelopment of the brick built two-storey barn, Building 3. The first is to install a timber bat box underneath the roof tiles on the southern elevation of the roof covering. The design proposal is bespoke fitted around the gaps between the roof rafters, and will be a constructed from rough sawn timber. To assure this a sample of the timber proposed should be sent to the ecologist for approval.

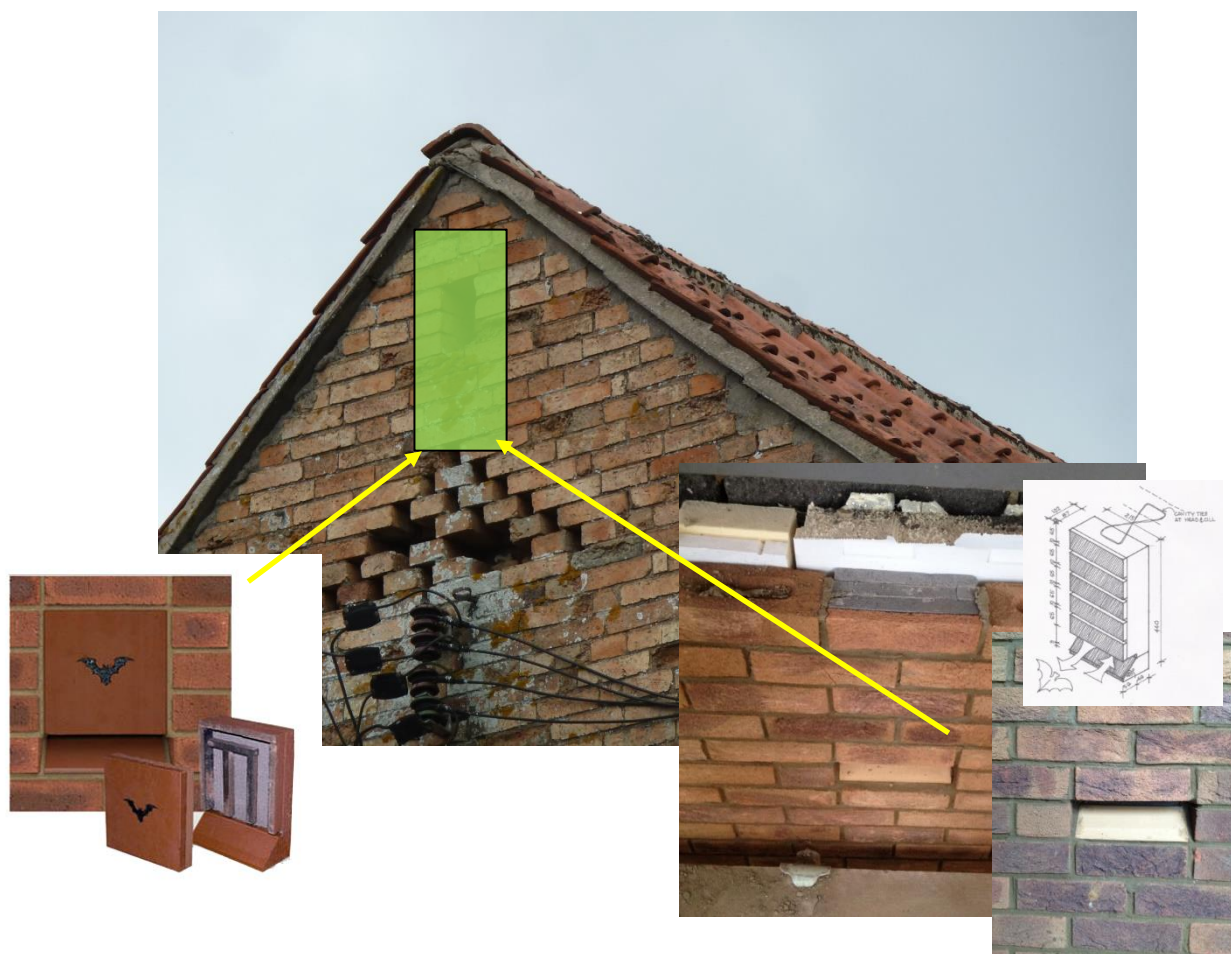
An enclosed bat tube is to be installed within the exterior wall at the eastern gable end of the new dwelling such that the access slot to the box sits flush with the wall to allow a bat to land below and crawl up to the box. An example of an installed Habitat box is provided in Figure 4.

Figure 4 - example installation for the proposed new bat tube including both specifications and types available and the ideal locations within the barn conversions. The unit to the left is from Ibstock brick, the unit to the right is a habibat unit available from NHBS.

The second alternative roost provision is that of a bat tube.

Other makes and finishes of enclosed bat tubes are available from building materials suppliers, including from frequent building supplies company Ibstock brick.
