**GEO-ENVIRONMENTAL DESK STUDY REPORT
FOR
ROCKS BUNGALOW, ST BRIAVELS COMMON,
LYDNEY, GLOUCESTERSHIRE, GL15 6SE**

**PREPARED FOR
MR TOM ADAMS**

Report No. 4882

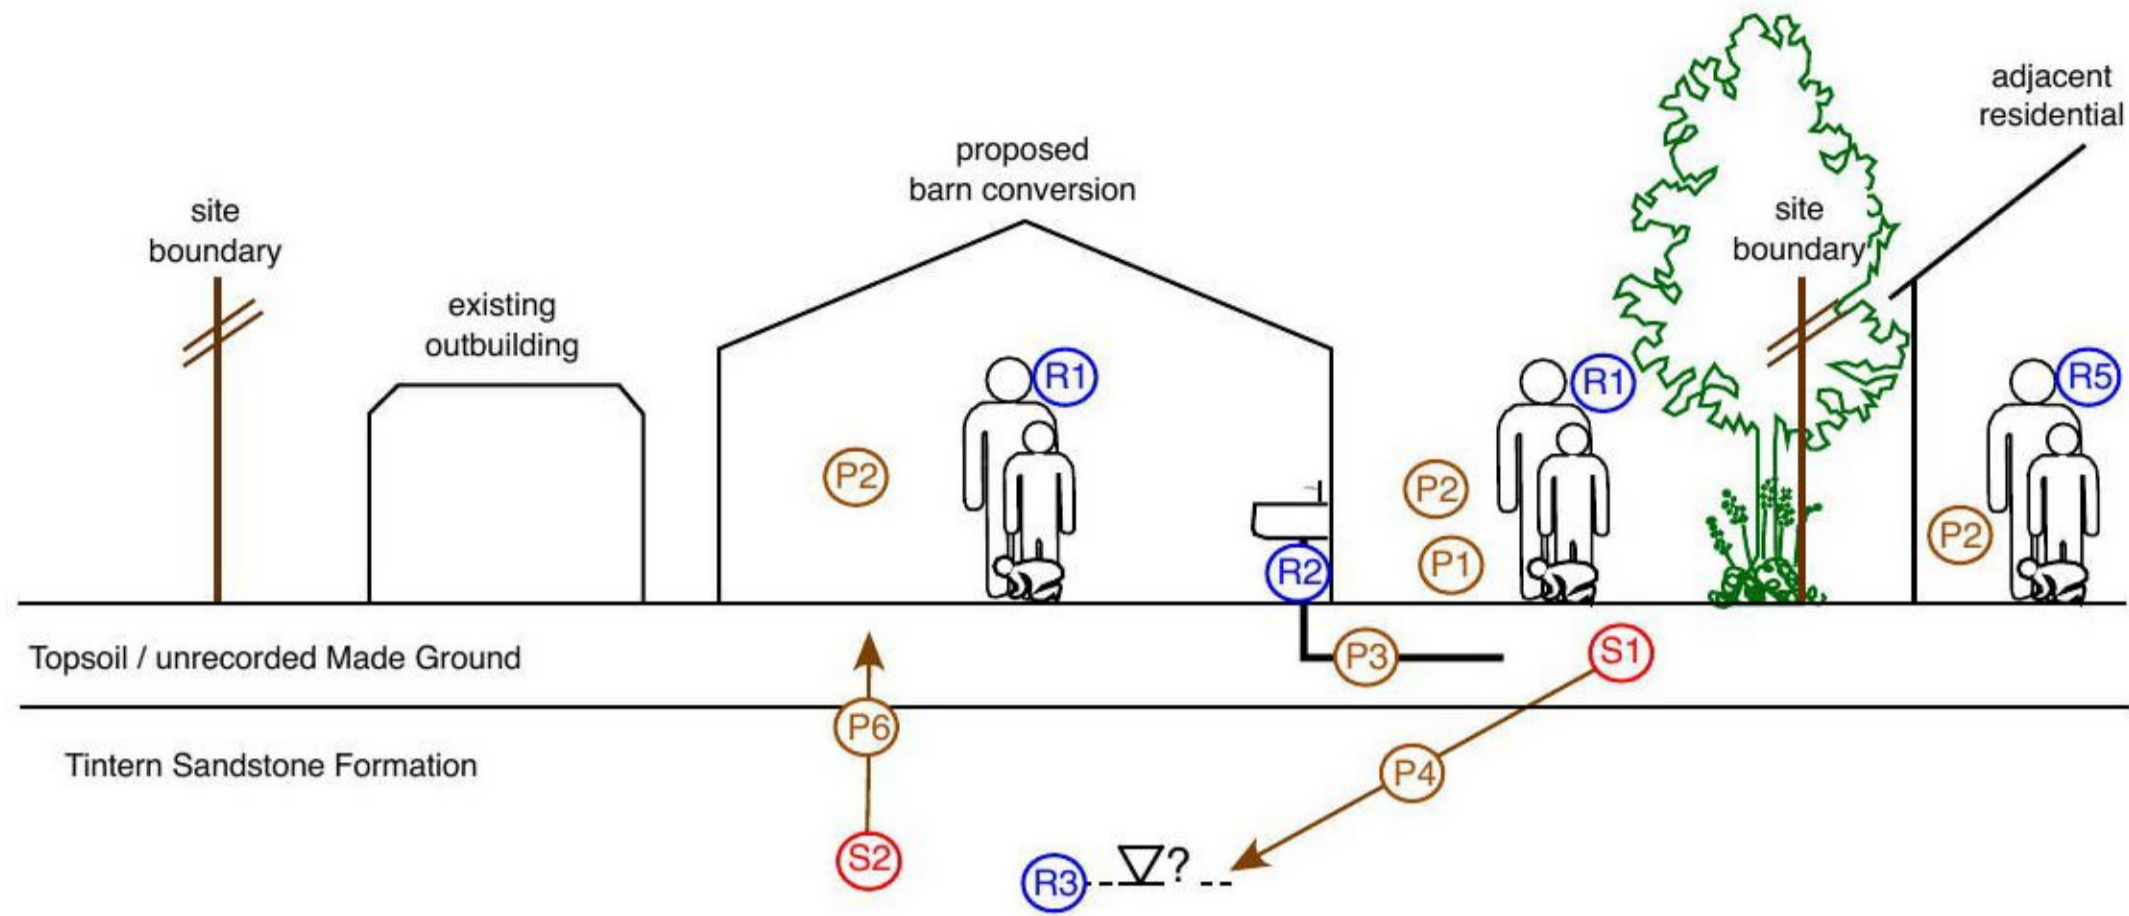
FIGURE 1: PRELIMINARY CONCEPTUAL SITE MODEL (NTS)

5.4 The above information is converted into the preliminary Conceptual Site Model shown in Figure 1 below, and the **potential pollutant linkages** involving future residents, proposed services and local environmental receptors are discussed in Table 3, with appropriate risk levels.

Potential Sources	Pathways	Receptors					Comments	Preliminary Risk Assessment
		R1	R2	R3	R4	R5		
ON SITE								
S1	P1	X					Proposed residential development; greatest risk within areas of proposed soft landscaping	Low
	P2	X						
	P3		X					
	P4			X				
	P5							
	P6							
S2	P1						Full radon protection required	High
	P2							
	P3							
	P4							
	P5							
	P6							
OFF SITE								
None								
SOURCES	S1	Possible elevated toxic and phytotoxic metals within near surface made ground (unlikely) / topsoil						
	S2	Natural radon gas emissions from TSF						
PATHWAYS	P1	Direct dermal contact or ingestion via soil attached to vegetables						
	P2	Inhalation of dust and vapours						
	P3	Permeation into new water supply pipework						
	P4	Vertical leaching of leachable contaminants in unsaturated zone and lateral migration in saturated zone						
	P5	Landfill gas migration through unsaturated zone and accumulation within confined spaces

P6	Radon gas migration through unsaturated zone and accumulation within confined spaces						
RECEPTORS	R1	Future occupants (critical residential receptor is female child age class 1-6)						
	R2	Potable water supply						
	R3	Groundwater (TSF classified as a 'Secondary A' aquifer)						
	R4	Surface waters (Unnamed Brook c120m NW)						
	R5	Adjacent site users (residential)

- 5.5** The findings of the Phase 1 desk study suggest a low risk that the site may contain contaminants at elevations sufficient to pose a significant risk to human health or environmental receptors, on which basis soil sampling, testing and quantitative risk assessment is deemed unnecessary. That said future funders and/or insurers may insist on some level of routine 'due diligence' assessment, in which case we could assist as required.

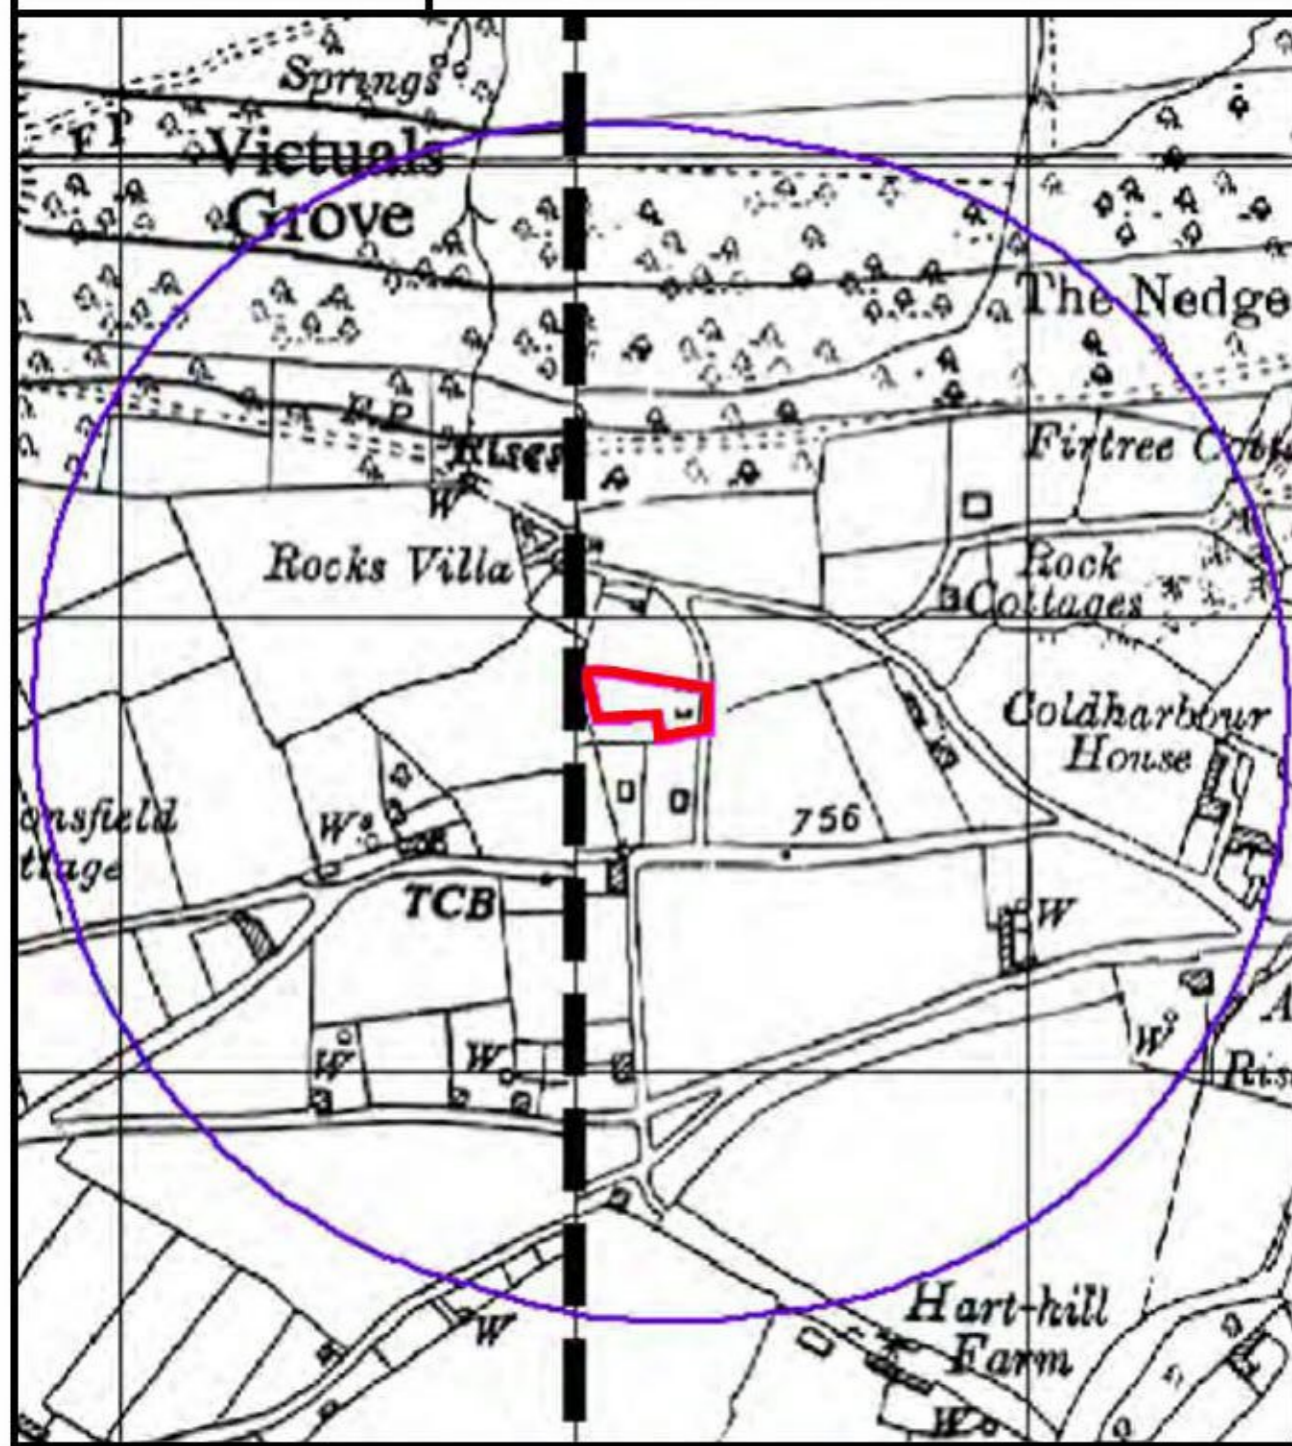
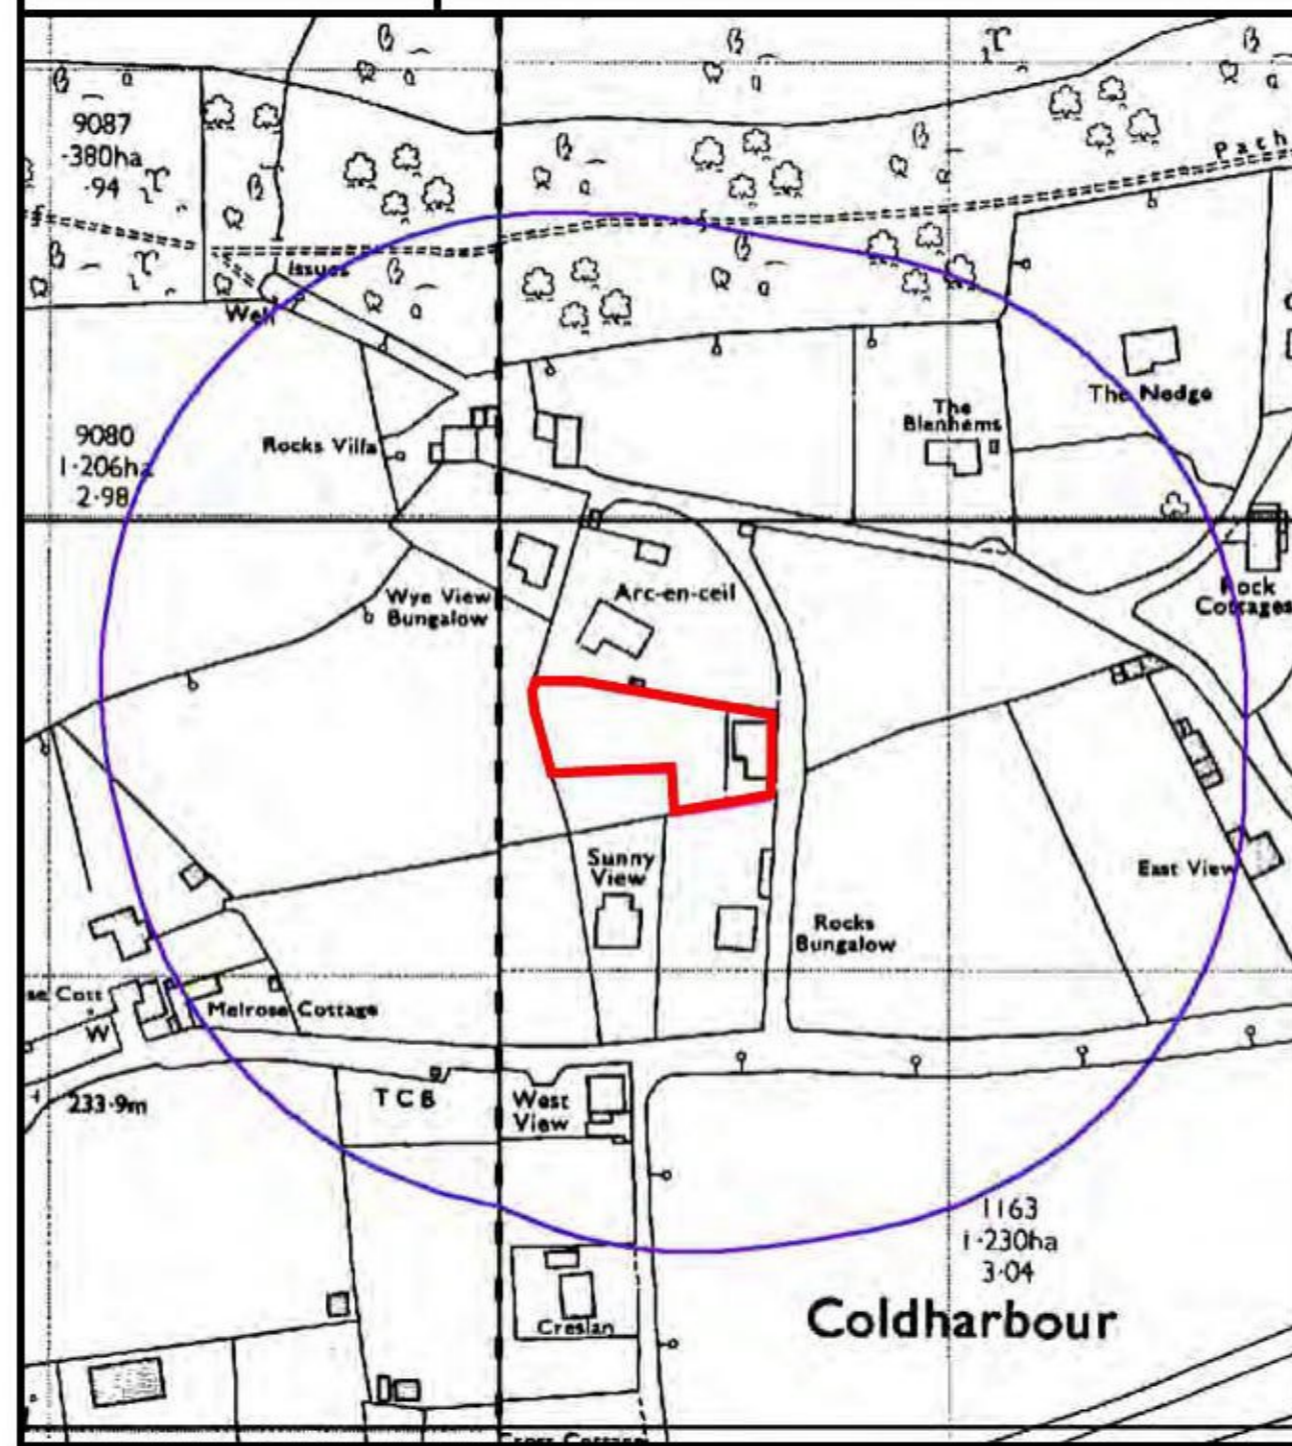
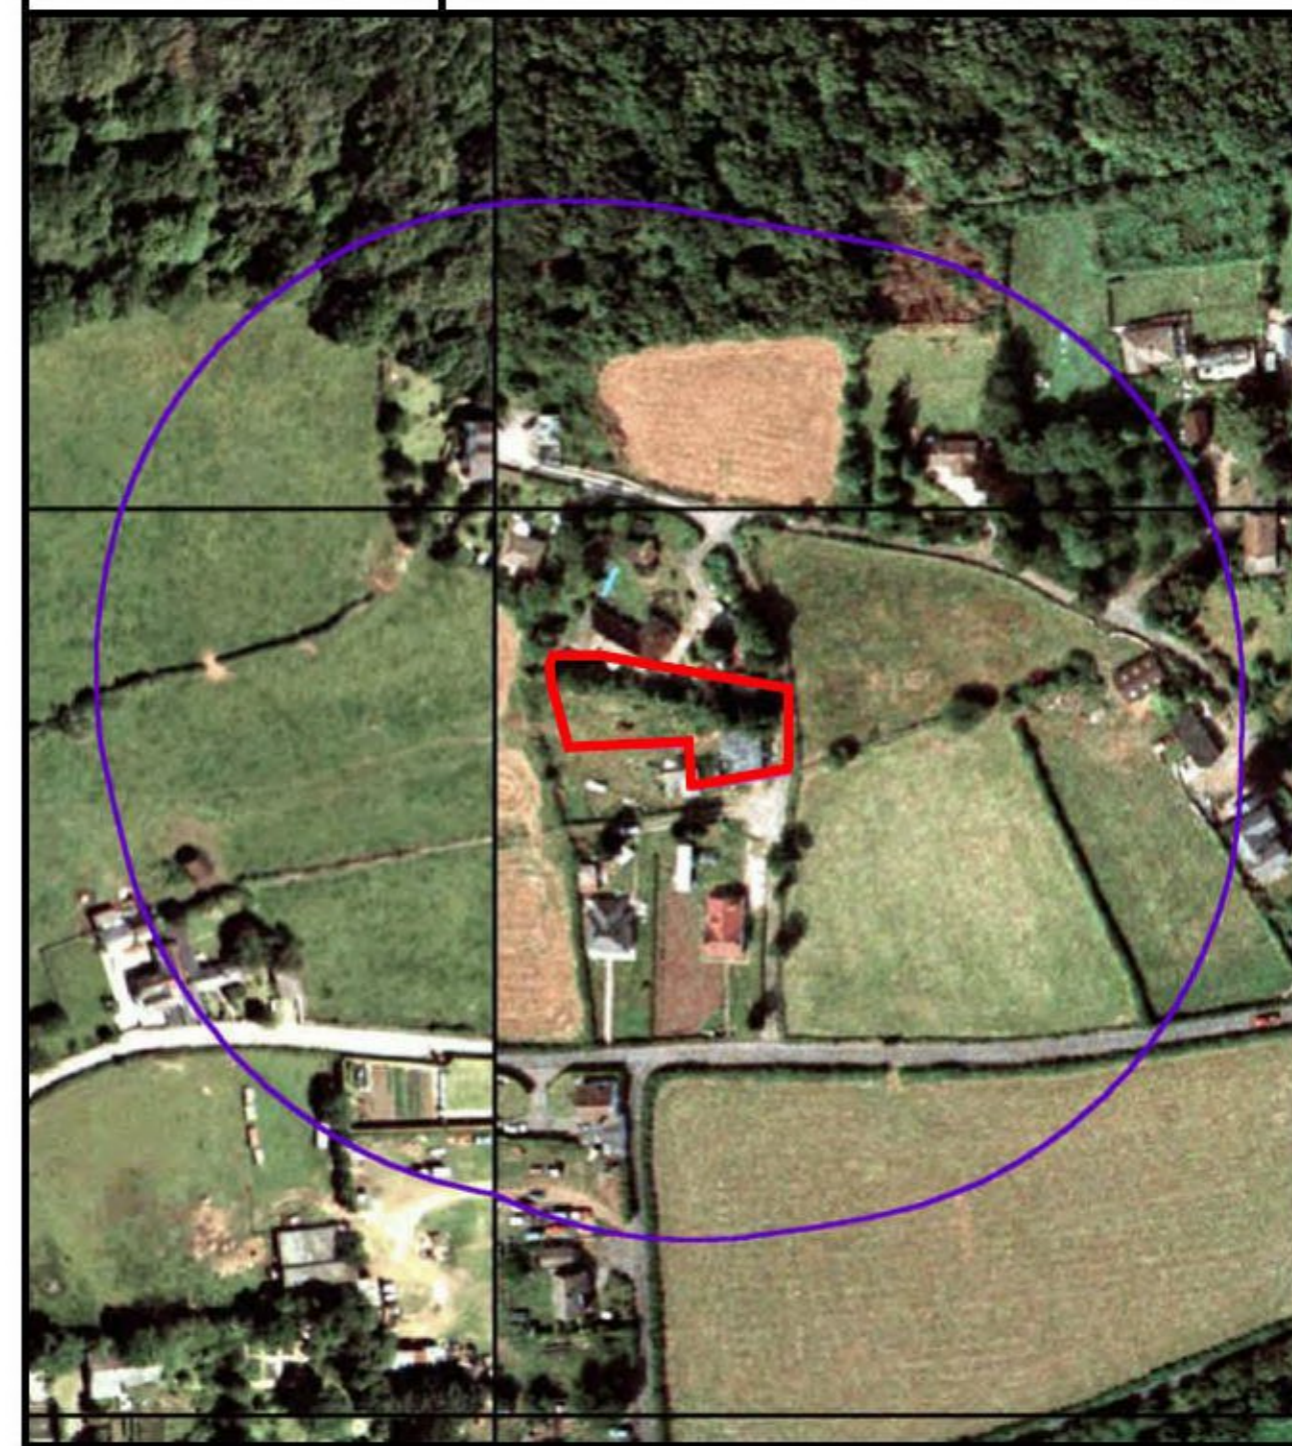
Job No.	4882	Date:	23-08-21
Drawing No.	4882/3	Scale:	as shown

EXTRACTS OF ORDNANCE SURVEY PLANS TO SHOW SITE HISTORY

3.7 The history of the site has been deduced by inspection of historical Ordnance Survey maps dating back to 1881 together with historical aerial imagery provided as part of the online Google Earth mapping service, and a selection of relevant extracts is presented as drawing 4882/3. Any on and/or off-site points of interest that may affect or be affected by the proposed development have been summarised within Table 1 below.

- 5.2** Review of historical mapping suggests that the site remained as a predominantly undeveloped grassy field since the earliest available mapping of 1881; a Chapel was constructed within the barn footprint in 1928 which was then converted to the current barn in 1971, followed by the construction of the outbuilding in c2000, remaining until the present day.
