PHASE 2: GROUND INVESTIGATION REPORT

AMETHYST HOMES

PROPOSED RESIDENTIAL DEVELOPMENT

Project No: 21-168

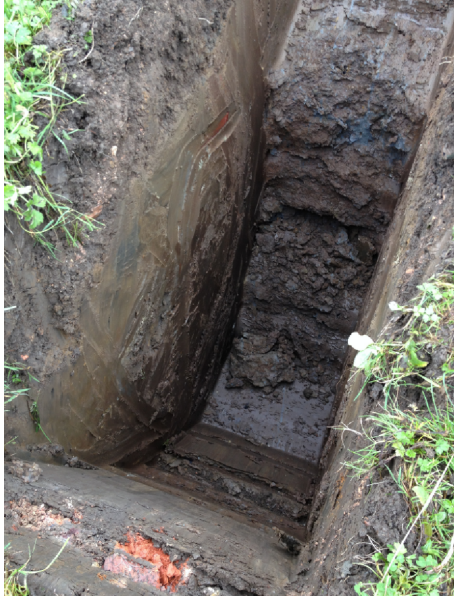
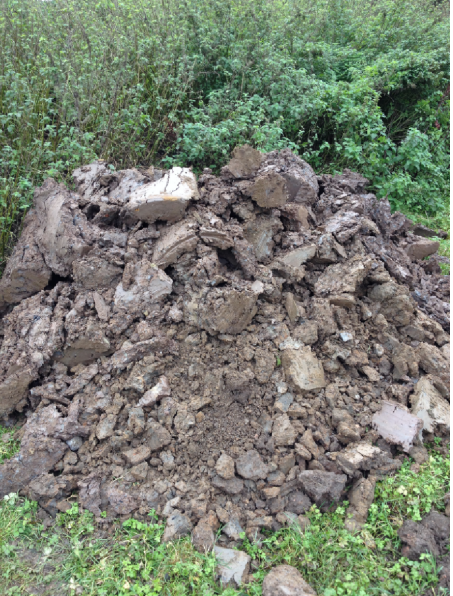
Project Spring Ville, East Sleekburn, Bedlington				TRIAL PIT No TP03
Job No 13-554	Date 06-11-13	Ground Level (m) 13.08	Co-Ordinates () E 428,751.3 N 583,648.4	
Contractor Arc Environmental Ltd				Sheet 1 of 1

STRATA			SAMPLES & TESTS		
Depth	No	DESCRIPTION	Depth	No	Remarks/Tests
0.00-0.20		Grass overlying dark brown clayey sandy soil with some fine to medium brick fragments. Some roots (MADE GROUND)			
0.20-0.50		Stiff dark brown, locally dark grey, sandy gravelly clay with many brick and drainage fragments (MADE GROUND)	0.35	B	
0.50-2.00		Stiff (high strength) brown mottled grey sandy gravelly CLAY with occasional sandstone cobbles and coal fragments (GLACIAL TILL)	0.50	V	4% 106kN/m ²
			0.50	B	
			0.60	B	
			1.15	V	112kN/m ²
			1.20	B	
2.00		Field drainage noted at 0.75m - minor water ingress from pipe	2.00	B	
			2.00	V	>120kN/m ²

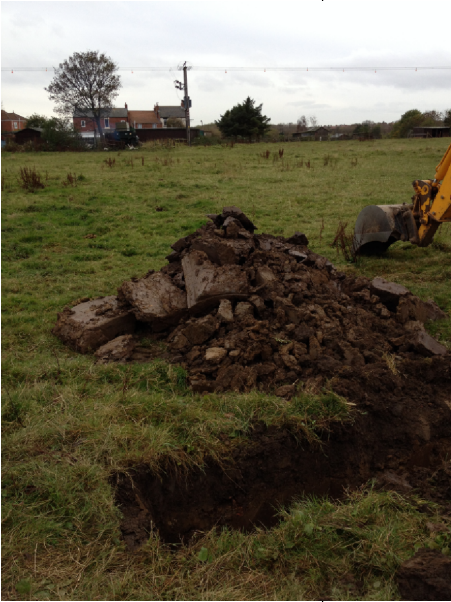
Project Spring Ville, East Sleekburn, Bedlington				TRIAL PIT No TP07
Job No 13-554	Date 06-11-13	Ground Level (m) 13.04	Co-Ordinates () E 428,750.3 N 583,596.3	
Contractor Arc Environmental Ltd				Sheet 1 of 1

STRATA			SAMPLES & TESTS		
Depth	No	DESCRIPTION	Depth	No	Remarks/Tests
0.00-0.30		Grass overlying dark brown clayey sandy soil with some fine to medium brick fragments. Some roots (MADE GROUND)	0.20	B	
0.30-0.40		Dark brown very sandy gravelly clay with occasional fine to medium brick fragments.	0.50	CBR	3.5%
0.40-2.40		Occasional concrete fragments (MADE GROUND) Stiff (high strength) brown mottled grey sandy gravelly CLAY with occasional coal fragments (GLACIAL TILL)	0.50	V	>120kN/m ²
			1.00	B	
			1.10	V	105kN/m ²
			2.00	B

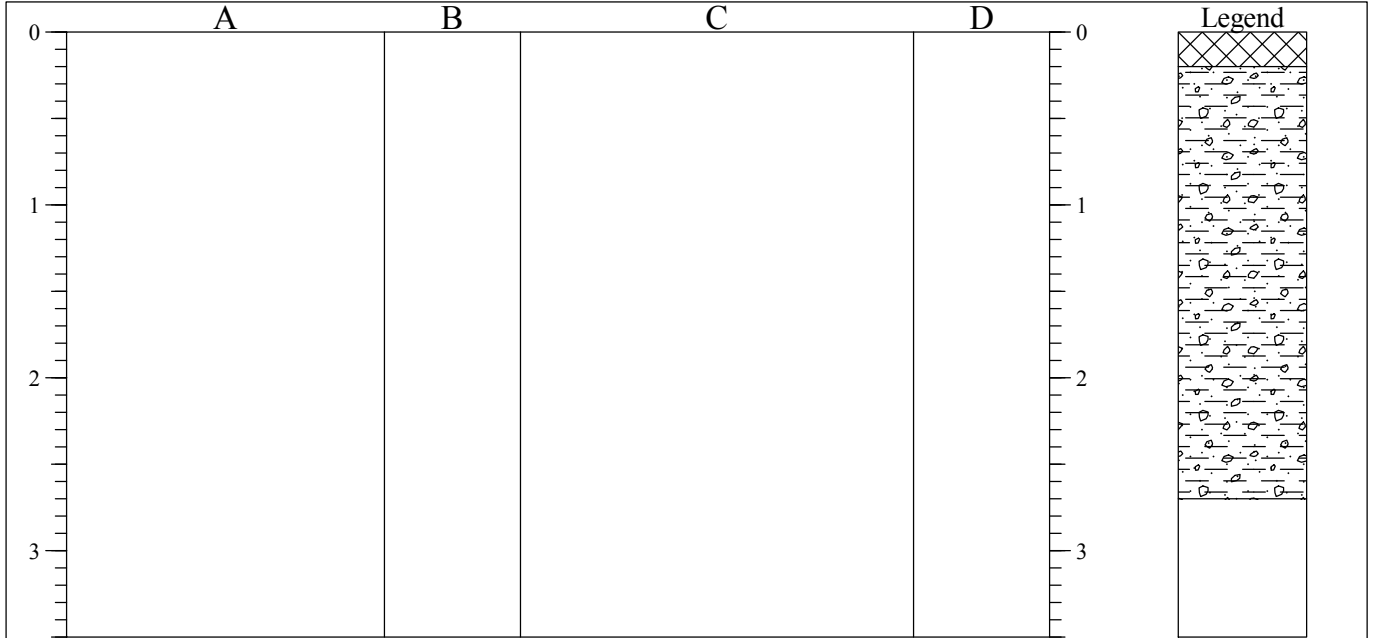
Project Land at Springville, East Sleekburn				TRIAL PIT No TP101
Job No 21-168	Date 07-06-21	Ground Level (m) 13.70	Co-Ordinates () E 428,669.0 N 583,537.5	
Contractor Arc Environmental Ltd				Sheet 1 of 1

STRATA			SAMPLES & TESTS		
Depth	No	DESCRIPTION	Depth	No	Remarks/Tests
0.00-0.20		Unmanaged grass overlying dark brown clayey sandy soil with fine roots (MADE GROUND)	0.00-0.20	J	
0.20-2.70		Stiff (high strength) brown mottled grey sandy gravelly CLAY with occasional sandstone cobbles and fragments of coal (GLACIAL TILL)	0.60	CBR	3.0%
			1.00-1.20	B	
			1.00	V	82kN/m ²
			2.00	V	>120kN/m ²

<p>Shoring/Support: Stability:</p> <div style="text-align: center;"> </div>	<p>GENERAL REMARKS</p> <p>WATER: Trial pit dry.</p>
---	--

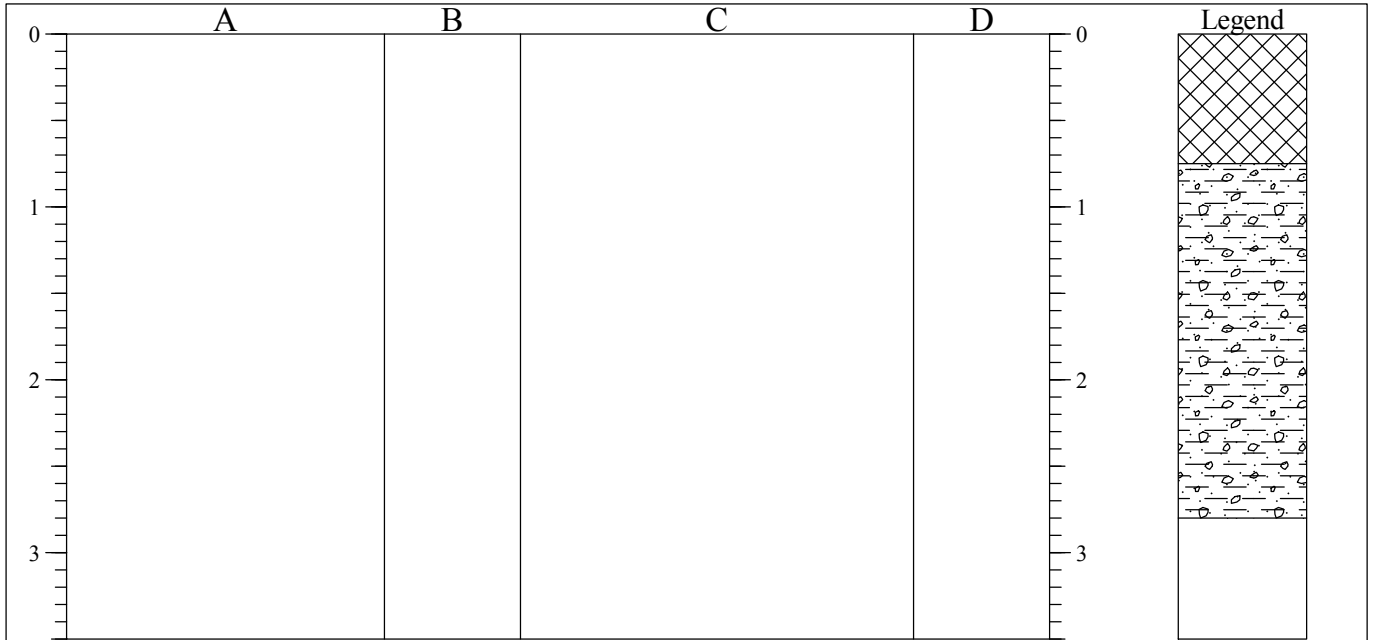
Project Land at Springville, East Sleekburn				TRIAL PIT No TP102
Job No 21-168	Date 07-06-21	Ground Level (m) 13.54	Co-Ordinates () E 428,706.3 N 583,555.4	
Contractor Arc Environmental Ltd				Sheet 1 of 1

STRATA			SAMPLES & TESTS		
Depth	No	DESCRIPTION	Depth	No	Remarks/Tests
0.00-0.75		Unmanaged grass overlying dark brown clayey sandy soil with fine roots and occasional whole and half bricks (MADE GROUND)	0.30-0.50	J	
0.75-2.80		Stiff (high strength) brown mottled grey sandy gravelly CLAY with occasional sandstone cobbles and fragments of coal (GLACIAL TILL)	1.00	V	90kN/m ²
			1.40-1.60	B	
			2.50	V	>120kN/m ²

<p>Shoring/Support: Stability:</p> <div style="text-align: center;"> </div>	<p>GENERAL REMARKS</p> <p>WATER: Trial pit dry.</p>
---	--

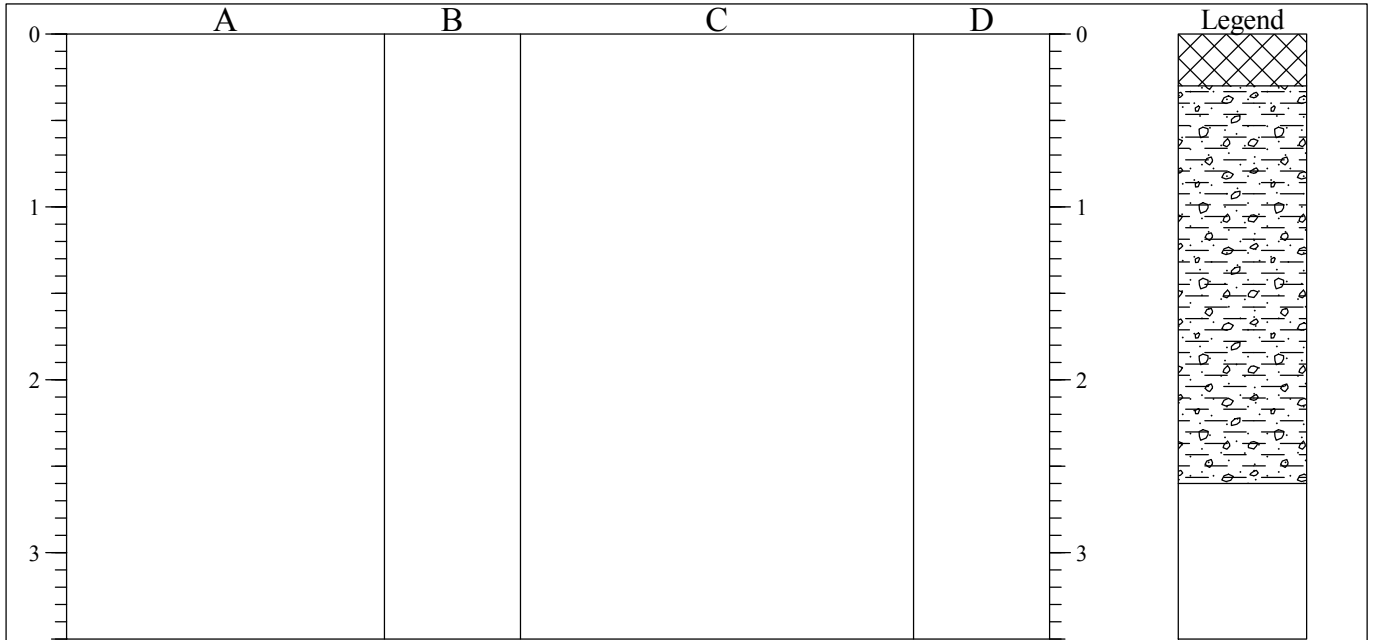
Project Land at Springville, East Sleekburn				TRIAL PIT No TP103
Job No 21-168	Date 07-06-21	Ground Level (m) 13.57	Co-Ordinates () E 428,698.4 N 583,602.2	
Contractor Arc Environmental Ltd				Sheet 1 of 1

STRATA			SAMPLES & TESTS		
Depth	No	DESCRIPTION	Depth	No	Remarks/Tests
0.00-0.30		Unmanaged grass overlying dark brown clayey sandy soil with fine roots and occasional fragments of brick (MADE GROUND)			
0.30-2.60		Stiff (high strength) brown mottled grey sandy gravelly CLAY with occasional sandstone cobbles and fragments of coal (GLACIAL TILL)	0.80	V	100kN/m ²
			1.00-1.20	B	
			1.60	V	>120kN/m ²

<p>Shoring/Support: Stability:</p> <div style="text-align: center;"> </div>	<p>GENERAL REMARKS</p> <p>WATER: Trial pit dry.</p>
---	--

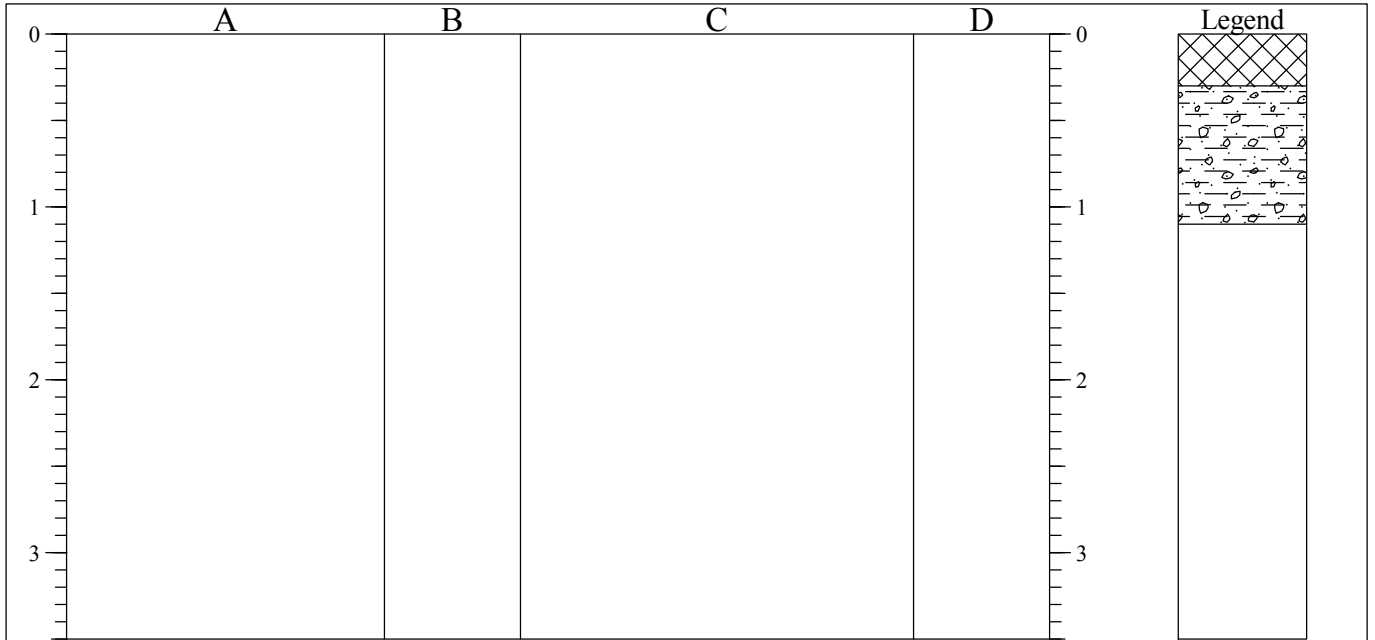
Project Land at Springville, East Sleekburn				TRIAL PIT No TP104
Job No 21-168	Date 07-06-21	Ground Level (m) 13.32	Co-Ordinates () E 428,727.4 N 583,586.5	
Contractor Arc Environmental Ltd				Sheet 1 of 1

STRATA			SAMPLES & TESTS		
Depth	No	DESCRIPTION	Depth	No	Remarks/Tests
0.00-0.30		Unmanaged grass overlying dark brown clayey sandy soil with fine roots and occasional fragments of brick (MADE GROUND)			
0.30-1.10		Stiff (high strength) brown mottled grey sandy gravelly CLAY with occasional sandstone cobbles and fragments of coal (GLACIAL TILL)	0.70	CBR	3.0%
			0.80-1.00	B	
			1.00	V	>120kN/m ²

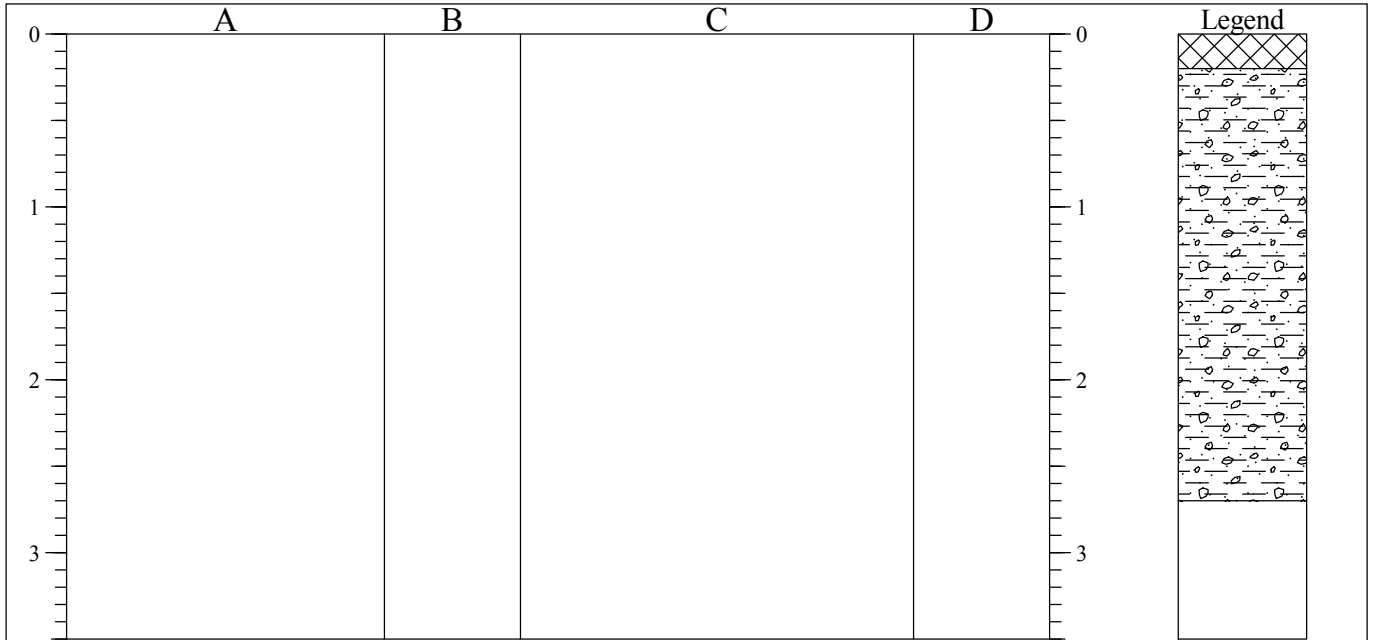
Project Land at Springville, East Sleekburn				TRIAL PIT No TP105
Job No 21-168	Date 07-06-21	Ground Level (m) 13.48	Co-Ordinates () E 428,719.0 N 583,642.1	
Contractor Arc Environmental Ltd				Sheet 1 of 1

STRATA			SAMPLES & TESTS		
Depth	No	DESCRIPTION	Depth	No	Remarks/Tests
0.00-0.20		Unmanaged grass overlying dark brown clayey sandy soil with large roots and occasional fragments of brick (MADE GROUND) Stiff (high strength) brown mottled grey sandy gravelly CLAY with occasional sandstone cobbles and fragments of coal (GLACIAL TILL)	0.00-0.20	J	
0.20-2.70			0.60	CBR	3.5%
			1.00	V	86kN/m ²
			1.40-1.60	B

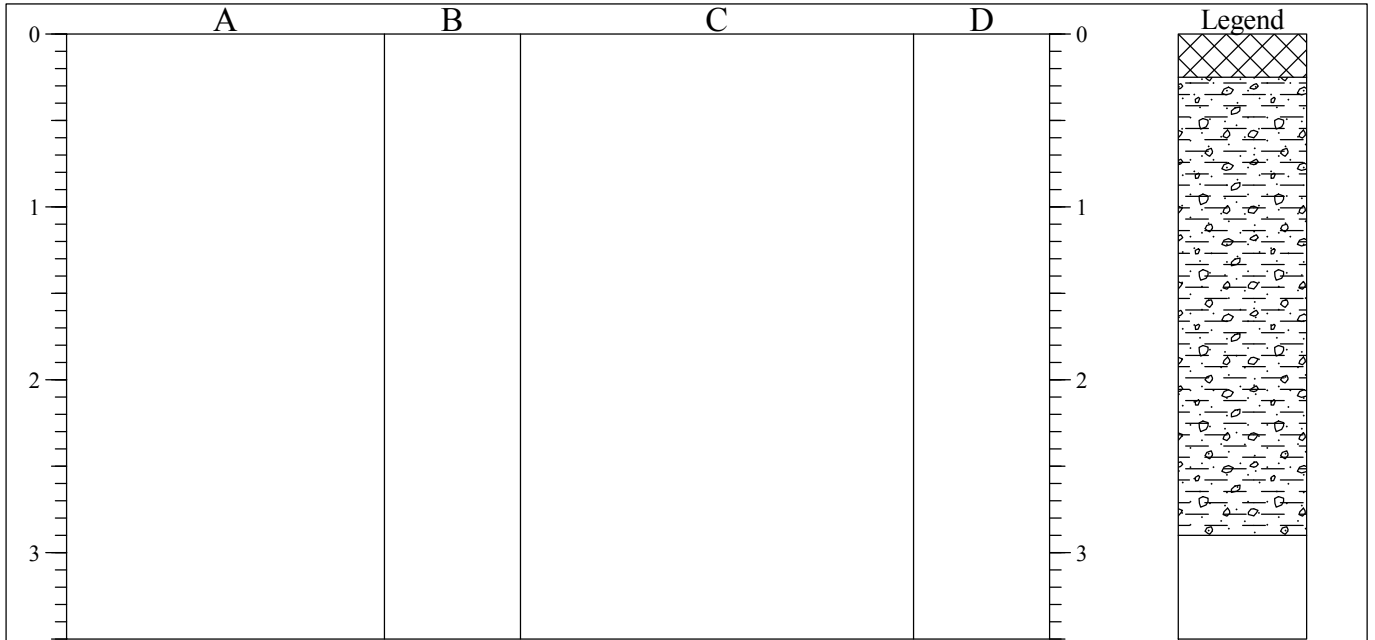
Project Land at Springville, East Sleekburn				TRIAL PIT No TP106
Job No 21-168	Date 07-06-21	Ground Level (m) 13.01	Co-Ordinates () E 428,746.9 N 583,605.5	
Contractor Arc Environmental Ltd				Sheet 1 of 1

STRATA			SAMPLES & TESTS		
Depth	No	DESCRIPTION	Depth	No	Remarks/Tests
0.00-0.25		Unmanaged grass overlying dark brown clayey sandy soil with fine roots and occasional fragments of brick (MADE GROUND) Stiff (high strength) brown mottled grey sandy gravelly CLAY with occasional sandstone cobbles and fragments of coal (GLACIAL TILL)	0.00-0.25	J	
0.25-2.90			0.50	CBR	4.0%
			1.00	V	100kN/m ²
			1.50-1.70	B	
			2.00	V	>120kN/m ²

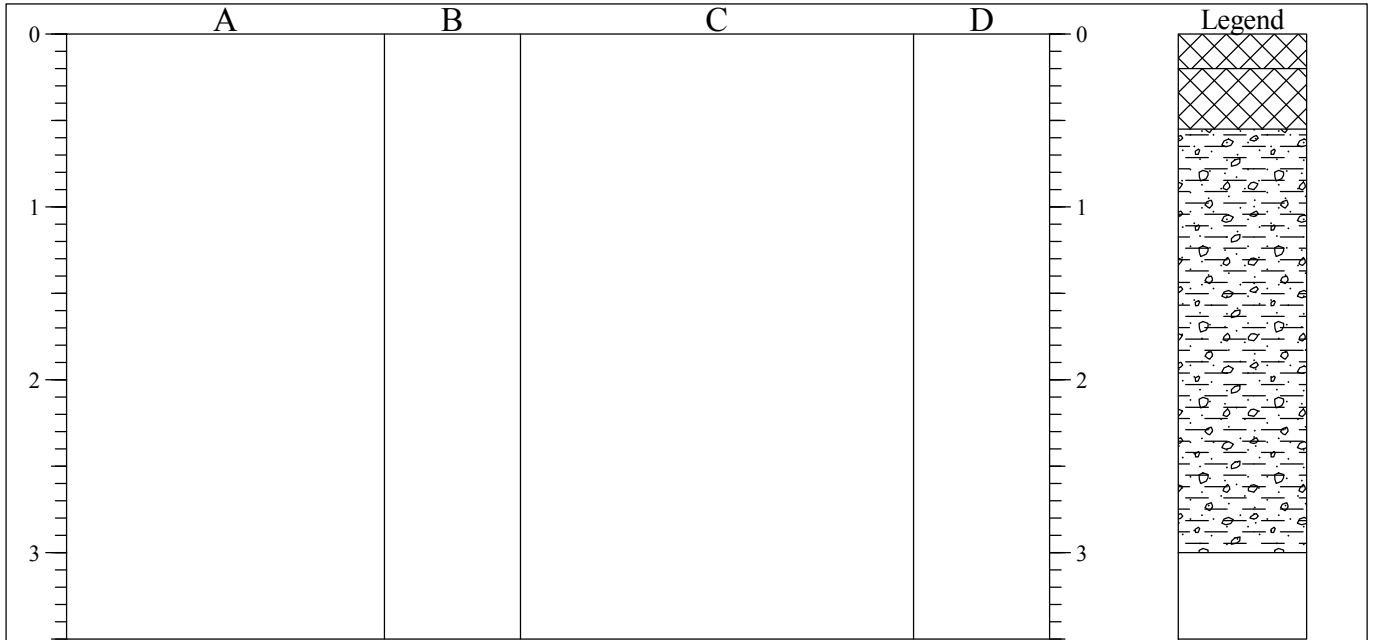
Project Land at Springville, East Sleekburn				TRIAL PIT No TP107
Job No 21-168	Date 07-06-21	Ground Level (m) 13.16	Co-Ordinates () E 428,767.8 N 583,616.4	
Contractor Arc Environmental Ltd				Sheet 1 of 1

STRATA			SAMPLES & TESTS		
Depth	No	DESCRIPTION	Depth	No	Remarks/Tests
0.00-0.20		Unmanaged grass overlying dark brown clayey sandy soil with fine roots and occasional fragments of brick (MADE GROUND)			
0.20-0.55		Red brick rubble (MADE GROUND)	0.30-0.50	J	
0.55-3.00		Stiff (high strength) brown mottled grey sandy gravelly CLAY with occasional sandstone cobbles and fragments of coal (GLACIAL TILL)	0.80-1.00	B	
			1.00	V	98kN/m ²
			1.60	V	>120kN/m ²

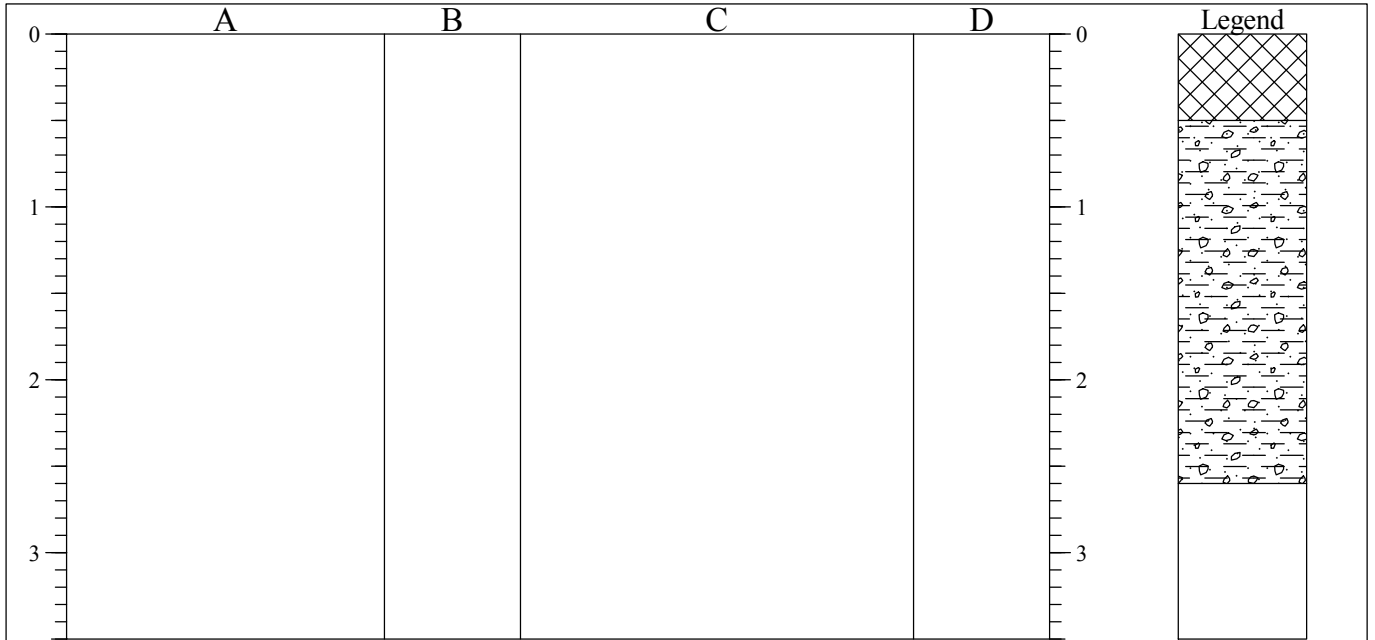
Project Land at Springville, East Sleekburn				TRIAL PIT No TP108
Job No 21-168	Date 07-06-21	Ground Level (m) 13.14	Co-Ordinates () E 428,774.4 N 583,640.2	
Contractor Arc Environmental Ltd				Sheet 1 of 1

STRATA			SAMPLES & TESTS		
Depth	No	DESCRIPTION	Depth	No	Remarks/Tests
0.00-0.50		Unmanaged grass overlying dark brown clayey sandy soil with fine roots and occasional fragments of brick (MADE GROUND)	0.20-0.40	J	
0.50-2.60		Stiff (high strength) brown mottled grey sandy gravelly CLAY with occasional sandstone cobbles and fragments of coal (GLACIAL TILL)	0.60	CBR	3.5%
			1.20-1.40	B	80kN/m ²
			1.20	V	
			2.00	V	>120kN/m ²

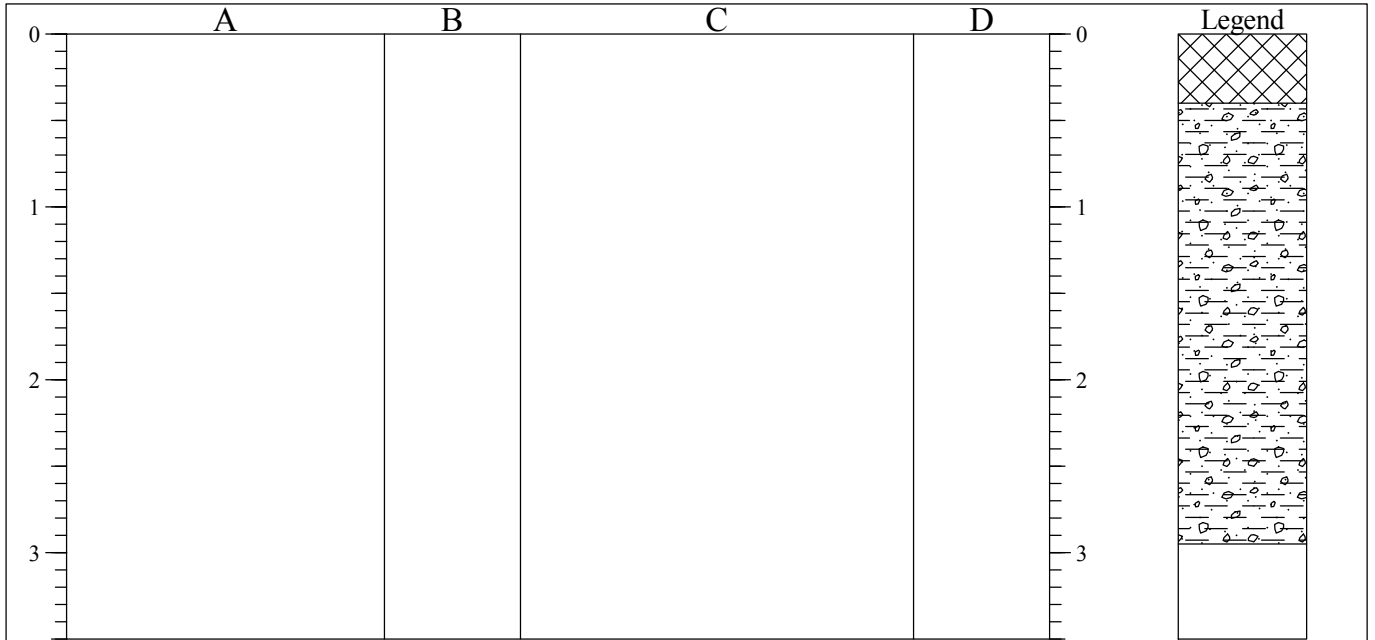
Project Land at Springville, East Sleekburn				TRIAL PIT No TP109
Job No 21-168	Date 07-06-21	Ground Level (m) 13.67	Co-Ordinates () E 428,727.5 N 583,660.4	
Contractor Arc Environmental Ltd				Sheet 1 of 1

STRATA			SAMPLES & TESTS			
Depth	No	DESCRIPTION	Depth	No	Remarks/Tests	
0.00-0.40		Unmanaged grass overlying dark brown clayey sandy soil with fine roots and occasional fragments of brick (MADE GROUND)	0.20-0.40	J		
0.40-2.95		Stiff (high strength) brown mottled grey sandy gravelly CLAY with occasional sandstone cobbles and fragments of coal (GLACIAL TILL)	1.00	V		78kN/m ²
			1.20-1.40	B		
			1.50	V		>120kN/m ²

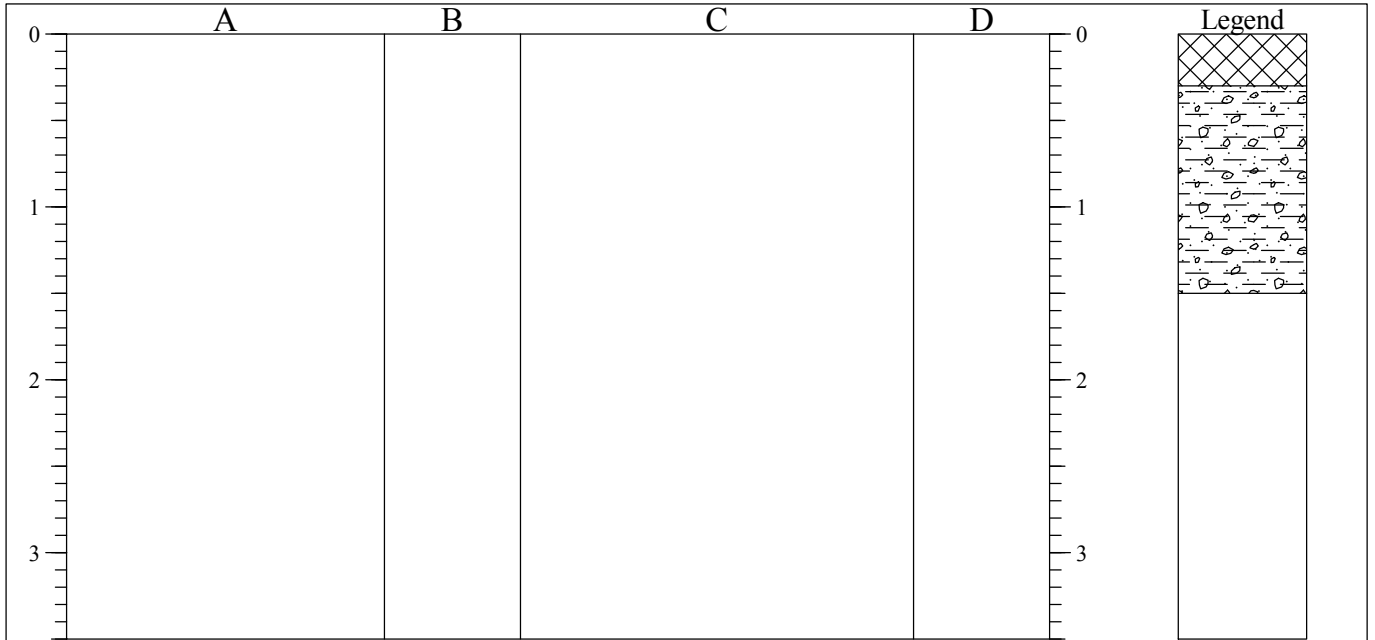
Project Land at Springville, East Sleekburn				TRIAL PIT No TP110
Job No 21-168	Date 07-06-21	Ground Level (m) 13.26	Co-Ordinates () E 428,753.2 N 583,644.5	
Contractor Arc Environmental Ltd				Sheet 1 of 1

STRATA			SAMPLES & TESTS		
Depth	No	DESCRIPTION	Depth	No	Remarks/Tests
0.00-0.30		Unmanaged grass overlying dark brown clayey sandy soil with fine roots and occasional fragments of brick (MADE GROUND)			
0.30-1.50		Stiff (high strength) brown mottled grey sandy gravelly CLAY with occasional sandstone cobbles and fragments of coal (GLACIAL TILL)	0.50	CBR	4.0%
			1.00	V	110kN/m ²
			1.20-1.40	B

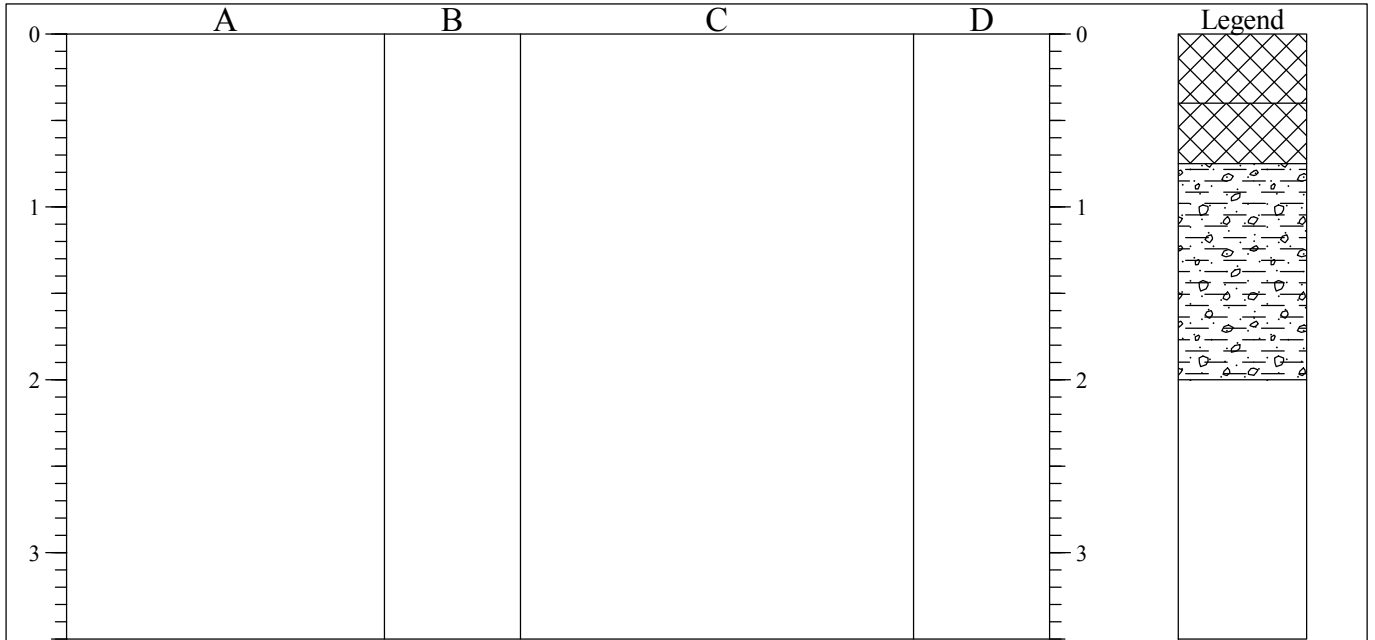
Project Land at Springville, East Sleekburn				TRIAL PIT No TP111
Job No 21-168	Date 07-06-21	Ground Level (m) 13.65	Co-Ordinates () E 428,789.2 N 583,667.5	
Contractor Arc Environmental Ltd				Sheet 1 of 1

No water ingresses/strikes were recorded with the majority of the exploratory positions remaining dry. However, water ingress was recorded within BH05, at c.2.50m, & TP111 at c.1.90m bcgl (associated with suspected relic drains). A minor ingress was also noted within TP05 at c.2.00m from an unrecorded relic drain. Subsequently, significant shallow water ingress should not be problematic with regards to future excavations. However, it would be prudent to allow for the introduction of suitable groundwater control measures, in order to take care of any localised ingresses of groundwater which may occur during the construction period, especially during the wetter periods of the year.

STRATA			SAMPLES & TESTS		
Depth	No	DESCRIPTION	Depth	No	Remarks/Tests
0.00-0.40		Unmanaged grass overlying dark brown clayey sandy soil with fine roots and occasional fragments of brick (MADE GROUND)			
0.40-0.75		Black ashy coal with occasional fragments of brick (MADE GROUND)	0.40-0.60	J	
0.75-2.00		Stiff (high strength) brown mottled grey sandy gravelly CLAY with occasional sandstone cobbles and fragments of coal (GLACIAL TILL)	1.00-1.20	B	86kN/m ²
			1.20	V	
1.90		Relic c.0.20m dia drain noted c.1.50m trending N-S. Heavy ingress of water noted.

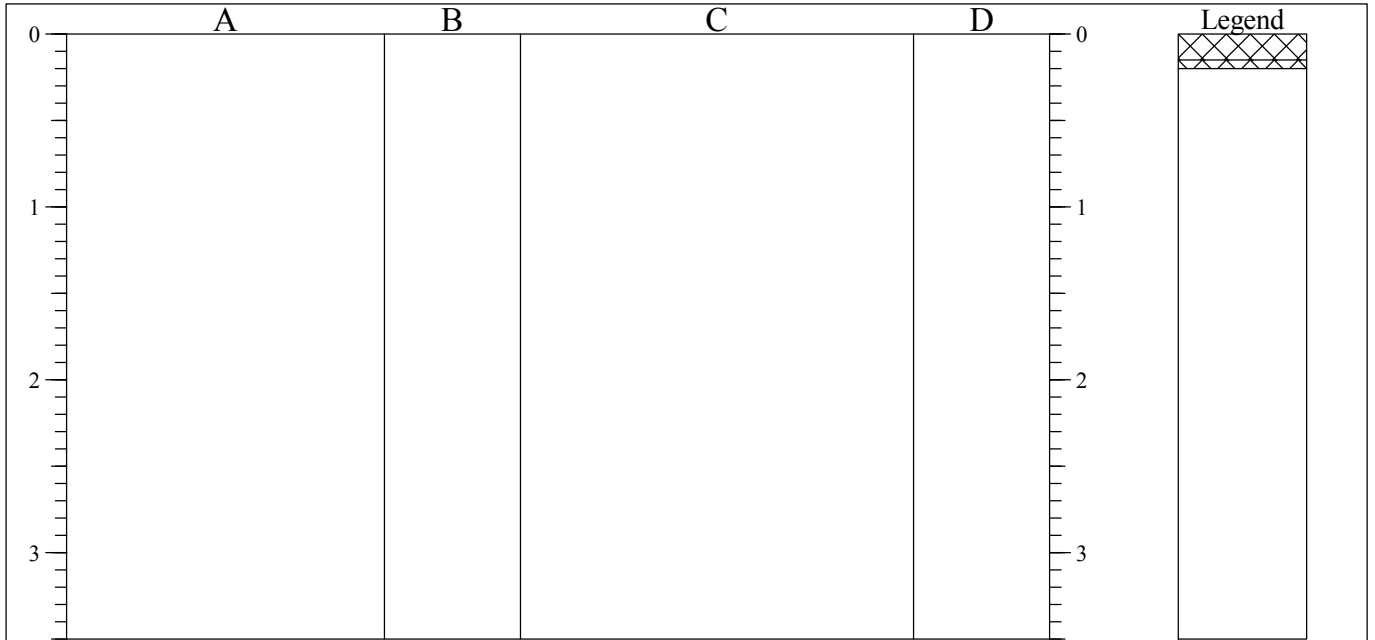
Project Land at Springville, East Sleekburn				TRIAL PIT No TP112
Job No 21-168	Date 07-06-21	Ground Level (m) 13.62	Co-Ordinates () E 428,797.2 N 583,618.0	
Contractor Arc Environmental Ltd				Sheet 1 of 1

STRATA			SAMPLES & TESTS		
Depth	No	DESCRIPTION	Depth	No	Remarks/Tests
0.00-0.15		Unmanaged grass overlying dark brown clayey sandy soil with fine roots and occasional fragments of brick (MADE GROUND) Concrete (MADE GROUND) Trial pit terminated			
0.15-0.20					
0.20

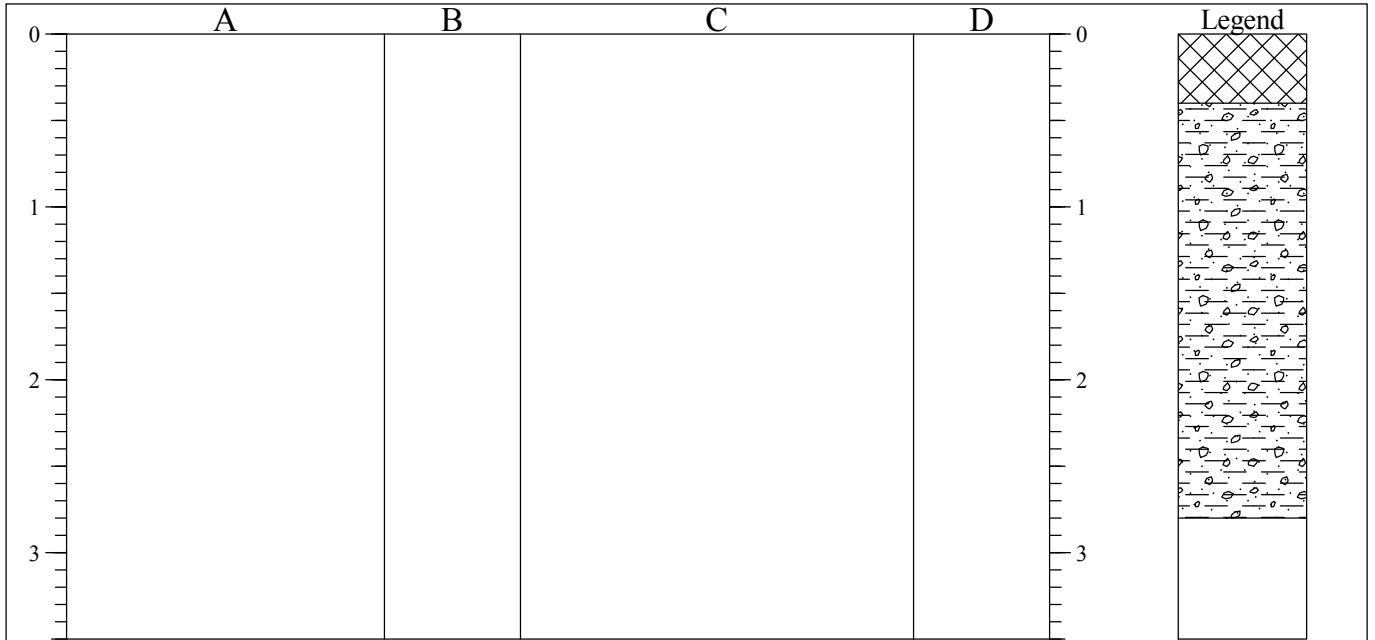
Project Land at Springville, East Sleekburn				TRIAL PIT No TP113
Job No 21-168	Date 07-06-21	Ground Level (m) 13.16	Co-Ordinates () E 428,778.7 N 583,589.5	
Contractor Arc Environmental Ltd				Sheet 1 of 1

STRATA			SAMPLES & TESTS			
Depth	No	DESCRIPTION	Depth	No	Remarks/Tests	
0.00-0.40		Unmanaged grass overlying dark brown clayey sandy soil with fine roots and occasional fragments of brick (MADE GROUND) Stiff (high strength) brown mottled grey sandy gravelly CLAY with occasional sandstone cobbles and fragments of coal (GLACIAL TILL)	0.20-0.40	J		
0.40-2.80			0.50	CBR		4.5%
			1.00	V		88kN/m ²
			1.40-1.60	B		115kN/m ²
			1.50	V

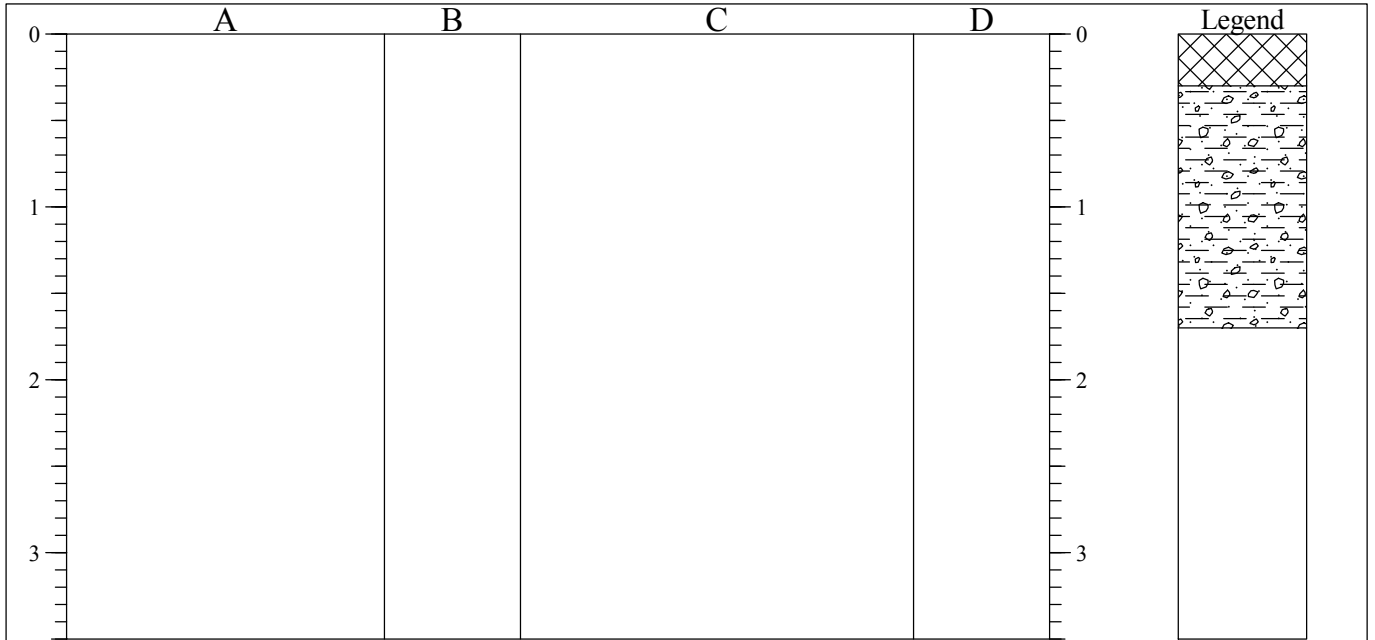
Project Land at Springville, East Sleekburn				TRIAL PIT No TP114
Job No 21-168	Date 07-06-21	Ground Level (m) 13.38	Co-Ordinates () E 428,758.5 N 583,571.9	
Contractor Arc Environmental Ltd				Sheet 1 of 1

STRATA			SAMPLES & TESTS		
Depth	No	DESCRIPTION	Depth	No	Remarks/Tests
0.00-0.30		Unmanaged grass overlying dark brown clayey sandy soil with fine roots and occasional fragments of brick (MADE GROUND)	0.10-0.30	J	
0.30-1.70		Firm becoming stiff (medium & high strength) brown mottled grey sandy gravelly CLAY with occasional sandstone cobbles and fragments of coal (GLACIAL TILL)	0.50	CBR	3.0%
			0.70	V	84kN/m ²
			1.00-1.20	B	
			1.50	V	>120kN/m ²

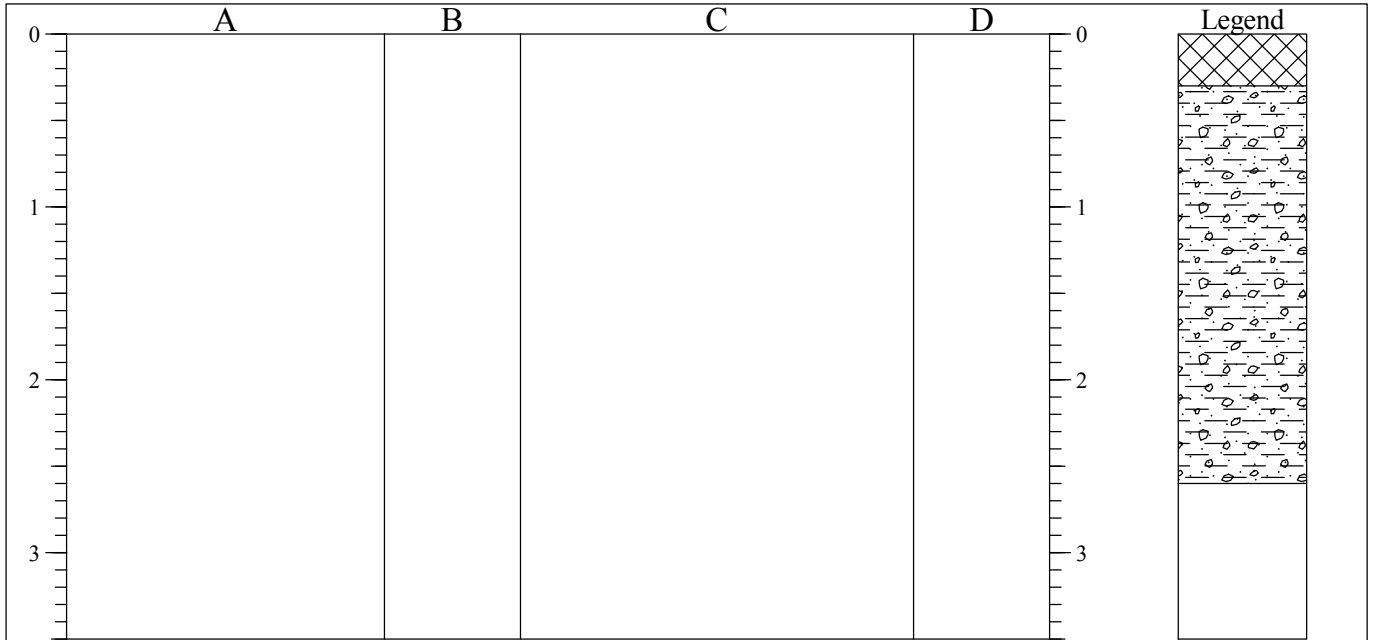
Project Land at Springville, East Sleekburn				TRIAL PIT No TP115
Job No 21-168	Date 07-06-21	Ground Level (m) 13.82	Co-Ordinates () E 428,754.3 N 583,550.6	
Contractor Arc Environmental Ltd				Sheet 1 of 1

STRATA			SAMPLES & TESTS		
Depth	No	DESCRIPTION	Depth	No	Remarks/Tests
0.00-0.30		Unmanaged grass overlying dark brown clayey sandy soil with fine roots and occasional fragments of brick (MADE GROUND)	0.10-0.30	J	
0.30-2.60		Stiff (high strength) brown mottled grey sandy gravelly CLAY with occasional sandstone cobbles and fragments of coal (GLACIAL TILL)	0.60	CBR	4.0%
			0.70-0.90	B	
			1.00	V	102kN/m ²

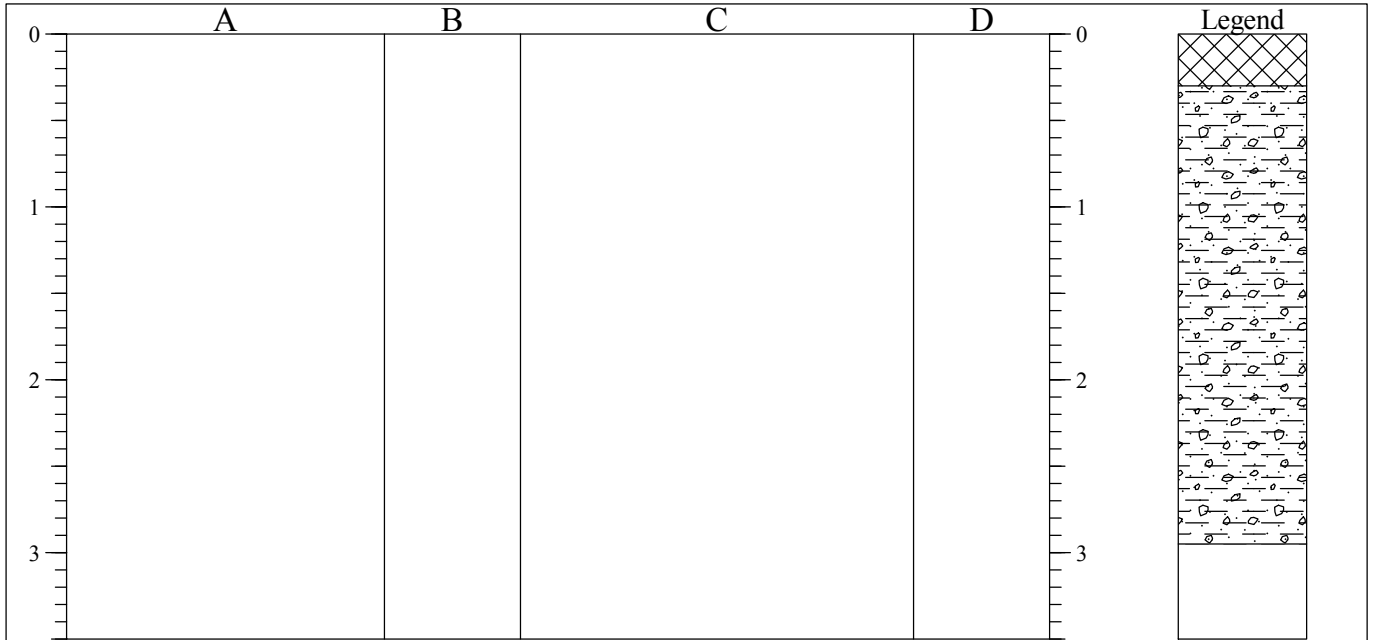
Project Land at Springville, East Sleekburn				TRIAL PIT No TP116
Job No 21-168	Date 07-06-21	Ground Level (m) 13.48	Co-Ordinates () E 428,728.7 N 583,560.2	
Contractor Arc Environmental Ltd				Sheet 1 of 1

STRATA			SAMPLES & TESTS		
Depth	No	DESCRIPTION	Depth	No	Remarks/Tests
0.00-0.30		Unmanaged grass overlying dark brown clayey sandy soil with fine roots and occasional fragments of brick (MADE GROUND)	0.10-0.30	J	
0.30-2.95		Stiff (high strength) brown mottled grey sandy gravelly CLAY with occasional sandstone cobbles and fragments of coal (GLACIAL TILL)	0.50	CBR	4.0%
			1.00	V	86kN/m ²
			1.10-1.30	B	
			2.00	V	>120kN/m ²
