# Adonis Ecology

## Preliminary Bat Roost and Owl Assessment of Timber Mill at Jewsons, Stowmarket to Support a Planning Application

Project Ref: 1534

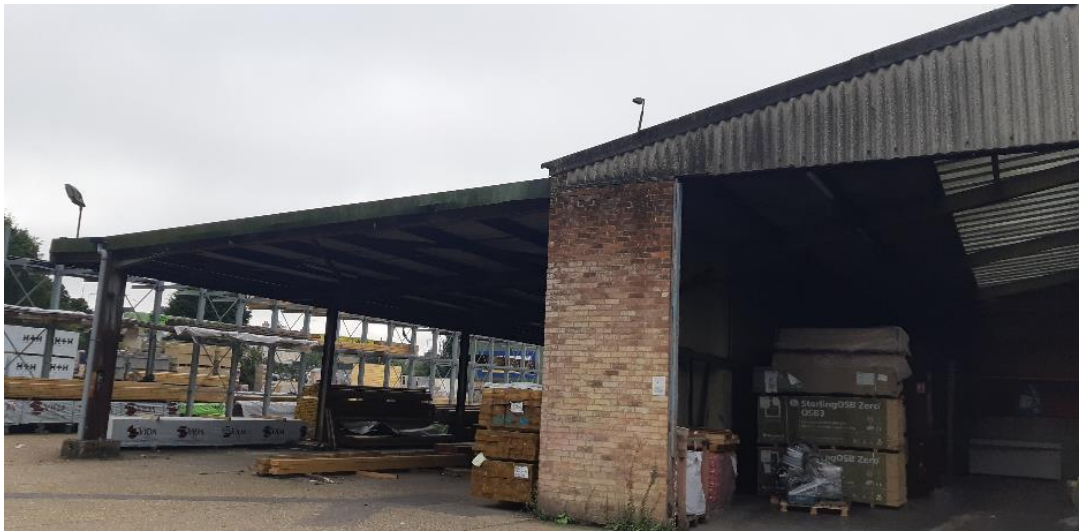
Photograph 1: External view of the surveyed building from north

- 3.3.1 The surveyed building had double walls with breeze blocks internally and bricks externally, and an unlined, pitched roof of asbestos sheet and glass windows along the ridge, supported by a metal girders. There were large doors at either ends of the building, the southern was made of metal while the northern was wooden. Attached to the eastern side of the building was a covered area with no walls, the roof made of metal supported by metal girders and columns (see Photograph 1 in Appendix 2).

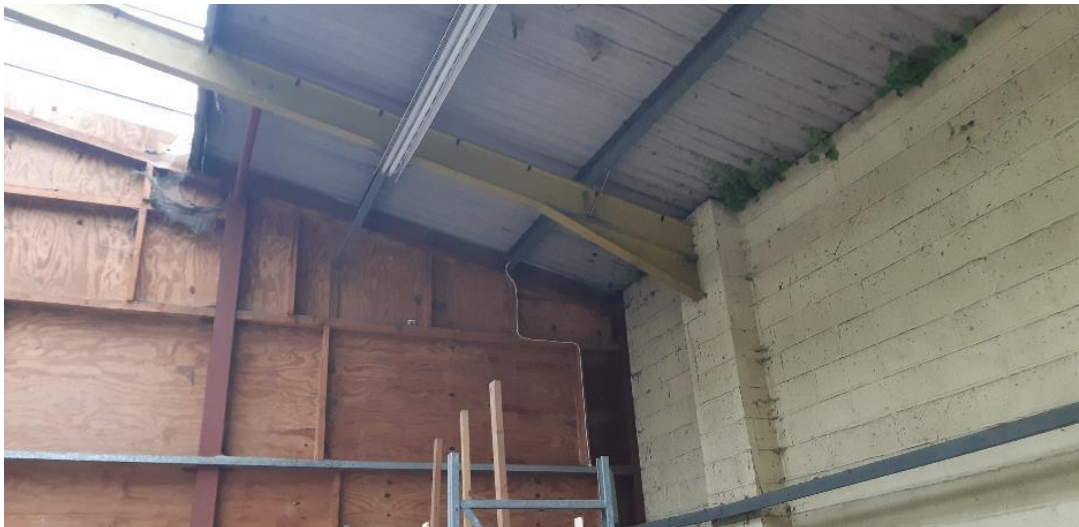
Photograph 2: Internal view of the surveyed building

- 3.3.2 Internally, the building was very bright in the daylight with no dark crevices or holes, and the roof was generally very cobwebbed. The building was divided in two by a cement block wall partly covered by wood (see Photograph 2 in Appendix 2).

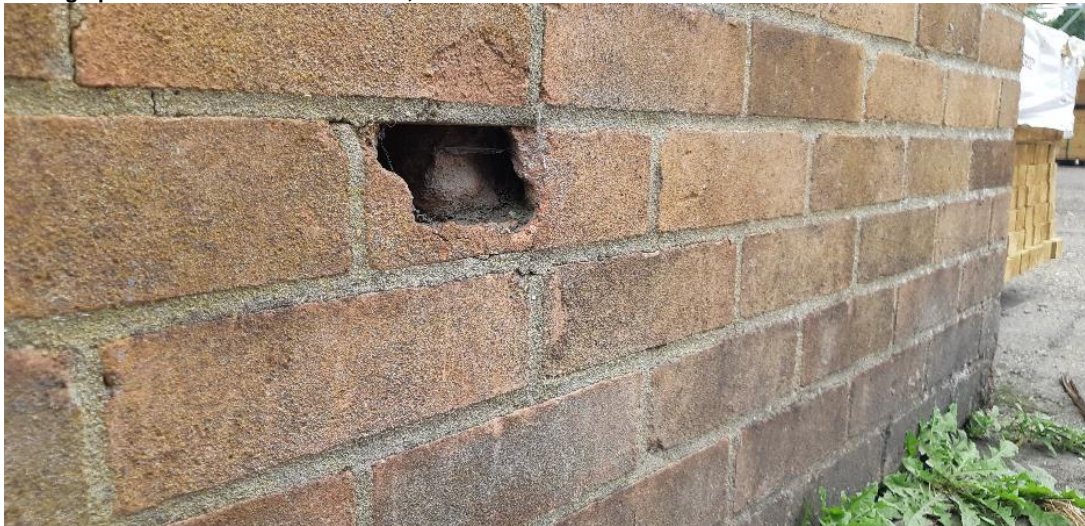
Photograph 3: Cobwebbed hole in brick, external southern wall

- 3.3.3 Externally, above the doorways were rows of holes where two corrugated asbestos sheets met. These were inspected by torch but no bats or bats signs were observed in these. Some damaged bricks were found on the eastern and southern side of the building with a few holes, however most of the holes were not deep enough for bats to roost in, and of those that did appear deep enough, inspection by torch revealed them to be very cobwebbed and no signs of bats were present (see Photograph 3 in Appendix 2).
