Phase II Geo-environmental Report

Hallington Mill,
Hallington,
Northumberland,
NE19 2LJ

H77273-JNP-XX-XX-RP-G-1002 P01

September 2021

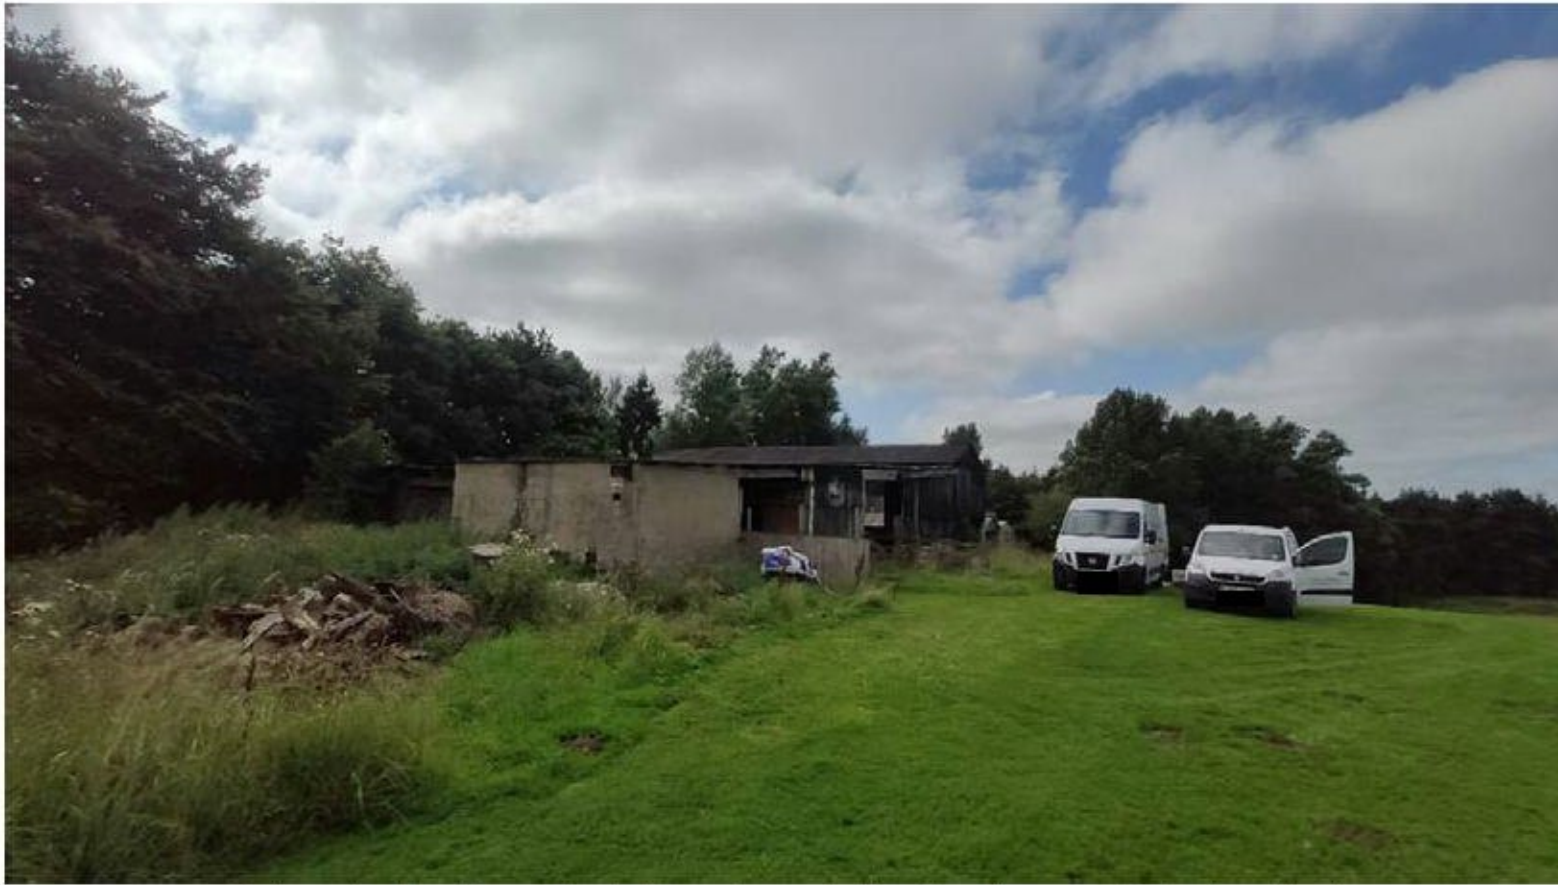
Photograph: 1 Looking west onto the eastern agricultural barn (proposed to be demolished)

- 2.1.9 The barn in the north east was noted to be of wooden frame construction clad with steel sheets on the roof and sides. The barn roof sloped from a two storey height in the west to a single storey height in the east.

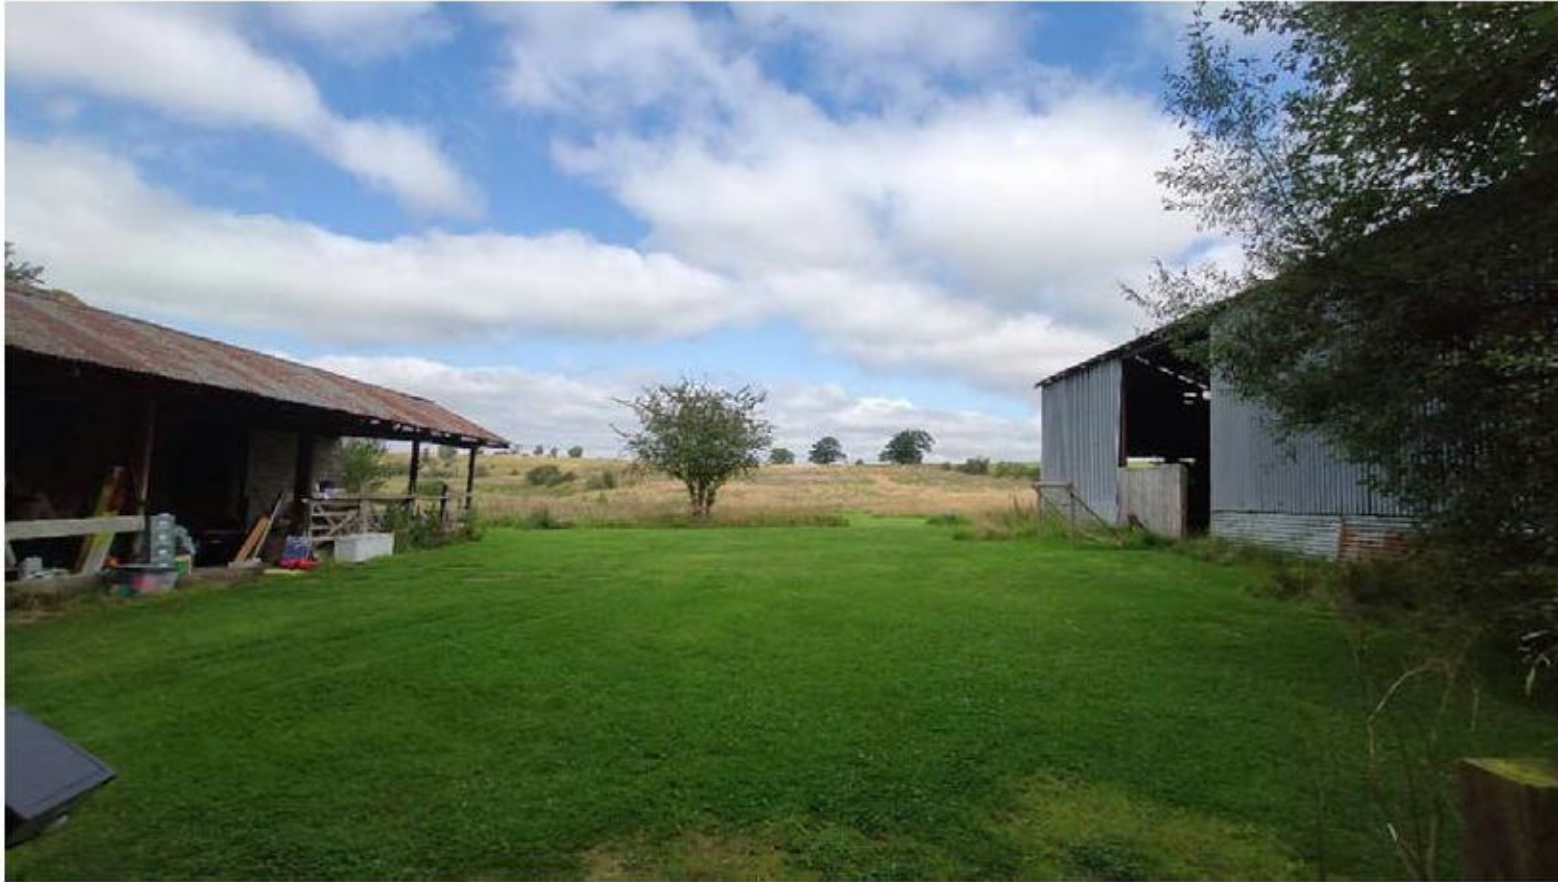
Photograph: 5 Area of former yard, between the two northern sheds

- 2.1.7 The ground coverage was noted to be 90% soft standing of grass and 10% of gravel and concrete. It is of note that the area between the stone barn and the barn in the north east featured hardcore beneath the grass surface covering. Anecdotal evidence from the sites owner suggests that this area was previously used as a yard area.

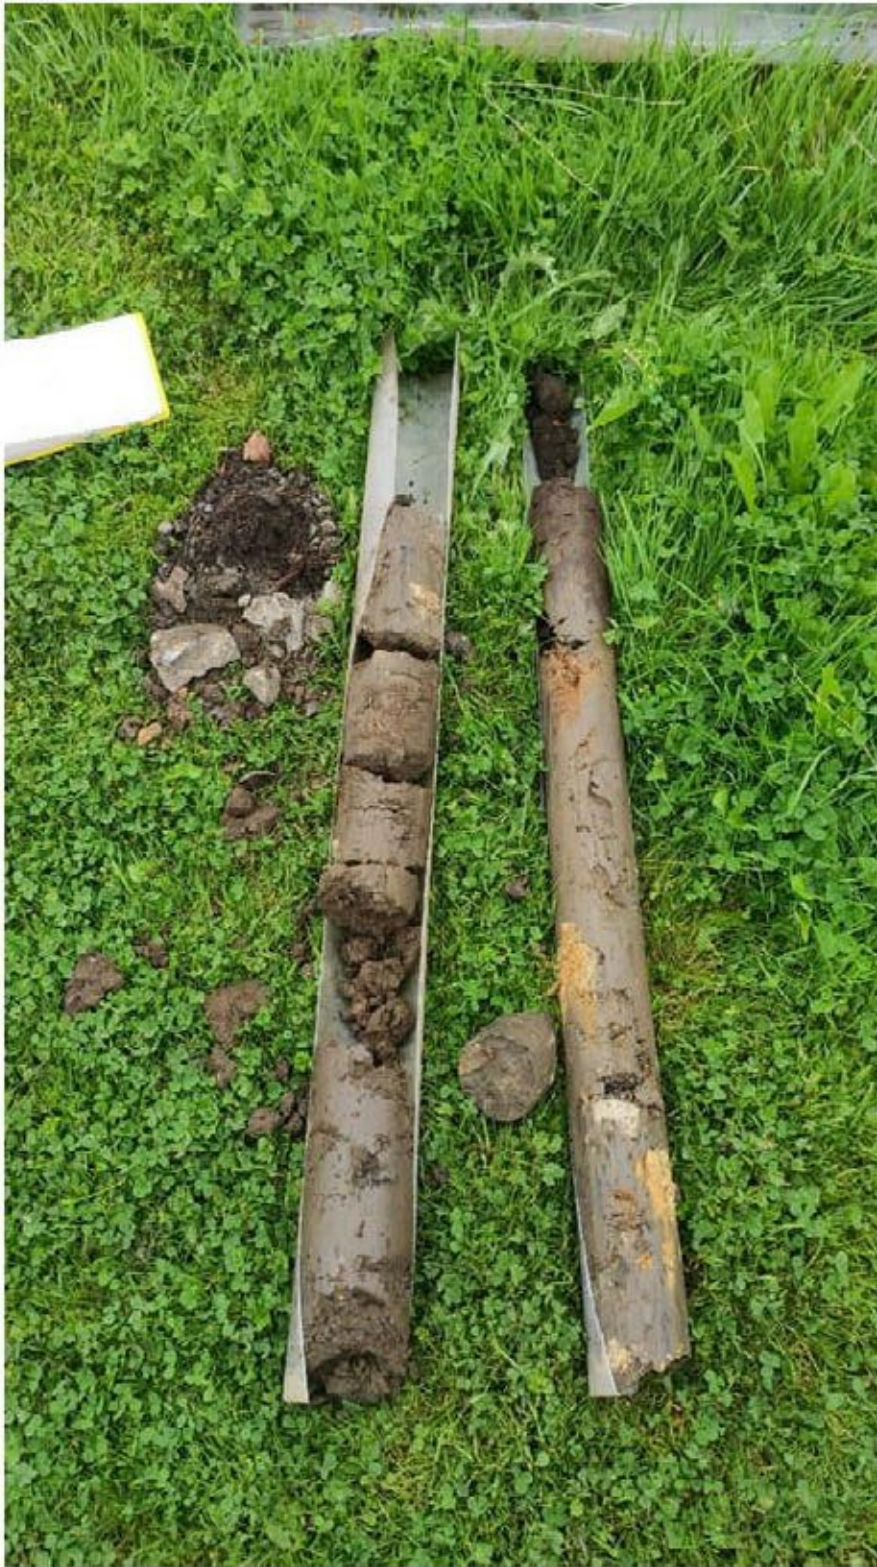
Photograph: 8: Ground conditions in WS1

9.2.1 A topsoil surface covering was encountered in all exploratory locations with the exception of WS1. The topsoil was generally described as brown and gravelly with abundant rootlets. The gravel fraction consisted of fine limestone and sandstone. At the location of WS1 a loamy gravel was encountered as the surface covering. The gravel fraction at this location was noted to feature fine, angular bricks, limestone and sandstone.

9.8 Fragments of plastic, glass and other detritus were observed in the made ground of WS1.

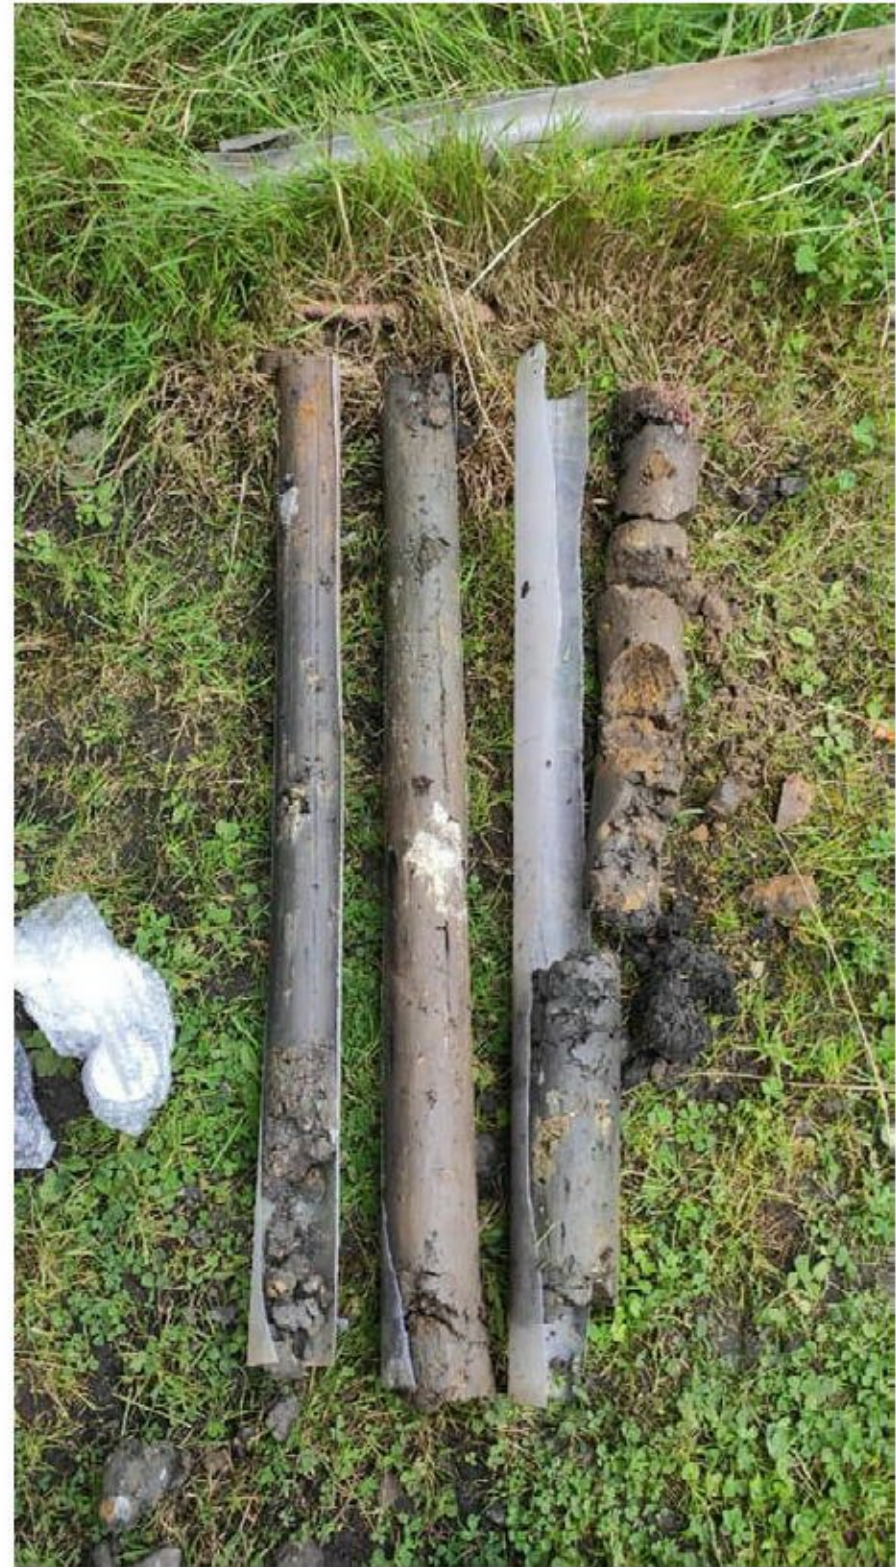
Photograph: 8: Showing ground conditions in WS2

9.1.1 The ground conditions encountered during the intrusive investigation were generally consistent with the published geological map. A variable thickness of made ground was found to be underlain by cohesive Devensian Till, which in turn was underlain by cohesive and granular strata of the Alston formation; this graded as a weak mudstone with increasing depth. The deepest made ground was encountered in WS2 to the north, of the existing eastern barn.

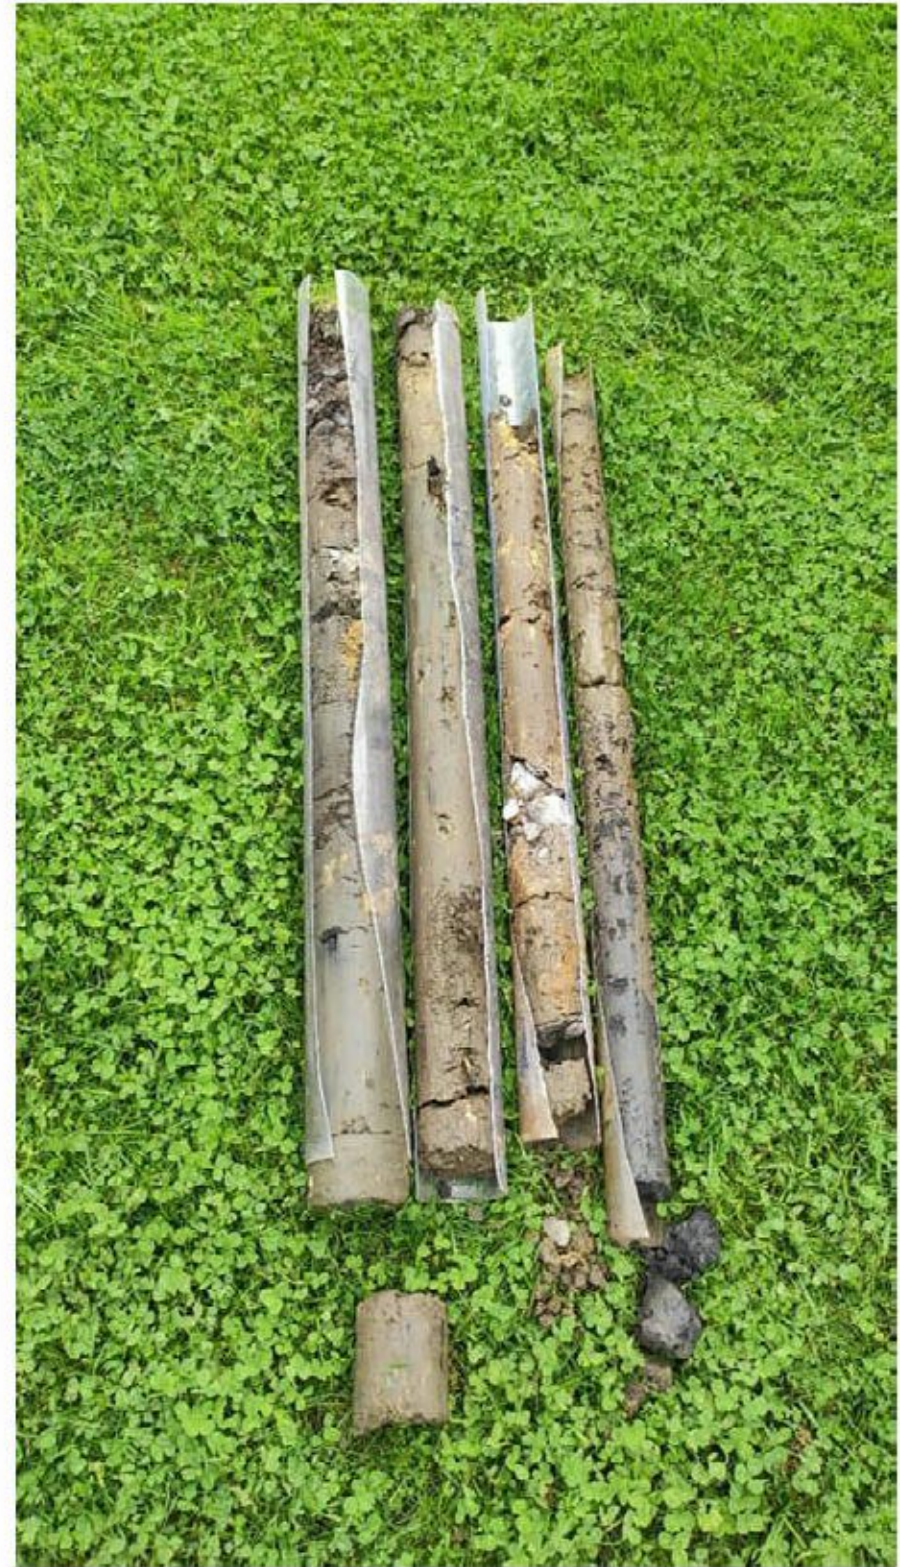
Photograph: 11 Showing WS5

9.4.2 The lithological unit was found to comprise, dark grey very silty gravel or a dark grey silty gravelly clay. Thinly laminated very weak mudstone was encountered at the sample location of WS5.
