**2021 Updated Bat Survey Report for  
9a Plymouth Road, Barnt Green,  
Birmingham, B45 8JE**

**28<sup>th</sup> February 2018, 13<sup>th</sup> January 2020 and 18<sup>th</sup> August 2021**

9a Plymouth Road, Barnt Green, Birmingham – 2021 Updated Bat Survey Report

Report Number: 3012-CWS-03

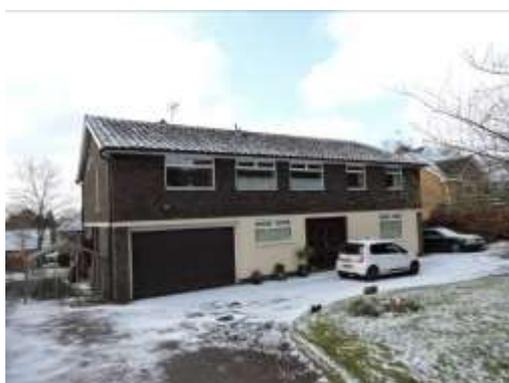
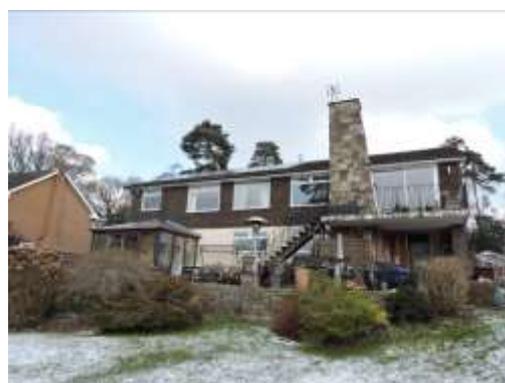
**Figs. 1 & 2 9a Plymouth Road in 2018 – front elevation (L) & rear elevation (R)**

The site comprised a fairly large, detached, two storey house with a pitched pantile roof and an integral garage (Fig. 1). To the rear there was a conservatory and a veranda, with large external chimney (Fig. 2).

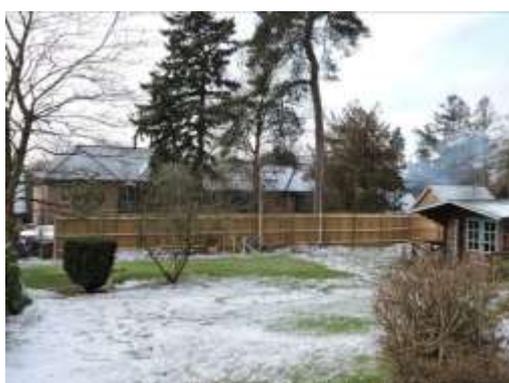
**Fig. 3 Rear garden**

The house was set in a fairly large garden, with trees and shrubs along the boundaries. The rear garden contained a timber summerhouse (Fig. 3), and the front garden had a dual entrance driveway around a central lawned area (Fig. 4).

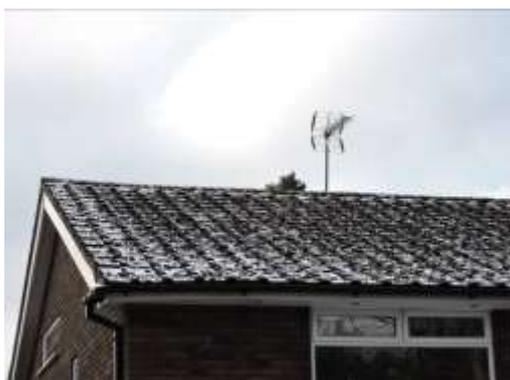
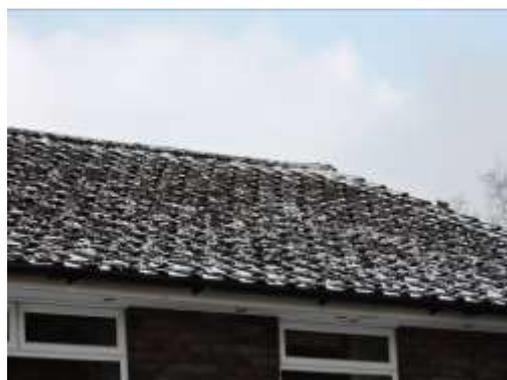
**Figs. 5 & 6 Ridges and tiles on north roof slope**

The ridge was fully intact and sealed, with no gaps or crevices, whilst all the roof tiles were tightly overlapping, with none raised, broken, dislodged or missing (Figs. 5-7).

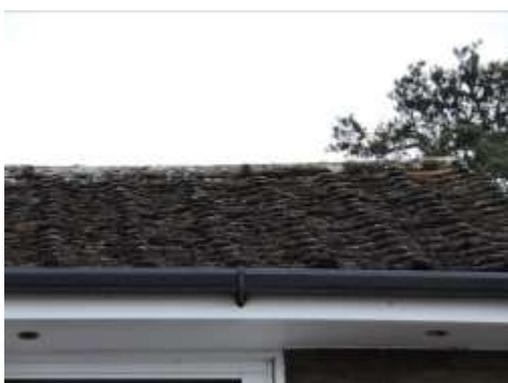
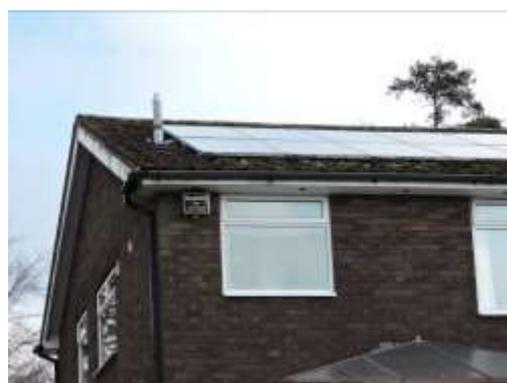
**Figs. 7 & 8 Ridge, tiles and solar panels on south roof slope**

The rear roof slope was partially covered with solar panels (Fig. 8).

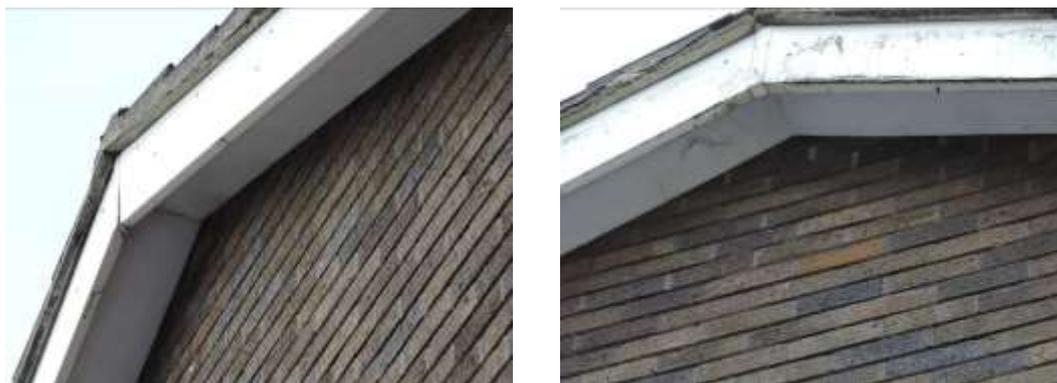
**Figs. 9 & 10 Sealed gable soffits**

The gables were finished with roof end soffits, these tightly joined and sealed against the gable brickwork (Figs. 9 and 10).

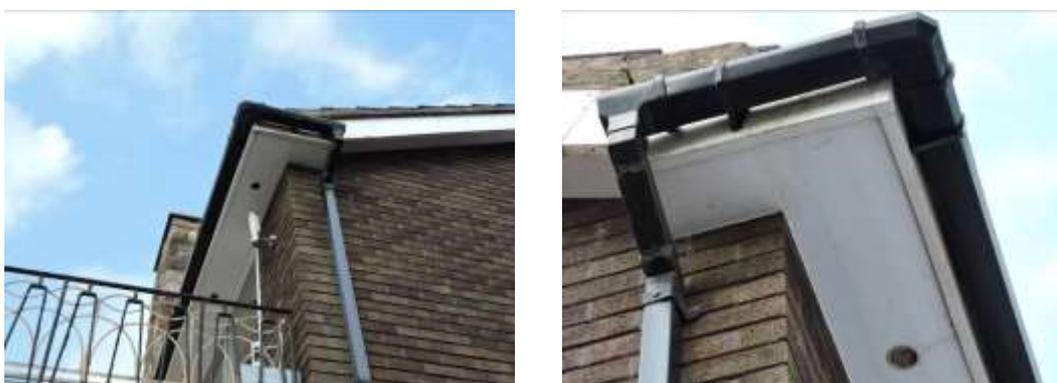
**Figs. 11 & 12 Sealed boxed eaves soffits**

The eaves were also finished with boxed soffits, these tightly fitting all round (Figs. 11 and 12). In the soffits there were ventilation holes, but all were grilled over.

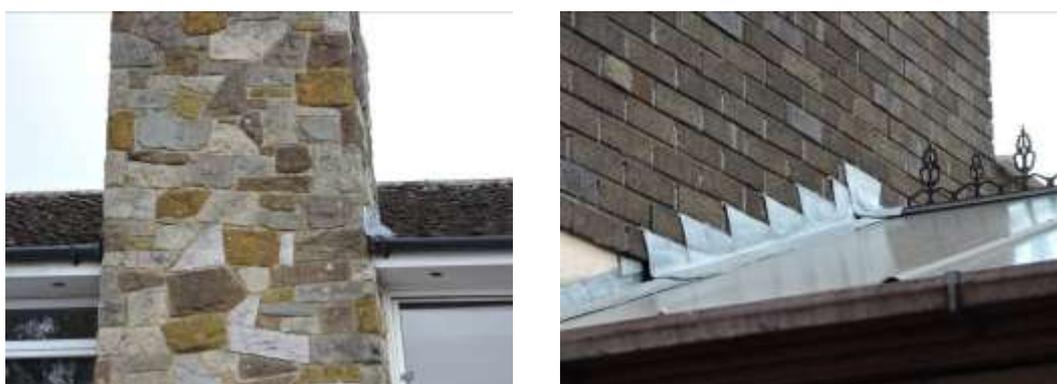
**Figs. 13 & 14 Tightly moulded lead flashing**

The lead flashing sealing the chimney breast and conservatory to the walls was tightly moulded, with just a very small hole at the end of the conservatory flashing – this was not suitable for bat roosting (Figs. 13 and 14).

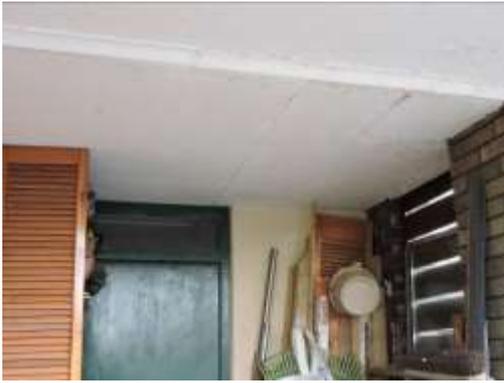
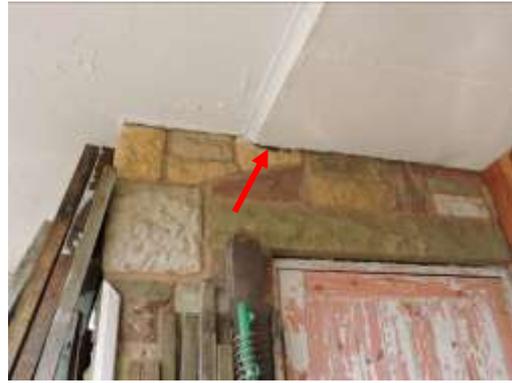
**Figs. 15 & 16 Ground floor storage area**

On the ground floor to the rear of the garage and under the veranda there was an open storage area (Fig. 15). This was generally sealed, except for one small gap which was choked with windblown debris (Fig. 16 – arrowed).

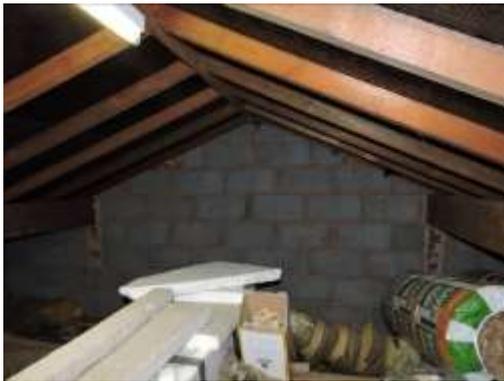
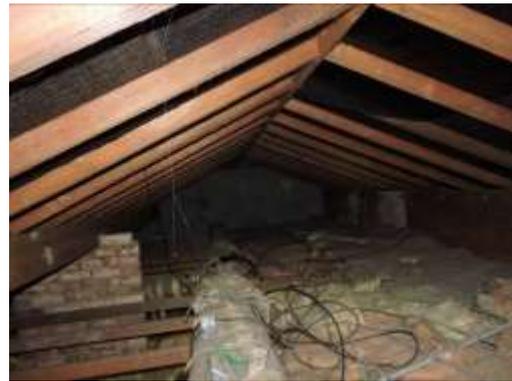
**Figs. 17 & 18 Roof void**

Internally the building had a single roof void, half of which was 1.8 m high and half 1.25 m high (Figs 17 and 18).

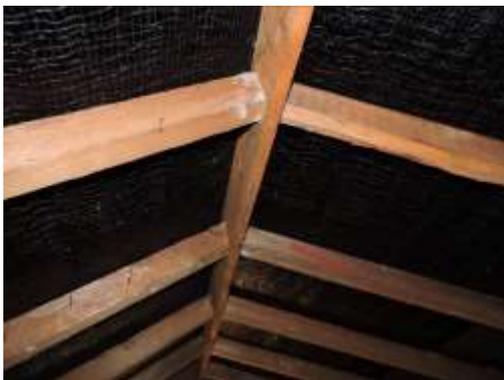
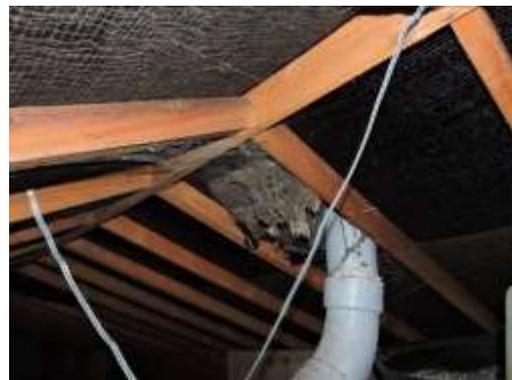
**Figs. 19 & 20 Tarred felt lined roof with heavy cobwebbing at vent**

The whole of the roof was lined with a tarred membrane felt in good condition with no holes or tears (Fig. 19). Only one small area next to a vent was heavily cobwebbed (Fig. 20), with the rest only sparsely cobwebbed.

There was no external light penetration, and the void was considered inaccessible to bats. Certainly no evidence of bat occupation was discovered inside the house.

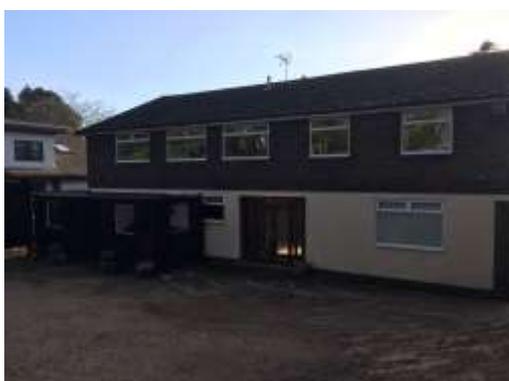
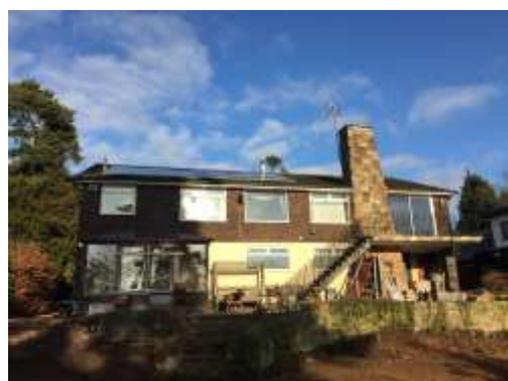
**Figs. 21 & 22 House in January 2020**

There had been little change in the appearance of the house since 2018, and the ridge was still fully intact and sealed, with no gaps or crevices, whilst all the roof tiles were tightly overlapping, with none raised, broken, dislodged or missing (Figs. 21 and 22).

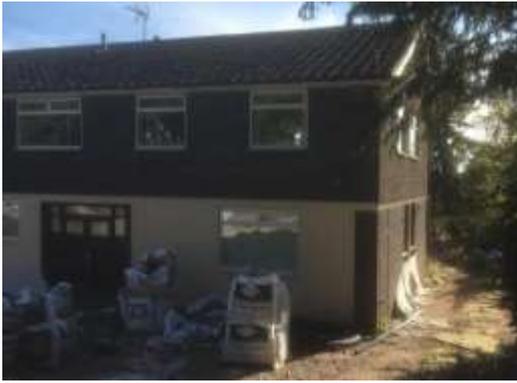
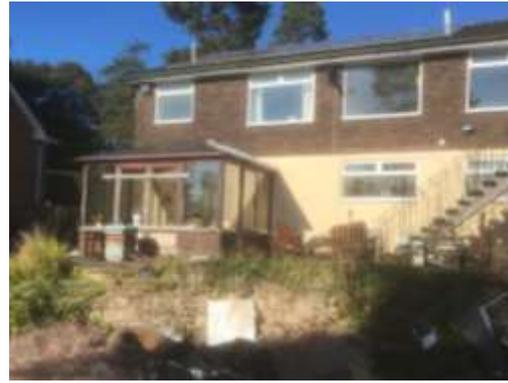
**Figs. 23 & 24 House in August 2021**

Since the 2020 survey, there had been little change in the condition of the house, the ridge was still fully intact and sealed, with no gaps or crevices, whilst all the roof tiles were tightly overlapping, with none raised, broken, dislodged or missing (Figs. 22 and 23).

The gable and eaves soffits were all tight, as were the window casements and door frames.

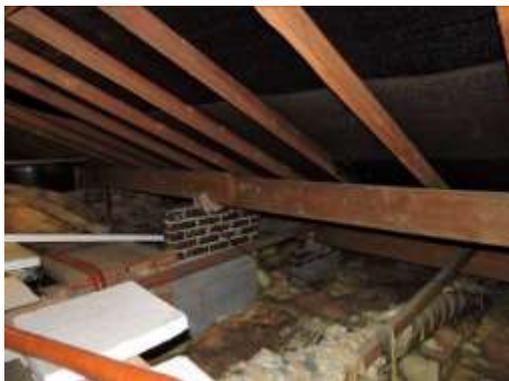
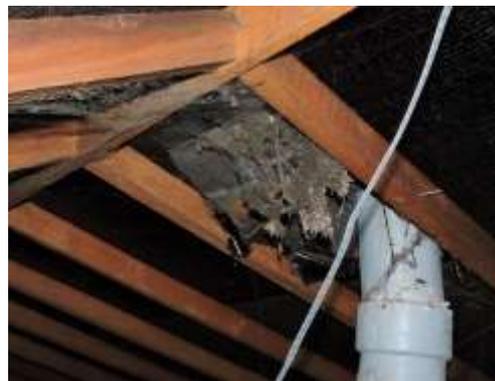
**Figs. 25 & 26 Roof void in January 2020**

Internally the roof void was still inaccessible to bats, with thick cobwebbing around the flue pipe and no light penetration (Figs. 25 and 26).

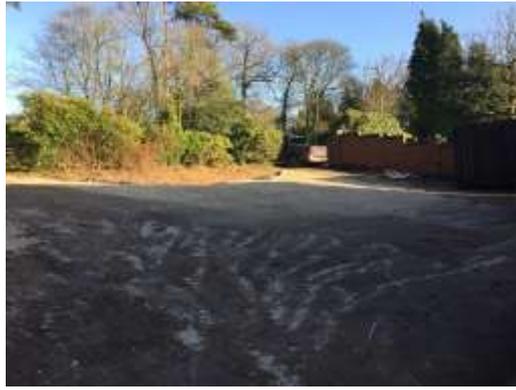
**Fig. 27 Front garden in January 2020**

In the garden the lawns had been cleared, but the boundary trees and shrubs were still present (Fig. 27).
