PHASE 2 BAT ACTIVITY SURVEY

UPPER UCHELDRE

Project name: Upper Ucheldre, Brooks, Welshpool, Powys,
SY21 8QW

Date: 02/08/2021

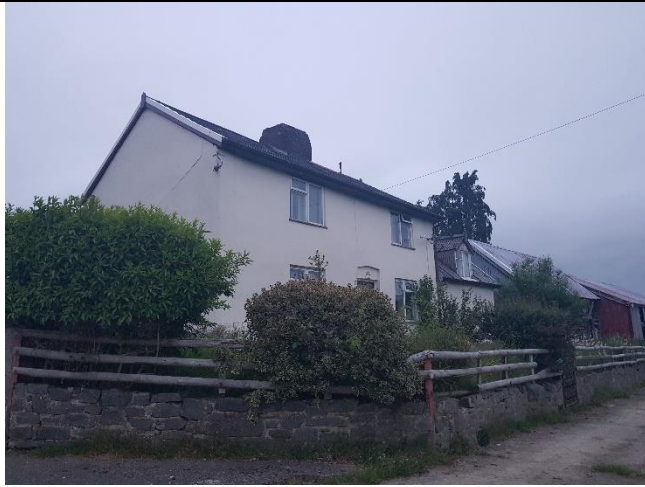
South west facing gable end.

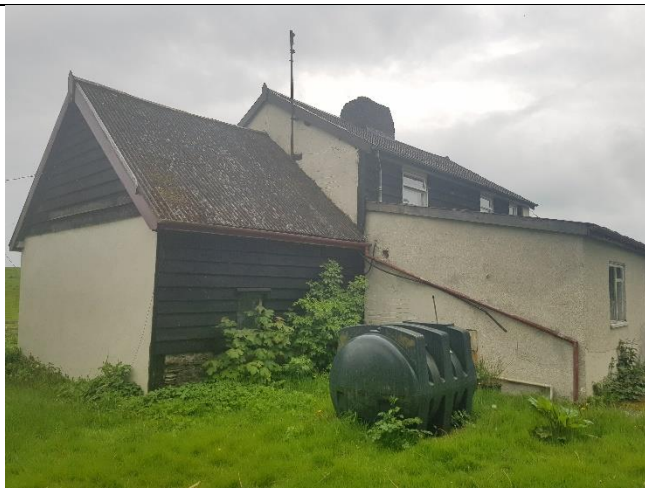
The timber soffits of the property are showing some signs of deterioration and there are a small number of gaps at the top of the wall plate on the house. There is one small access point visible within the loft space at the north-east facing gable.

North east facing gable end.

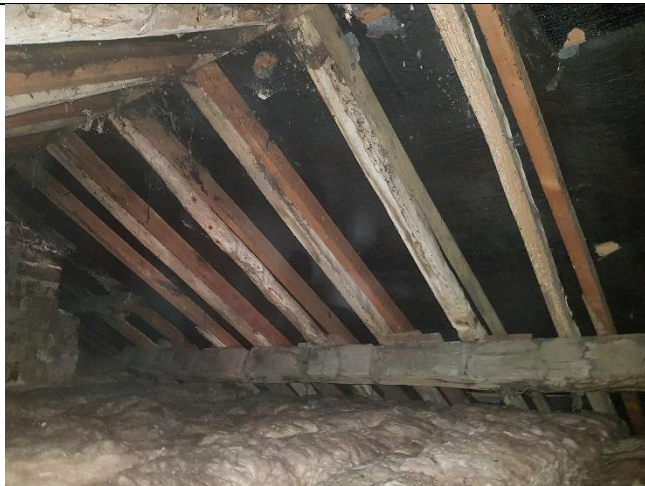
There is a small loft space above the house which is approximately 1m in height at the apex, supported by a mixture of old and new timbers. The roof has been re-lined relatively recently and therefore has a mixture of breathable and bituminous lining. There is a thick layer of insulation on the floor and one small access hatch.

There is no evidence within the loft space of the house or first floor of the extension to suggest that either are in use by bat species. Given the internal loft and small number of Potential Roosting Features present, the property has 'moderate' potential as a bat roost.

Small loft space above the house.

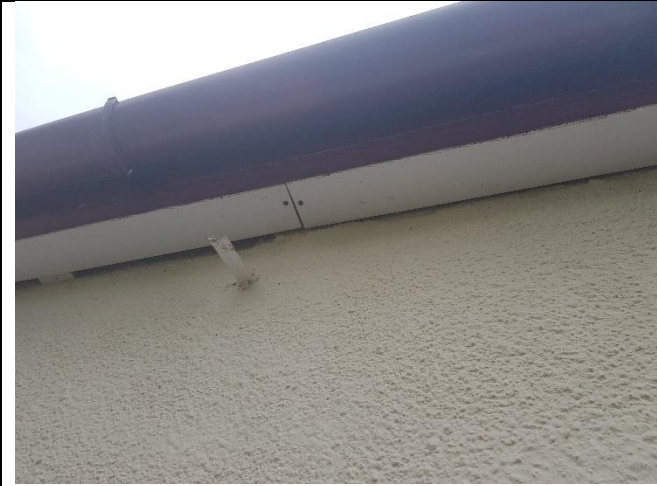
Eaves of the property are partially boxed in.

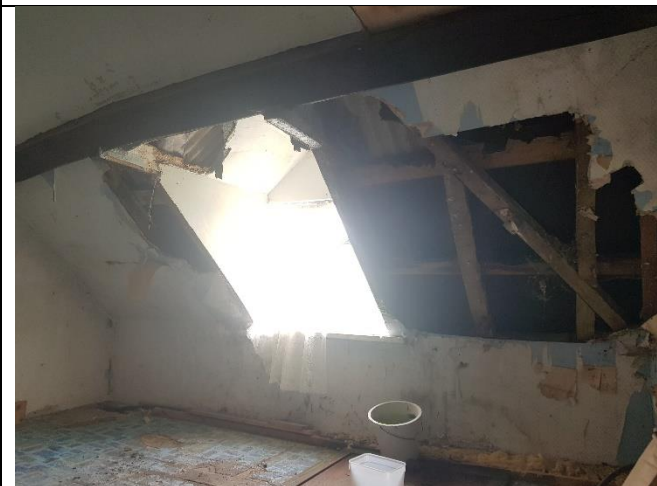
The extension at the north-east gable has a steeply pitched roof, covered with corrugated tin and fitted with timber fascia boards. The exterior of the extension is partially clad with planed timber boarding to the north and west facing elevation. The first floor of the extension does not have a loft space but is boarded up to the rafters. Parts of the ceiling are failing due to water damage and the breathable lining of the roof is visible.

First floor of side extension. Ceiling failing in places.
