BAT, BARN OWL AND NESTING BIRD SURVEY

**SUN VILLA, SUNNY CORNER, CUSGARNE,
TRURO, CORNWALL**

August 2021

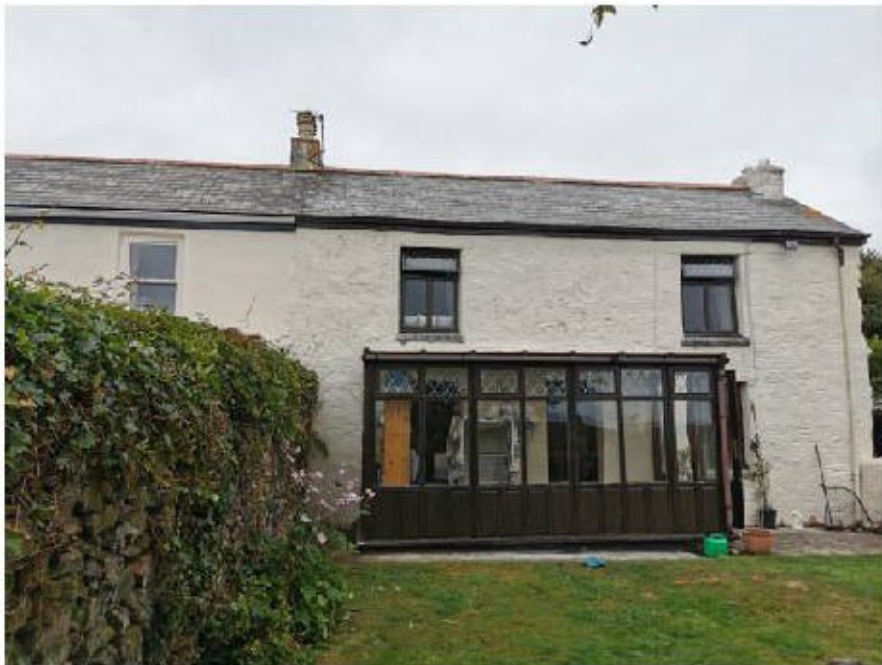
The building subject to this survey is a painted stone end of terrace house with an attached single storey stone stable block to the east. The house is two storeys high with a pitched slate covered roof which is attached to the adjacent house to the west. The eastern end is a gable end with a built-in chimney. To the south is a single storey large glass porch and to the rear the garden is raised, see photos 1, 2 and 3.

Photo 1. Showing the house from the south

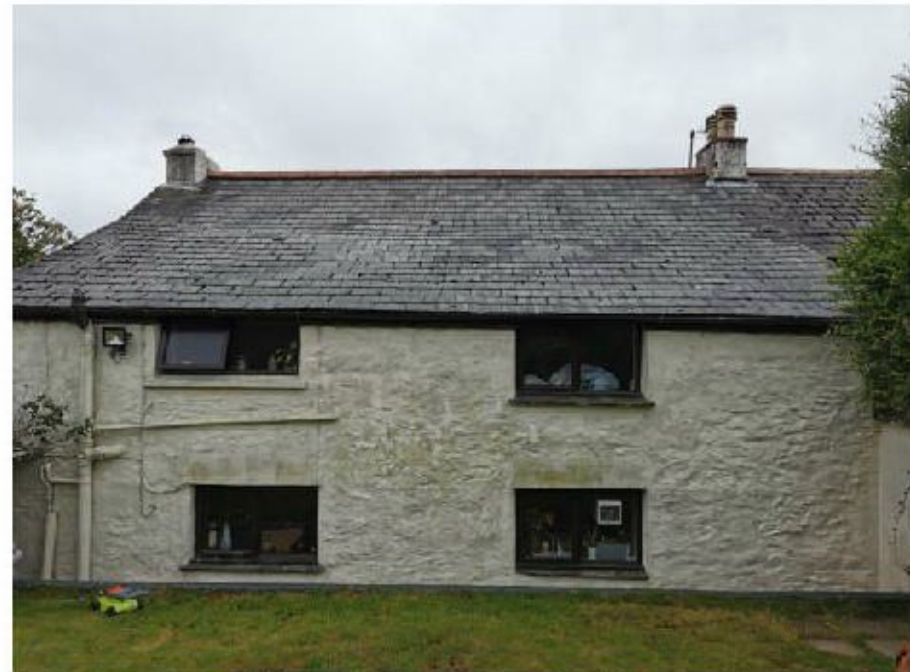
Photo 2. Showing the house from the north

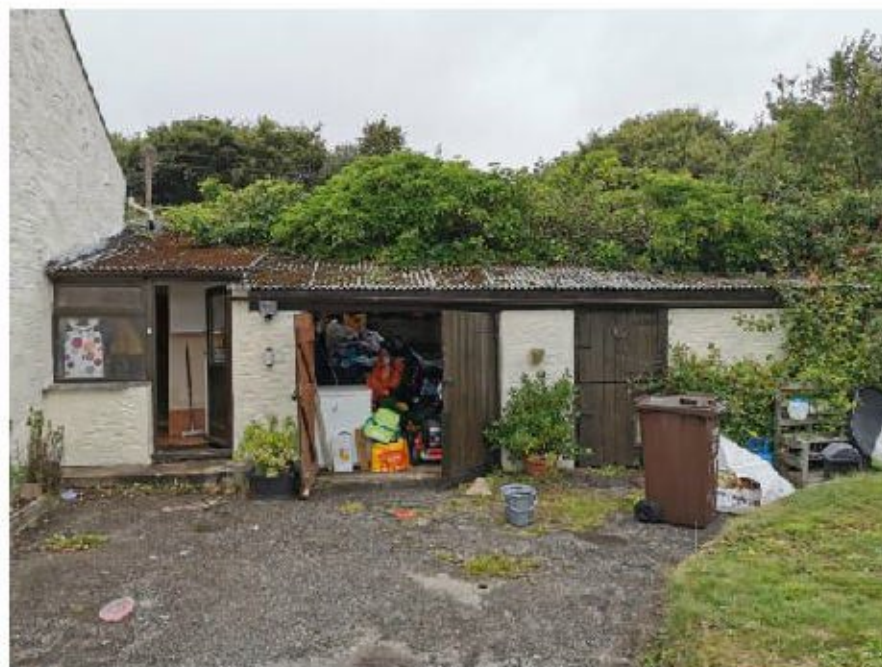
Photo 3. Showing the attached stable block

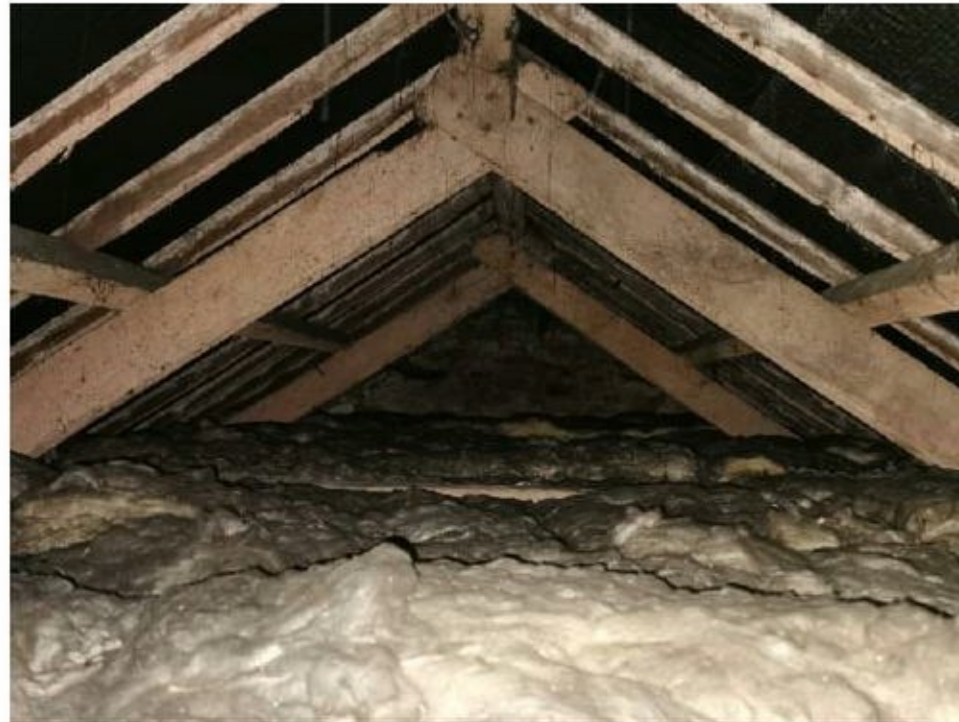
There is a single shallow roof void running the length of the house, which is supported by timber trusses and is open from the fibreglass insulation covered floor to the underside of the roof which is lined with bitumen felt. The interior of the roof void is full of cobwebs with both the cobwebs and surfaces in the roof void being covered with soot, see photos 4.

Photos 4. Showing the roof void over the house

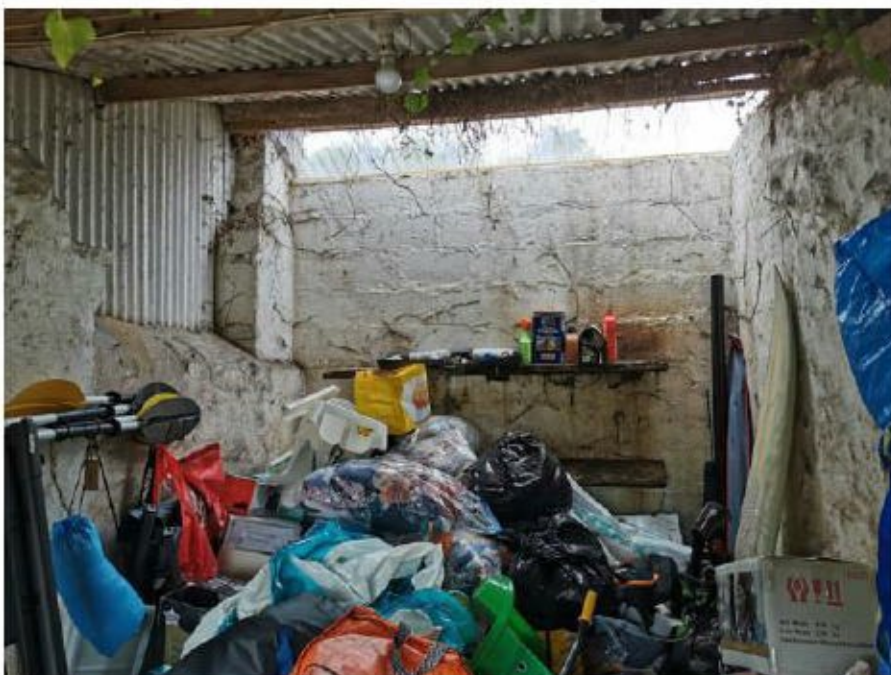
The attached stable block comprises three rooms, a small porch nearest the house with a store in the centre and a former stable at the eastern end. This part of the building is built from blockwork or stone and is roofed with corrugated cement fibre sheeting. The central room has double doors to the south and a section of the roof is covered with corrugated Perspex sheeting making it light internally. The eastern room has stone walls and is accessed via a stable door. Both rooms in this section of the building are used for storage and are open from the floor to the underside of the roof which is unlined, see photos 5 and 6.

Photo 5. Showing the central room in the stables

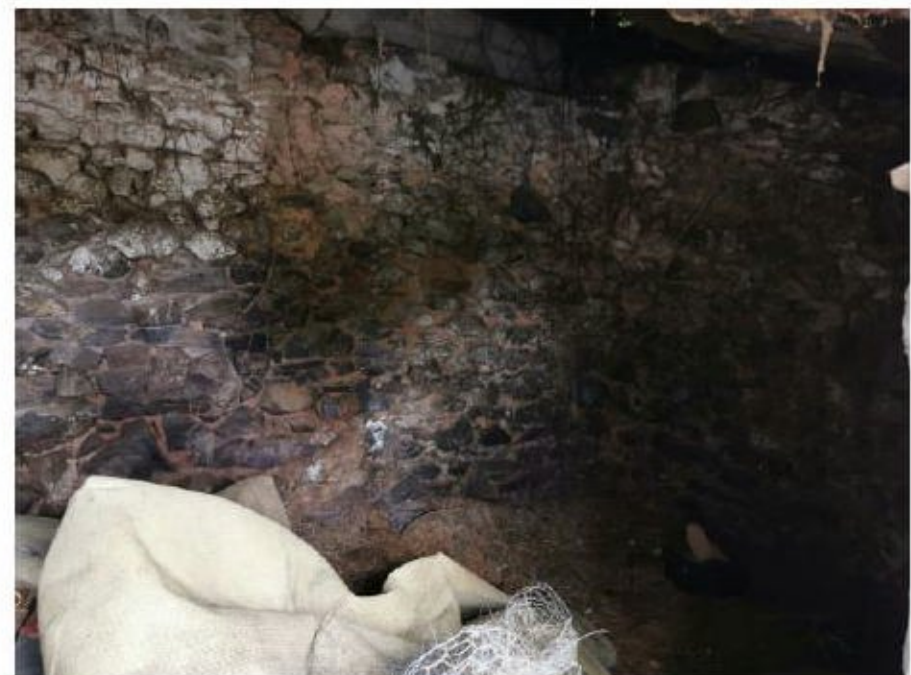
Photo 6. Showing the eastern room in the stables
