PRELIMINARY SITE RISK ASSESSMENT TIER 1

SITE: LAND ADJ TO:
NEWLYN
CHURCH LANE
CARGREEN
SALTASH
CORNWALL
PL12 6NS

Our Ref: A1904/PSRA/JW

Date: 12th May 2021

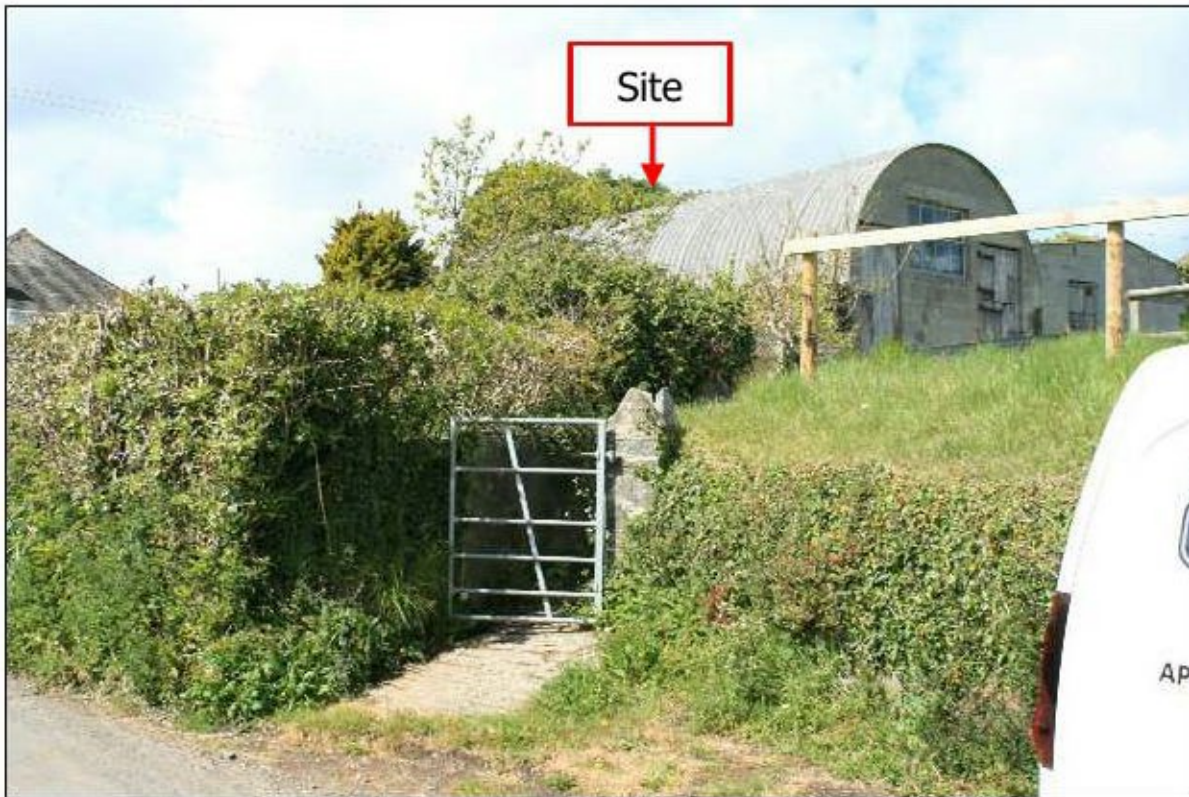
Photograph 1.

View: northwest

Looking towards the pedestrian access gate from the adjacent public road.

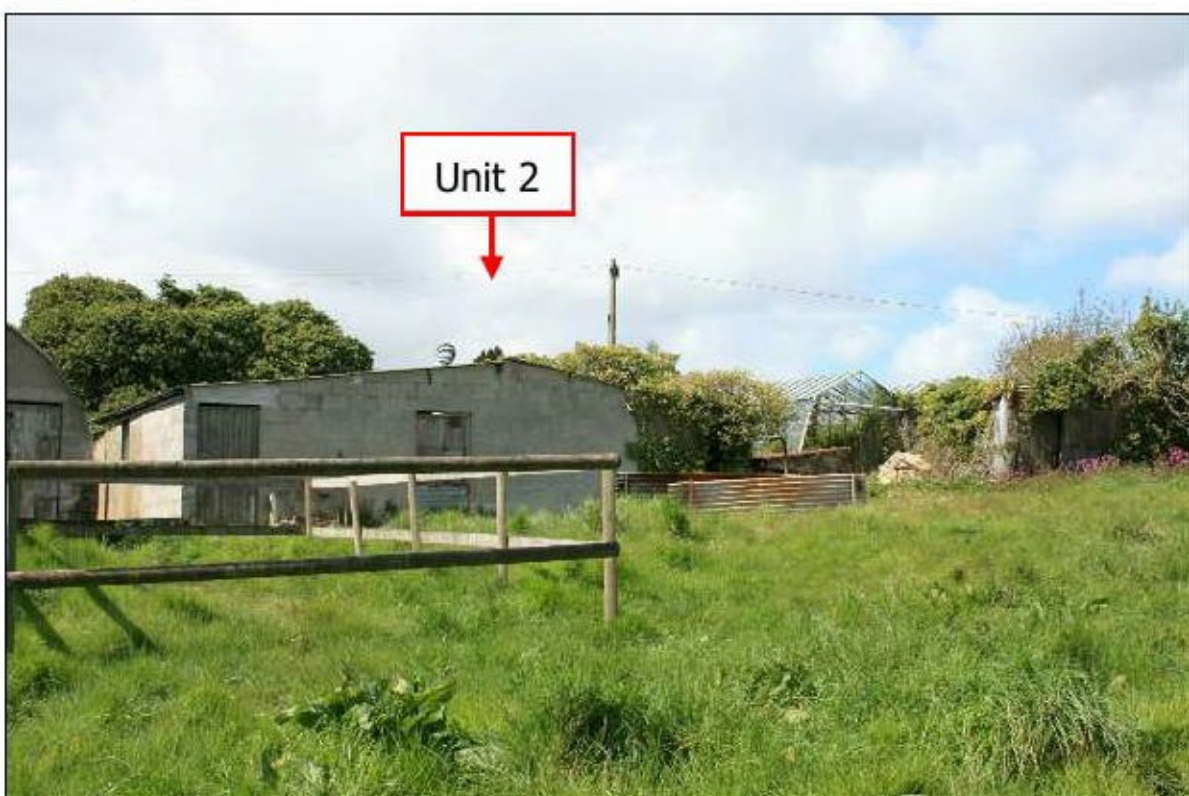
Photograph 3.

View: northwest

Looking across the site and associated land from the southeast corner of the plot.

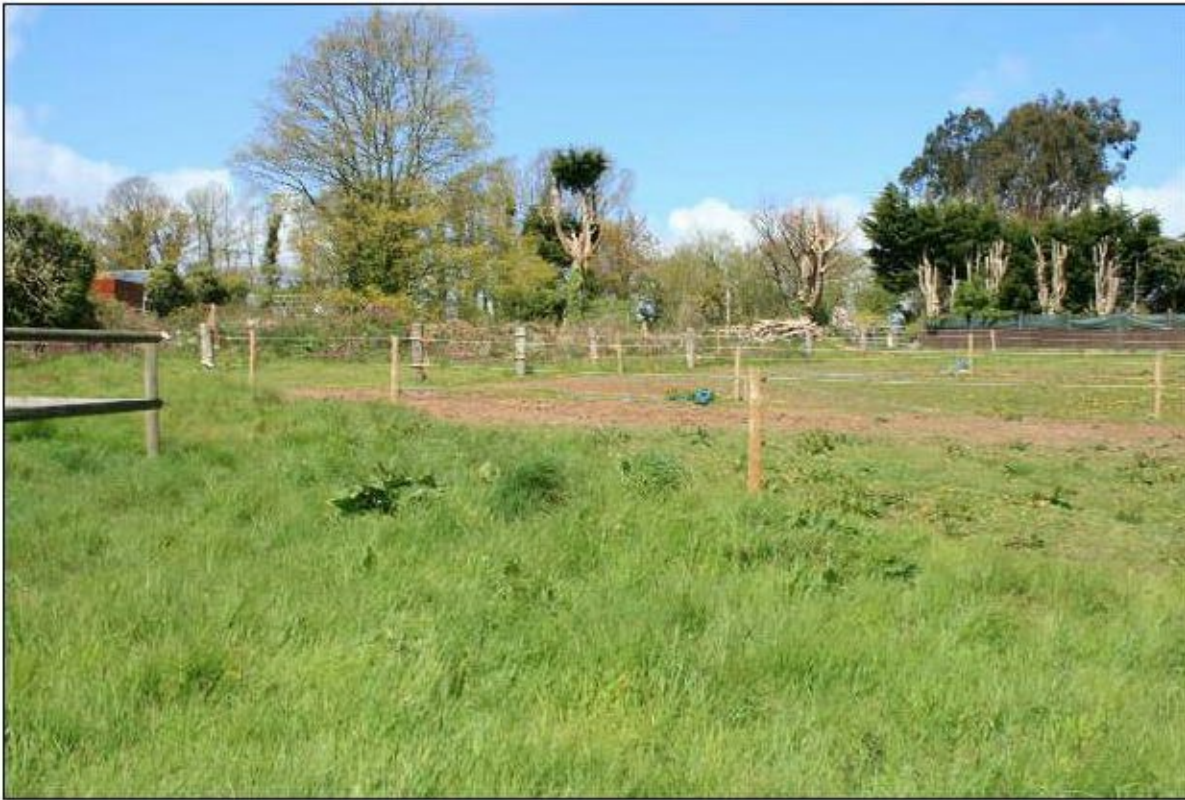
Photograph 4.

View: north-northwest

Continuation of open land to the northeast of the site buildings.

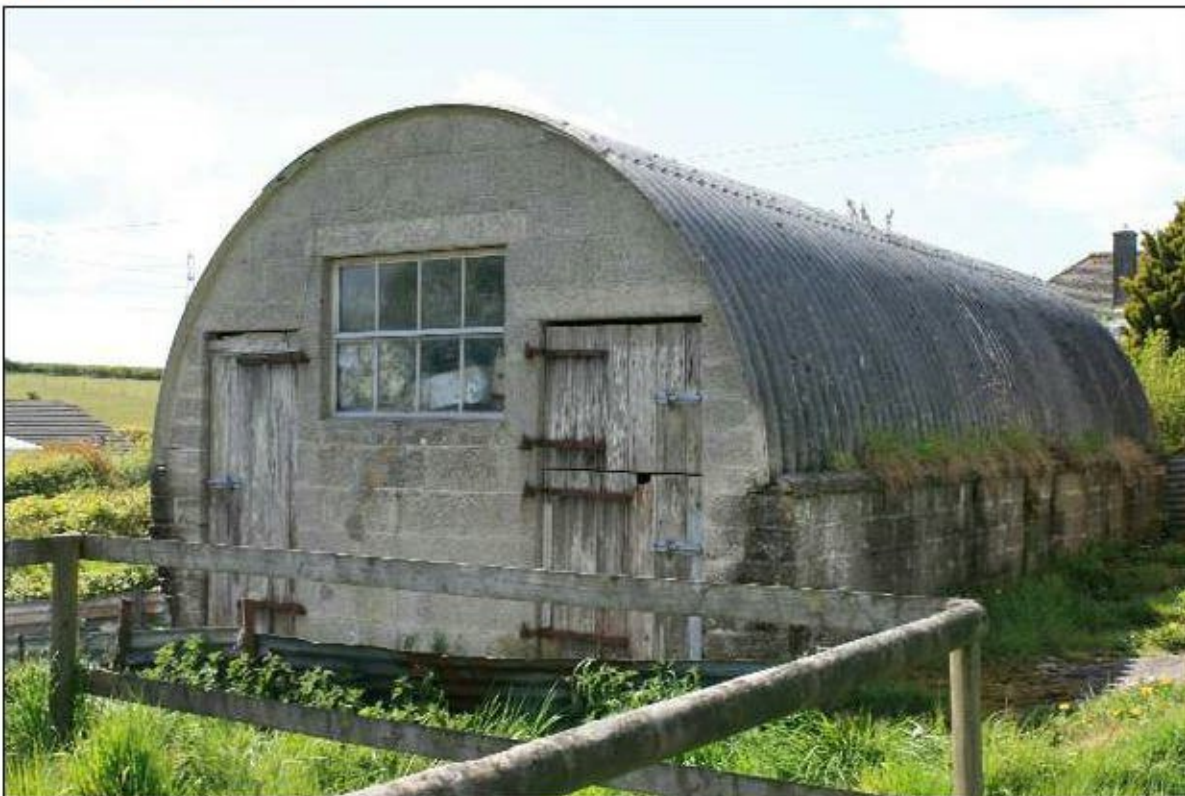
Photograph 5.

View: southwest

Close up view of Unit 1.

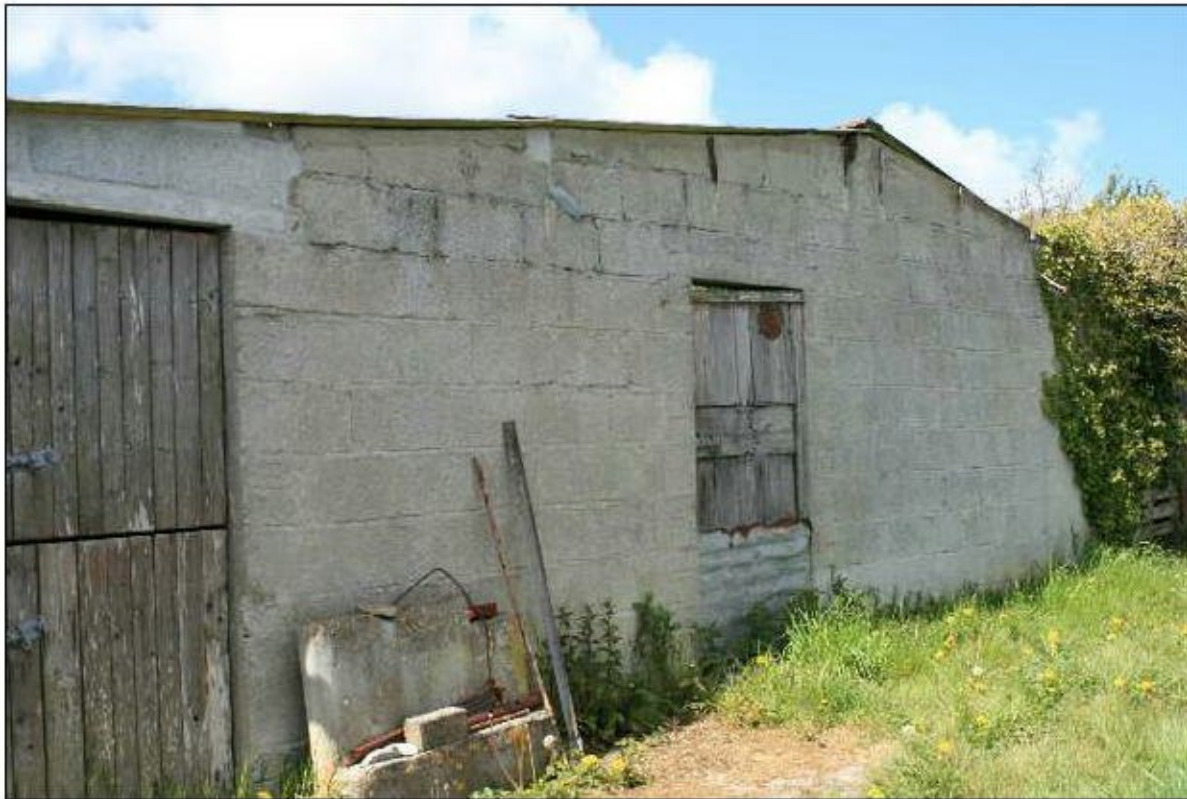
Photograph 7.

Unit 2 is the largest building, a single-storey concrete barn which lies towards the central north-western boundary of the site. The roof appears to be a mixture of corrugated metal sheets and suspected cement fibre asbestos panels, although the roof on the north-western side has largely collapsed inwards which, along with the extensive vegetation covering it, renders a large part of the interior unsafe to access. The only accessible part of the interior is the south-eastern side, which contains animal pens (former piggery) divided by concrete walls and concrete flooring throughout. The building is redundant and currently used to store items such as timber lengths and fencing wire.

View: northwest

Close up view of Unit 2.

We would recommend that all cement based asbestos sheet panels encountered during the clearance phase be removed from site by an accredited asbestos removal operator and disposed of at a licensed waste disposal facility. Records must be kept of all transportation and disposal for future reference should they be required.

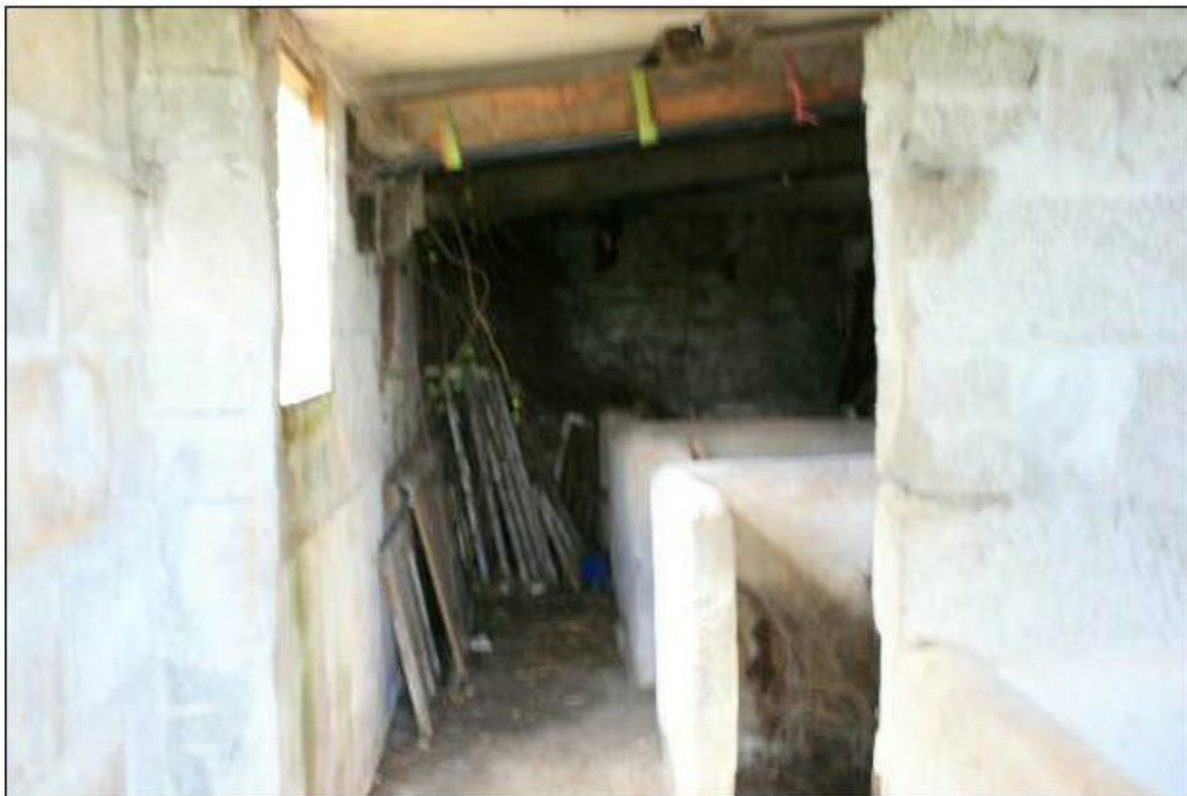
Photograph 8.

View: southwest

Internal view of Unit 2 used historically as a piggery.

All internal surfacing was recorded to comprise of concrete.

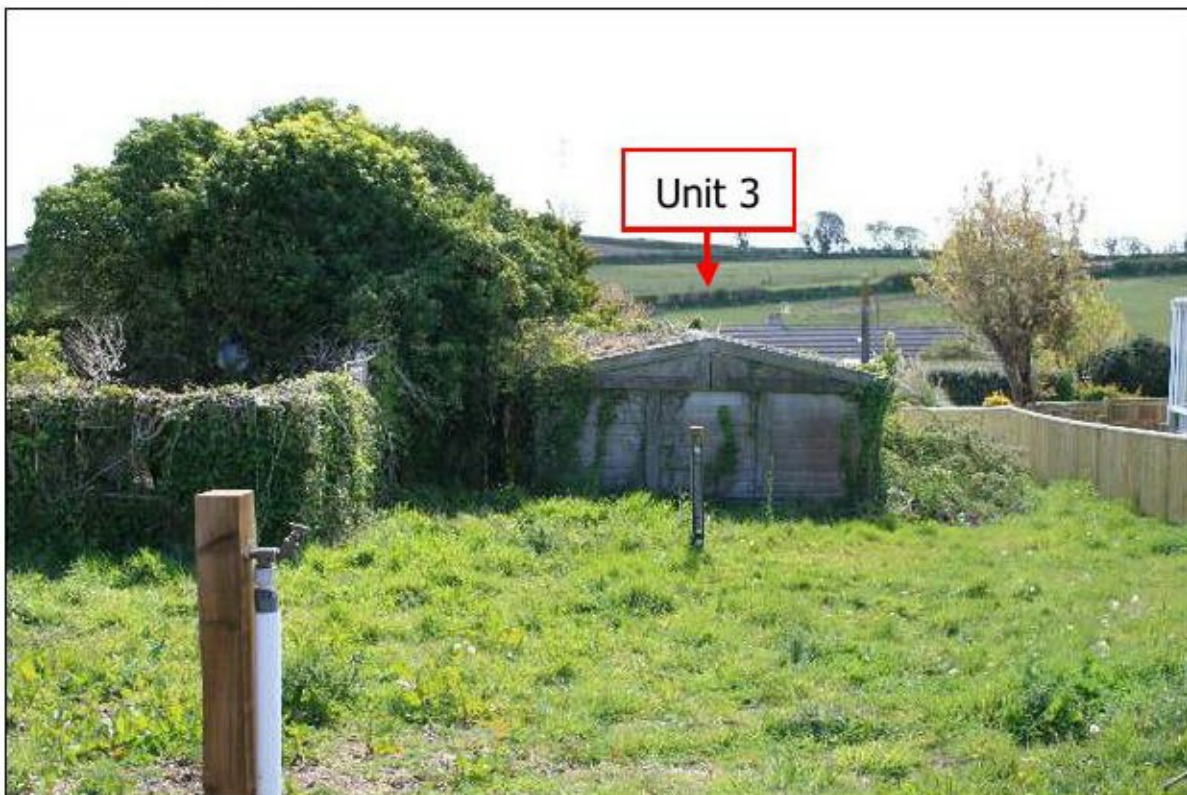
Photograph 9.

View: southeast

Looking from the northern extent of the site toward Unit 3, located upon the southwest elevation of Units 1 & 2.

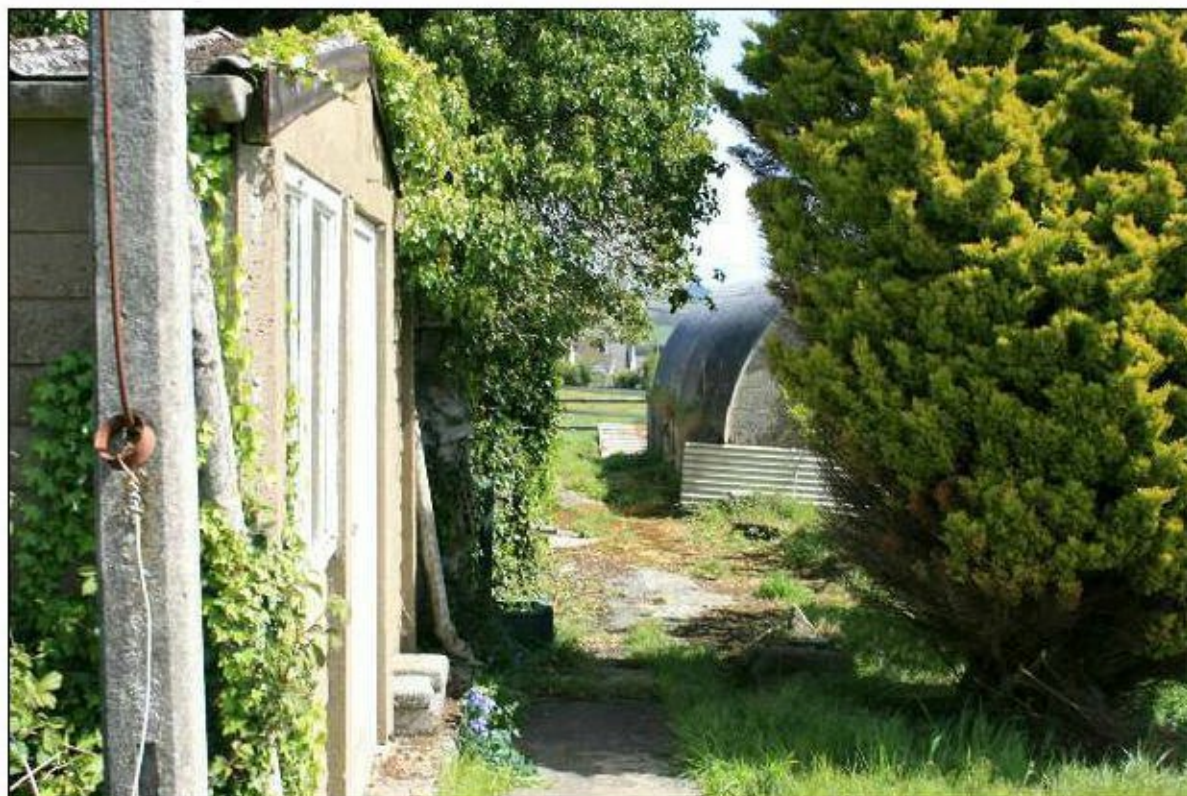
Photograph 10.

View: northeast

Looking from the front elevation of Unit 3 toward Unit 1. Note surfacing between buildings comprises of concrete.

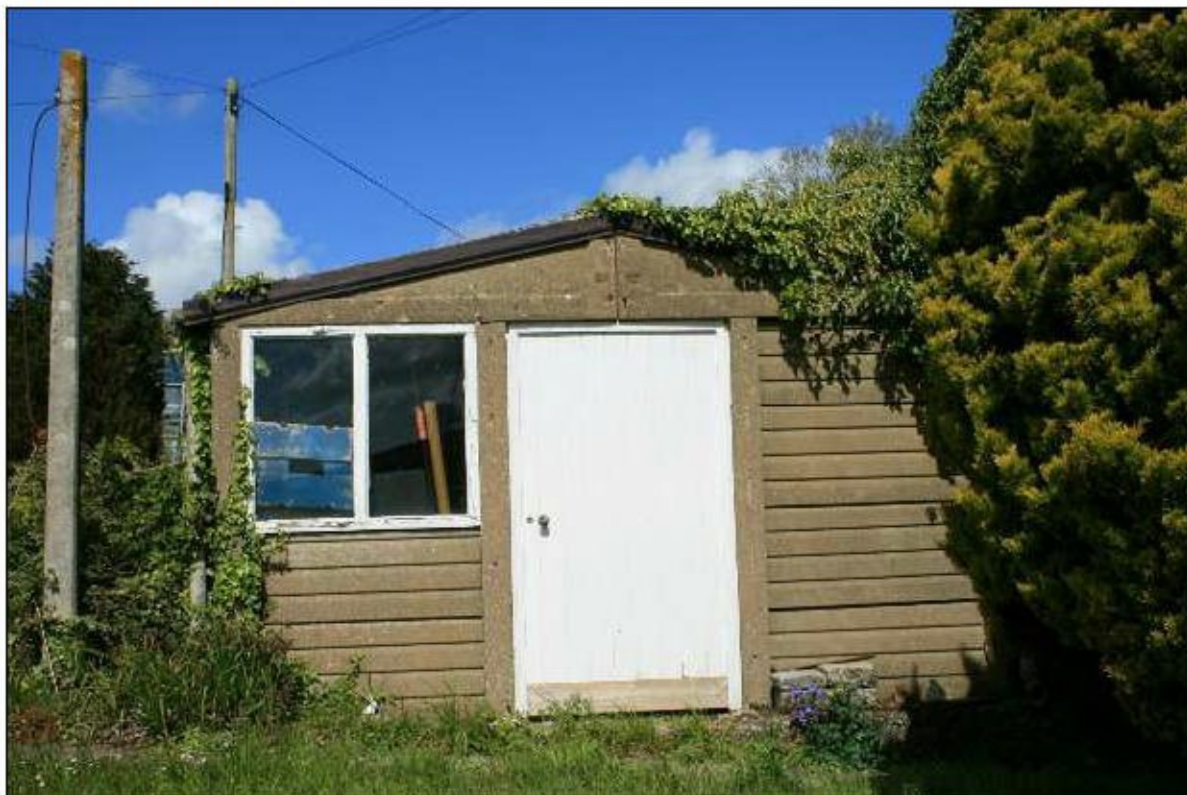
Photograph 11.

Unit 3 is a small shed style outbuilding next to the south-western elevation of Unit 2 and located towards the western extent of the site. This unit appears to be constructed from pre-fabricated concrete panels, which due to the age of the building, is likely to contain asbestos, along with the roof panels. Internally, it has a concrete floor and is being used to store general domestic items including armchairs and garden tools. It stands in a poor condition, with considerable ivy growth penetrating into the interior.

View: north-northwest

Close up view of Unit 3.

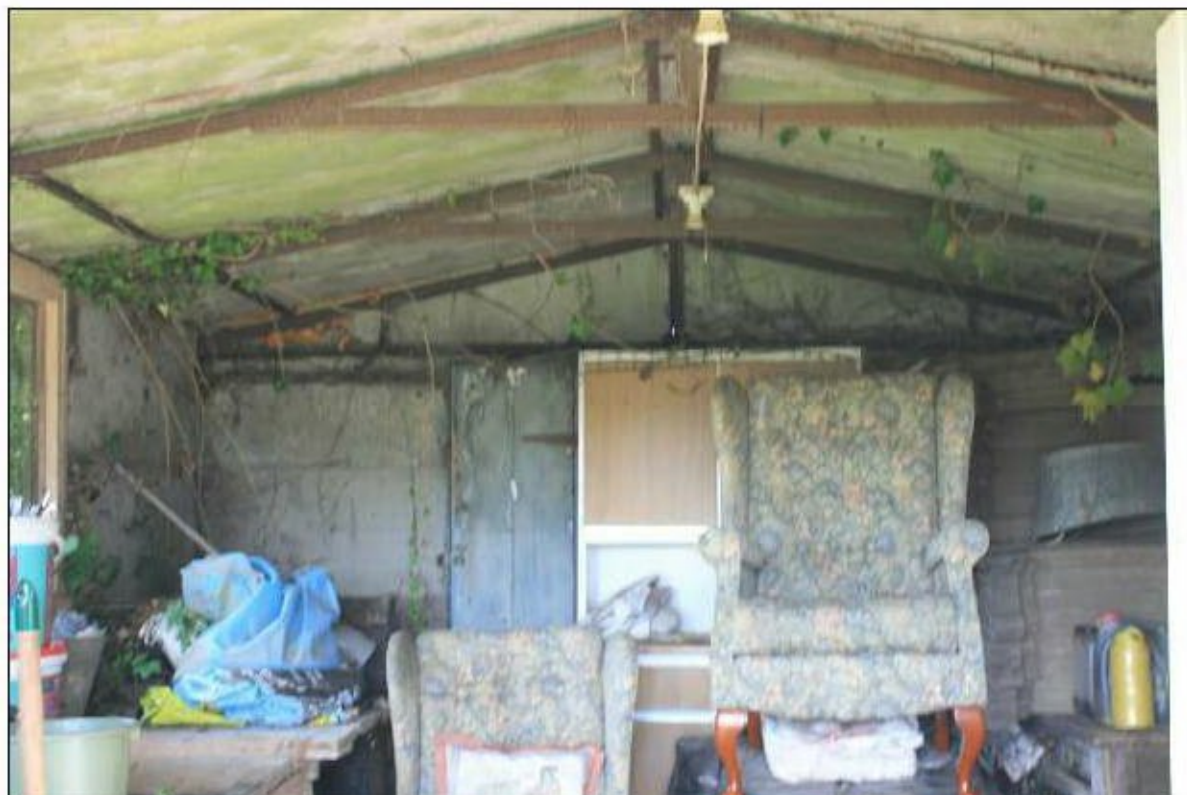
Photograph 12.

View: north-northwest

Internal view of Unit 3 used historically for market gardening purposes/storage.

All internal surfacing was recorded to comprise of concrete.

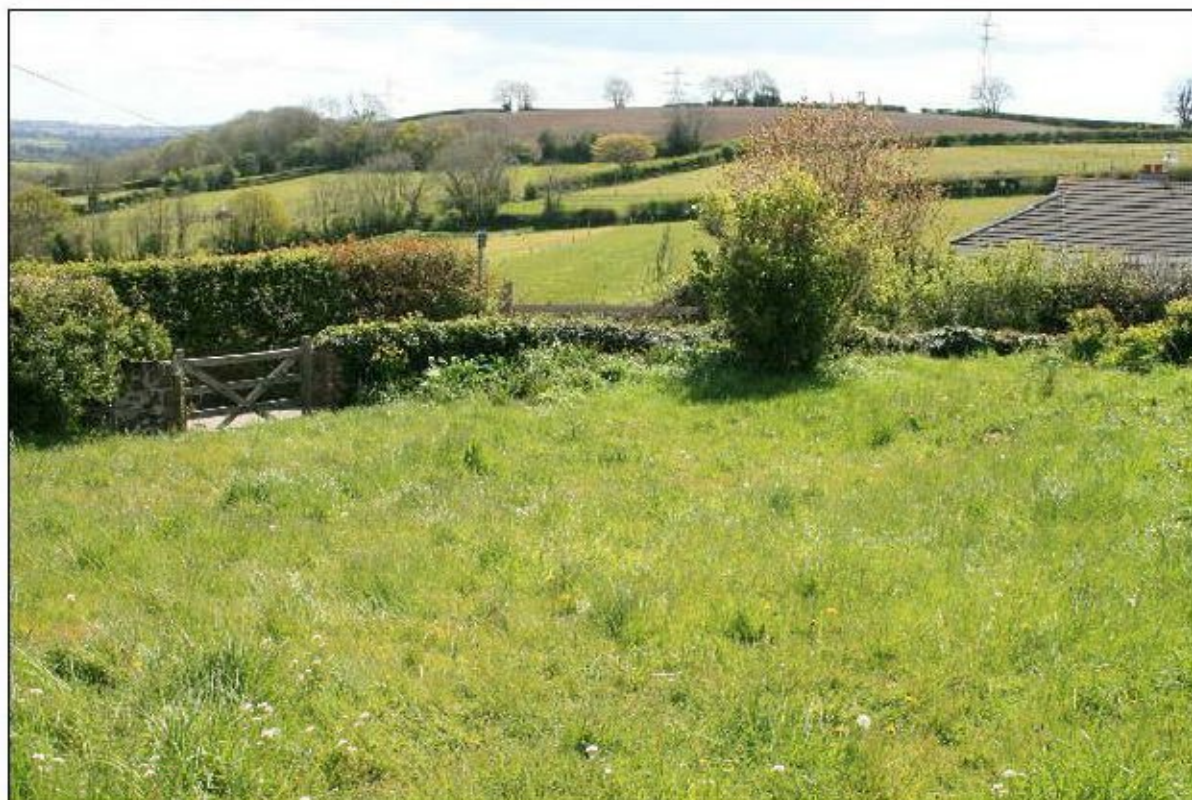
Photograph 13.

View: south

Looking from Unit 3 toward open land associated to the site and the existing gated entrance.

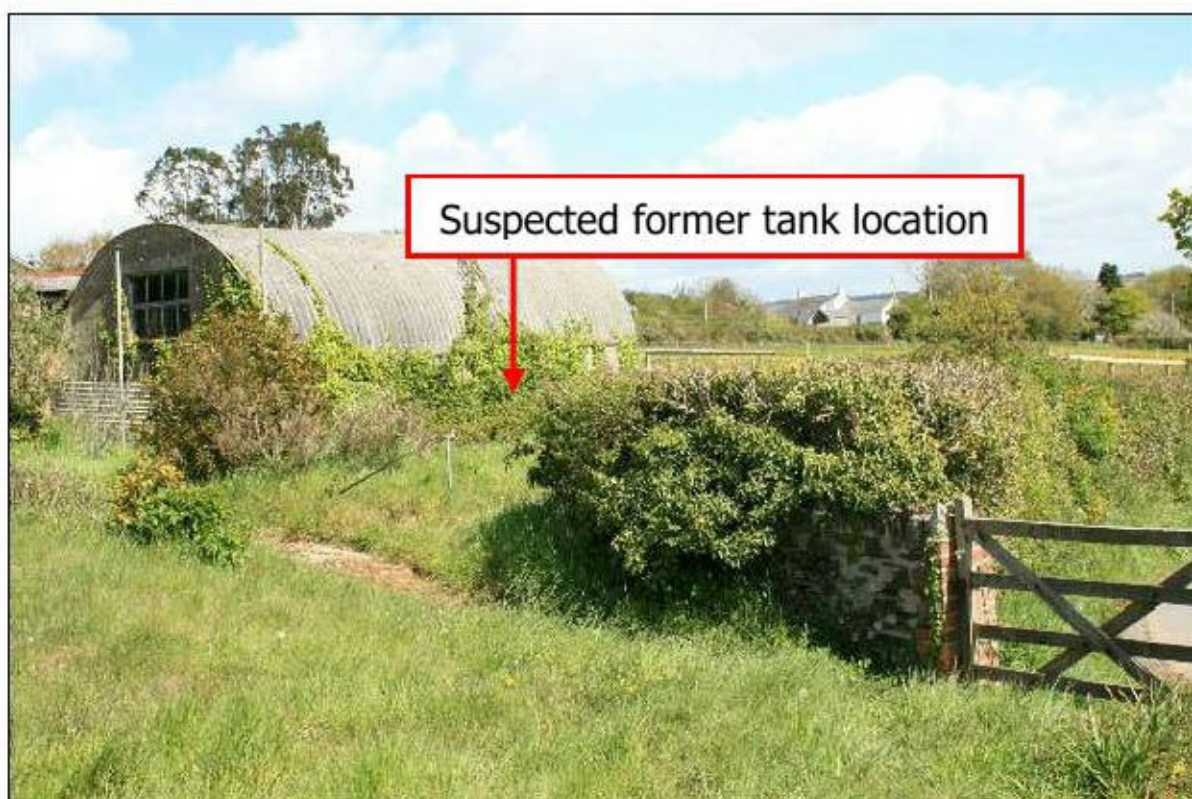
Photograph 15.

CURRENT/PAST CONTAMINATION SOURCES : ONSITE (continued)		(1,2,3) number of entries/features identified HC - Homecheck Ref	0m (onsite)
POTENTIAL CONTAMINATION SOURCE	POTENTIAL CONTAMINANTS & PATHWAY LINKAGE		POTENTIAL RISK TO RECEPTORS
Tank (1) Error identified within HC report, tank feature relates to HC ref 15, not HC ref 14.	Hydrocarbons: potential migration via soil & water. Probability: unlikely, tank historically removed from site, no evidence for this feature currently exists, or residual contamination features from former tank location (staining, odours, reduced plant growth). Likely former water tank for market garden/orchards.		Low

View: north

Looking from the southern boundary to the former area of the suspected historic tank location.
