GPE 21.037

Parsons Farm, Stratfield Saye  
Planning application No.

We refer to the above project and now have pleasure in enclosing a walkover survey/initial site inspection in support of the planning application for this project.

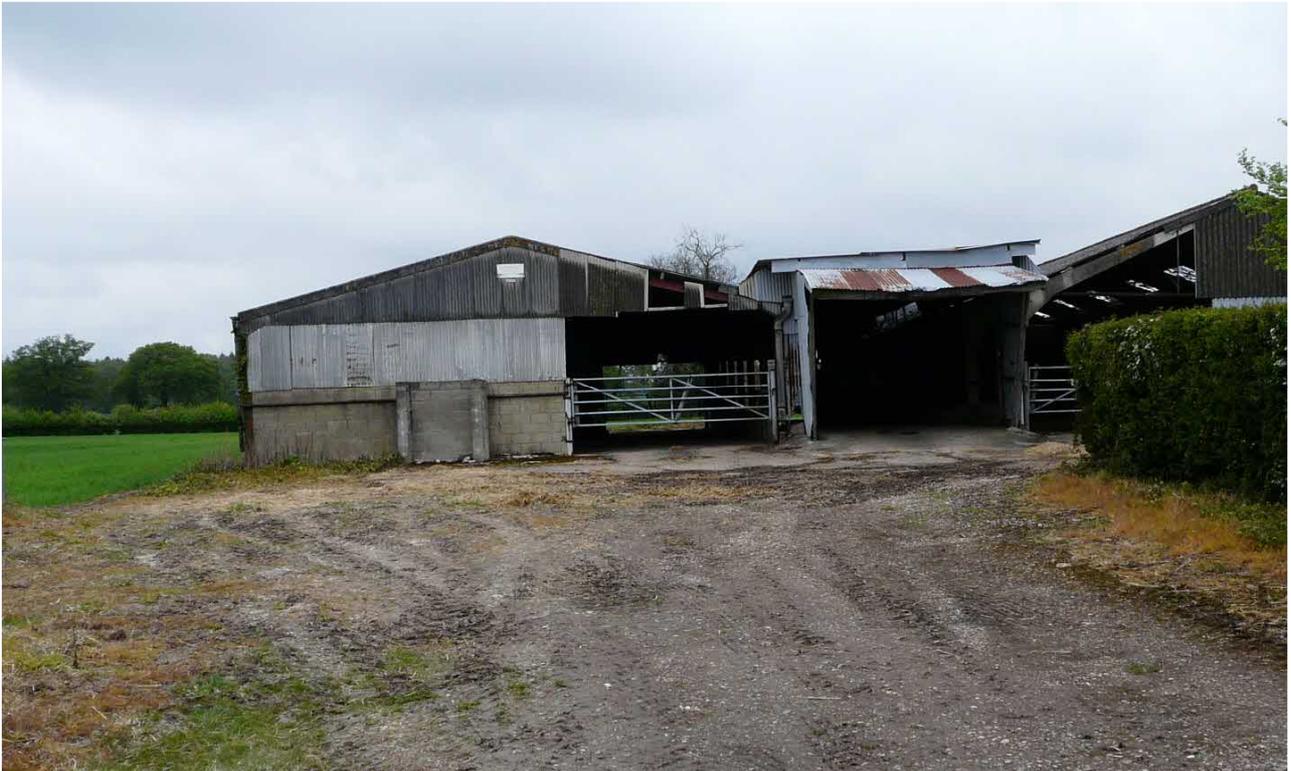
The site, which is located at Ordnance Survey National Grid Reference SU 670 618, currently comprises two barns with covered link between the two. The barn to be converted, which was built in 1984, is steel framed, whilst the one to be removed is concrete framed. Both barns and the connecting link are roofed and clad with asbestos and also have asbestos guttering and downpipes. The barns are currently used to store hay bales and some farm

Southern side of barns viewed north-west

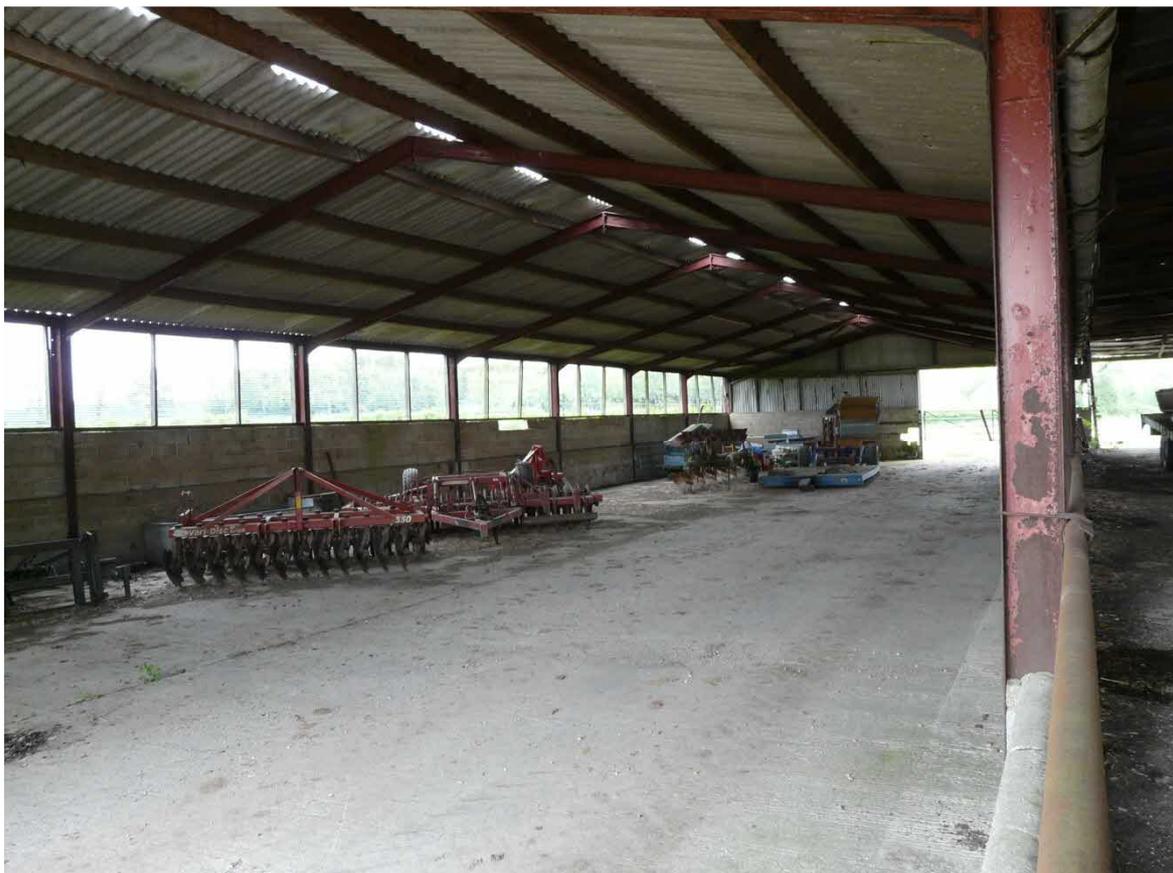
Interior of western barn to be converted

It is therefore recommended that the investigation is completed once the roof and cladding etc has been removed otherwise a return visit would be required to check that the asbestos removal has not resulted in the release of fibres or fragments into the development area. The investigation report would provide details of any remedial works that may be required prior to final occupation of the property.

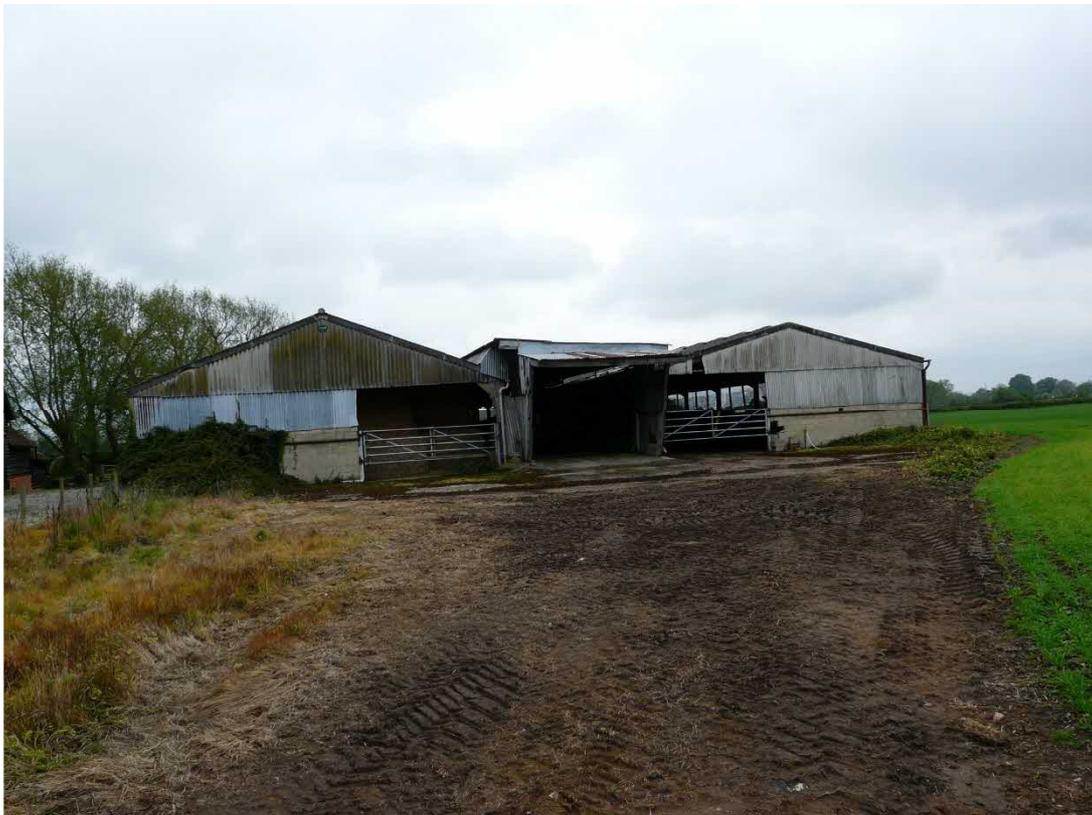
Northern side of barns viewed southwards

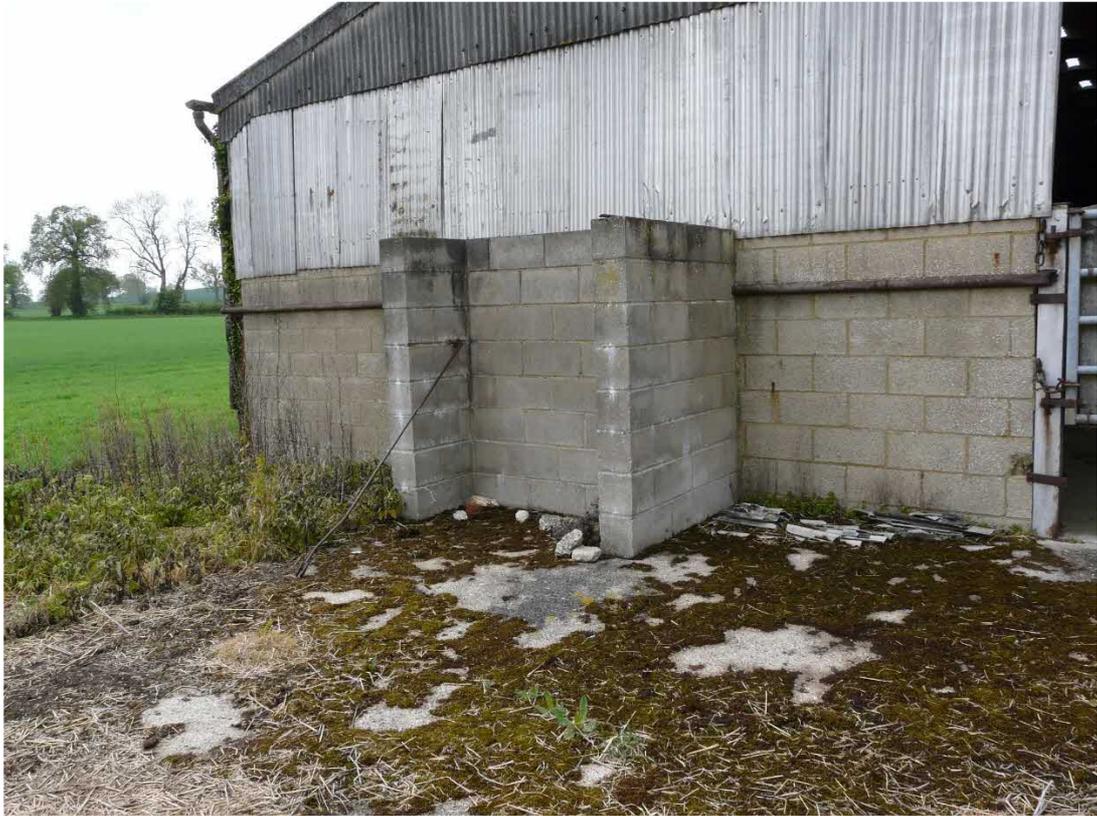
The entire development area including inside the barns are surfaced with concrete. The plinths from a former fuel tank are located on the south side of the western barn. It is understood that the tank was relocated 15 to 20 years ago due to theft of fuel from the tank. The land to the west and north of the barns is arable farmland apart from a concrete road into the barns from the north. The area to the south is an additional concrete access road and the land to the east is occupied by the farmhouse and additional farm buildings. The gardens of the farmhouse are located to the south and east and contain a pond and several trees and shrubs of varying species and maturity. The surrounding area is entirely farmland, and the nearest property other than the farmhouse is approximately 200m to the west.

| Contaminant/Source | Pathway | Receptor | Risk |
|---|--|---|--|
| Hydrocarbons from former fuel tank | Dermal contact, ingestion and inhalation | Site workers | Dismissed as correct use of PPE will break viable pollutant linkages |
| | | Residents | Low, but testing of soils will determine whether remedial measures need to be undertaken |
| | Migration through soils | Groundwater | Negligible but testing of soils will determine whether remedial measures need to be undertaken |

Plinth for former fuel tank

Although the former oil tank is in area that is to becoming parking it is recommended that this area is inspected once the plinths and surface concrete has been removed. Hydrocarbon testing of the underlying soils can be completed to determine whether remedial measures will be required. As the underlying soils are anticipated to be cohesive it is unlikely that groundwater would be impacted and that significant remedial measures would be required in this area.
