# Bat Survey of The Forge, Street End, Blagdon, Somerset

Client    Sworders

Reference    S1179.001

Date    16 August 2021

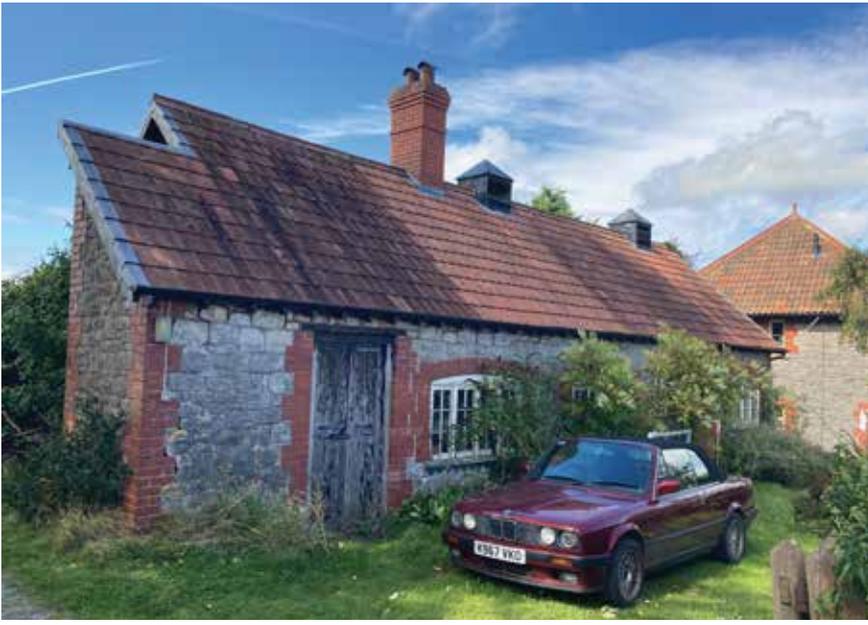
Photograph 1:

Front; eastern elevation

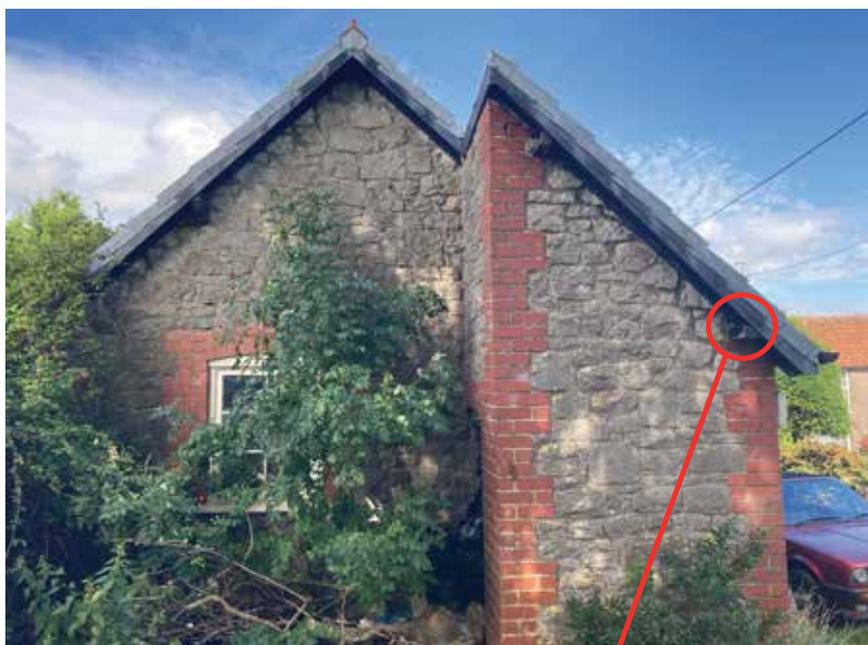
Photograph 2:

Southern gable

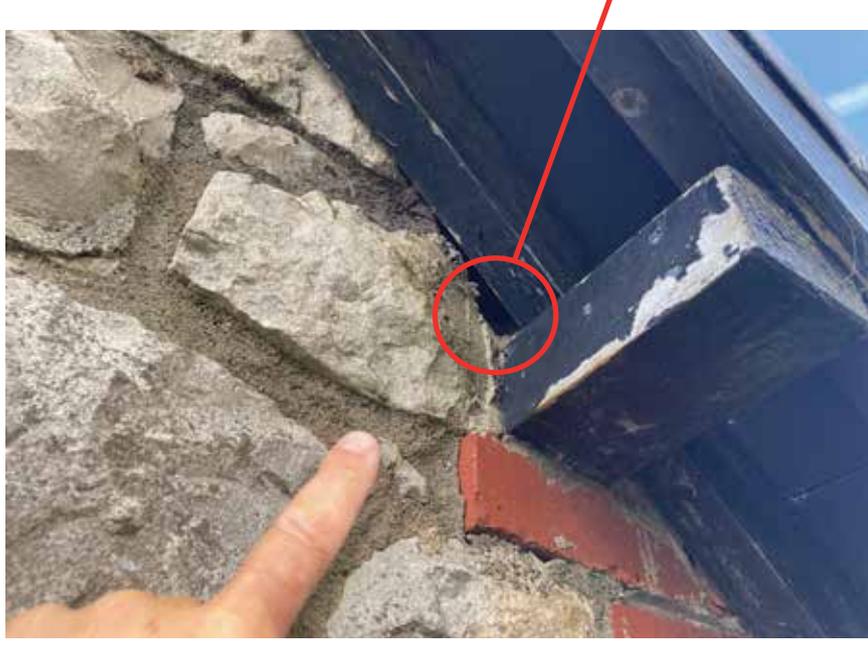
Photograph 3:

Significant crevice located near wall plate on gable end

Building	Feature	Feature Description	Bat suitability
		significant crevices are present where mortar / timber has shrunk back allowing access to small and hidden cavities.  Refer to photographs 3 & 5.

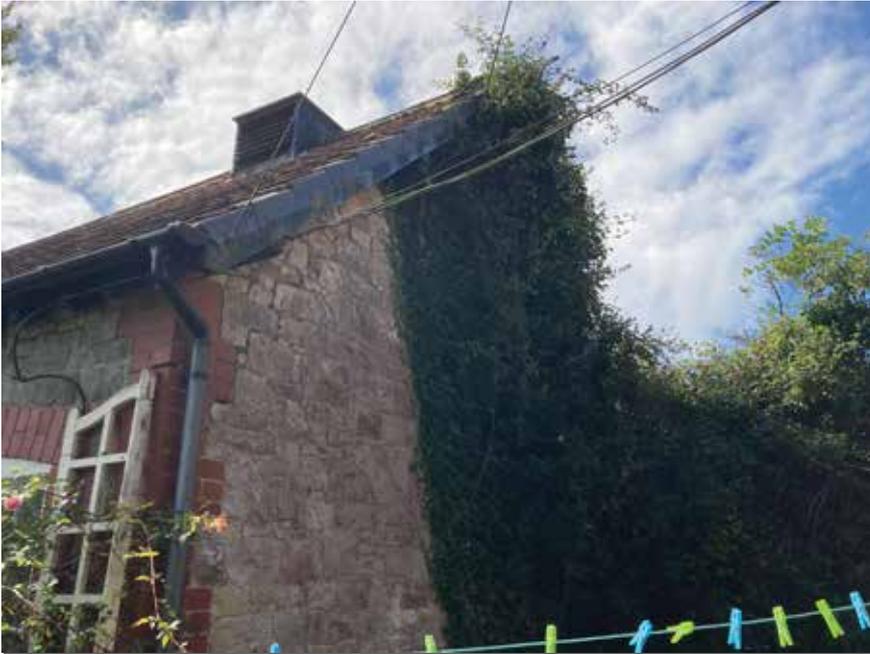
Photograph 4:

The northern gable, which has become partially encroached by ivy.

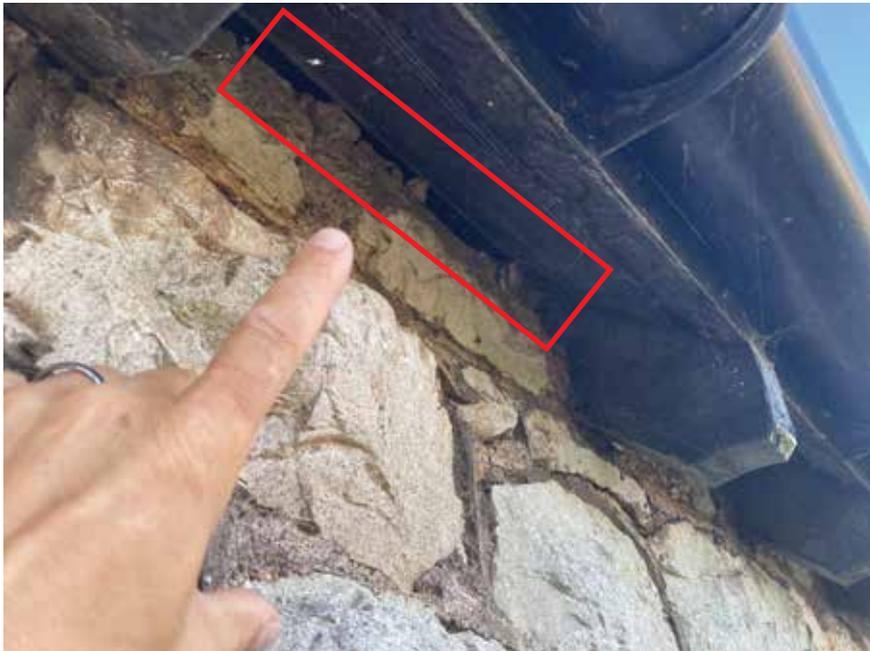
Photograph 5:

- 3.15. During one of the activity surveys in 2020 and the survey in 2021, one soprano pipistrelle bat was recorded emerging from a crevice associated with the eaves on the northern end of the building (eastern elevation), refer to Photograph 5.

Significant crevices associated with the eaves along the eastern (front) elevation, as highlighted

This is the location that 1 number soprano emerged from on the emergence survey 27 July 2020.

- 4.9. The conversion of the dwelling will result in the likely loss of one number non-breeding soprano pipistrelle summer roost used by low numbers of bat. Due to the low conservation status of the roost there is not considered to be any timing constraint to the development.
- 4.10. Prior to works commencing there will be a requirement to undertake a toolbox talk which will be a conversation between the ecologist and the builders to inform them of their obligations in relation to roosting bats. The toolbox talk will cover basics such as bat biology and where bats might be found during the development and what to do with a bat is found during works.

- 4.14. Replacement bat roosts for soprano pipistrelle bat will consist of two integrated (in-built) Habibat type 001 bat roosting boxes.
- 4.15. This model is designed for a variety of bat species, including pipistrelle bats making it suitable as both a maternity roost and hibernation roost. The boxes are approximately the size of a shoebox and are incorporated in the outer skin of the supporting walls as they are constructed. The boxes can be fitted to suit any existing brick, wood, stonework or rendered finish, making the box unobtrusive and aesthetically pleasing. On existing walls a section of masonry / cladding will require removal.

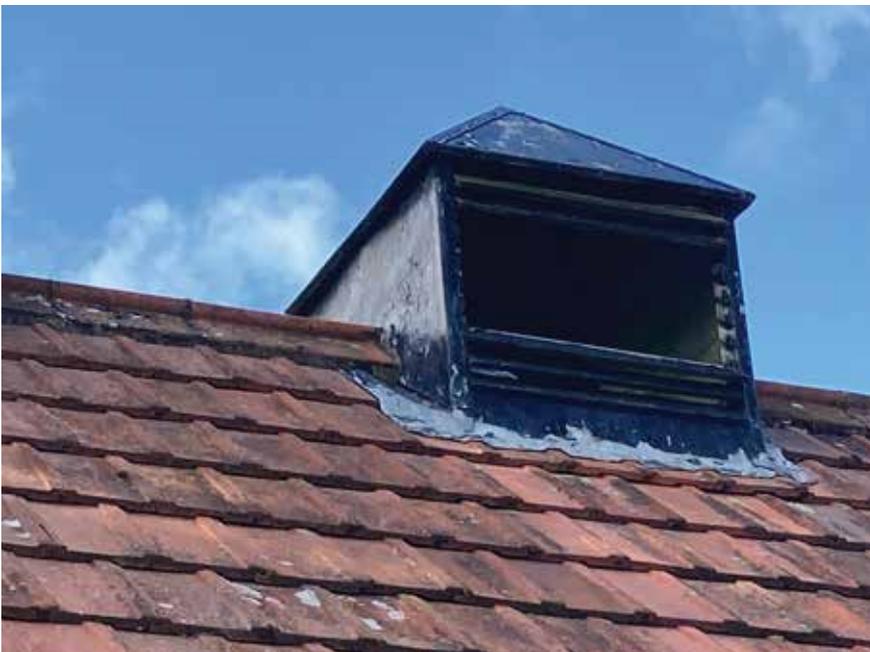
Photograph 6:

Roof vent, one of two located on the roof apex, the ventilation louvres are broken and missing on both the vents. The base of the vents have been sealed where they enter the interior roof void.

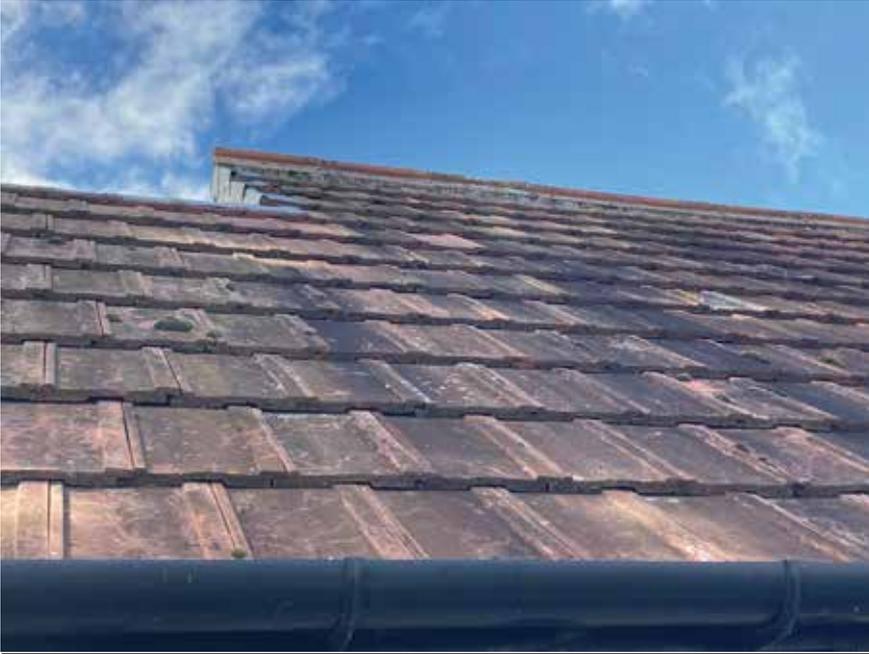
Photograph 7:

The roof, which is double pitched is clad with a type of flat interlocking clay peg tile. All tiles remain present and well fitted, resulting in a well-sealed roof.

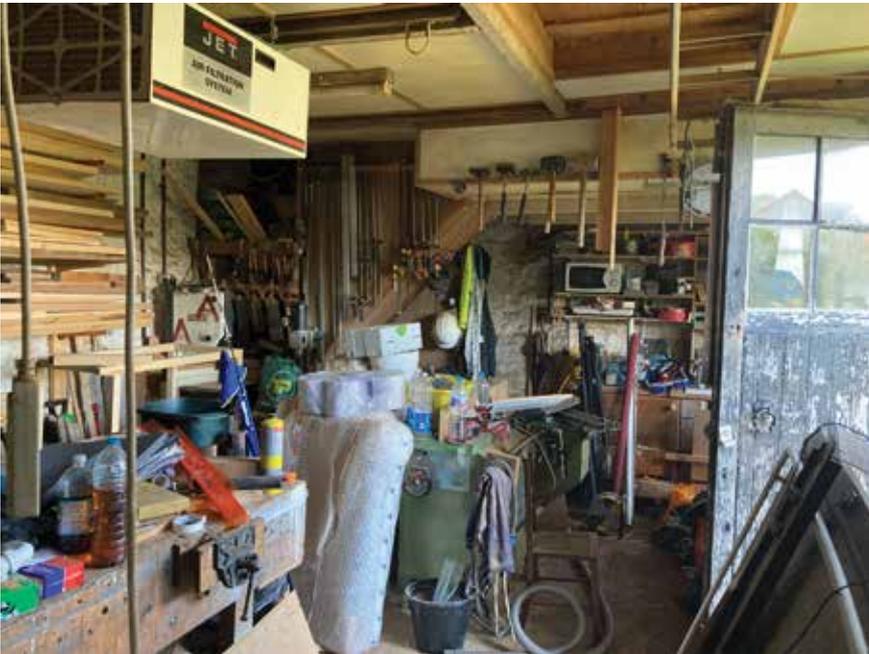
Photograph 8:

Ground floor; approximately 3/4 of the ground floor which occupies the northern end is in use as an active carpenter's workshop.

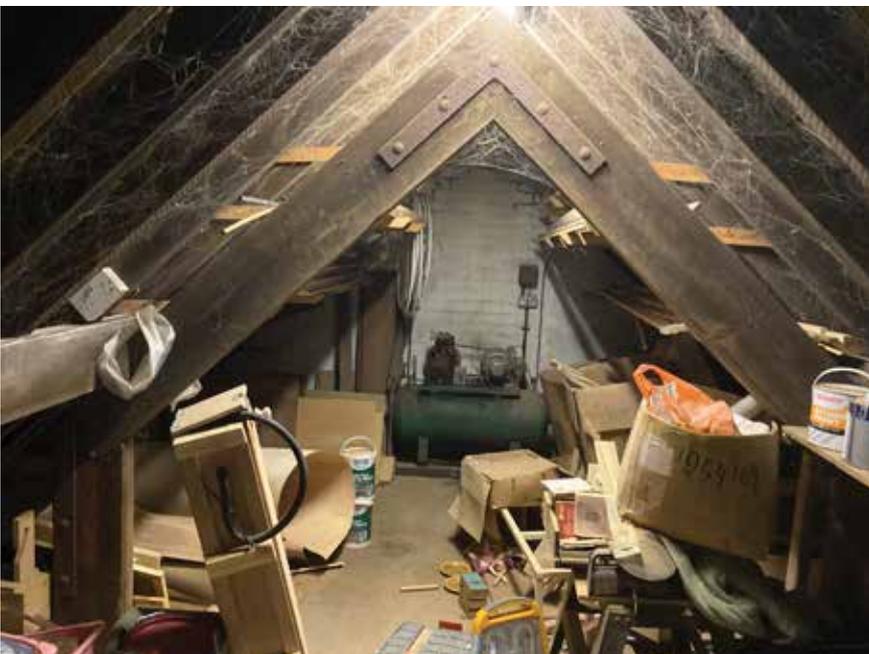
Photograph 9:

A roof void mirroring the carpenter's workshop, lies directly above and is used as storage and an office and is accessed by a wooden staircase.

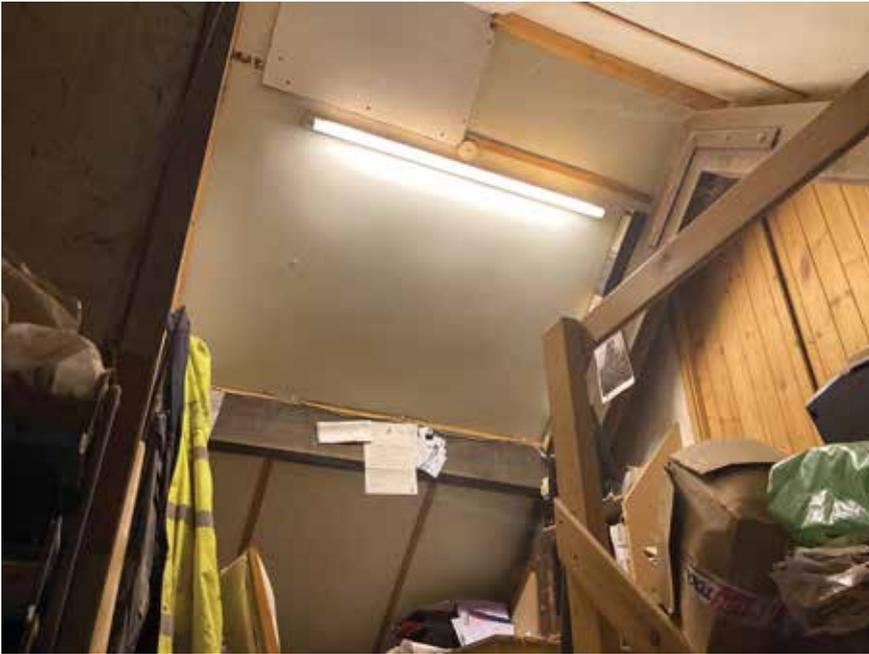
Photograph 10:

The office and toilet which is present at the extreme northern end of the roof void.

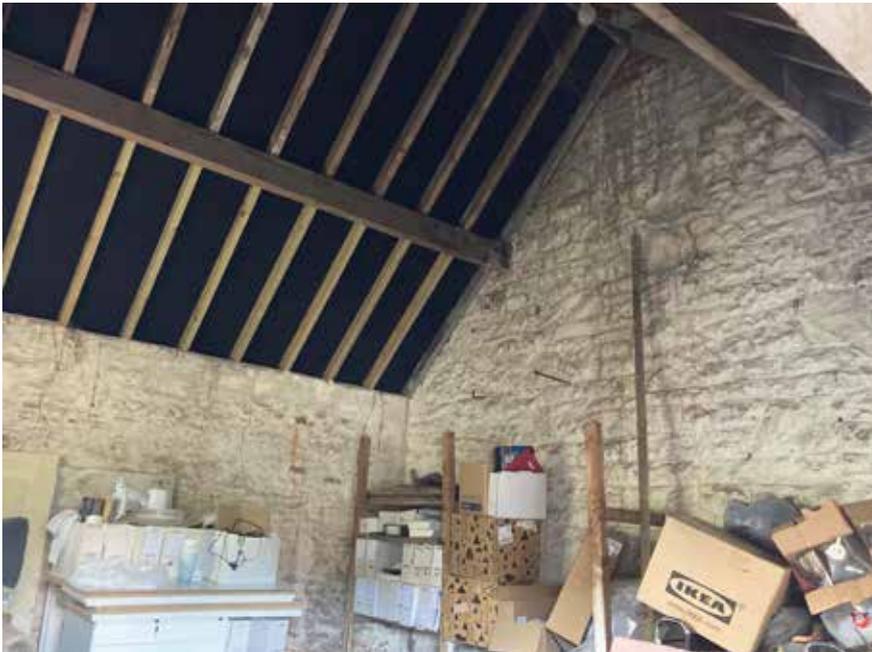
Photograph 11:

Internal; southern end. This provides a single ground floor bay with a vaulted roof void and is used as storage
