**Extended Phase 1 Ecology and Bat Survey Report
For Bovill's Farm Barn
Osyth Road
Little Clacton**

For Strutt and Parker LLP

11th July 2014

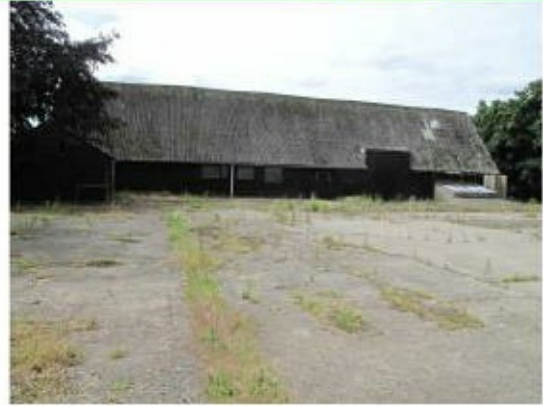
The listed timber barn, north elevation

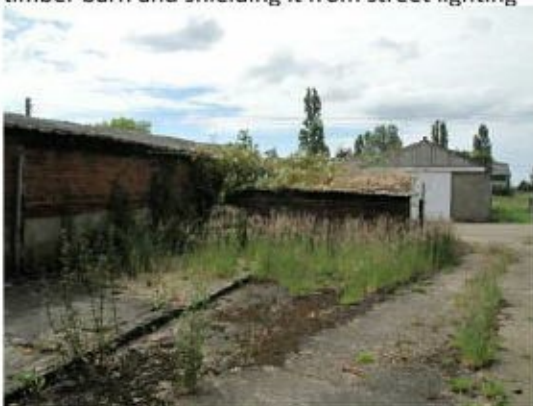
Off the most westerly of these shelter sheds are two brick pig sties with a mono-pitched, asbestos clad roof that has collapsed and is part of the building that is becoming overgrown with 'Russian vine' (*Fallopia baldschanica*).

West elevation of the shelter sheds and the piggery covered in Russian vine

The site has no amphibian or reptile interest and no further surveys are required. No rare or protected plants were found on site. 'Russian vine' has established on the piggeries and its removal is recommended as soon as possible as this plant grows at tremendous speed and will damage the fabric of the building. The existing trees have landscape value and should be retained.

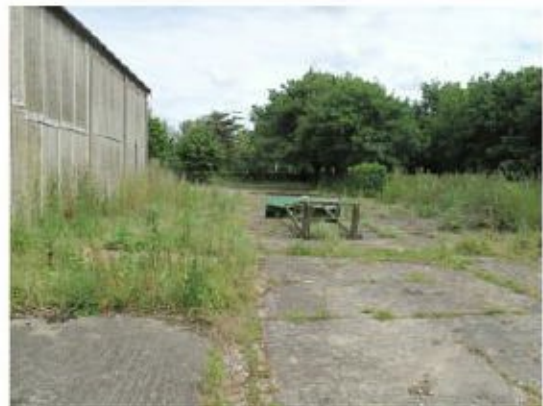
Some of these species are also found growing on organic material that has collected on the east side of the modern farm barn in the centre of the yard and between cracks in the concrete as a result of the site not being used.

East side of the modern barn and colonization of the concrete by ruderal

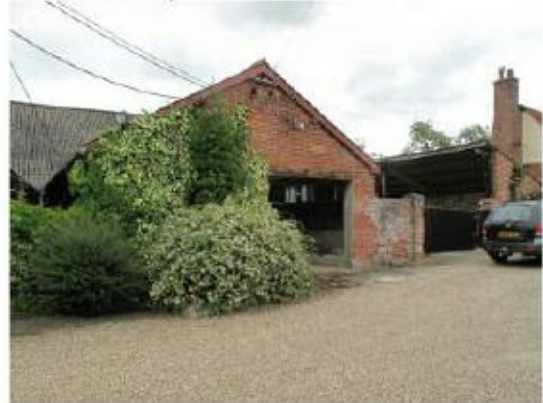
Southern gable of the shelter shed with the barn owl box

Possibly as a result of the pigeon there was no evidence of the barn being used by the off-duty barn owl as found in the earlier surveys. The barn owl box is also no longer being used.

The barn owl box should be retained as the birds may return once the feral pigeon have been dealt with and the development completed.

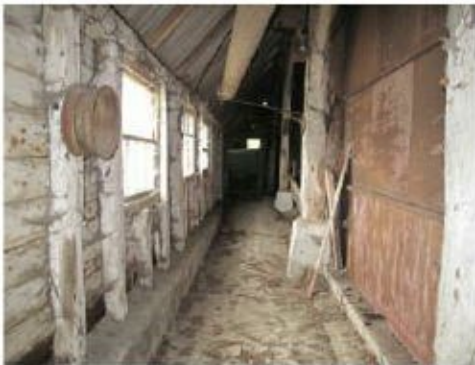
In the recent past the timber barn has been used as a modern granary with storage bins and associated plant occupying the majority of the nave and rising up into the roof. It may have been for this purpose that some of the braces had been removed, leaving open mortise joints. The interior of the building is very dusty with extensive cobwebs while the concrete floor is covered with dirt, including leaves that have blown in under doorways.

The interior of the barn was very dirty

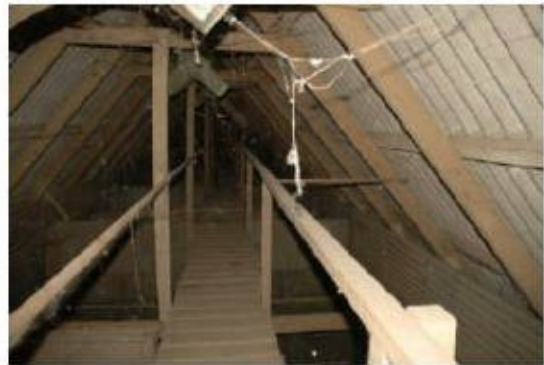
Mortise joints in the timber frame that had been cleaner than others in 2010 were now cobwebbed or contained nesting material indicating that they are no longer used by bats.

The roof area was still cobwebbed in areas

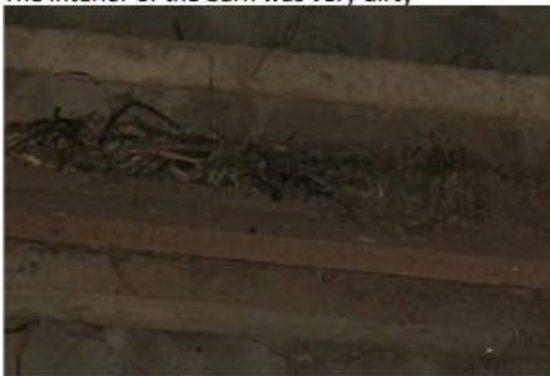
The dominant bird on site is feral pigeon. During the 2010 survey these birds were breeding in the modern barn but on the recent visit numbers had increased dramatically and the birds now occupy and breed in the traditional barn.

Pigeon nest remains at the ridge

However, the feral pigeon are protected by the *Wildlife and Countryside Act 1981* (as amended) when breeding. Therefore it is recommended that a suitably qualified person is employed to deal with the birds outside the bird breeding season. For pigeons the breeding season can be quite long and it will probably not be till the winter that they can be humanely destroyed.

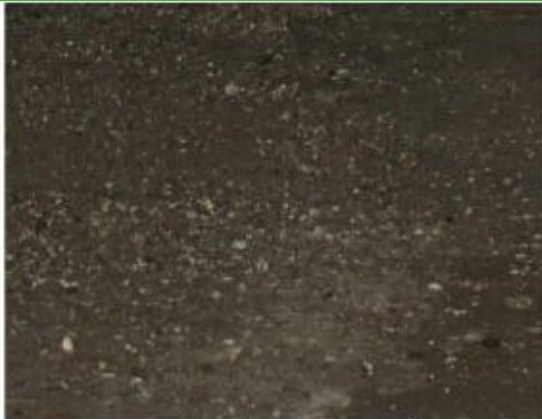
Pigeon guano was beginning to occur in quantity on areas of the floor
