Photographic Survey

Appendix B - GQA PORTFOLIO

GQA portfolio

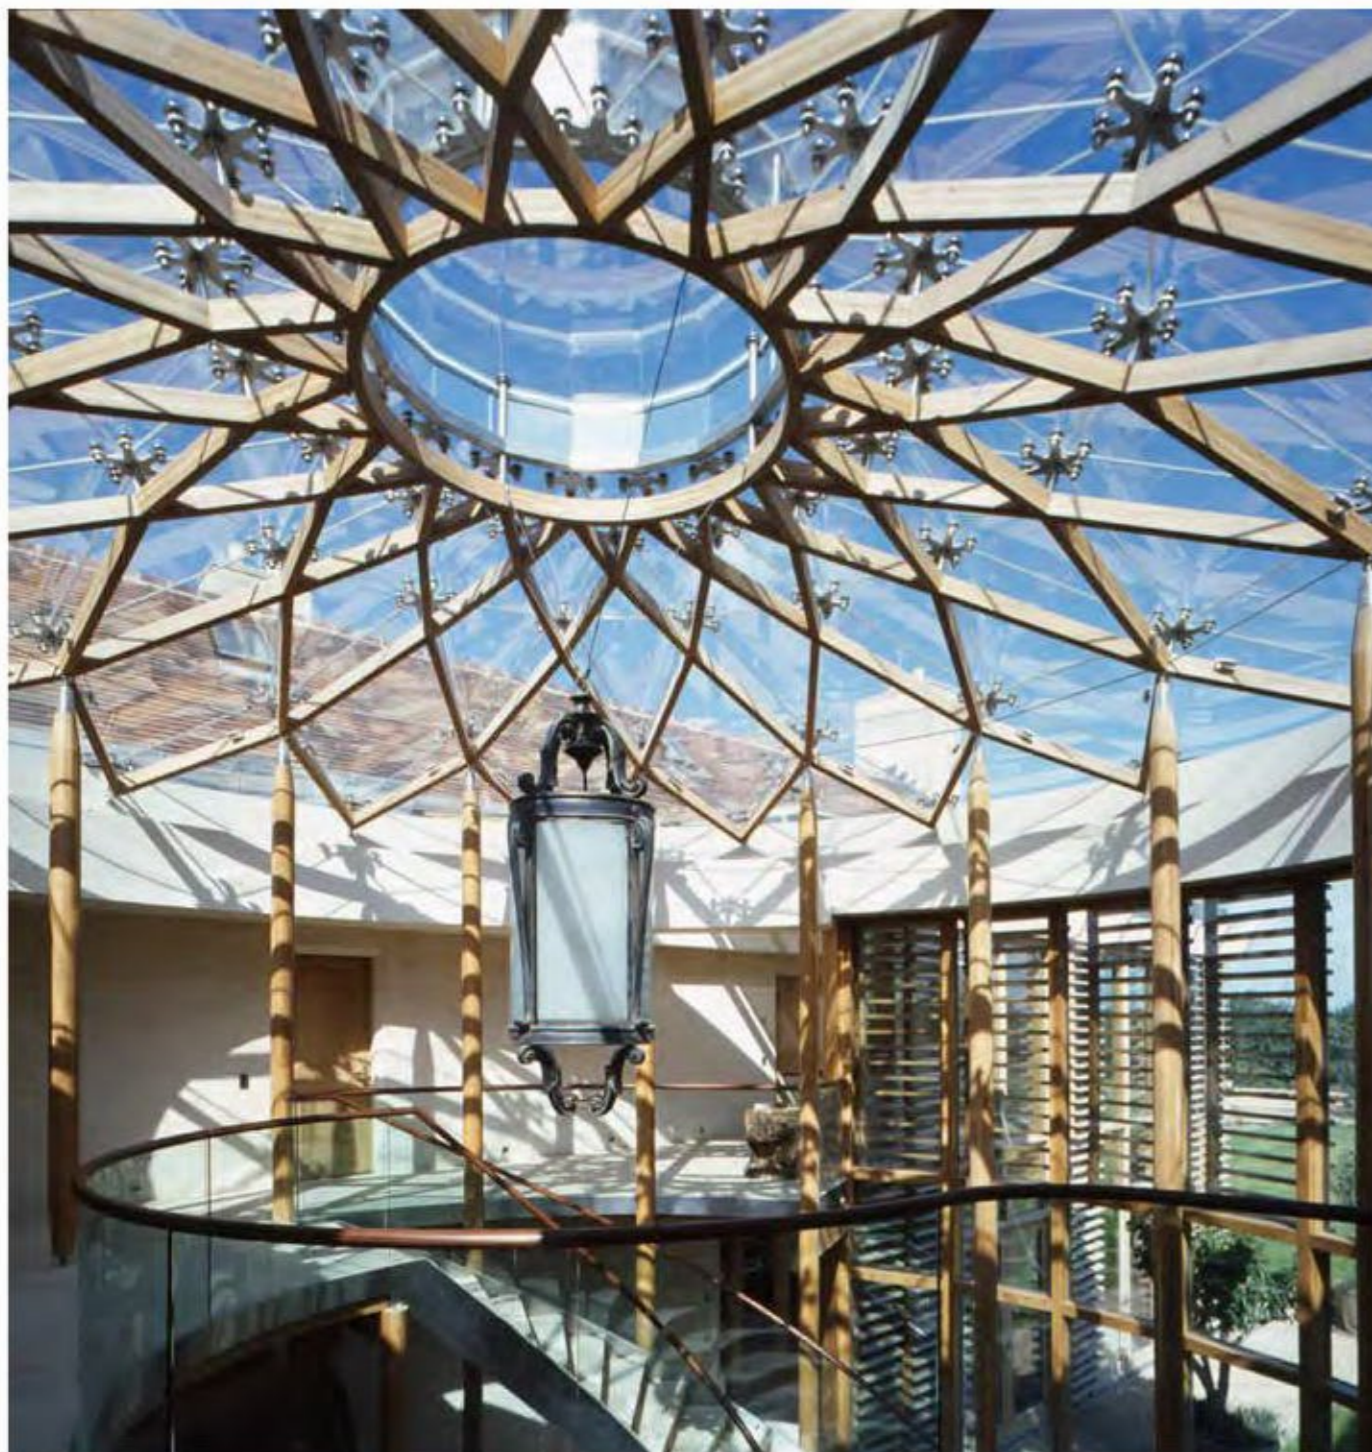
Detail of glazed roof structure over staircase.

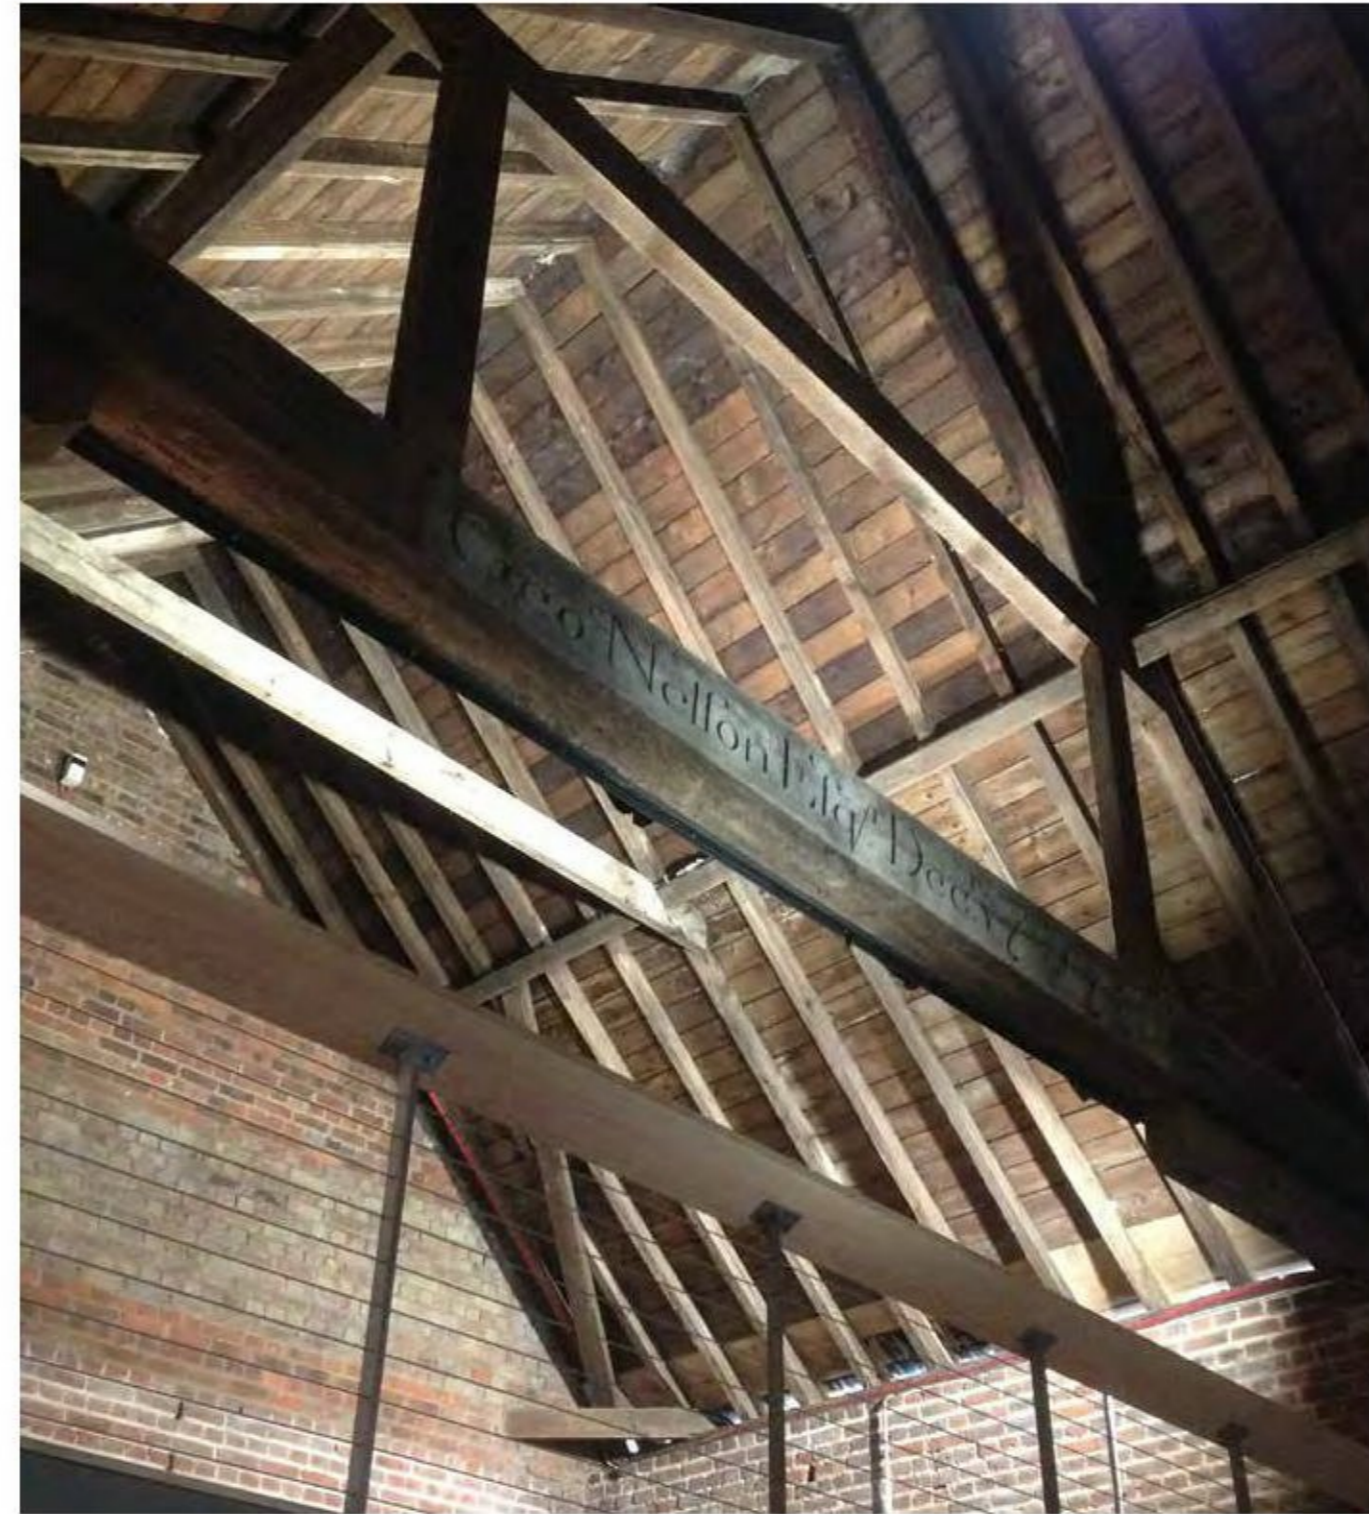
Historic roof trusses.

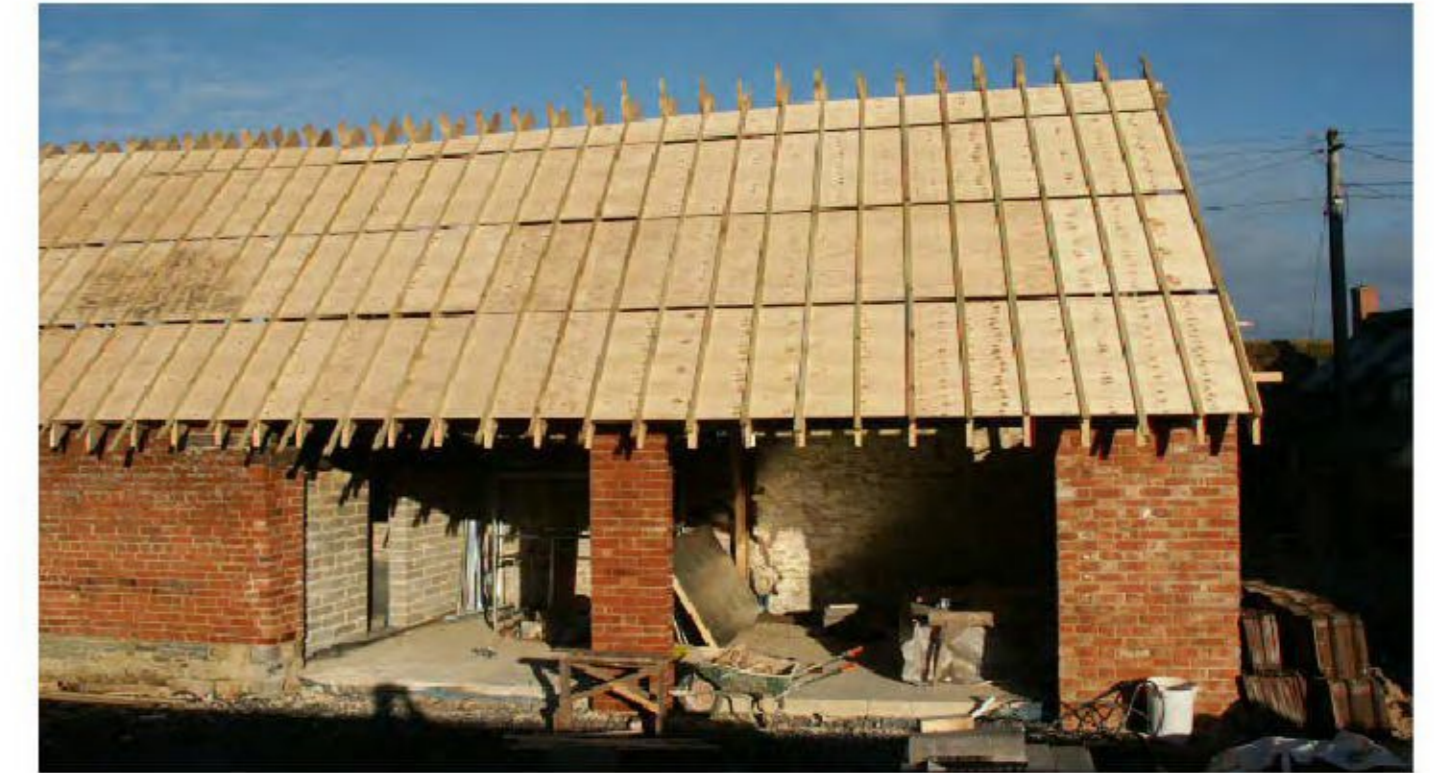
Adjoining barn mid restoration.

The adjoining barn was in an equally derelict condition due to long term neglect. The unique 16th century 'Sling' brace truss was carefully repaired and the roof reconstructed.

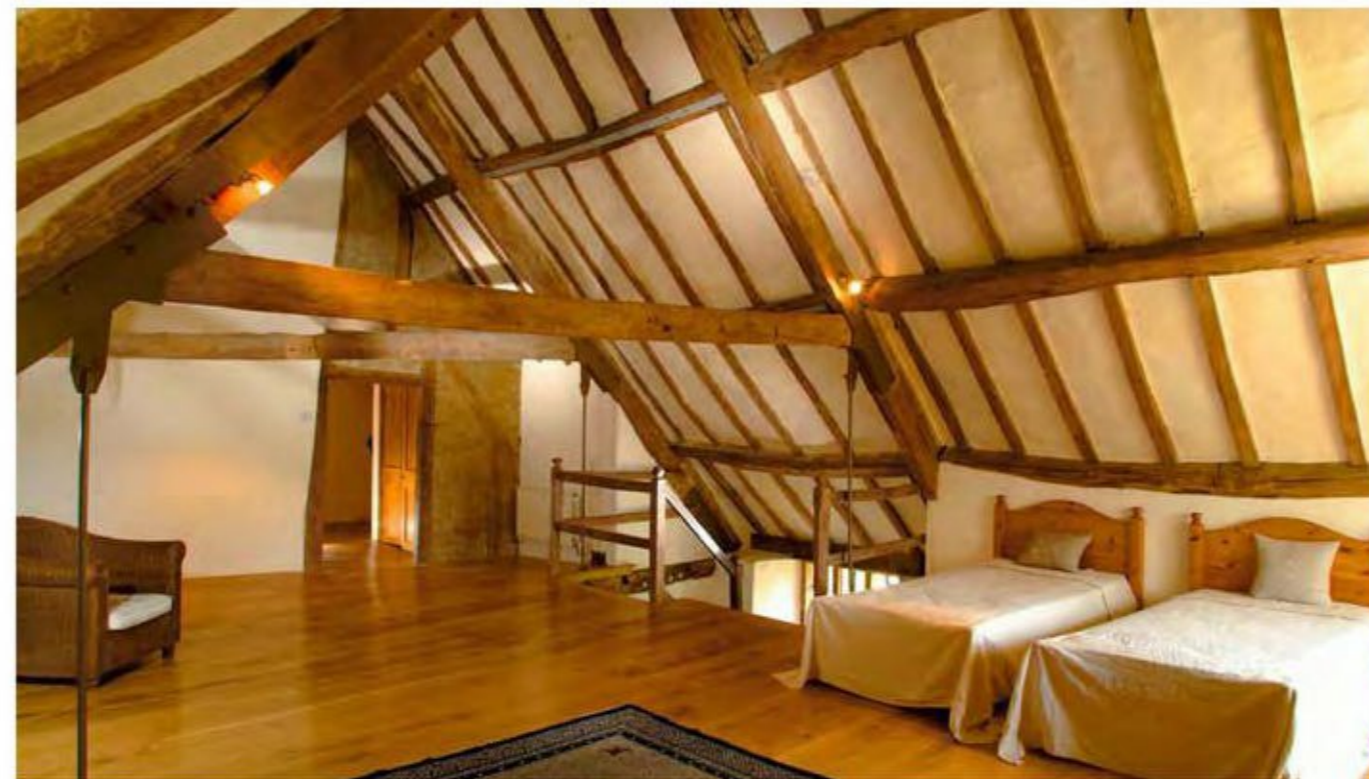
Steel hangers in attic of the house.

Internally extremely derelict and suffering from severe Death Watch Beetle. All the elm roof trusses had to be strengthened internally using steel plates and hangars (see attic photo), to allow the historic thatch and internal plaster ceilings to be retained. Each truss had to be repaired on an individual basis to prevent collapse of the building.

The work done at Ashford House demonstrates that GQA has ability to retain and repair historic fabric in an innovative structural manner. The steel hangers were used to support concealed mild steel fitch plates. Siebeg drills were used to assess the residual strength of the timber trusses and beams to assess the amount of steel reinforcing required.

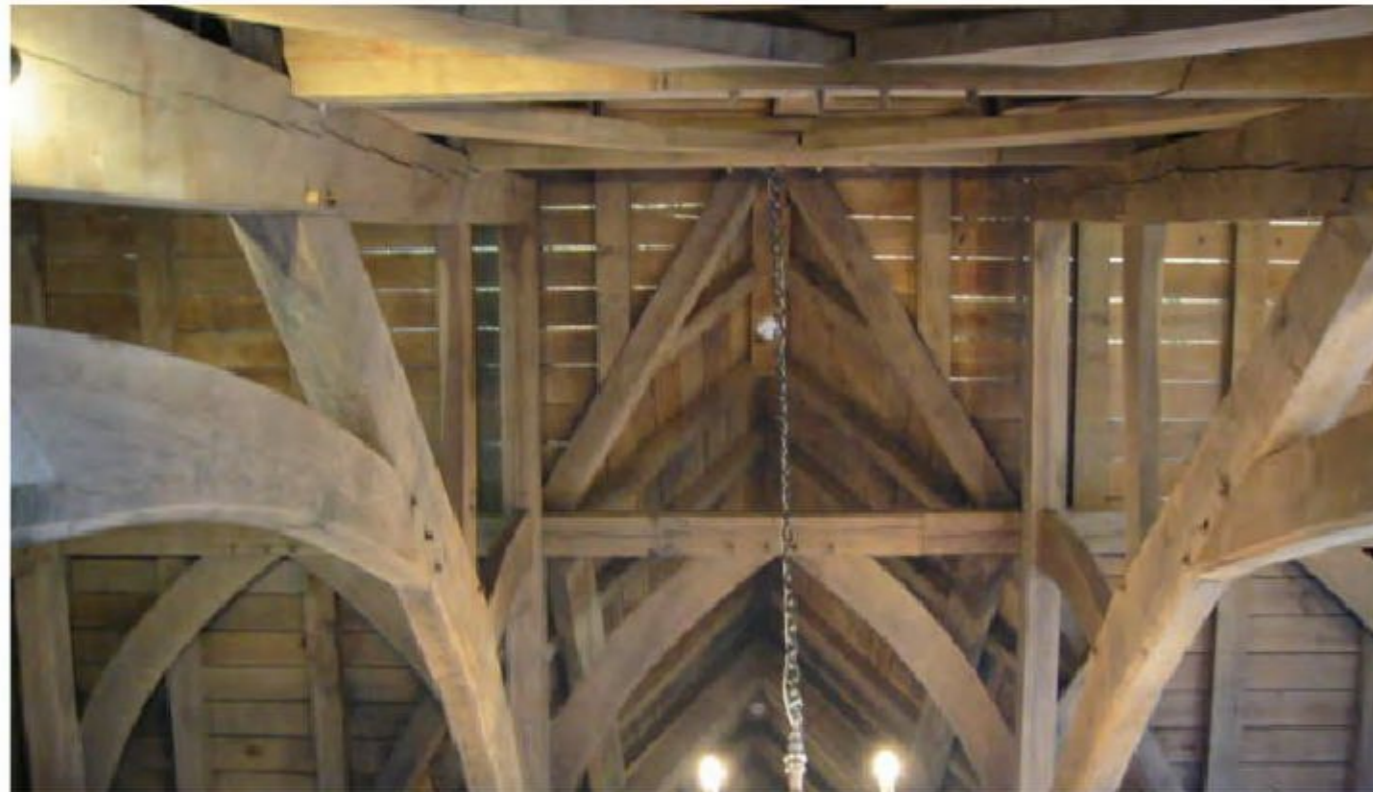
New Green Oak dining room roof.

Of particular relevance is the 'Green Oak' timber work which we did. This involved the creation of a new historically detailed dining room with a truss roof and a carefully detailed Doric screen with glass and steel conservatory behind. It was designed to conceal a very badly detailed Orangery, that harmed the appearance of this important historic building.

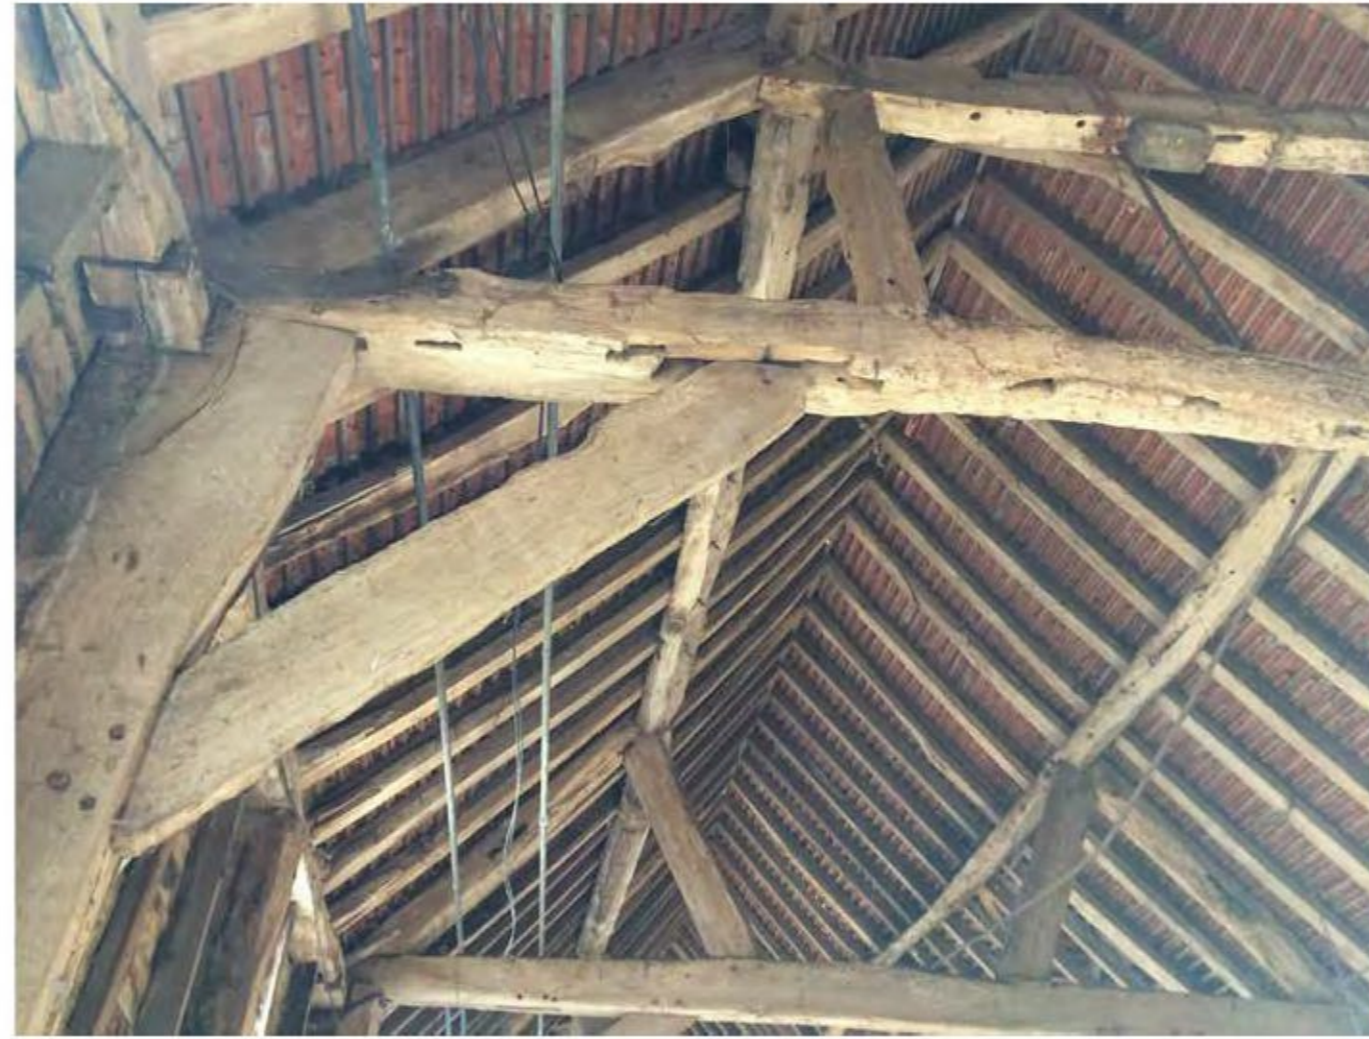
Queen post truss.

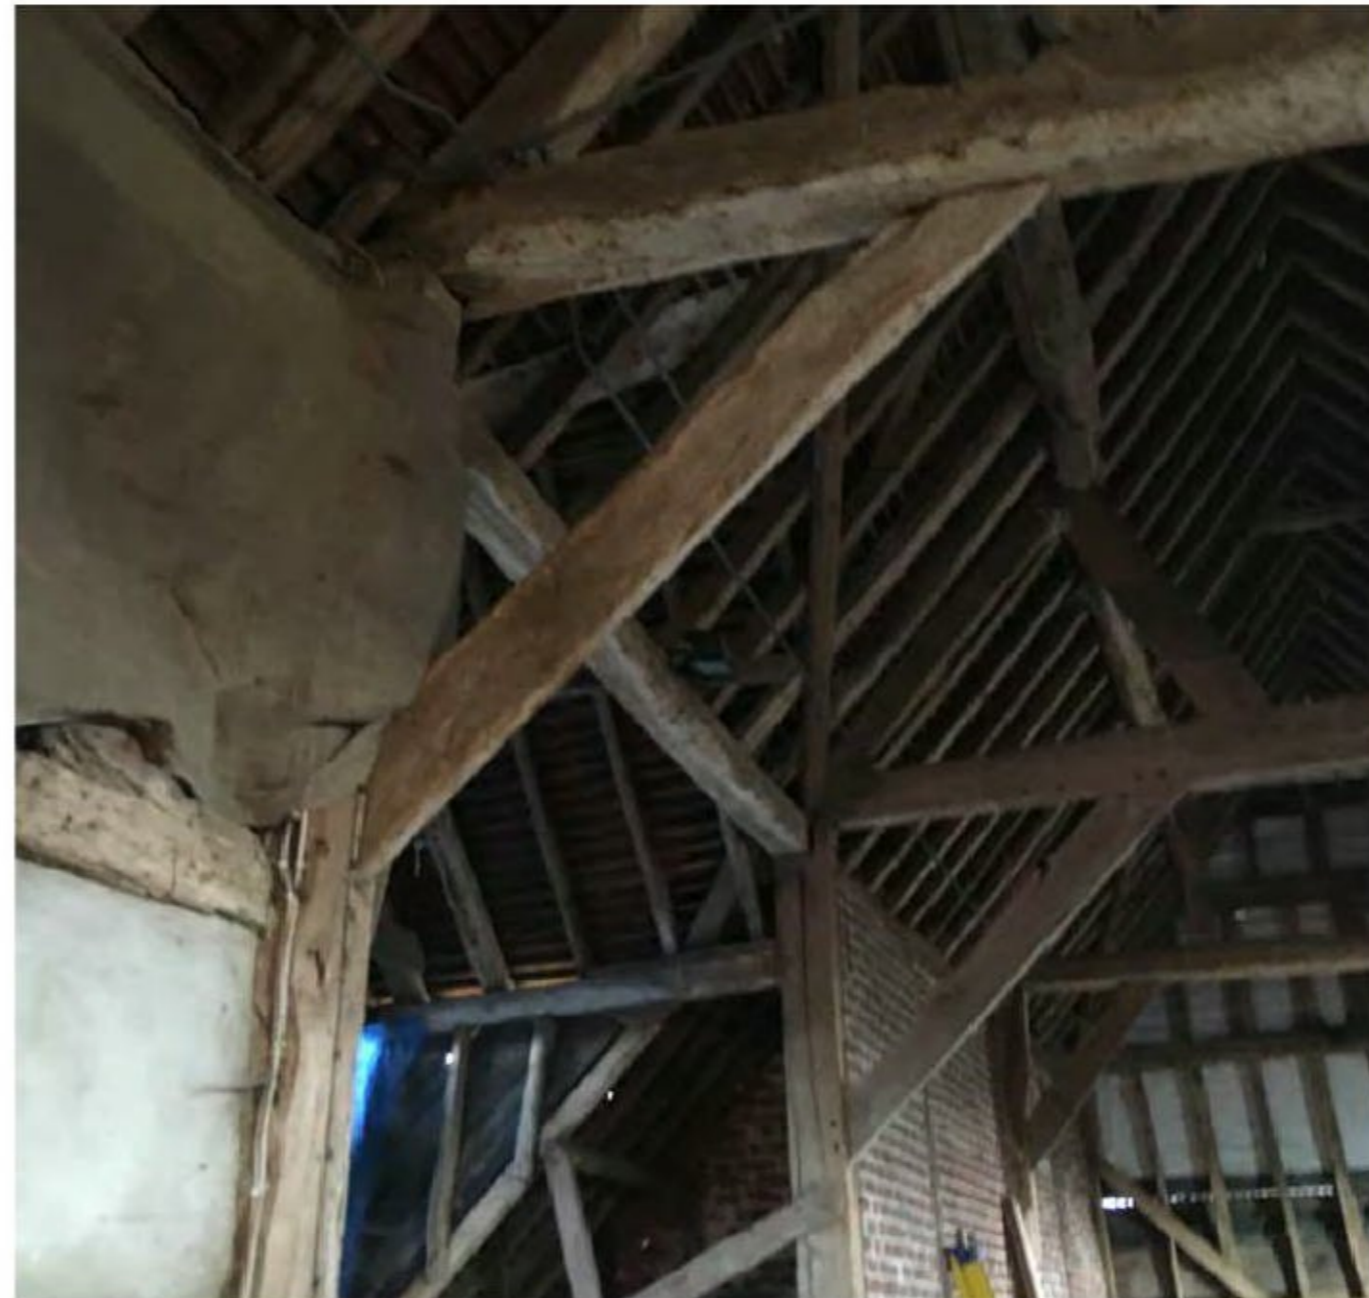
Purlin supporting truss.

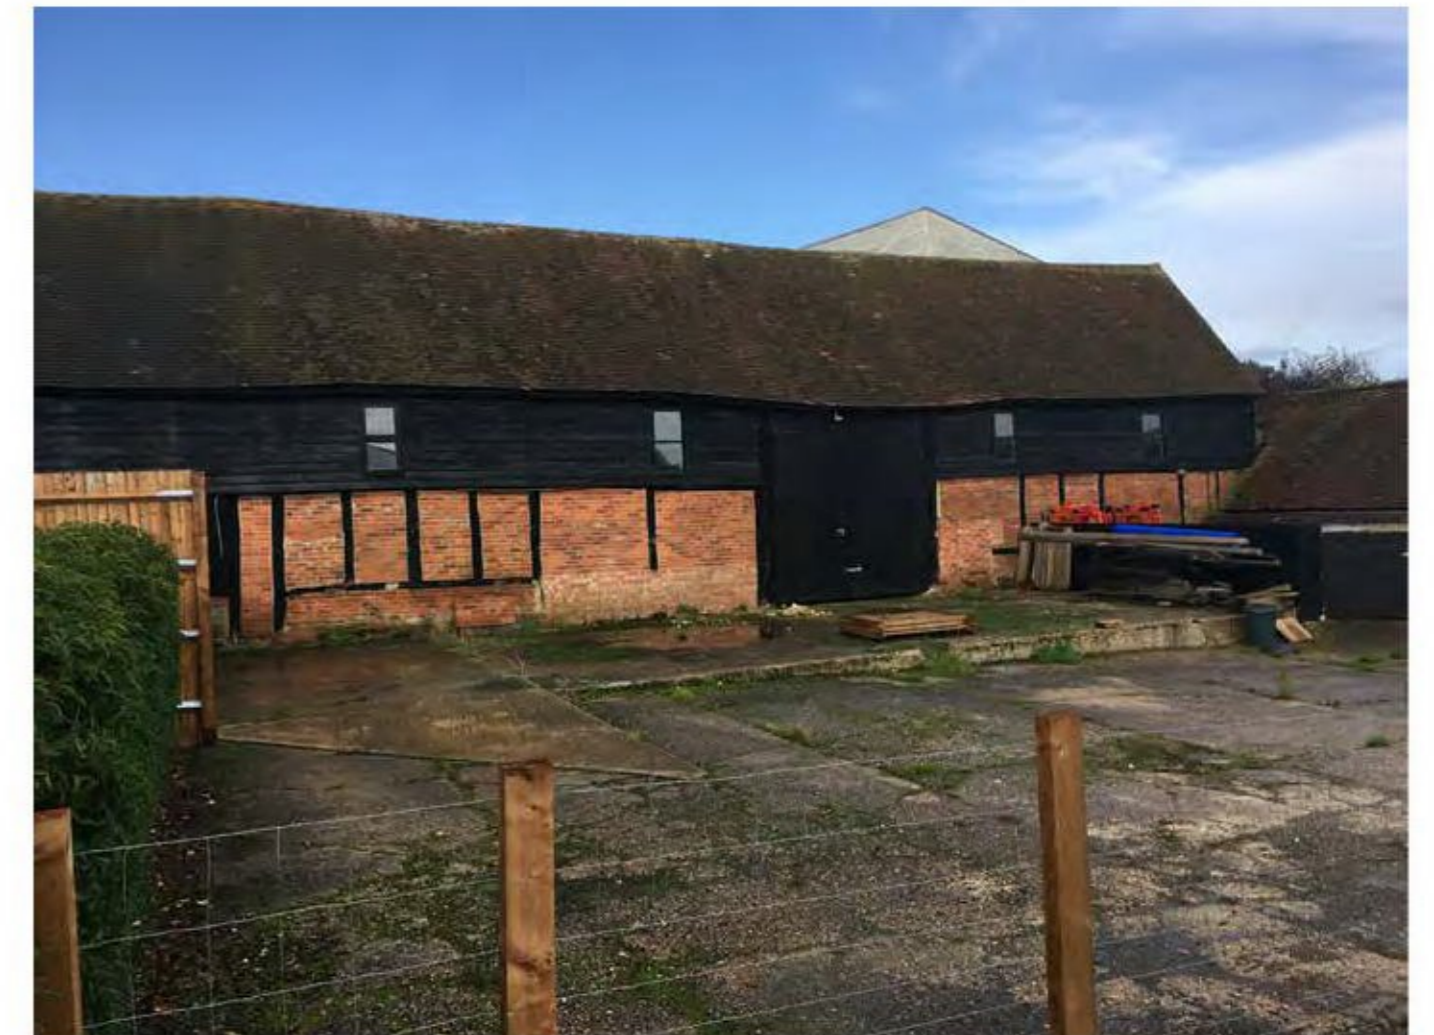
Rear elevation.

The rear elevation indicates how the original timber framing at low level has rotted away and been bricked up rather than repaired. Unfortunately the cement mortar of the brickwork has exacerbated and accelerated the decay of the remaining studs and wall plates. The building also suffers from severe damage to the mixture of trusses. They have structurally failed and this is causing the roof to settle and for 'racking' to occur that threatens the stability of the structure.

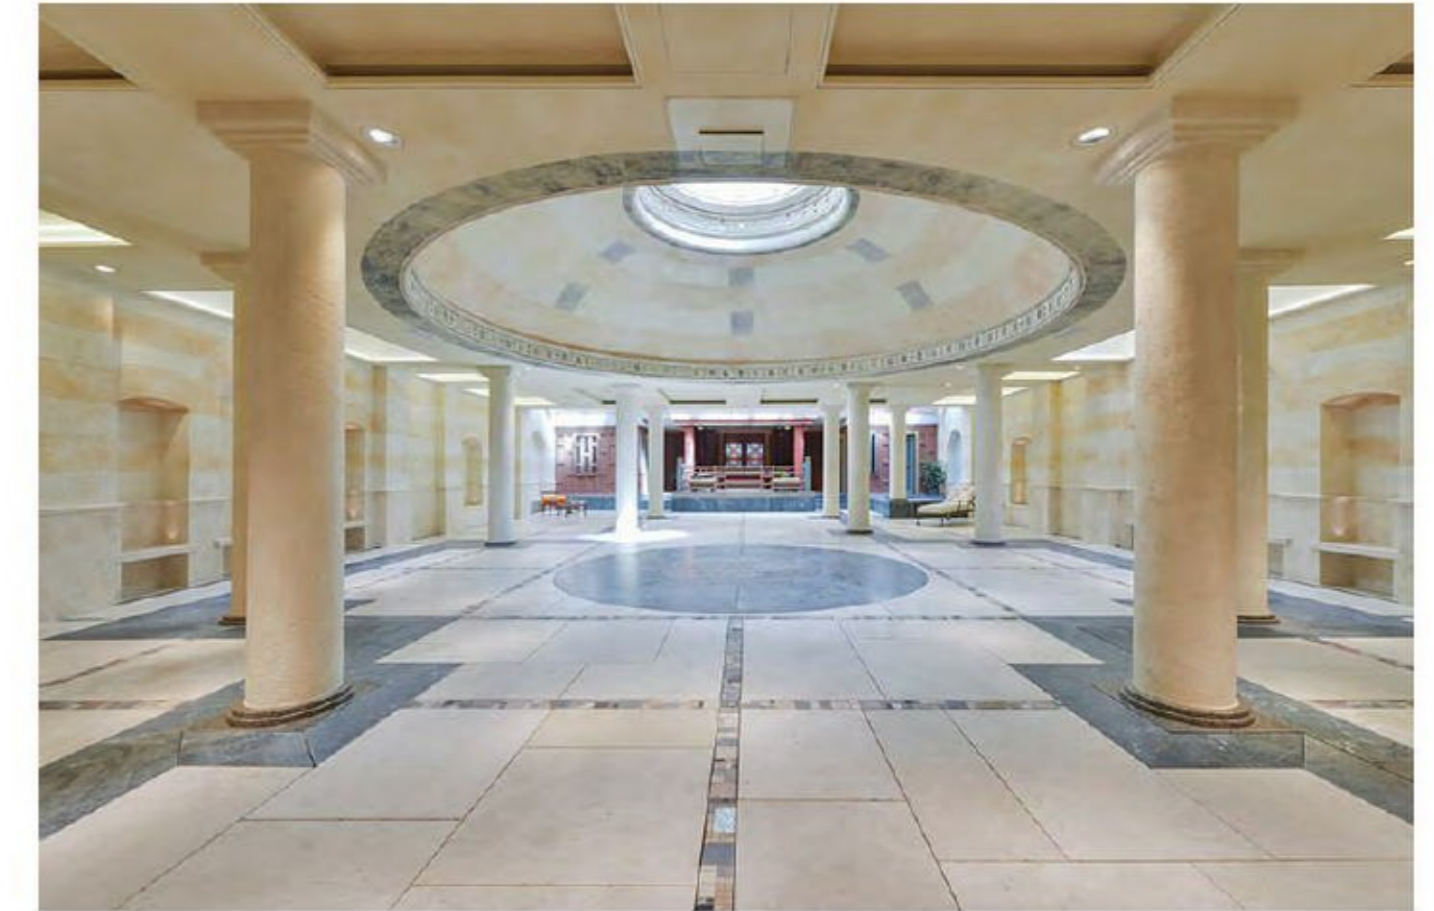
Underground pool with raised floor.

The two photographs of the swimming pool can be seen (1) finished and full of water, and (2) finished with the stone floor raised. This allows the room to be used for different entertaining scenarios rather than just a pool room.

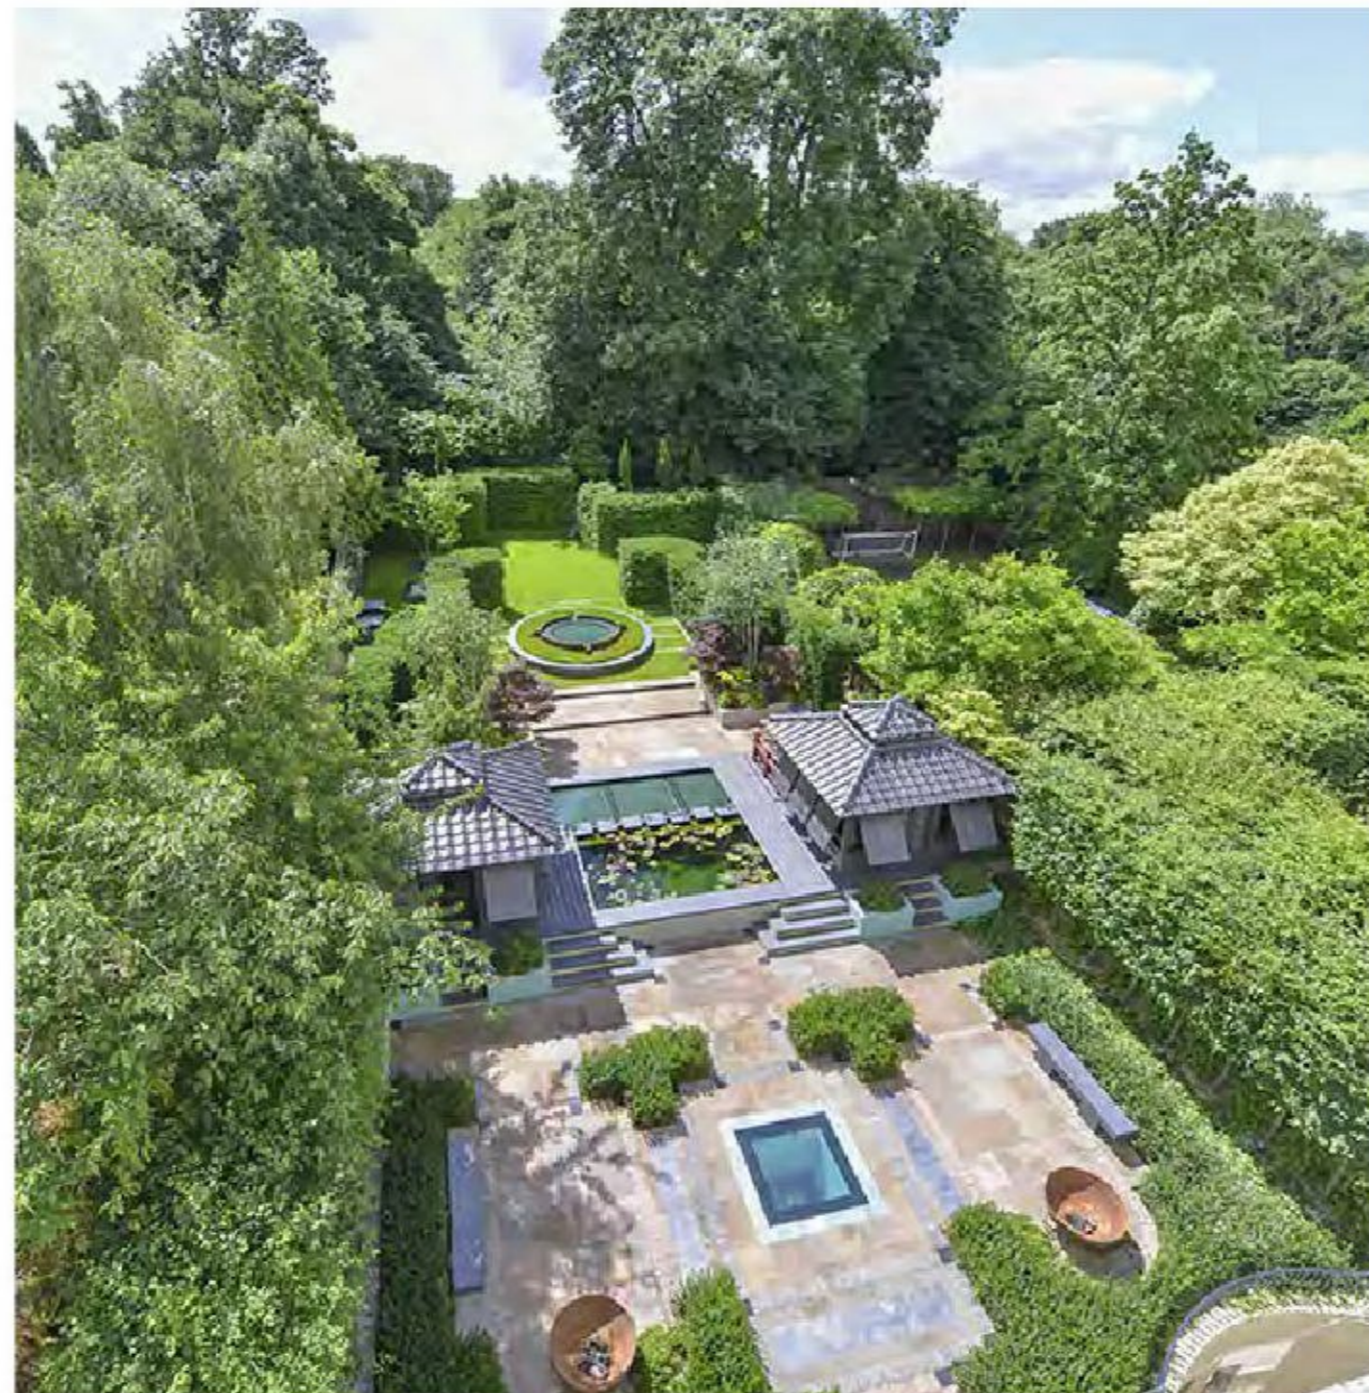
Garden with light wells to illuminate the underground pool.

The pool is lit by the glazed roof lights discretely incorporated within water features in the garden. The interior designer, who was the clients aunt, was responsible for the marble fit-out.

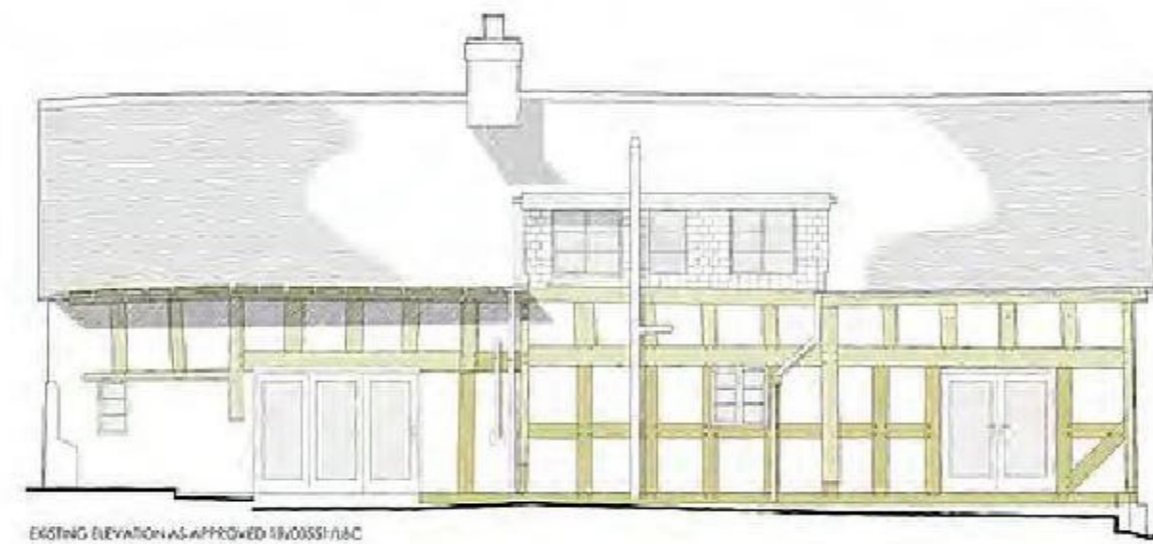
EXISTING ELEVATION AS APPROVED 18/05/21 ABC

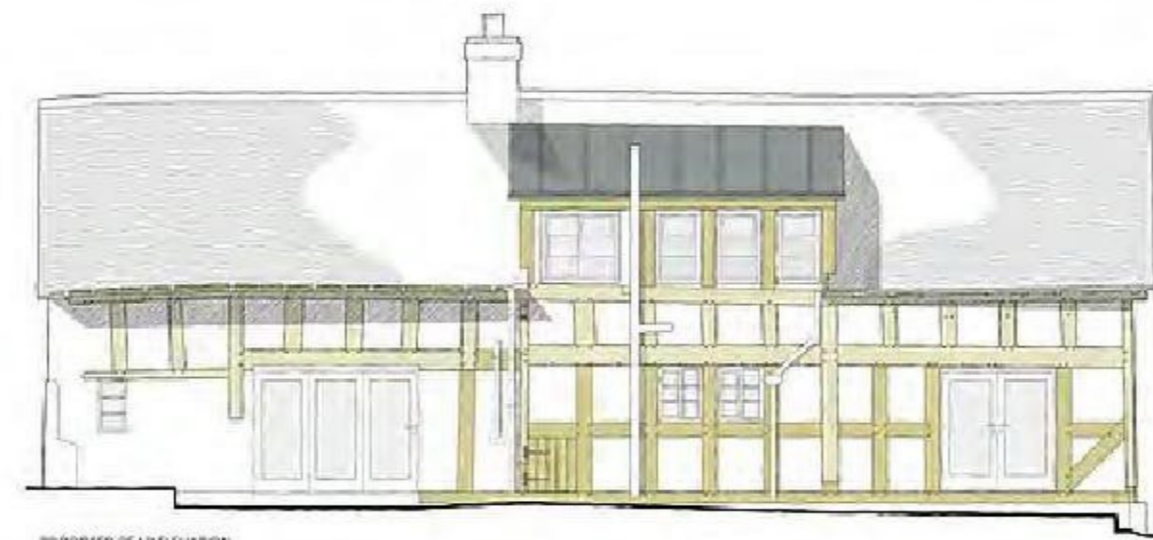
PROPOSED REAR ELEVATION

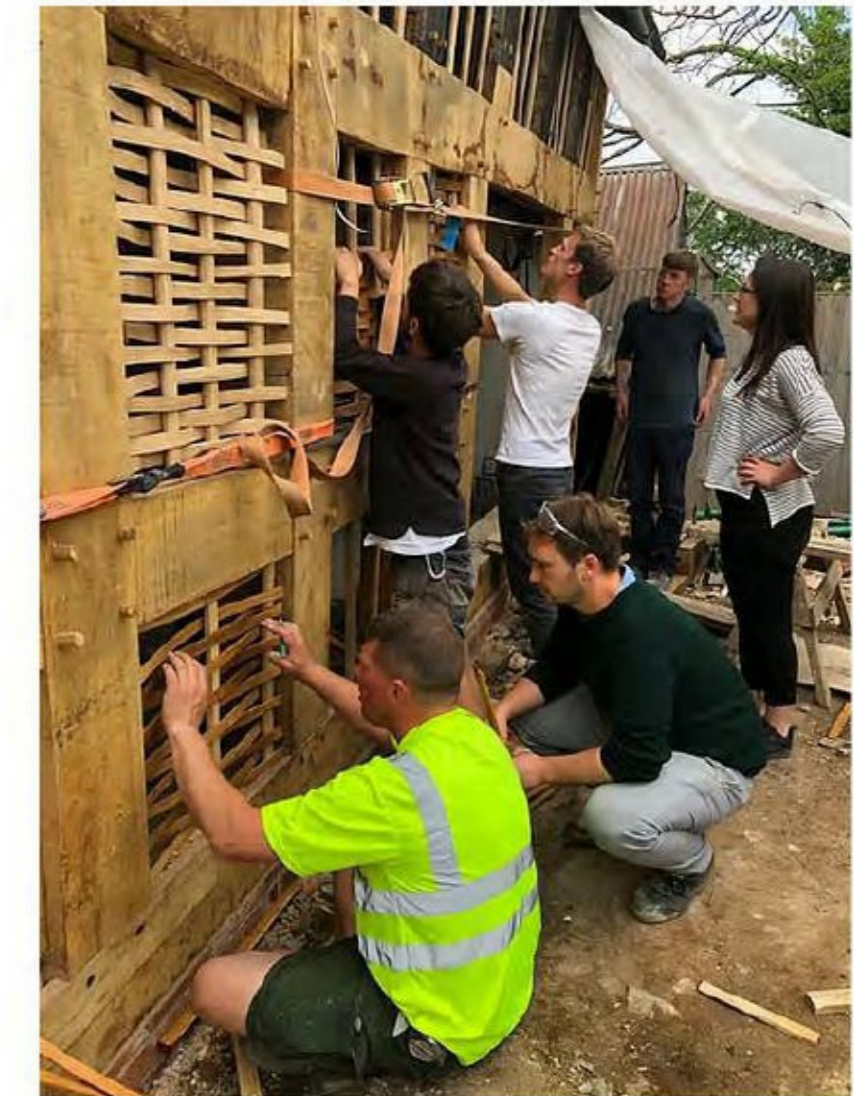
S.P.A.B. Scholars and fellows helping Paul Walters with the installation of wattle and daub panels
