## Ashes Farm, Mendlesham, Suffolk

# Ecological Impact Assessment

**Ref: 1662**

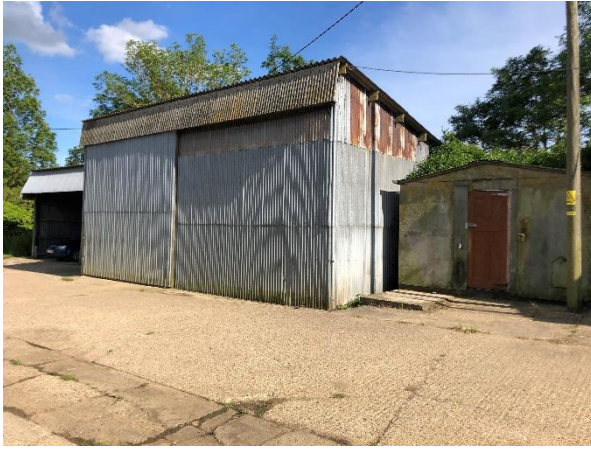
4.18 Half of the building is open fronted to the north, with two sections closed and used to store farm machinery. Adjoining the western wall is a small single storey shed with chipboard sheet walls on a wooden frame, and a corrugated tin roof.

Photo 1: Northern and western facades of B1

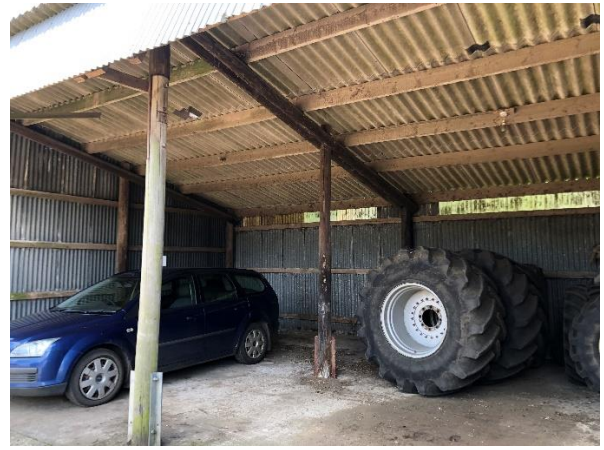
Photo 2: Internal view of B1 open section

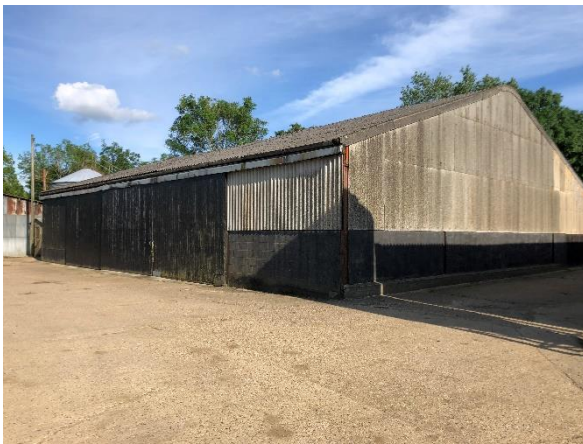
- 4.19 Three Perspex skylights create a very light internal environment, with the building used to store farm machinery at the time of survey. Wooden sliding doors are present on the northern façade.

Photo 3: Building 2, northern and western facades

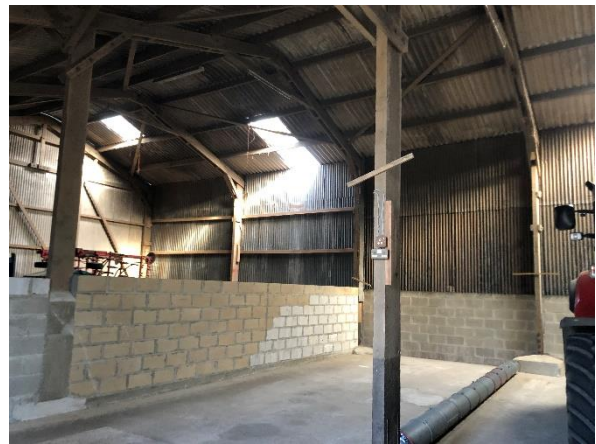
Photo 4: Internal view of B2

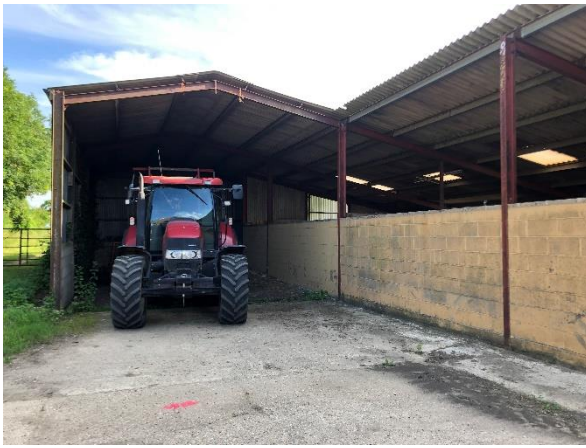
Photo 5: Southern end of B4

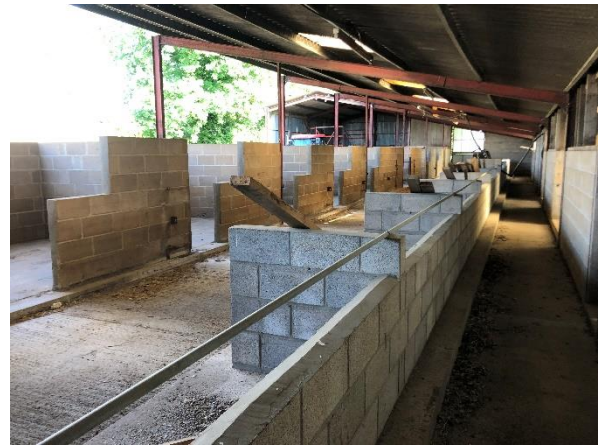
- 4.21 Large building, formerly used to house pigs and divided internally into pig pens by breeze block walls. It is open on one side, and very light and airy internally.

Photo 6: Internal view of B4

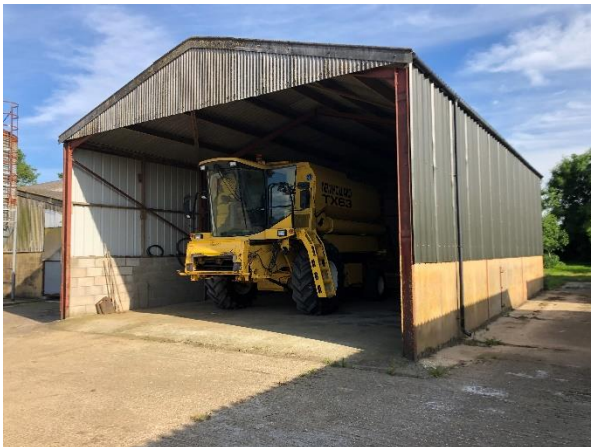
- 4.22 Small, two storey building open to north. Very occasional small (c.5mm) crevices between adjoining beams, easily inspected from ground level.

Photo 7: North western façade of B5

Building	Suitability for roosting bats	Survey / working recommendations
<b>B1-B4</b>	Negligible	None
<b>B5</b>	Negligible to low	Inspect crevices between adjoining beams prior to commencement of works; powerful torch or ladder required
<b>B6</b>	Negligible	None
<b>B7</b>	Negligible to low	Inspect low level loose render on southern gable end prior to commencement of works; endoscope required
<b>B8</b>	Negligible to low	Inspect beneath warped chipboard barge board along the eastern façade prior to commencement of works
<b>B9 – B10</b>	Negligible	None
<b>B11</b>	Negligible to low	Inspect small gap between wooden door frame and surrounding breeze blocks on the south western corner of the building
<b>B12</b>	Negligible to low	Inspect small gap between wooden door frame and surrounding breeze blocks on the south western corner of the building; ladder required
<b>B13 – B14</b>	Negligible	None

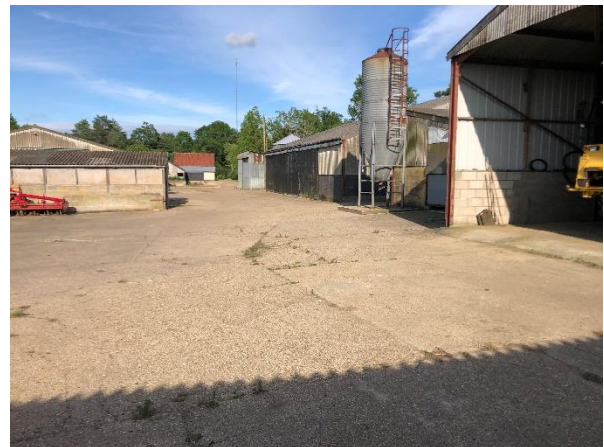
4.7 The vast majority of the areas between and around the buildings comprise concrete hardstanding, in good overall condition with very few cracks or crevices. The farmyard is maintained in a tidy state, with little to no build-up of vegetation or detritus around the base of the buildings. As a result, very little vegetation grows around the buildings or in cracks and crevices.

Photo 8: Concrete farmyard extending north and east from B5

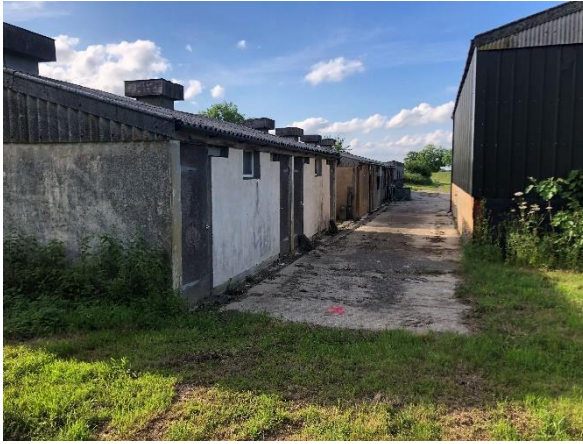
- 4.24 Very similar to Building 6, but the northern half of the building has chipboard external walls and wooden door and window frames, all tightly fitted and in good condition. At the southern end is a small area of loose render at c.400mm height. Inspection revealed the resultant crevice to be filled with dirt, debris and cobwebs.

Photo 9: South eastern façade of B7, with B8 immediately beyond, and B5 to east

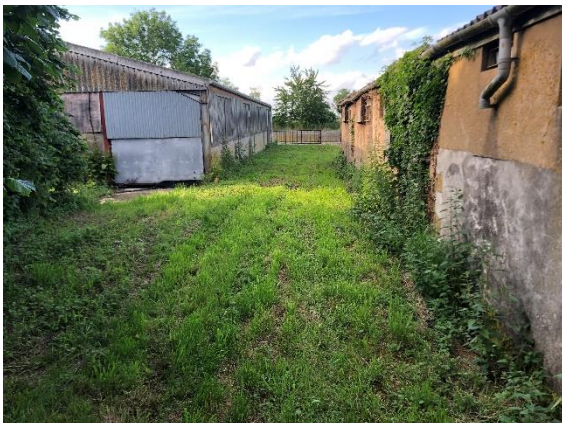
- 4.26 Walls comprise breezeblocks to c.1.5m with vertical wooden slats between here and the single storey eaves. Permanently open to the north and with eight skylights, the internal environment is very light and airy. The south western corner of the building is partially covered with ivy *Hedera helix*.

Photo 11: Southern end of B9, with B8 to east and mown grass between the two buildings

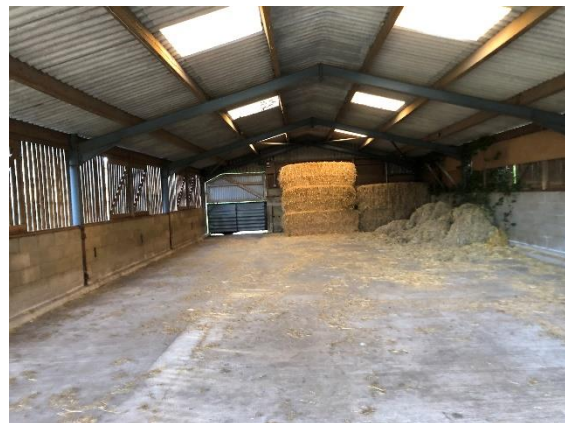
Photo 12: Internal view of B9

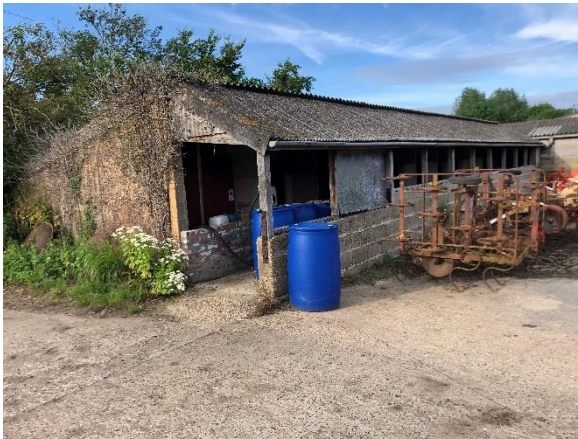
Photo 13: South eastern façade B10

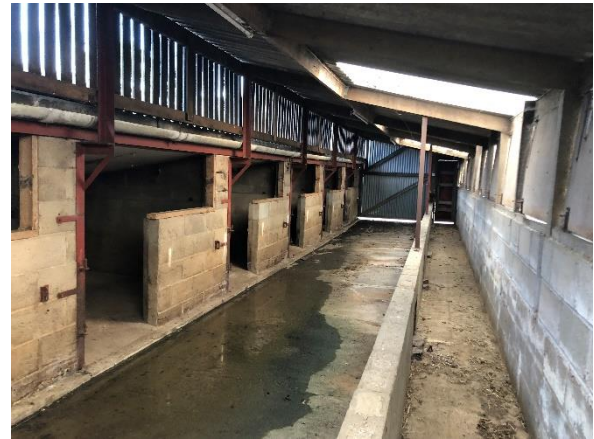
4.28 Single storey building, half of which is a porch providing cover to a concrete walkway. The remainder of the building supports former pig pens. Wooden door and window frames have very minor (<5mm) gaps between here and the surrounding breeze block walls, easily inspected from ground level, and generally full of dirt and debris. At the end of B11, also adjoining B10 is a small corrugated asbestos Nissen hut style building, with an apparent large opening in the roof.

Photo 14: Internal view of B11

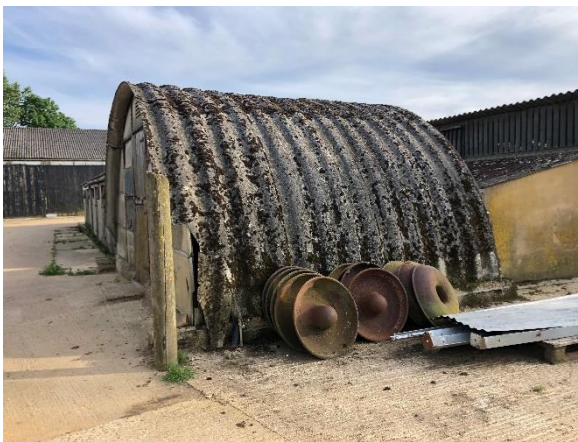
Photo 15: Nissen building at end of B10 and B11

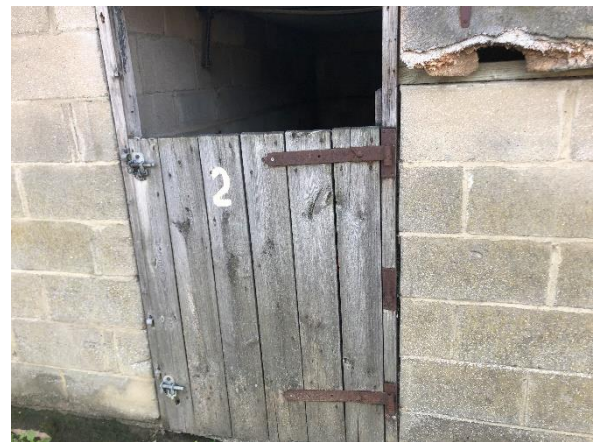
Photo 16: Door on western side of B11, with small gaps around door frame

4.34 A small number of small and / or superficial crevices were noted in Buildings B5, B7, B8, B11 and B12 as described in Table 2, below. None of these features were considered to warrant further survey beyond a precautionary check for the presence of roosting bats immediately prior to removal. Due to the ease with which these features can be thoroughly checked for roosting bats from ground level or with a ladder, the single dusk / dawn survey that current best practice guidelines would require for a building of 'low suitability' for roosting bats is unlikely to be any more effective than the site survey of 26<sup>th</sup> June in determining presence / absence of roosting bats. These buildings are therefore classified as being of negligible to low suitability but do not require any further detailed survey following the absence of roosting bats or any evidence of roosting bats recorded during the building inspection.

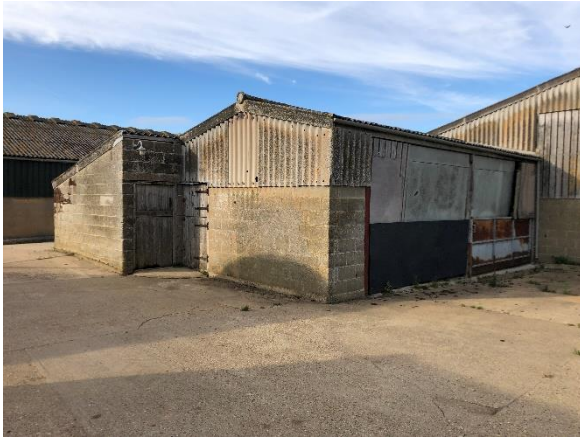
4.30 Modern two storey grain / agricultural store, empty at the time of survey.

Photo 17: South eastern façade of B12

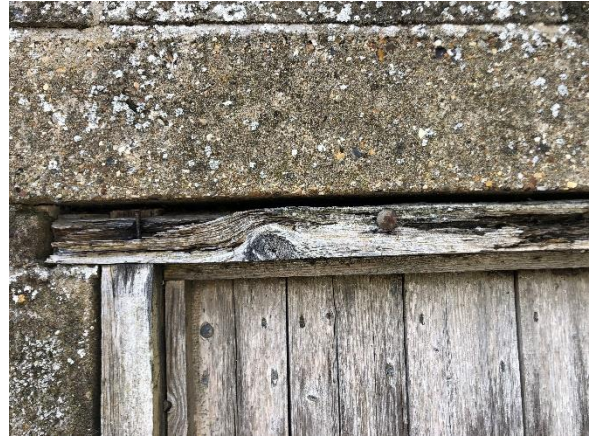
Photo 18: Gap above door frame of B12

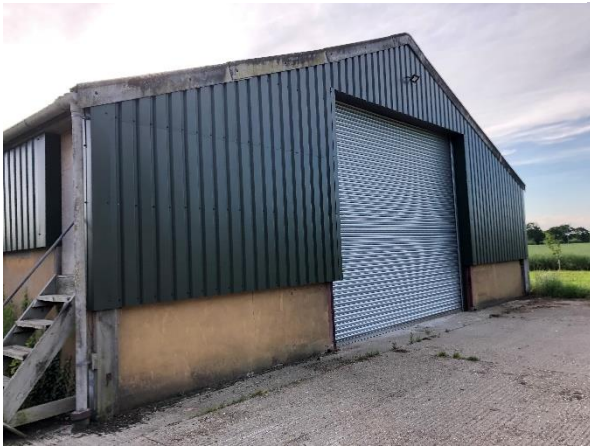
Photo 19: Eastern façade of B13

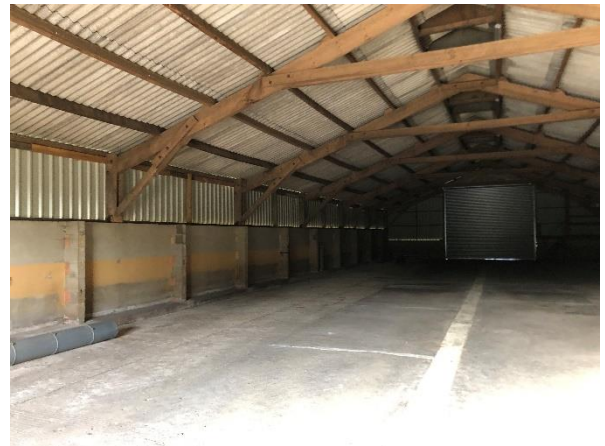
Photo 20: Internal view of B13

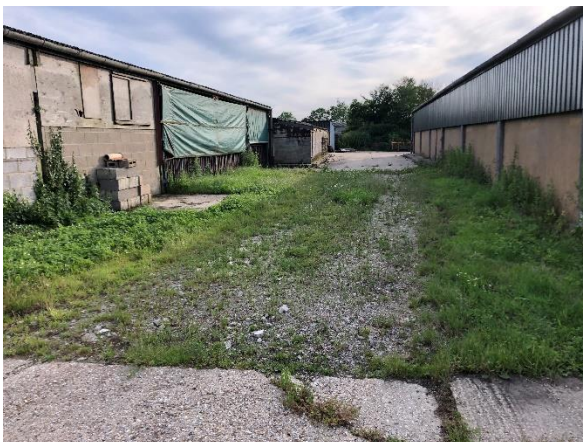
Photo 21: Short vegetation between B13 and B14

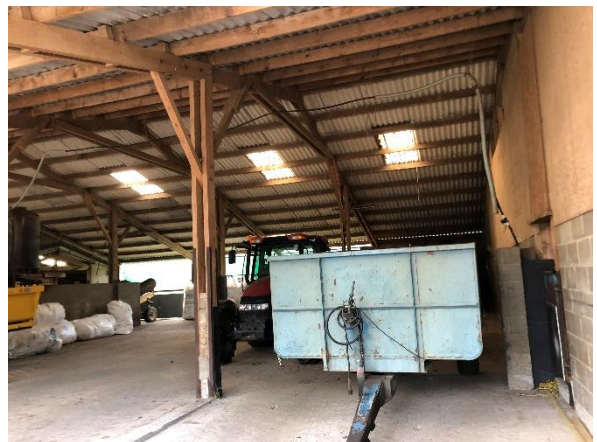
4.31 Two storey modern barn used to store agricultural machinery. Building is open to south, with low metal gates. Similar gates are present on the northern and western façades with plastic mesh and / or tarpaulin above.

Photo 22: Internal view of B14

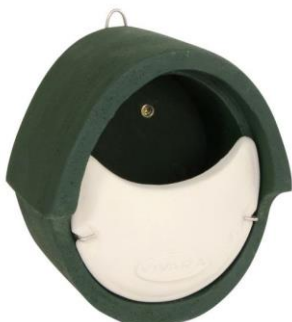
*Woodstone Alicante Nest Box*

*Made of long lasting woodstone; can be fixed with a nail, screw or narrow tree strap*

- 6.2 Two open fronted bird boxes suitable for wrens, robins and blackbirds should be provided in the western retained hedgerow. The boxes should be located at a height of 1-1.5m, in an area of dense vegetation, and facing between north and east. The recommended box type is shown below, and can be fixed with a nail or a strap.

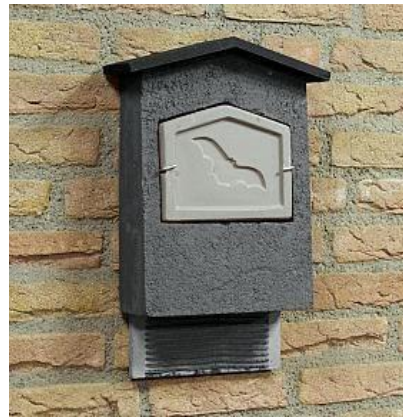
*Beaumaris woodstone bat box midi – for installation on building walls or large tree trunks*

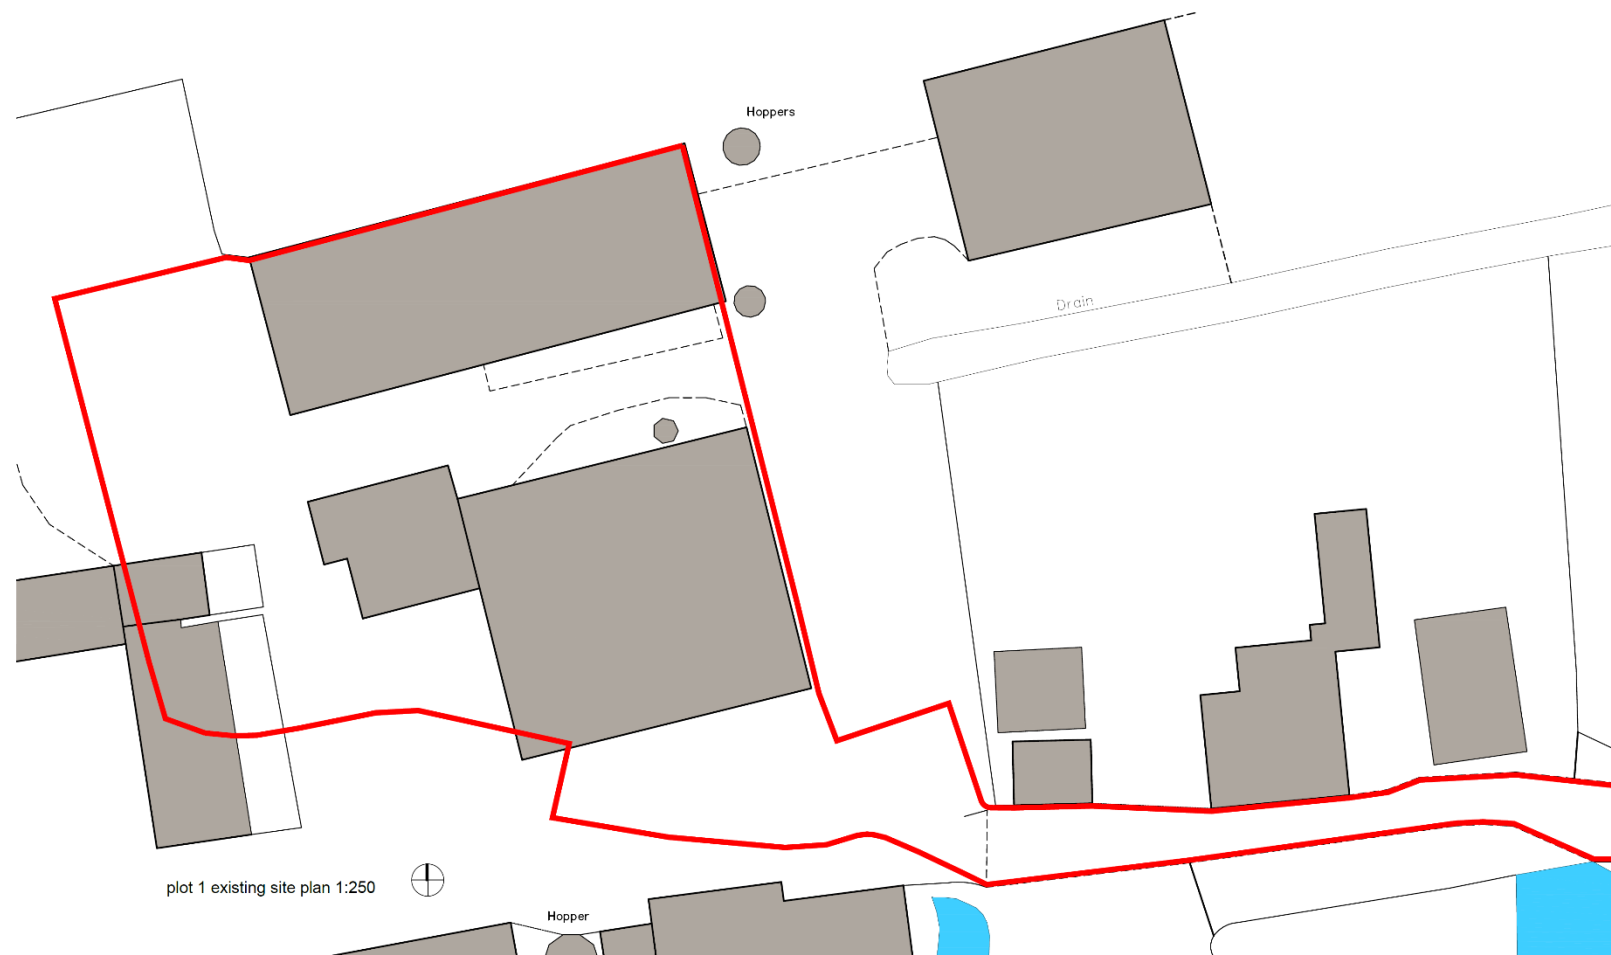
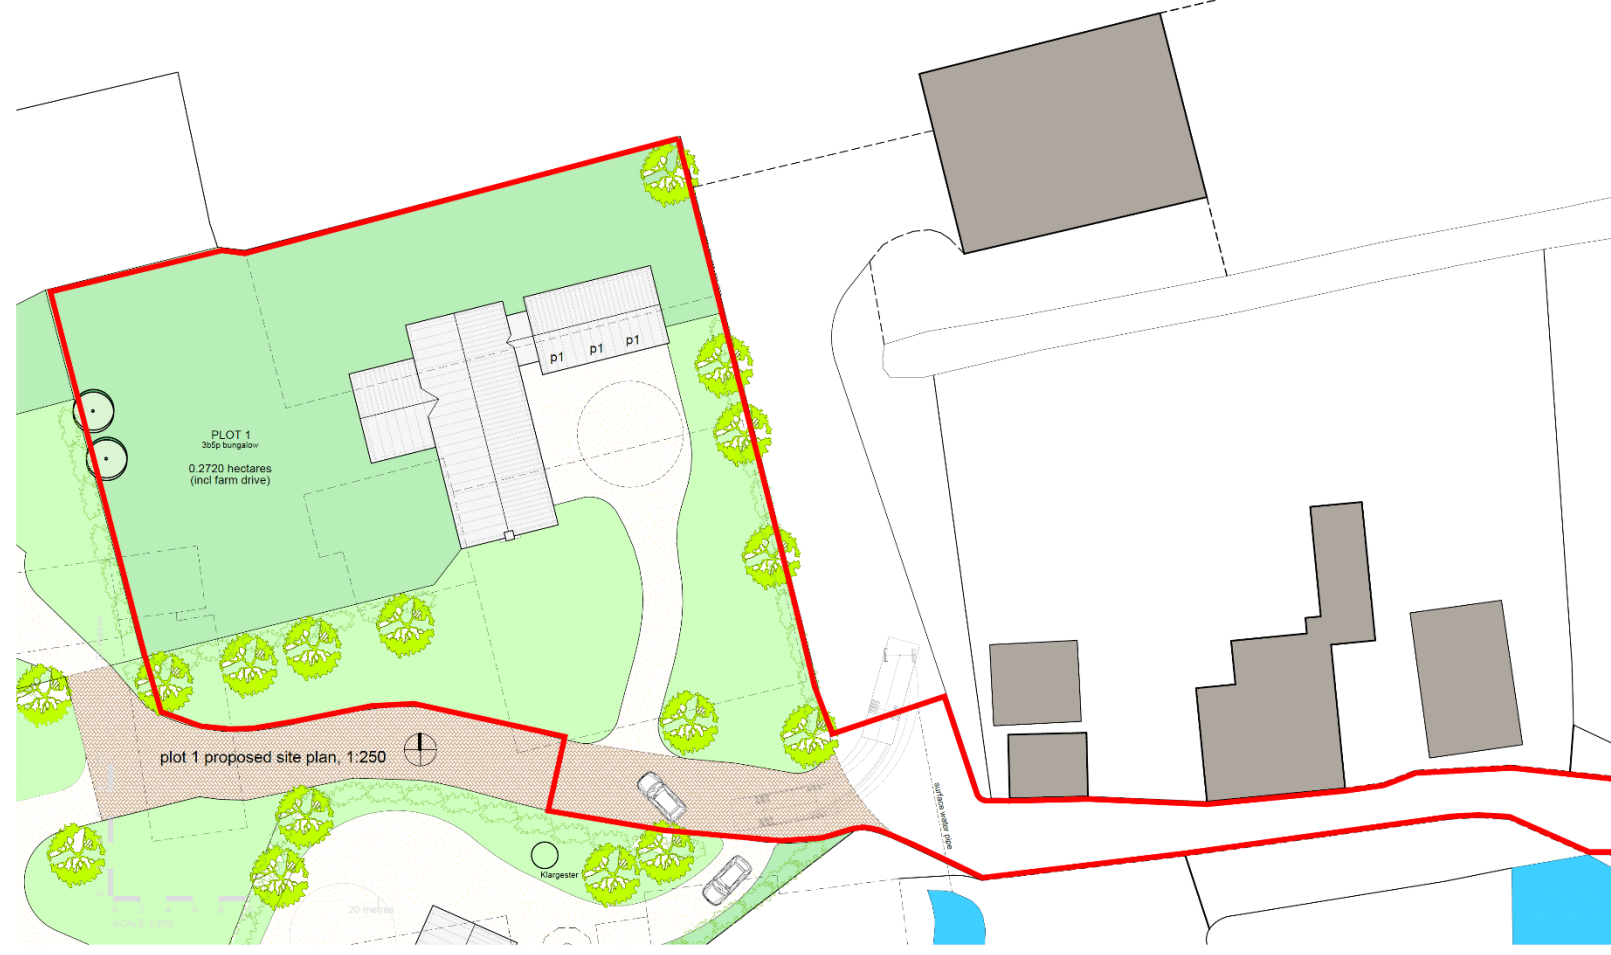
Task	Revision	Description	WPS Drawn	PWS Checked
<b>peterwellsarchitects</b>				
office farm, letteringham, woodbridge, suffolk, ip13 3ra - 01728 745356 - info@peterwellsarchitects.co.uk				
Project:	Ashes Farm, Oak Farm Lane, Mendlesham, Stowmarket, Suffolk, IP14 5TE			
Dwg Title:	Plot 1, Existing & Proposed Site Plan & Location Plan			
Client:	Simon Colchester	Dwg Status:	Planning	
Date:	Sep 2021	Scale:	1:250, 1:1250 @ A1	Dwg No.: PW1056_PL100
		Revision:	/

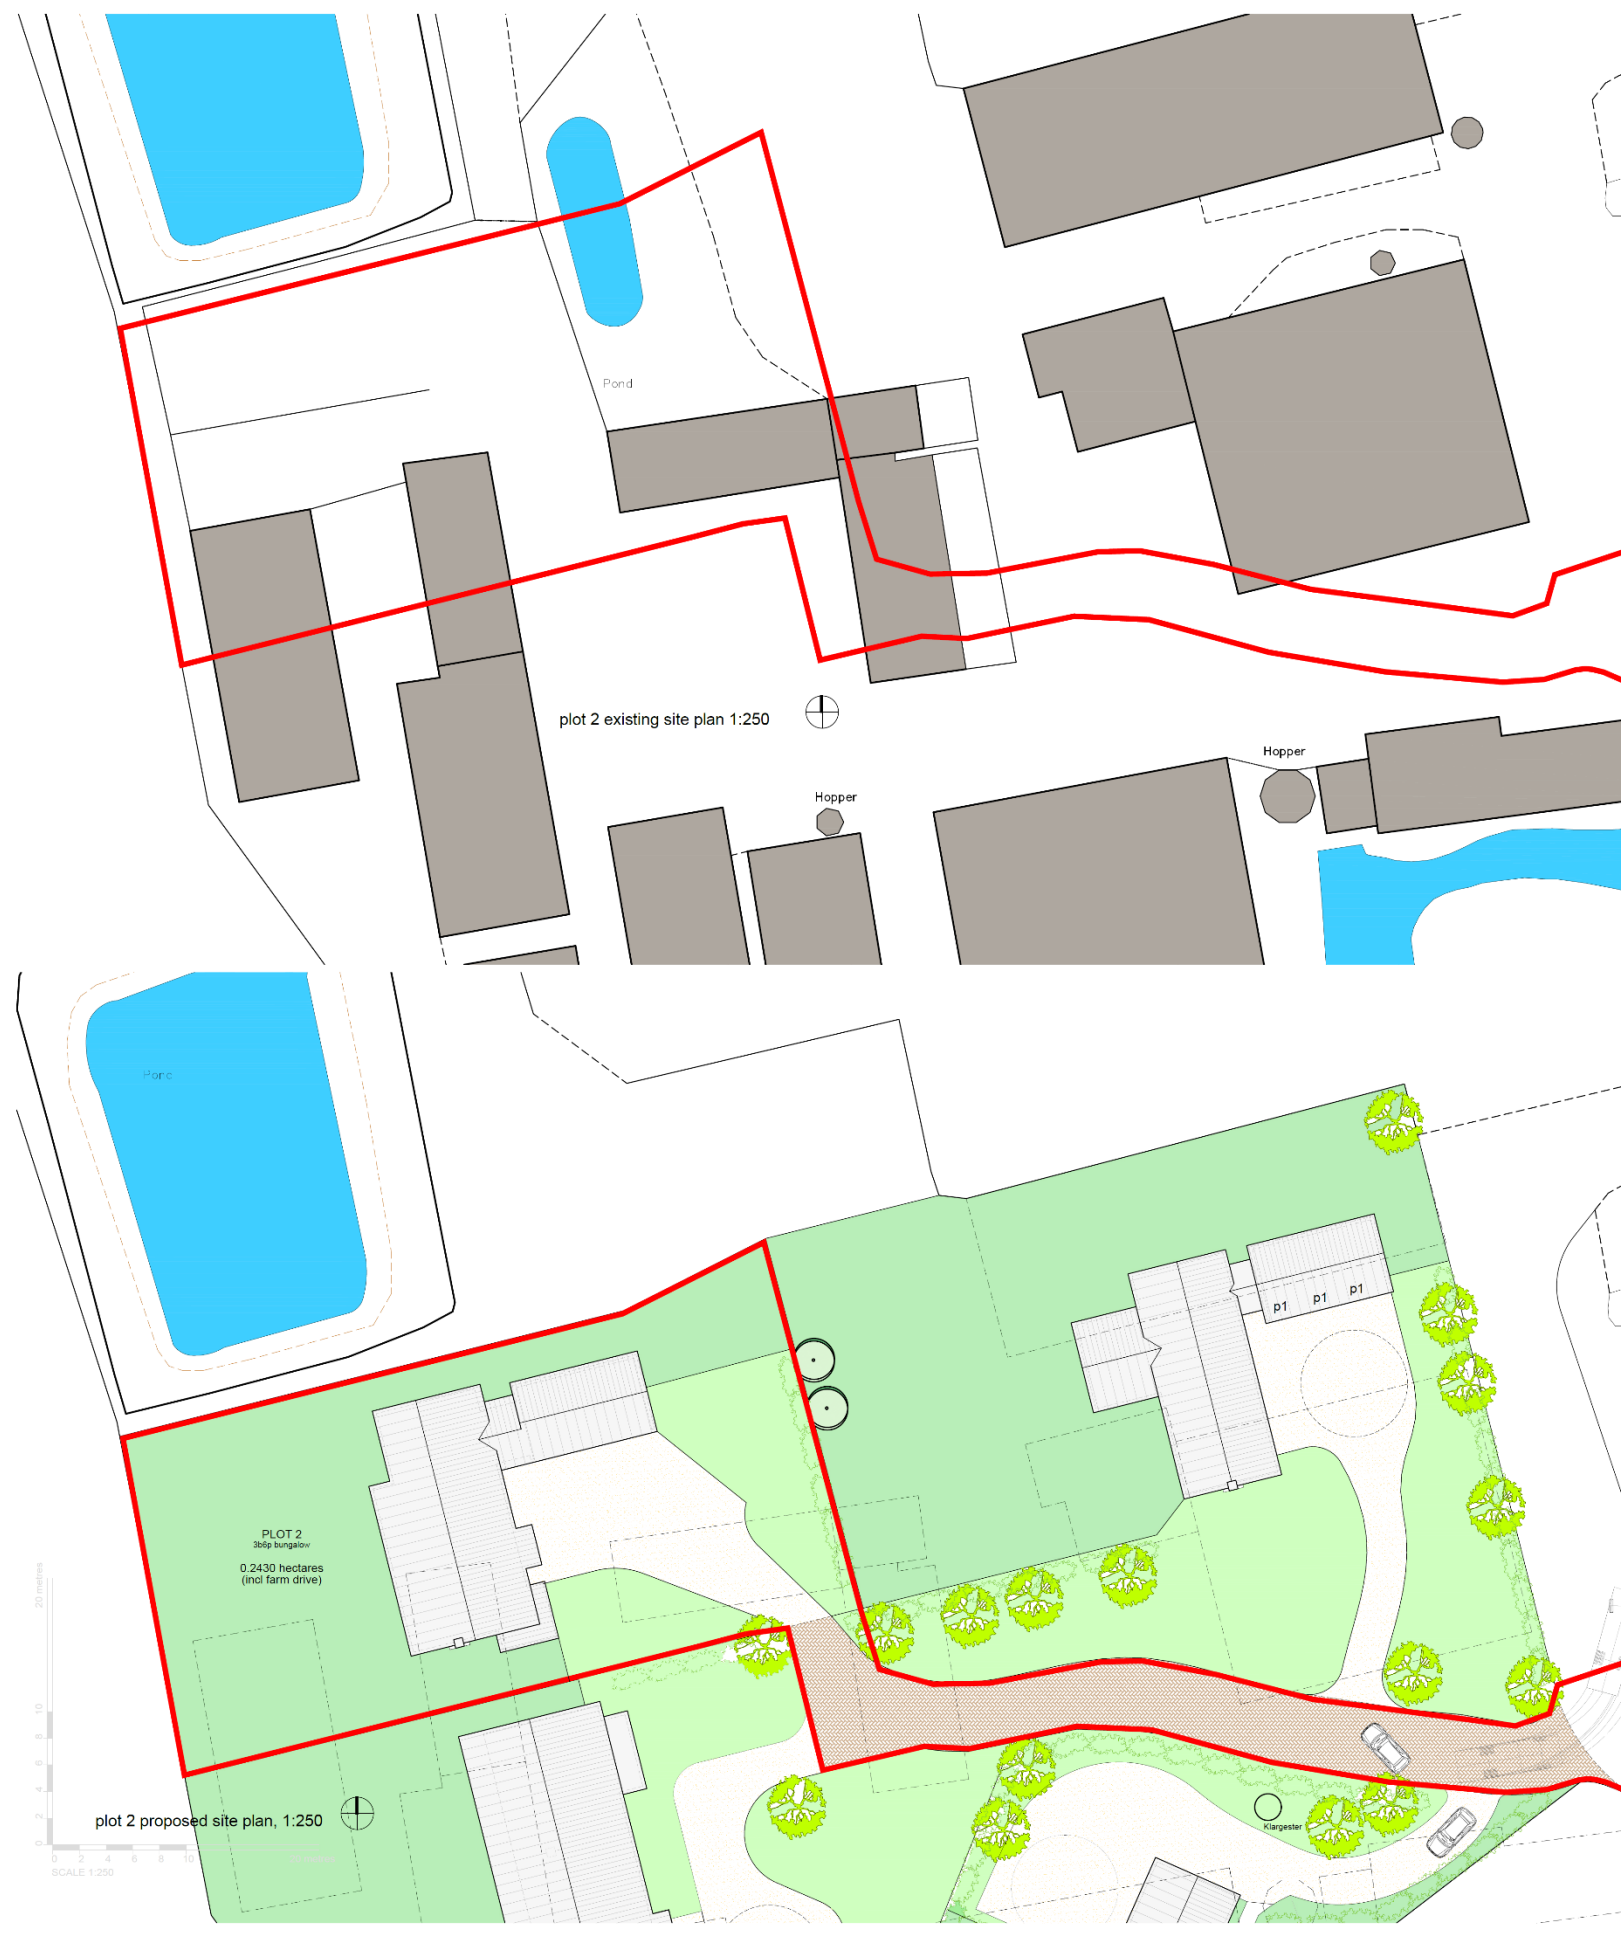
Date	Revision	Description	mmg	PW
			Drawn	Checked
<b>peterwellsarchitects</b>				
office farm, Itheringham, Woodbridge, Suffolk, IP13 7RA - 01728 745356 - info@peterwellsarchitects.co.uk				
Project: <b>Ashes Farm, Oak Farm Lane, Mendlesham, Stowmarket, Suffolk, IP14 5TE</b>				
Dwg Title: <b>Plot 2, Existing &amp; Proposed Site Plan &amp; Location Plan</b>				
Client: <b>Simon Colchester</b>			Dwg Status: <b>Planning</b>	
Date: <b>Sep 2021</b>	Scale: <b>1:250, 1:1250 @ A1</b>	Dwg No: <b>PW1056_PL200</b>	Revision: <b>/</b>

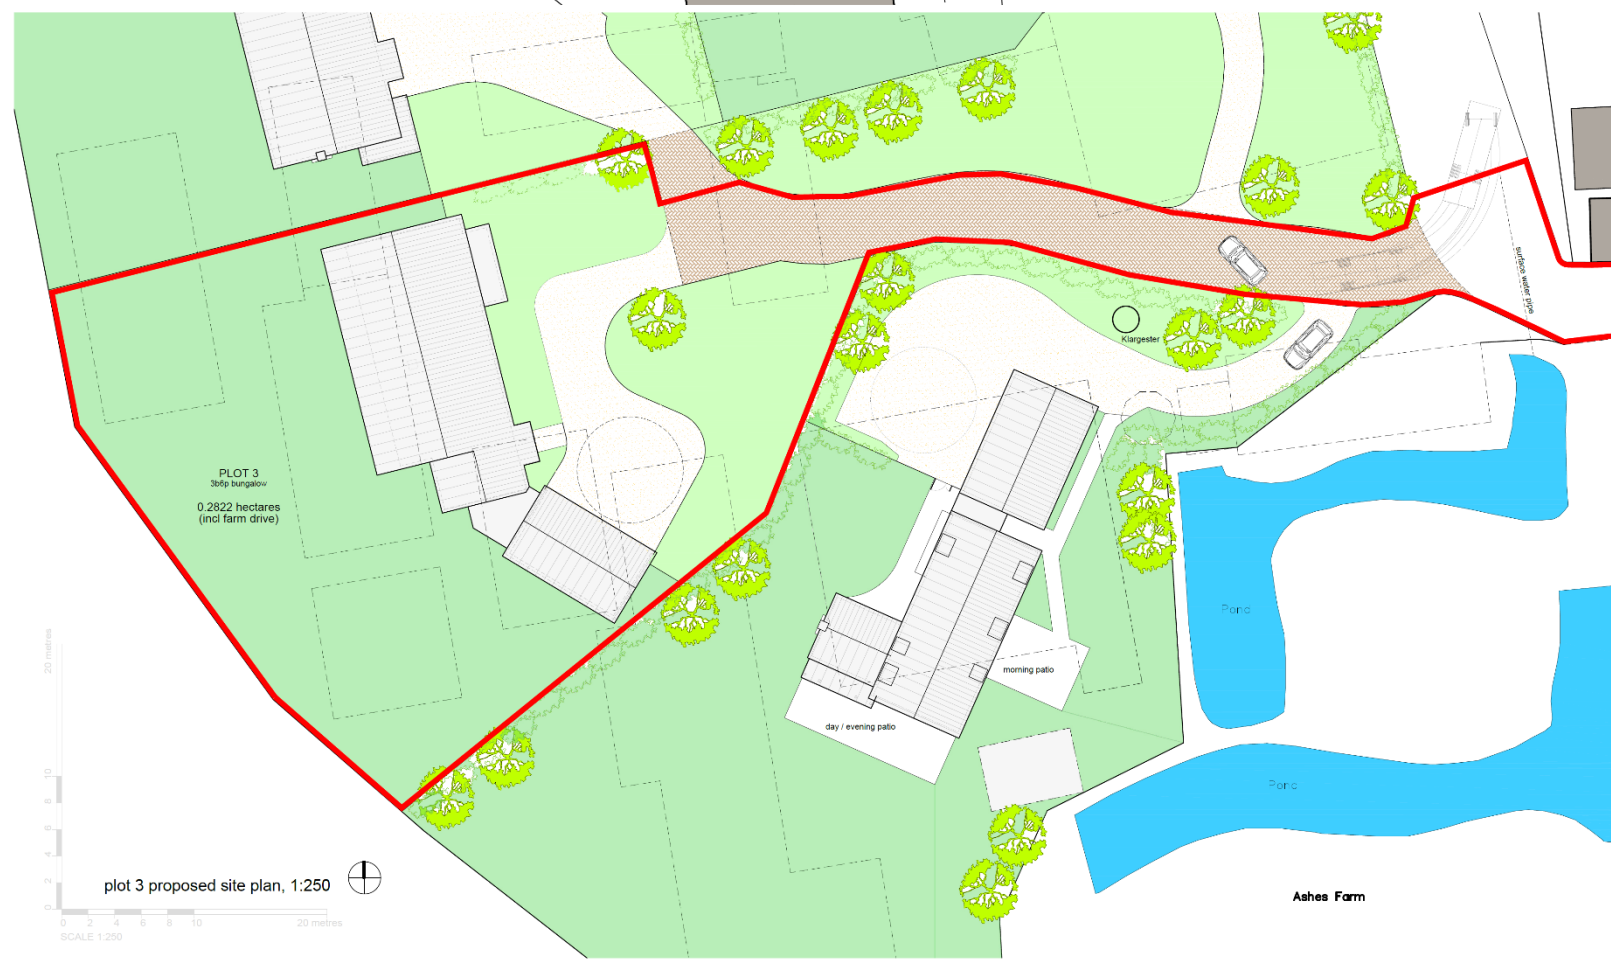
Date	Revision	Description	MD	PW
			Drawn	Checked
<b>peterwellsarchitects</b>				
office farm, letheringham, woodbridge, suffolk, ip13 1ra - 01728 745356 - info@peterwellsarchitects.co.uk				
Project	Ashes Farm, Oak Farm Lane, Mendlesham, Stowmarket, Suffolk, IP14 5TE			
Dwg. Title	Plot 3, Existing & Proposed Site Plan & Location Plan			
Client	Simon Colchester	Dwg. Status	Planning	
Date	Sep 2021	Scale	1:250, 1:1250 @ A1	Dwg. No.: PW1056_PL300
		Revision	/

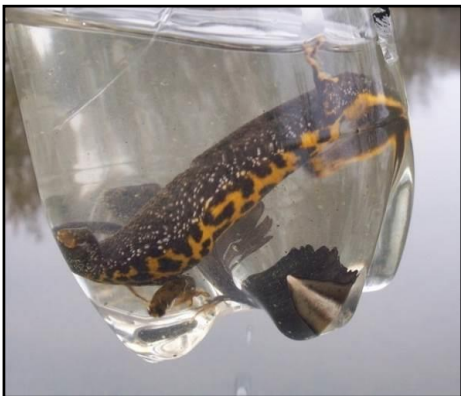
Female Great Crested Newt

Great crested newts: these newts are **noticeably black to very dark brown** in colour, with a warty texture to their skin. Some of the warts are white, accentuating the warty and slightly speckled appearance. In spring male newts have a white stripe along the centre of their tail, and females have an orange stripe at the end of their tail. The bright orange-yellow belly colouring extends fully to join with the dark upper skin tone.

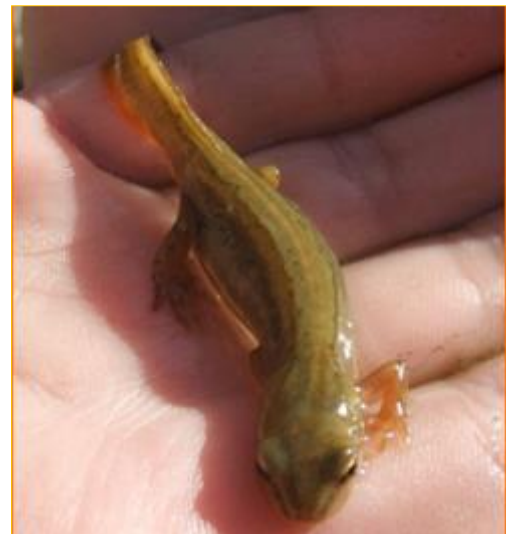
Female Common Newt

By contrast, common or palmate newts are a lighter brown-green colour and are significantly smaller (up to 9cm in length, whilst great crested newts may be up to 15cm in length). **Both common and great crested newts have an orange-yellow belly with black spots**; however the orange colouring fades towards the edges of the belly of common newts. Both males have crests in the spring.

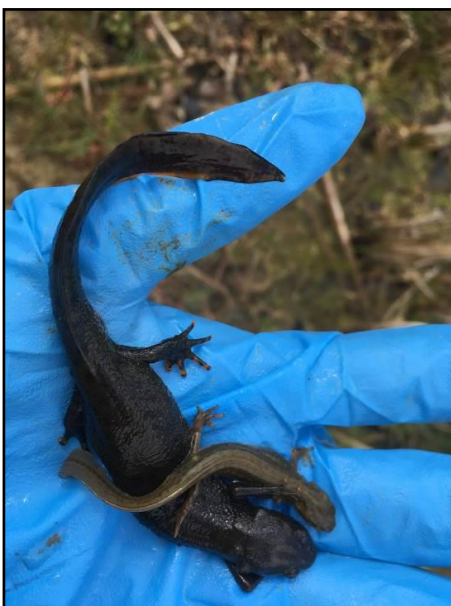
Female Great Crested Newt & Smooth Newt

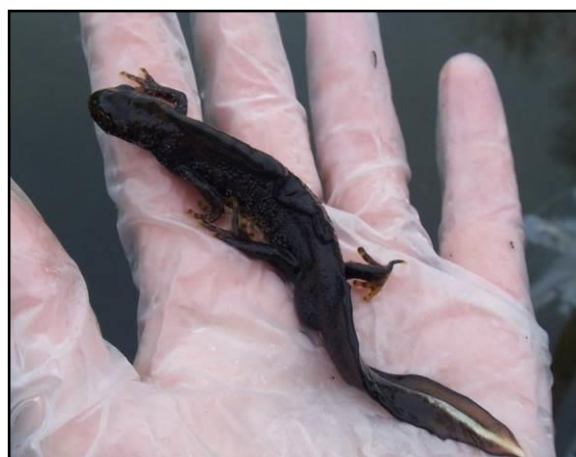
Male Great Crested Newt
