Ashes Farm, Meddlesham, Newmarket, IP14 5TE

PHASE I – Contaminated Land Assessment

Site Name & Address:	Ashes Farm, Oak Farm Lane, Mendlesham, IP14 5TE
Client:	Mr Simon Colchester
Architect:	Peter Wells Architects
Local Planning Authority:	Babergh and Mid-Suffolk District Councils
Historical Site Use:	Agricultural land
Present Site Use:	Agricultural barns
Proposed Site Use:	Residential development (4No.)
Date of most recent investigation:	Tuesday, 2 nd December 2019 - Site walkover
Objectives:	
<ul style="list-style-type: none"> ▪ To develop a good understanding of the site's history and environmental context; ▪ To determine the potential existence of any significant pollutant linkages which might represent a potential risk to construction workers, future occupants of the site or controlled waters; ▪ To undertake a Tier 1 'Contaminated Land' investigation in accordance with CLR11 and guidance contained in the NHBC Publication 66: 2008. 	
Geology, Hydrogeology & Hydrology:	
<ul style="list-style-type: none"> ▪ Based on the BGS online mapping, the site is likely to be underlain by Lowestoft Formation – Diamicton and Crag Formation – Sand; ▪ The BGS borehole[TM16SW4] is located appr

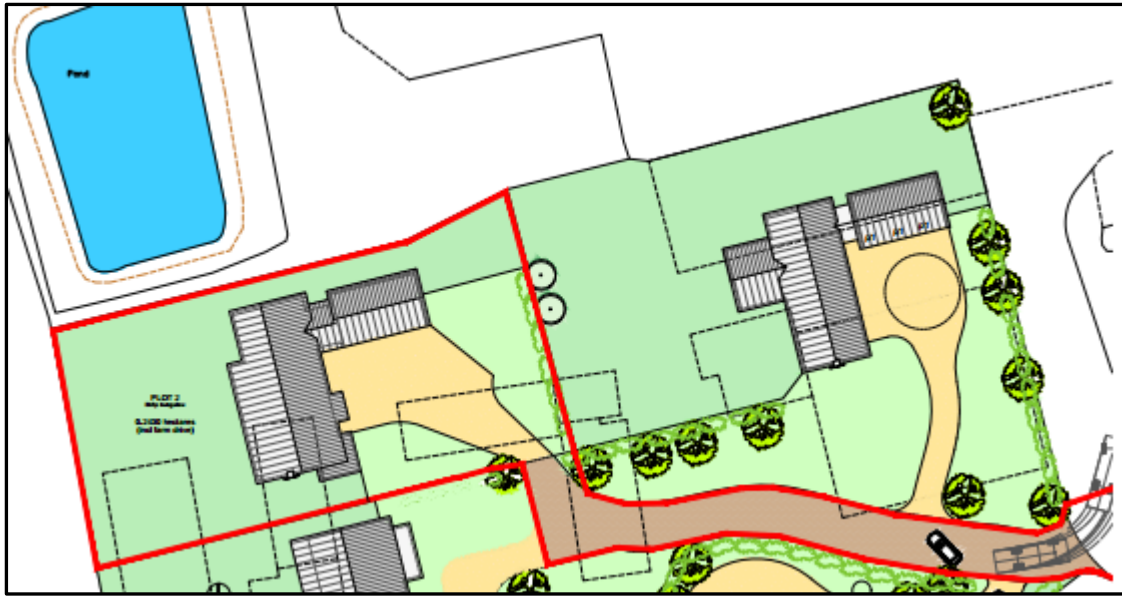
Figure 2 – Extract from Architectural Layout- Plot 2

2.02.6 The section of farmyard, which will be redeveloped as Plot 2 is currently occupied by is a single storey steel framed barn, wooden purlins and with concrete block walls. The barn is currently used to store hay. Beyond the barn is an unlined pond used for farm effluent and a separate building with a fuel tank enclosed in concrete blockworks. Immediately north of the third barn is an area of

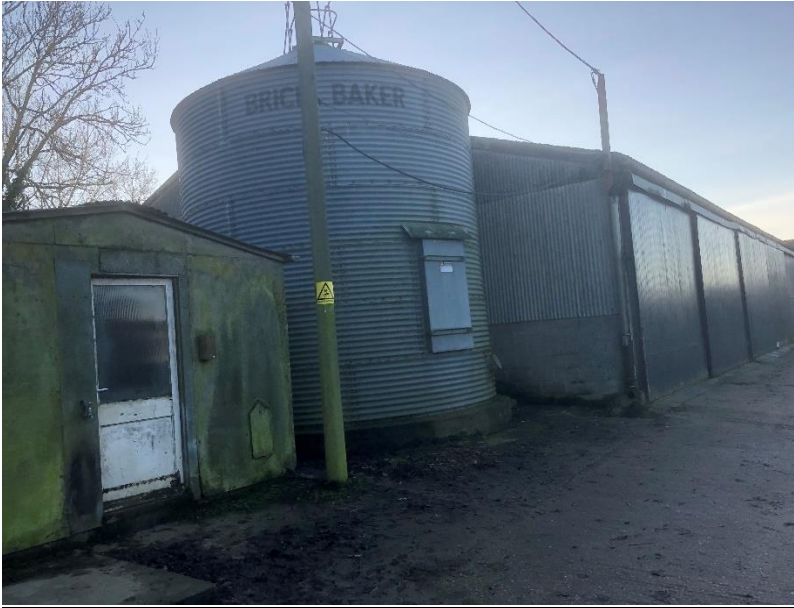
2.02.3 The section of farmyard, which will be redeveloped as Plot 4 is currently occupied by a barn constructed of wood and steel frame, blockwork walls and asbestos cladding. This building is subdivided into 4 No. sections. The first section facing the yard is used for storage of agricultural silos and the second section for grain and agricultural machinery. In the south western quadrant, there were a range of tractor mountable implements and next to this a waste oil holding area. This was laid to concrete with a raised edge, forming a 'bund'. A number of oil drums and a metal storage container for oils were stored in this feature. The south western section is a workshop, used for general storage and vehicle maintenance with a vehicle inspection pit. In a separate building to the east, is room with an enclosed metal storage container used for pesticides and herbicides. Figure 5 below shows an internal layout of the barn. An adjacent building to the barn will also need to be demolished in order to create garden land for this plot.

**Photograph 1 – Browns Barn to the east with
Asbestos concrete cladding on the side**

5.03 Although not related to the condition of the on-site soils, we would recommend undertaking HSG264 Pre-demolition/ major refurbishment asbestos survey on the existing building. All identified asbestos containing materials (ACMs) should then be removed, by a suitably experienced contractor, prior to the demolition/ conversion of the buildings.

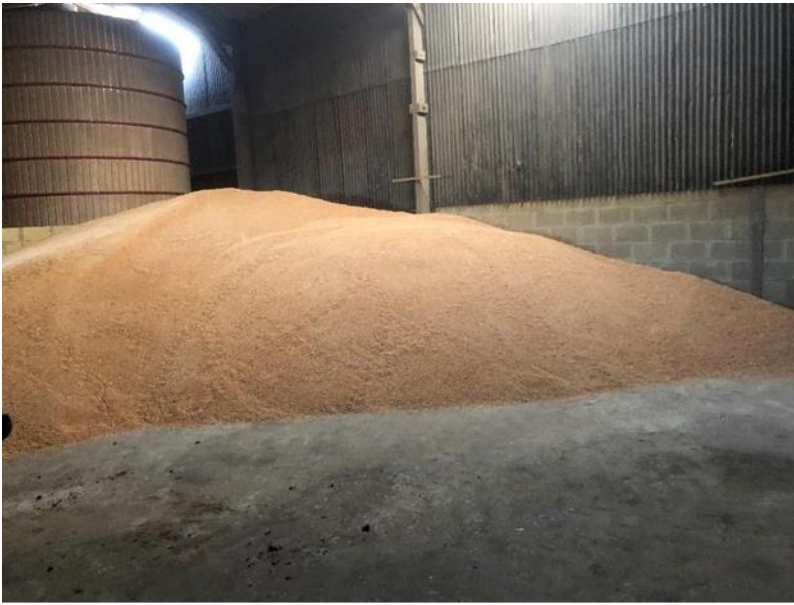
Photograph 2 – inside the Browns barn with silos and farm produce (Corn)

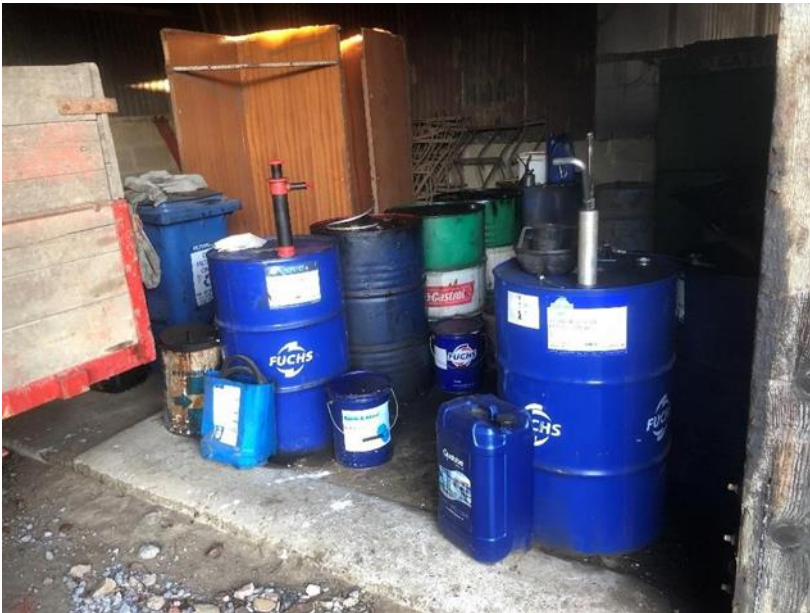
Photograph 4 – oil drum storage in South western quadrant of Browns Barn

4.04.1 We would recommend that a site investigation is undertaken following the removal of the hardstanding particularly in the vicinity of the workshops and waste oil storage area, to determine whether any of the previous on-site activities have adversely impacted the on-site soils. Due to the presence of suspected asbestos containing materials, we would recommend that these materials are removed from site by an experienced and competent contractor prior to any demolition works.

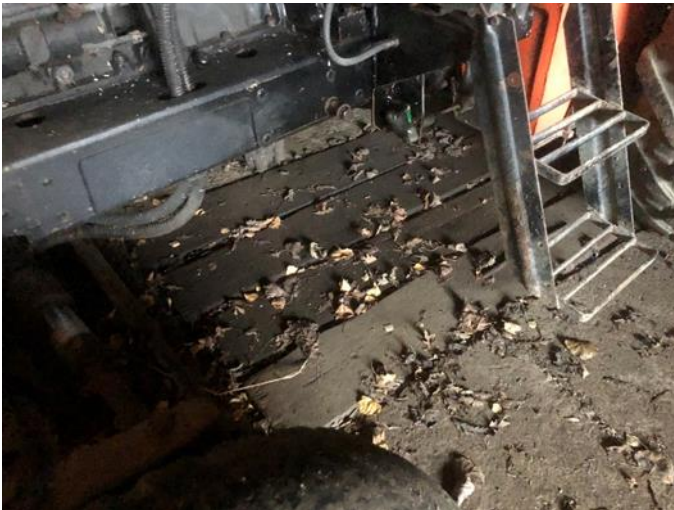
Photograph 6 – Vehicle Inspection pit in the south eastern quadrant of Browns Barn

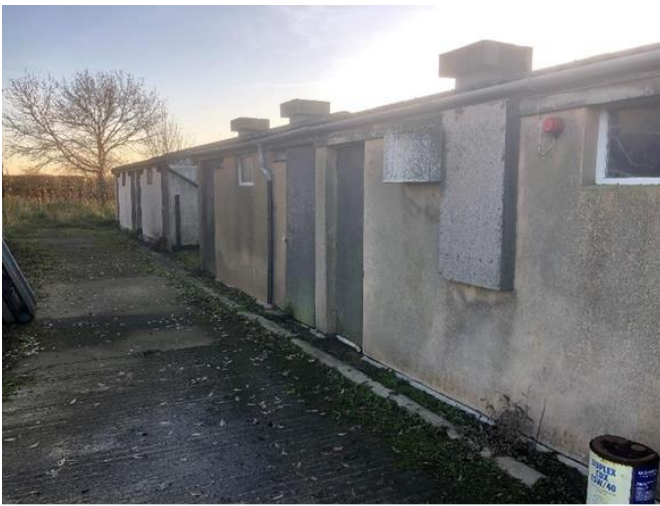
2.02.4 The section of farmyard, which will be redeveloped as Plot 3 is currently occupied by an open fronted barn structure, comprising a steel and timber frame, concrete blockwork to 1.5m and metal sheet cladding over. The floor comprises a substantial concrete slab which is in good condition. The barn is used for storage of agricultural machinery. To the west of the building are a collection of single storey former piggery units, which at the time of our inspection contained empty spray containers and remains of a farrowing unit.

Photograph 10- former Piggery unit used to store spray empty containers

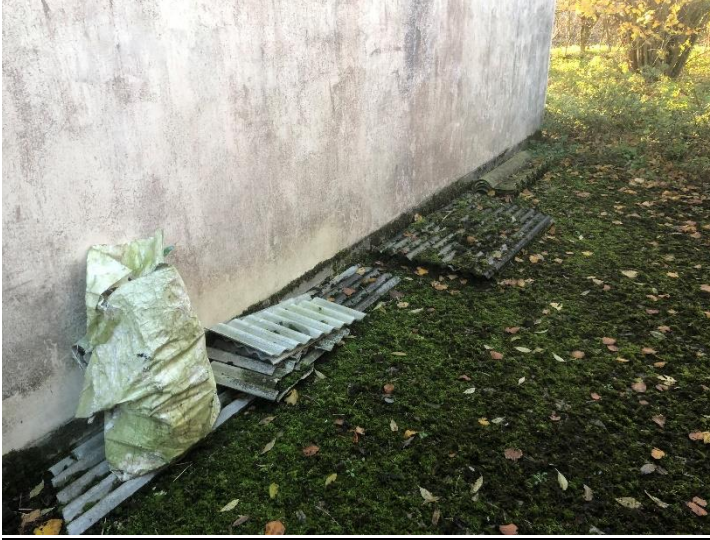
2.02.5 Between the former piggery buildings, the ground is laid to concrete hardstanding and in one of the gaps was a tidy stockpile of corrugated asbestos cement sheeting and ridge pieces. The cement sheet appeared to be in good condition and not fragmented.

Photograph 11- stockpile of Asbestos containing roof tiles

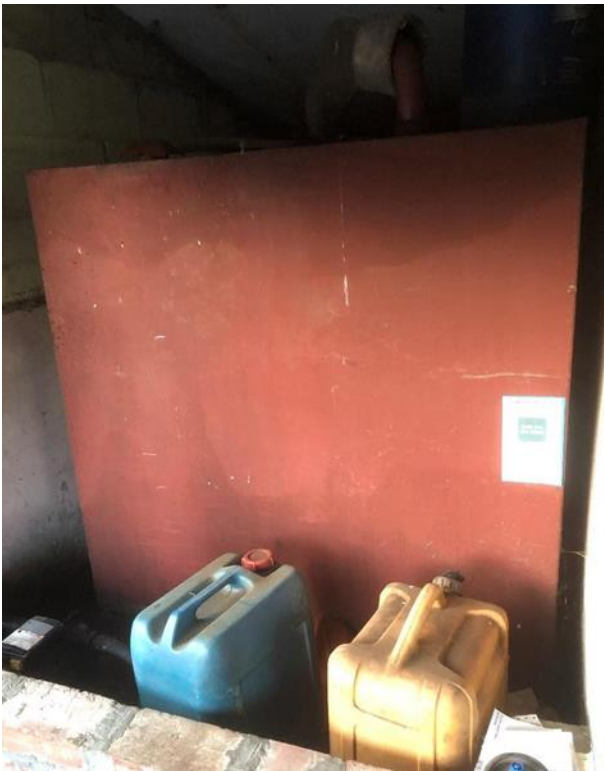
Photograph 14 – Fuel tank used for agricultural machinery

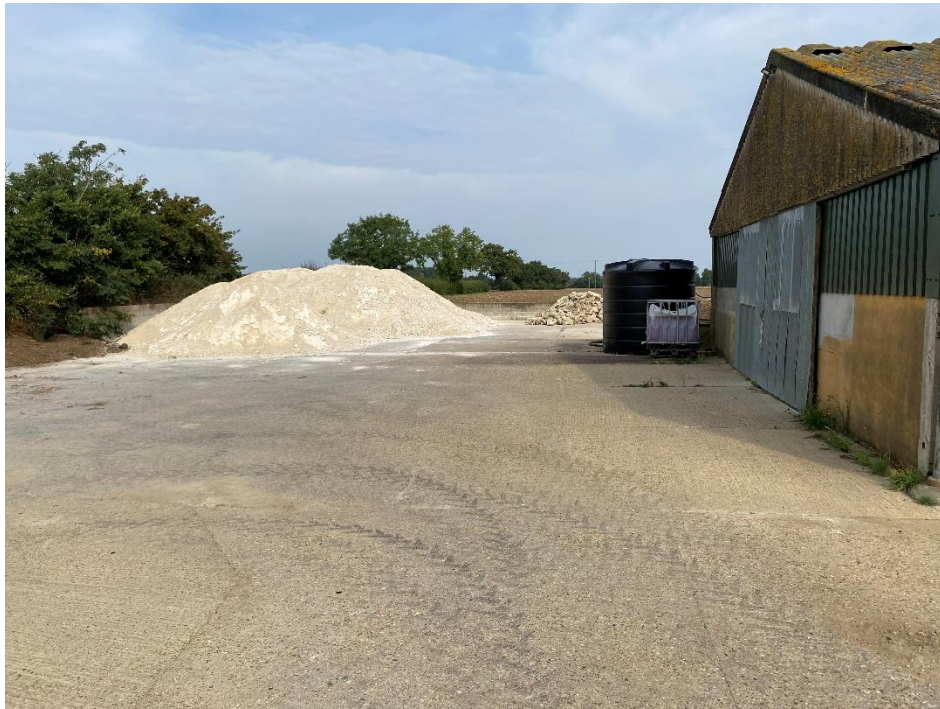
- 2.02.7 The section of farmyard, which will be redeveloped as Plot 1 is currently occupied by an asbestos clad barn, which we understand was built after a former barn burnt down approximately 30 years ago. The barn had concrete hardstanding throughout and was used for the storage of grain. A large heap of lime was present on the north boundary and an empty IBC. Adjacent to this was a water tank, which was used for diluting soil treatments. The external hardstanding to the north was currently be used to store a heap of concrete, which was from the demolition of an on site 'out building'. The heap was thoroughly inspected and no evidence of potential asbestos fragments was noted. We understand the hardstanding had been previously used to store manure.

Photograph 15 – Asbestos clad barn, with heap of lime on adjacent hardstanding

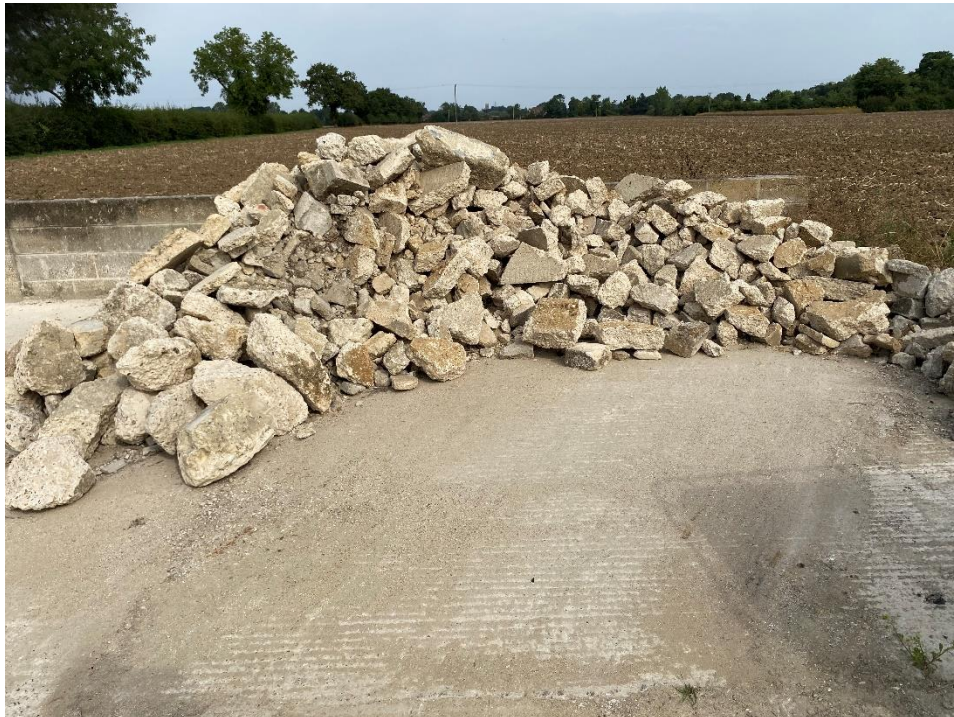
Photograph 16 – Heap of rubble, from demolition of on site building.
