**79 Chain Lane, Staining, Blackpool, FY3 0DB**

**Bat Building Inspection**

**Simply Ecology Limited**

**Ref: SE/KDQG060/01**

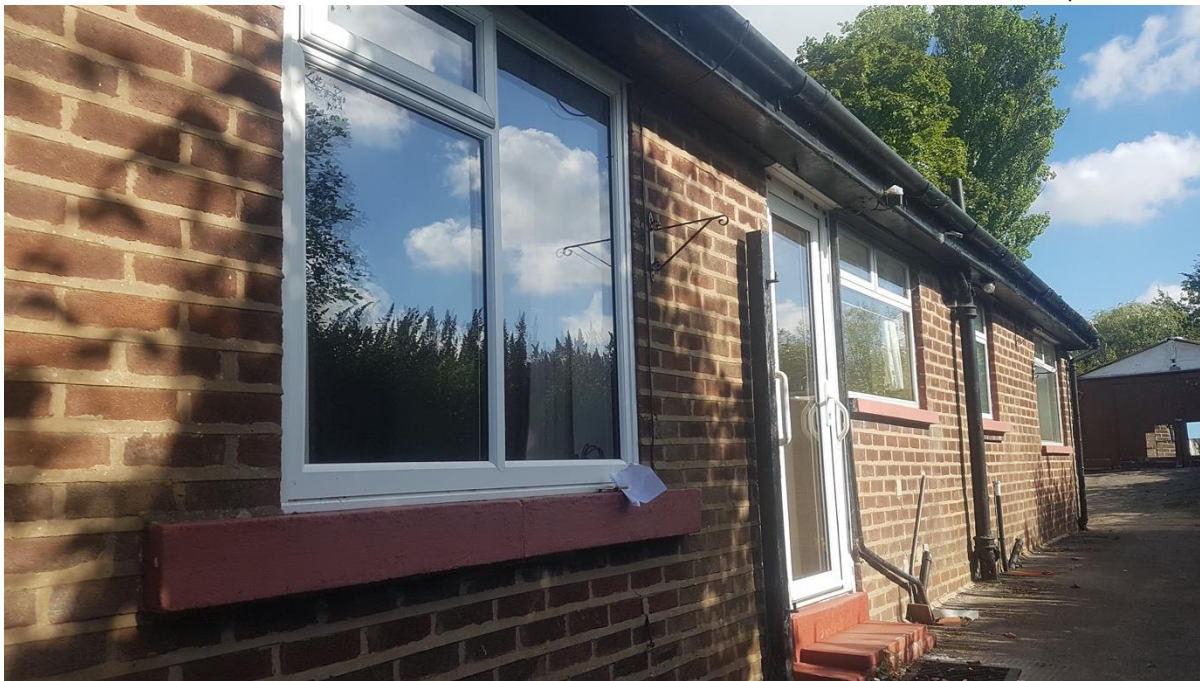
- 3.1.8 The doors and the windows of the residential property all appeared well sealed, with no gaps or PRFs identified (See

Plate 7).

*Plate 7: The doors and windows of the building were well sealed offering no roosting opportunities.*

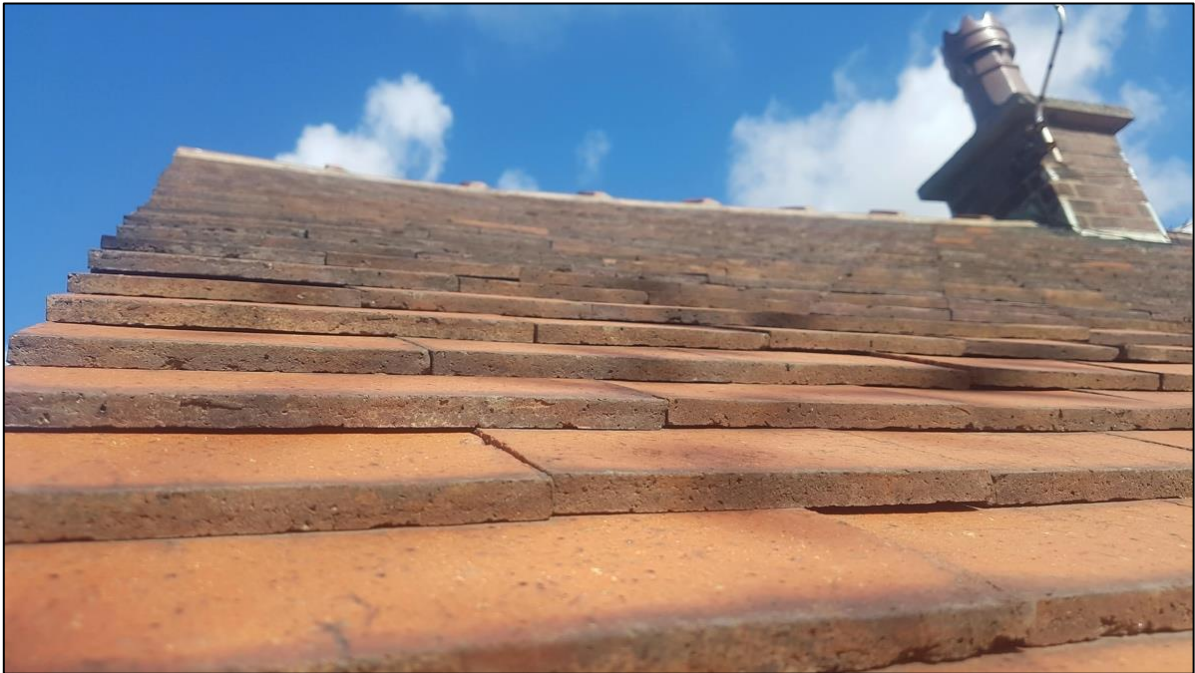
- 3.1.2 The pitched roof of the residential property was in very good condition, with very tight tiles and no cracked or missing tiles (See Plate 1).
- 3.1.3 A small number of gaps existed under slipped tiles across the pitched roof, or in roof verges (See Plate 2) however, when these were examined they were deemed too small for bats to utilise and were therefore deemed to offer no Potential Roosting Features (PRFs) and also showed no evidence of bat activity.

*Plate 1: The roof of the building was in very good condition, with no cracked or missing tiles offering no roosting potential or access to internal spaces.*

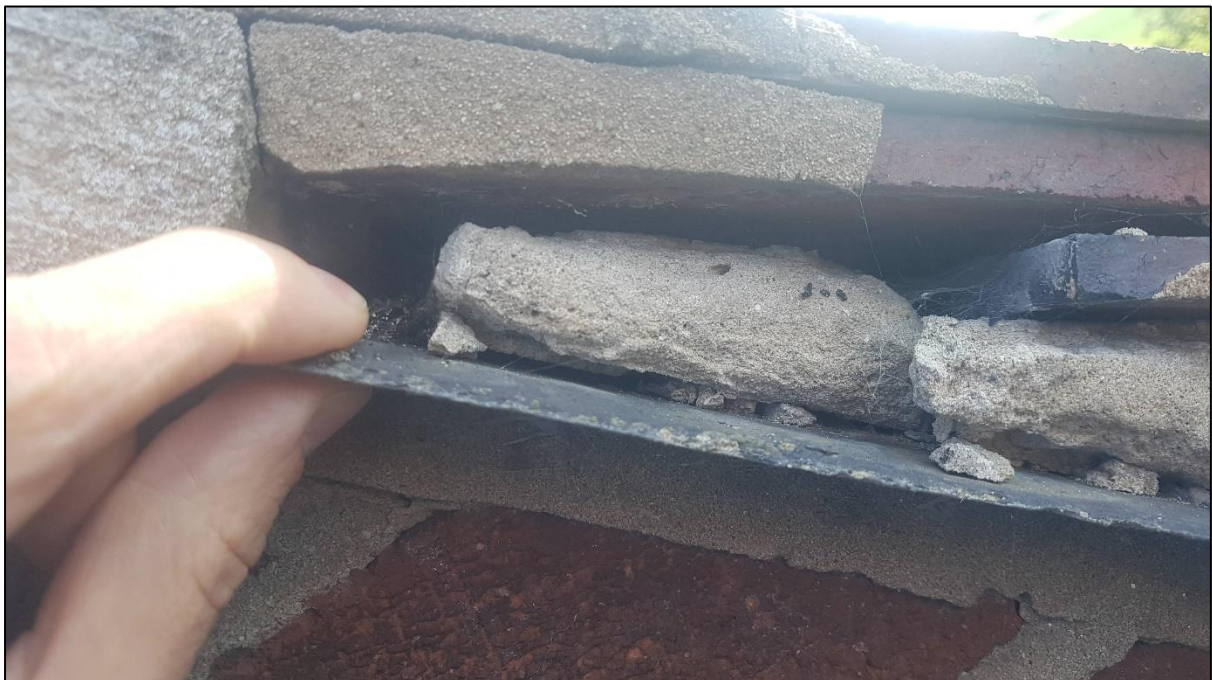
*Plate 2: Any gaps that existed in the roof tiles or in roof verges were deemed too small to be accessible for bats, offering no roosting potential.*

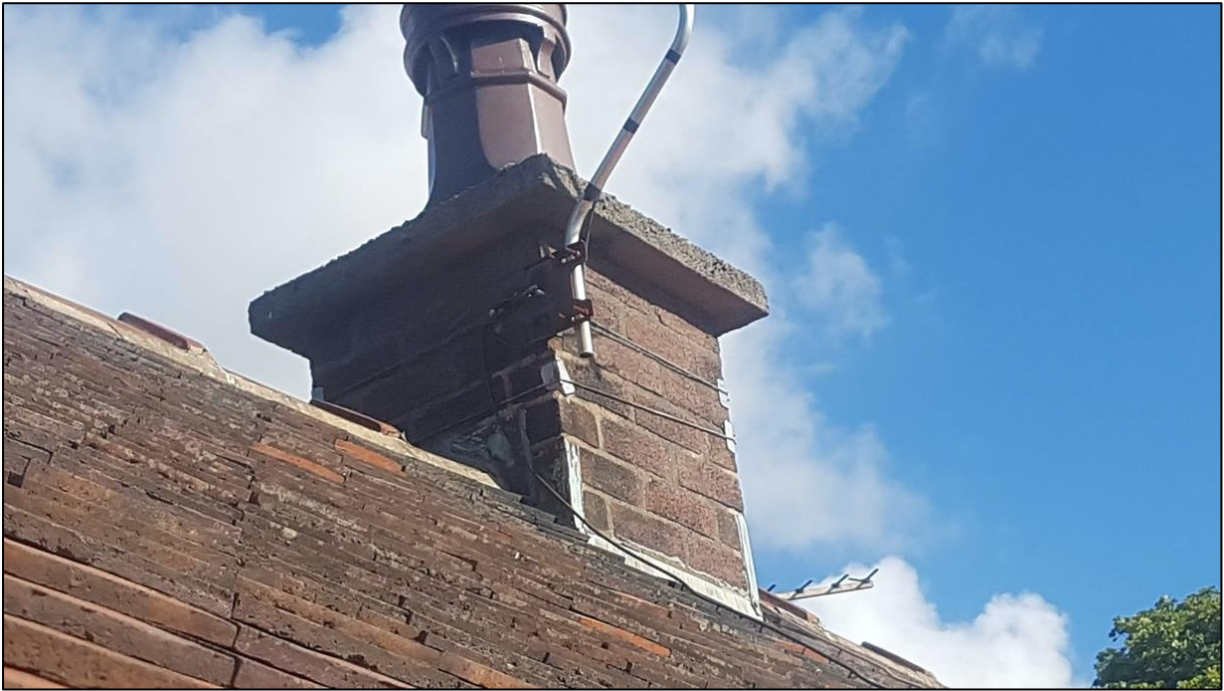
- 3.1.4 The brickwork of the chimney appeared in good condition and offered no PRFs (See Plate 3).
- 3.1.5 The redbrick walls of the building were in good condition, with no gaps in the mortar or cracks in the walls offering no PRFs (See Plate 4).

*Plate 3: The brickwork of the chimney was in good condition and offered no roosting opportunities.*

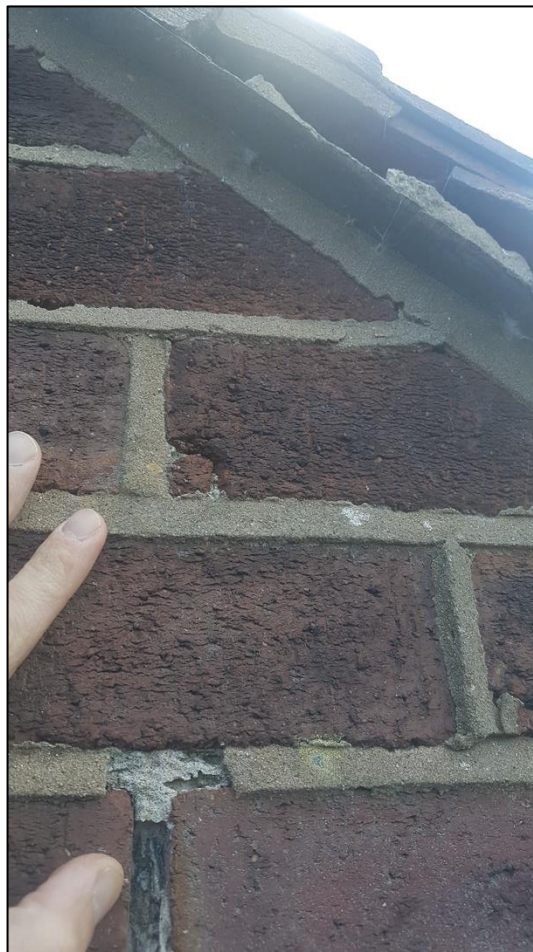
*Plate 4: The walls of the building were in good condition and offered no roosting potential and showed no signs of bat activity.*

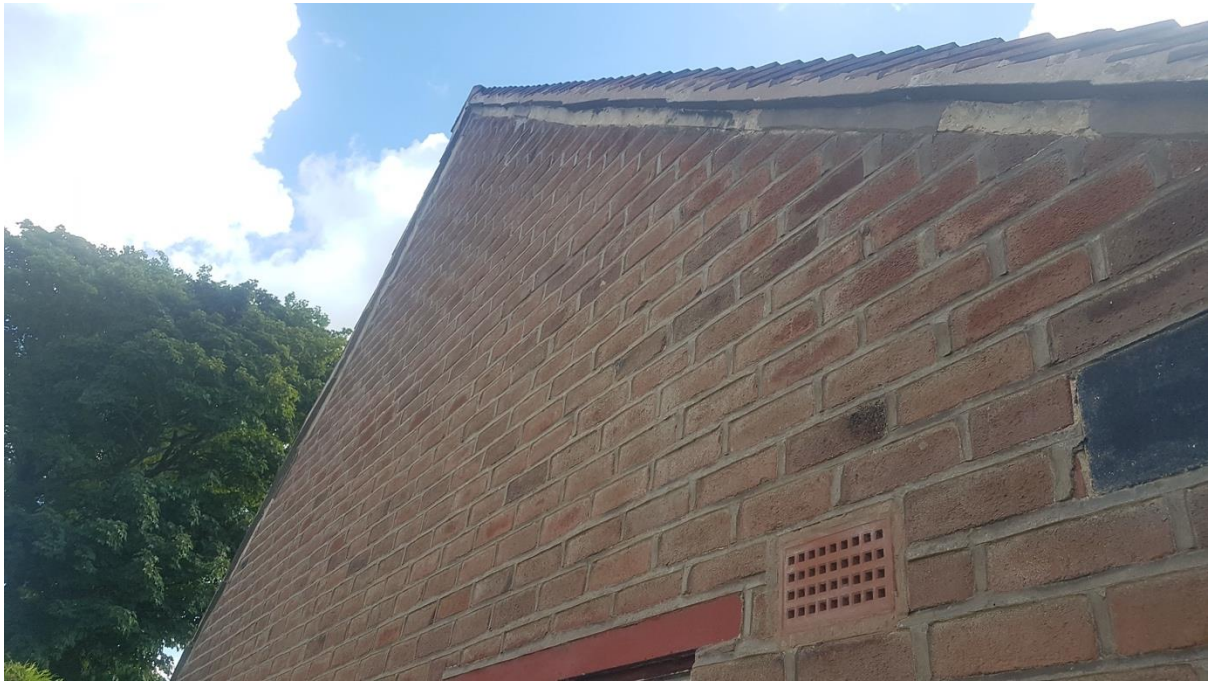
- 3.1.6 The gable wall brickwork and bargeboards appeared in good condition with no gaps or cracks offering no PRFs (See Plate 5).
- 3.1.7 The building eaves were well sealed and offered no PRFs (See Plate 6).

*Plate 5: The walls of the roof gable was in good condition and the roof barge boards were in good condition.*

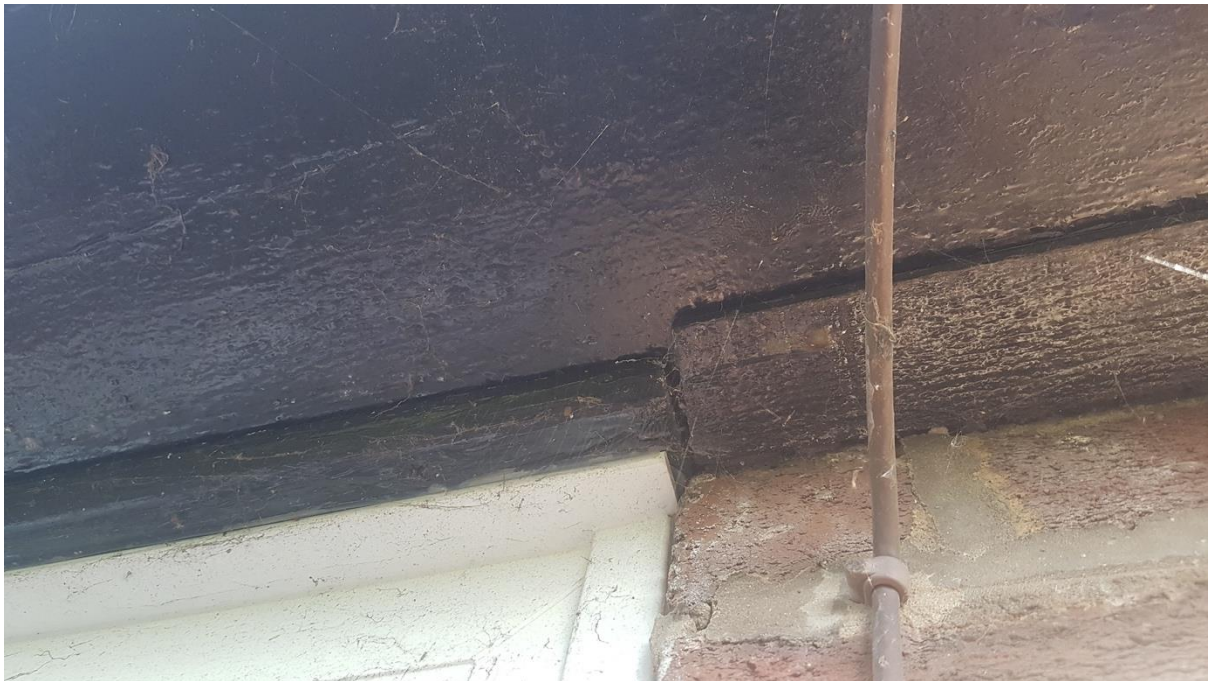
*Plate 6: The building eaves were in good condition and offered no bat roosting potentials.*

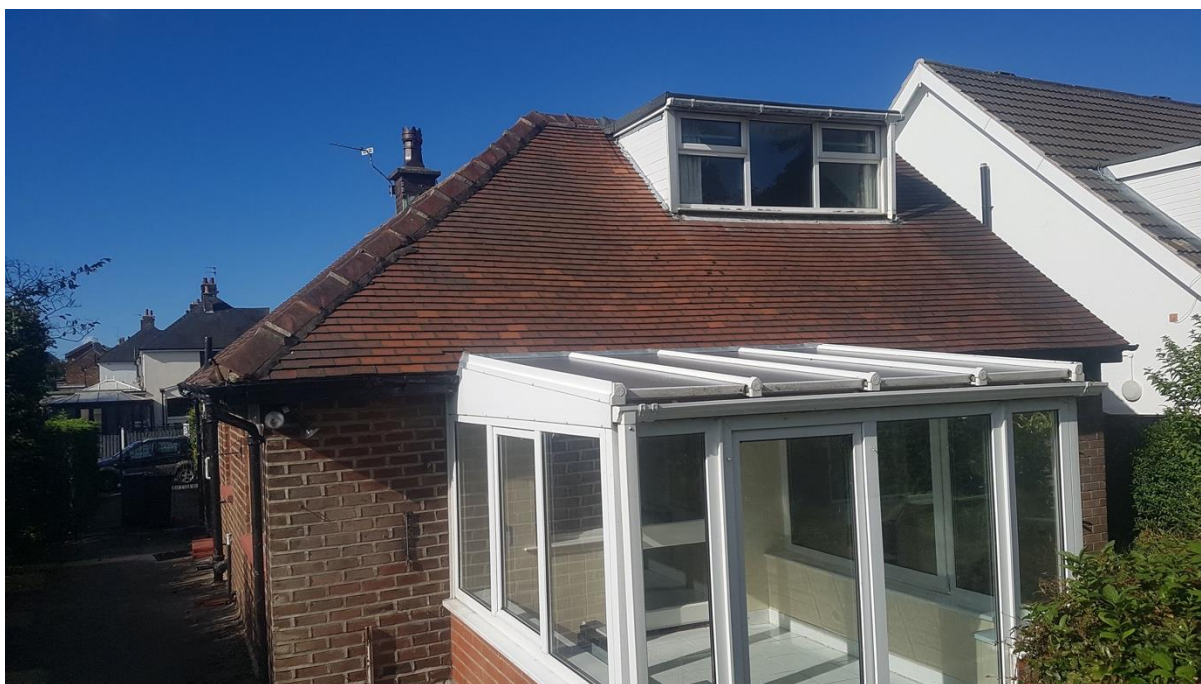
- 3.1.9 The dormer roof and windows were in good condition with no gaps in tiles or cracks, with the flashing appearing well sealed offering no PRFs (See Plate 8).

- 3.1.10 The flat roof of the conservatory was in good condition and offered no PRFs (See Plate 8).
- 3.1.11 A thorough search of external walls, roof surfaces and flat surfaces was carried out to determine any evidence of bat activity at the site (such as droppings, feeding remains or staining). However, no evidence of bat activity was found at the site.

*Plate 8: The dormer roof, windows and flashings were in good condition as well as the flat roof of the conservatory being in good condition.*

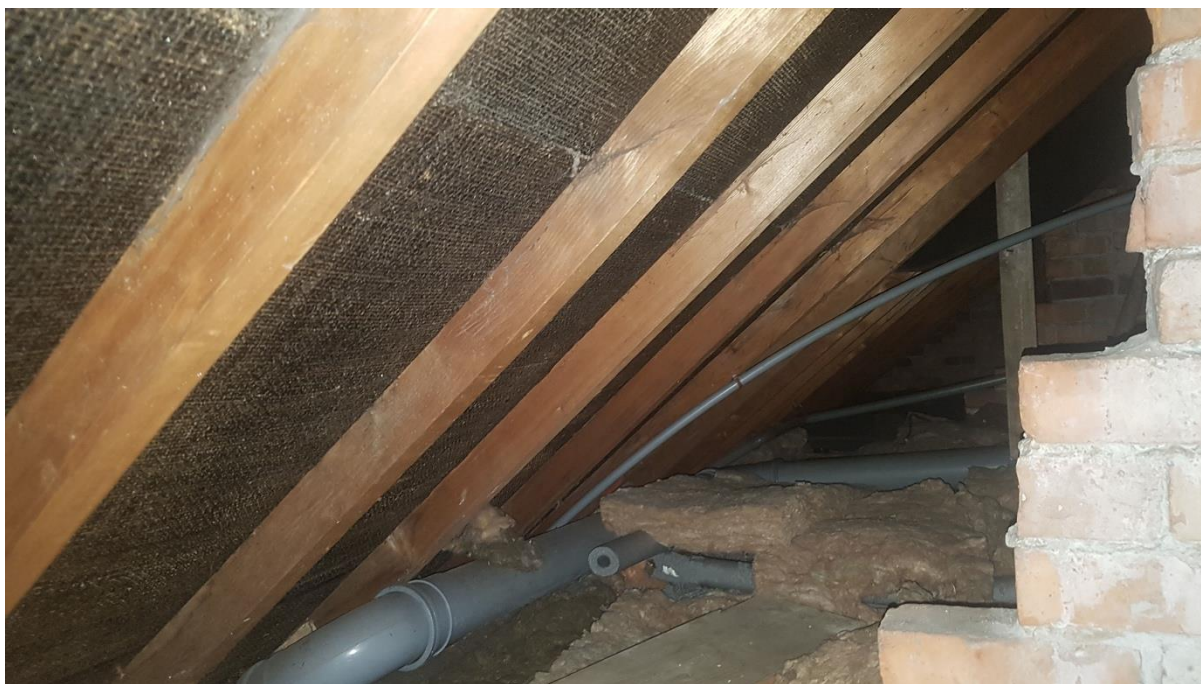
- 3.1.13 The internal loft was generally well-sealed, with roof underfelt membrane and wooden beams appearing to be in good condition and offering no PRFs (See Plate 9). No staining or other evidence of bats was found in these areas.
- 3.1.14 In one place the membrane was ripped and the roof tiles were exposed, however due to the good condition of the roof tiles, no PRFs or bat access to internal space was identified (See Plate 10).
- 3.1.15 All of the flat surfaces in the internal loft voids were thoroughly searched for evidence of bat activity, however none was found (See Plate 11).

*Plate 9: The roof was felted, and no signs of bats were present around purlins or on rafters or trusses.*

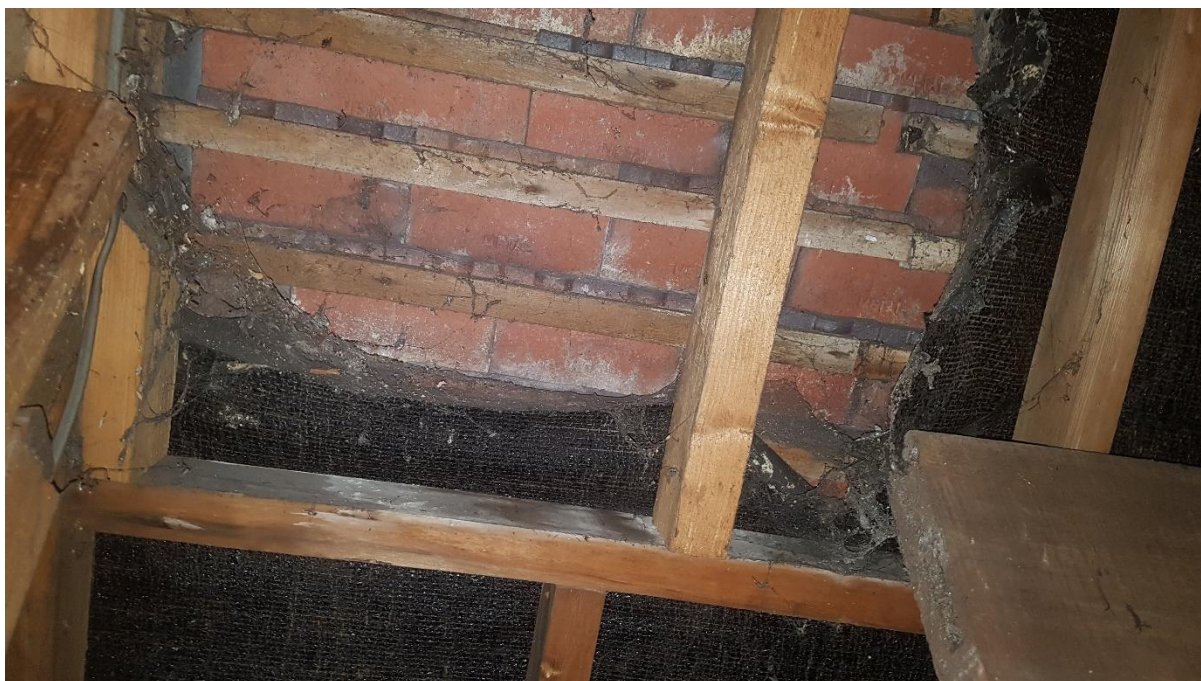
*Plate 10: Tears in the underfelt were inspected and no signs of bats were present.*

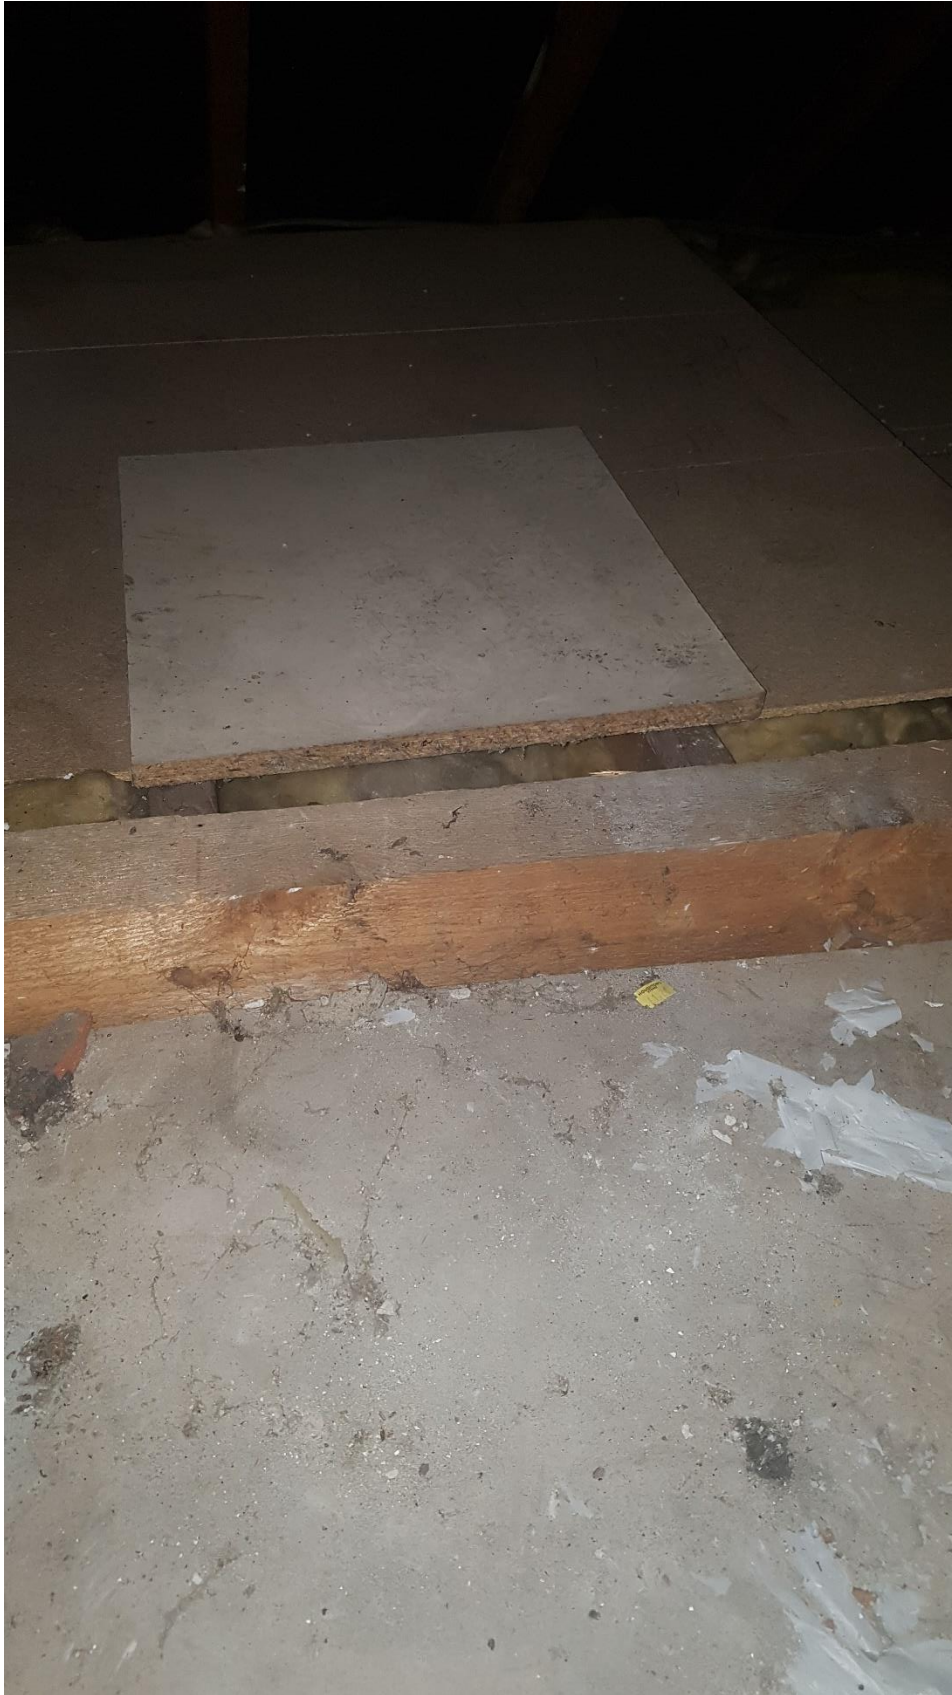
*Plate 11: All flat surfaces were checked, but no evidence of bat activity was present.*

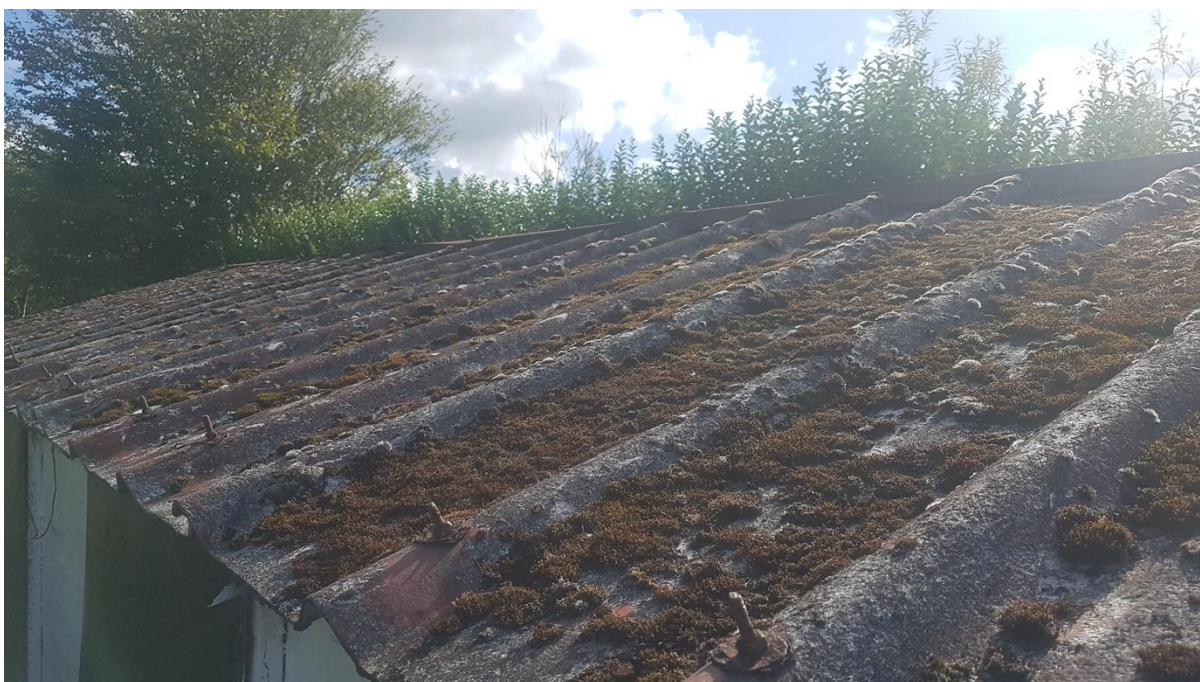
- 3.1.16 The pitched roof of the outbuilding was generally in good condition, however, there was a large moss covering (See Plate 12).
- 3.1.17 The concrete shed was in relatively good condition, however the internal space was easily accessible to bats due to the gaps at the top of the walls (See Plate 13).
- 3.1.18 The doors and windows of the outbuilding were generally in good condition and reasonably well sealed, however some gaps did exist above the door frame.
- 3.1.19 The doors and walls of the outbuilding were in relatively good condition, and were thoroughly searched for evidence of bat activity, however no evidence was found.

*Plate 12: The roof of the outbuilding was generally in good condition, despite the large moss covering.*

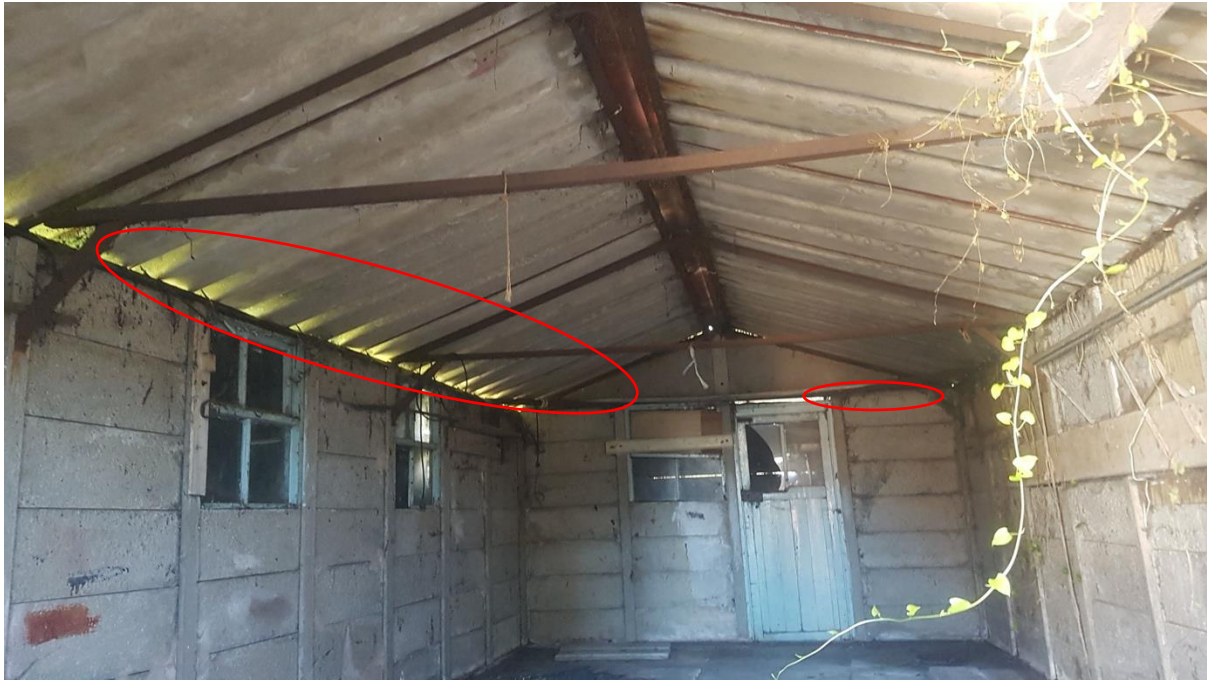
- 3.1.20 The internal space of the outbuilding was a simple structure comprised of a single void with no hidden places or PRFs identified internally (See Plate 13).
- 3.1.21 A thorough search of flat surfaces internally and nearby the building cleared showed no evidence of bat activity (See Plate 14).

*Plate 13: A gap can be seen above the walls of the outbuilding, offering access to internal spaces. Although, this internal space was a very simple structure offering no roosting opportunities.*

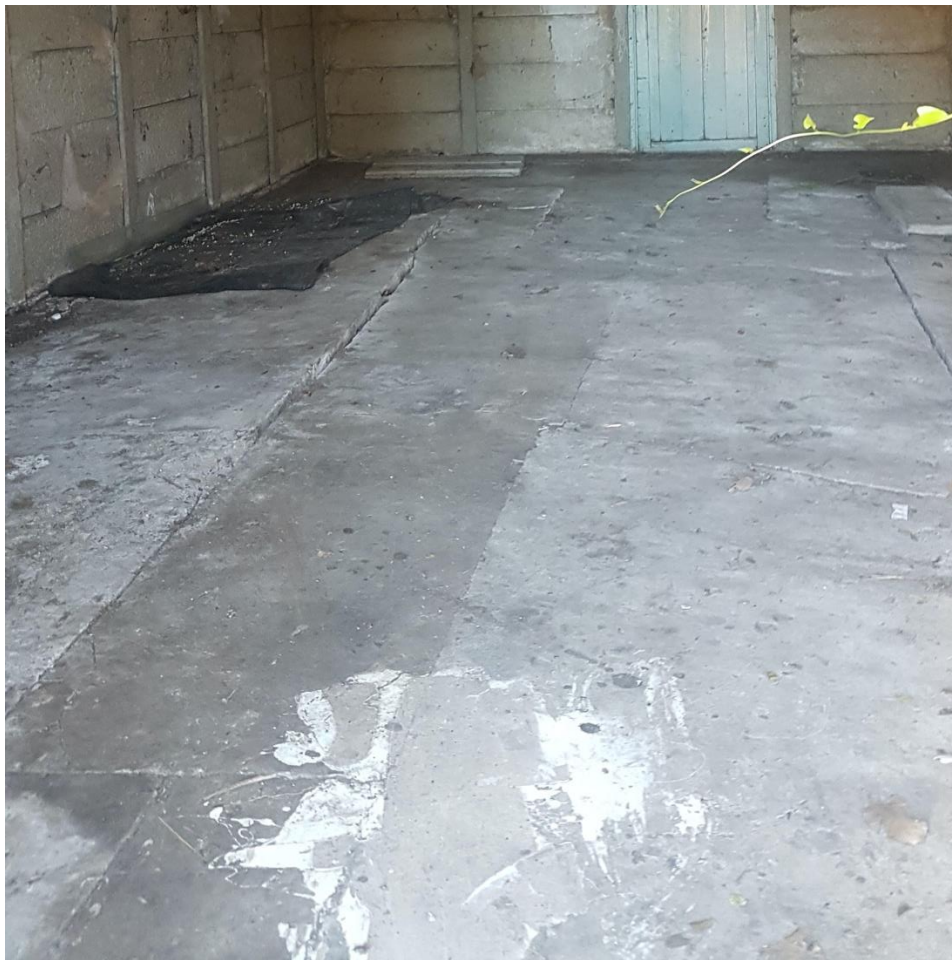
*Plate 14: The flat surfaces of the internal space showed no evidence of bat activity.*
