Report type	Phase 1 Preliminary Risk Assessment
Date	14 May 2021
Client	██████ Muturi
Site address	15 Myrtle Close, Erith, Kent, DA8 3PT
Report prepared by	Mr Louis Turner BSc (Hons)
Supervised by	Mr Joseph Turner

1. Introduction

The client's proposed project involves the construction of a residential dwelling at 15 Myrtle Close, Erith, Kent, DA8 3PT. A Phase 1 Preliminary Risk Assessment has been requested by the client to support a planning application for the proposed project. Oakshire Environmental have carried out a Phase 1 Preliminary Risk Assessment, as described below.

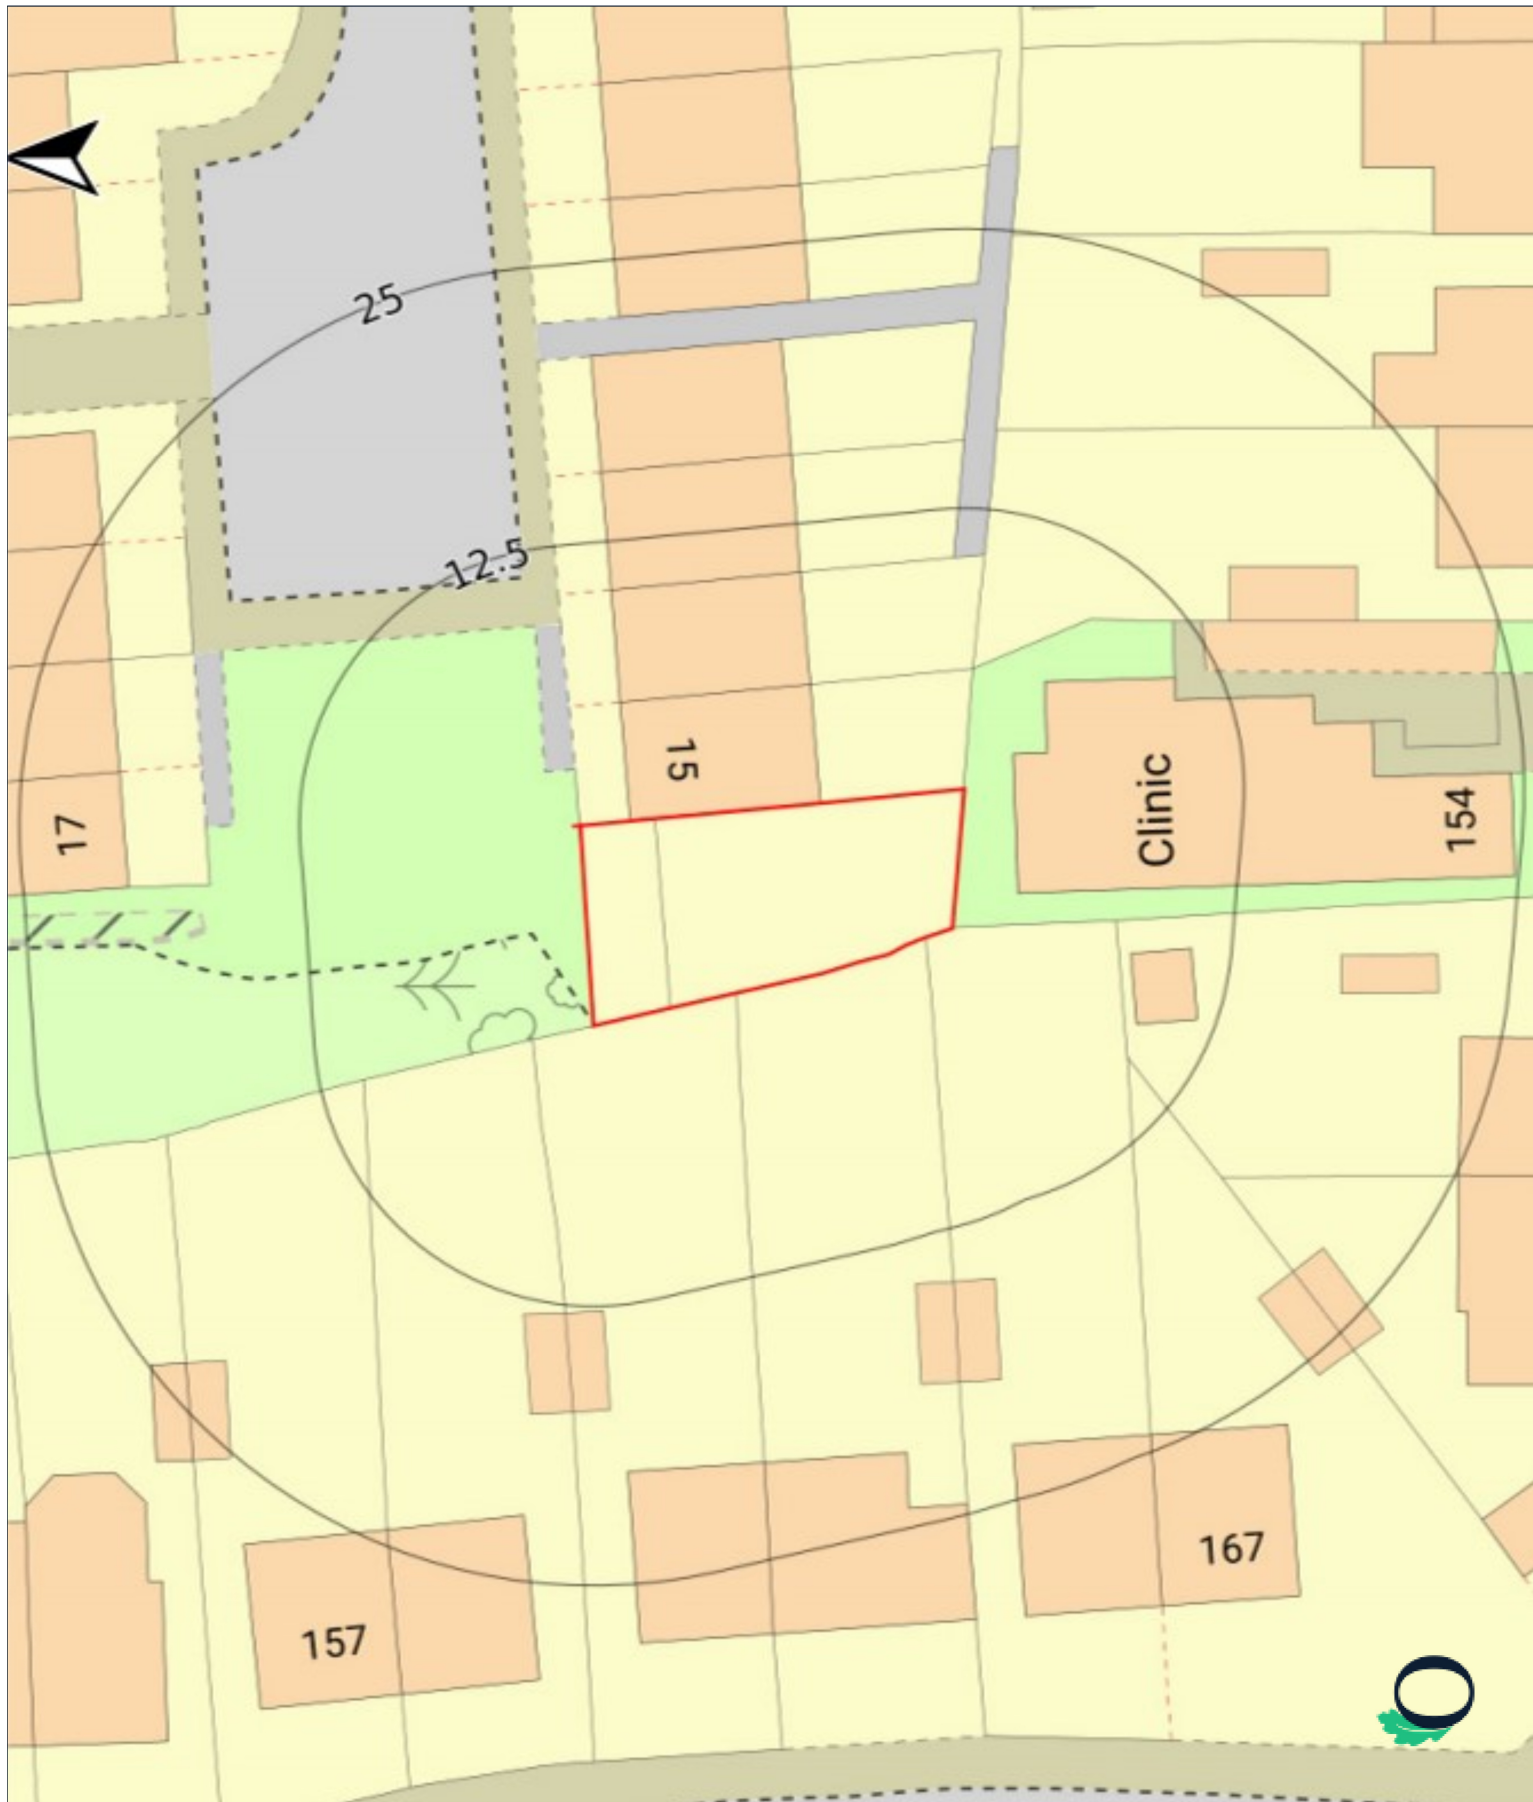
Description	
OS MasterMap site plan	
Sources	
© Crown copyright and database rights 2021. Ordnance Survey licence 100035207	
Key	
Site boundary	
Name	Figure 1

The site is located on Myrtle Close to the south of the town of Erith and is approximately 130m². The site currently comprises the garden of the neighbouring property (15 Myrtle Close). There is a grass area at the north separated from the rest of the site by a wooden fence, a small wooden shed just south of the fence, a paved path along the east boundary. There is another area of grass at the west and south of the site with some gravel and soft landscaping separated from the path by a retaining wall. This grass area is ~1m higher than the path and slopes from west to east. There is soft landscaping curtailing the grass area of the site to the north, west and south.

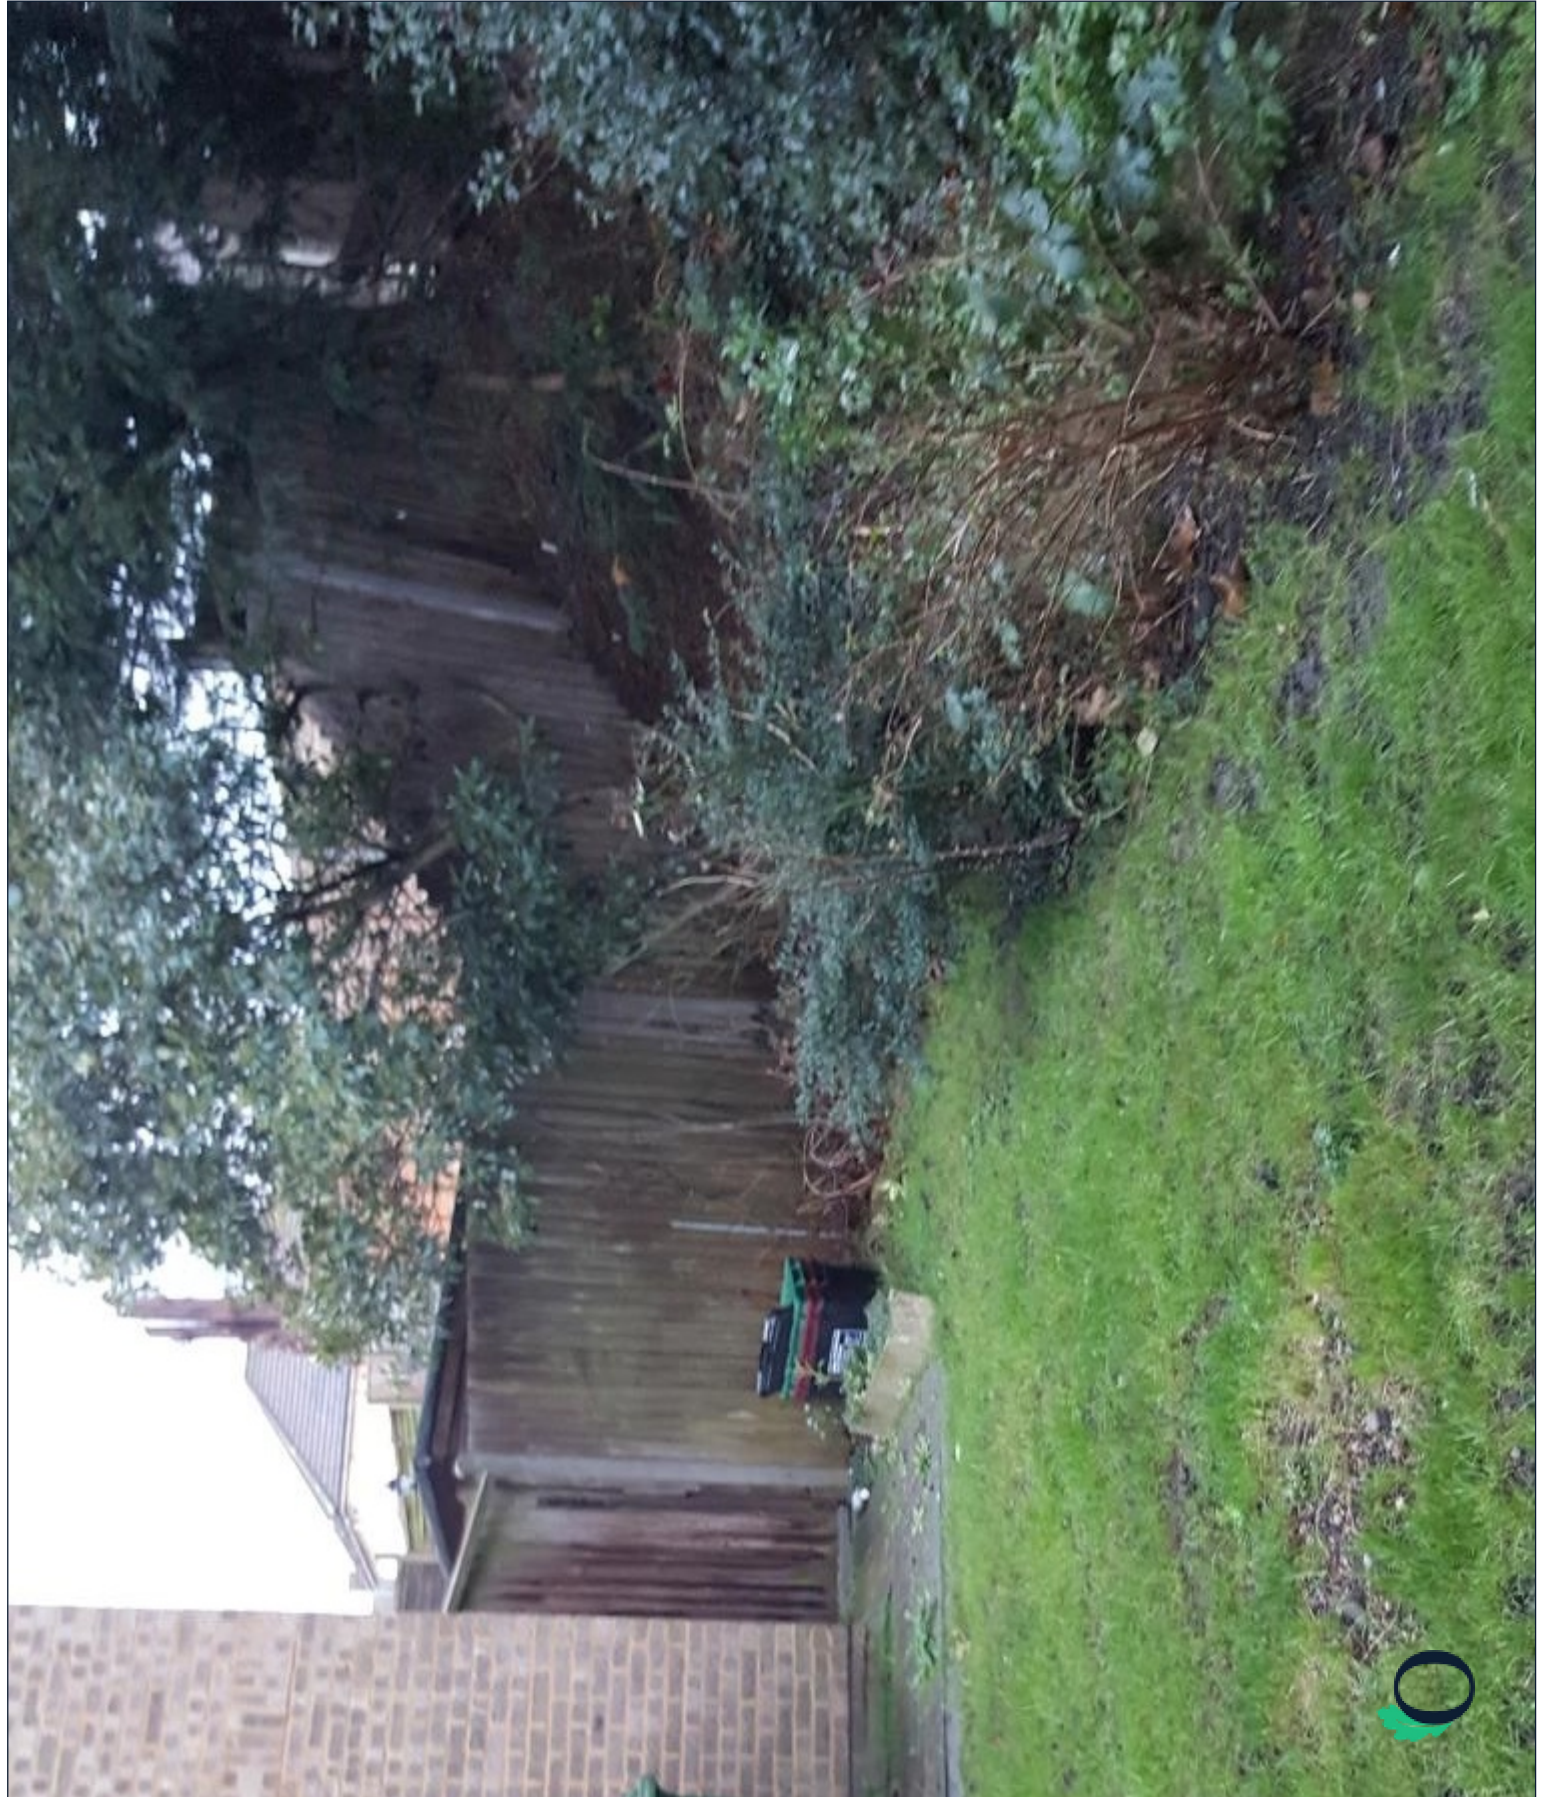
Description	
Photo of the grass area at the north of the site facing south west	
Sources	
Key	
Name	Figure 3

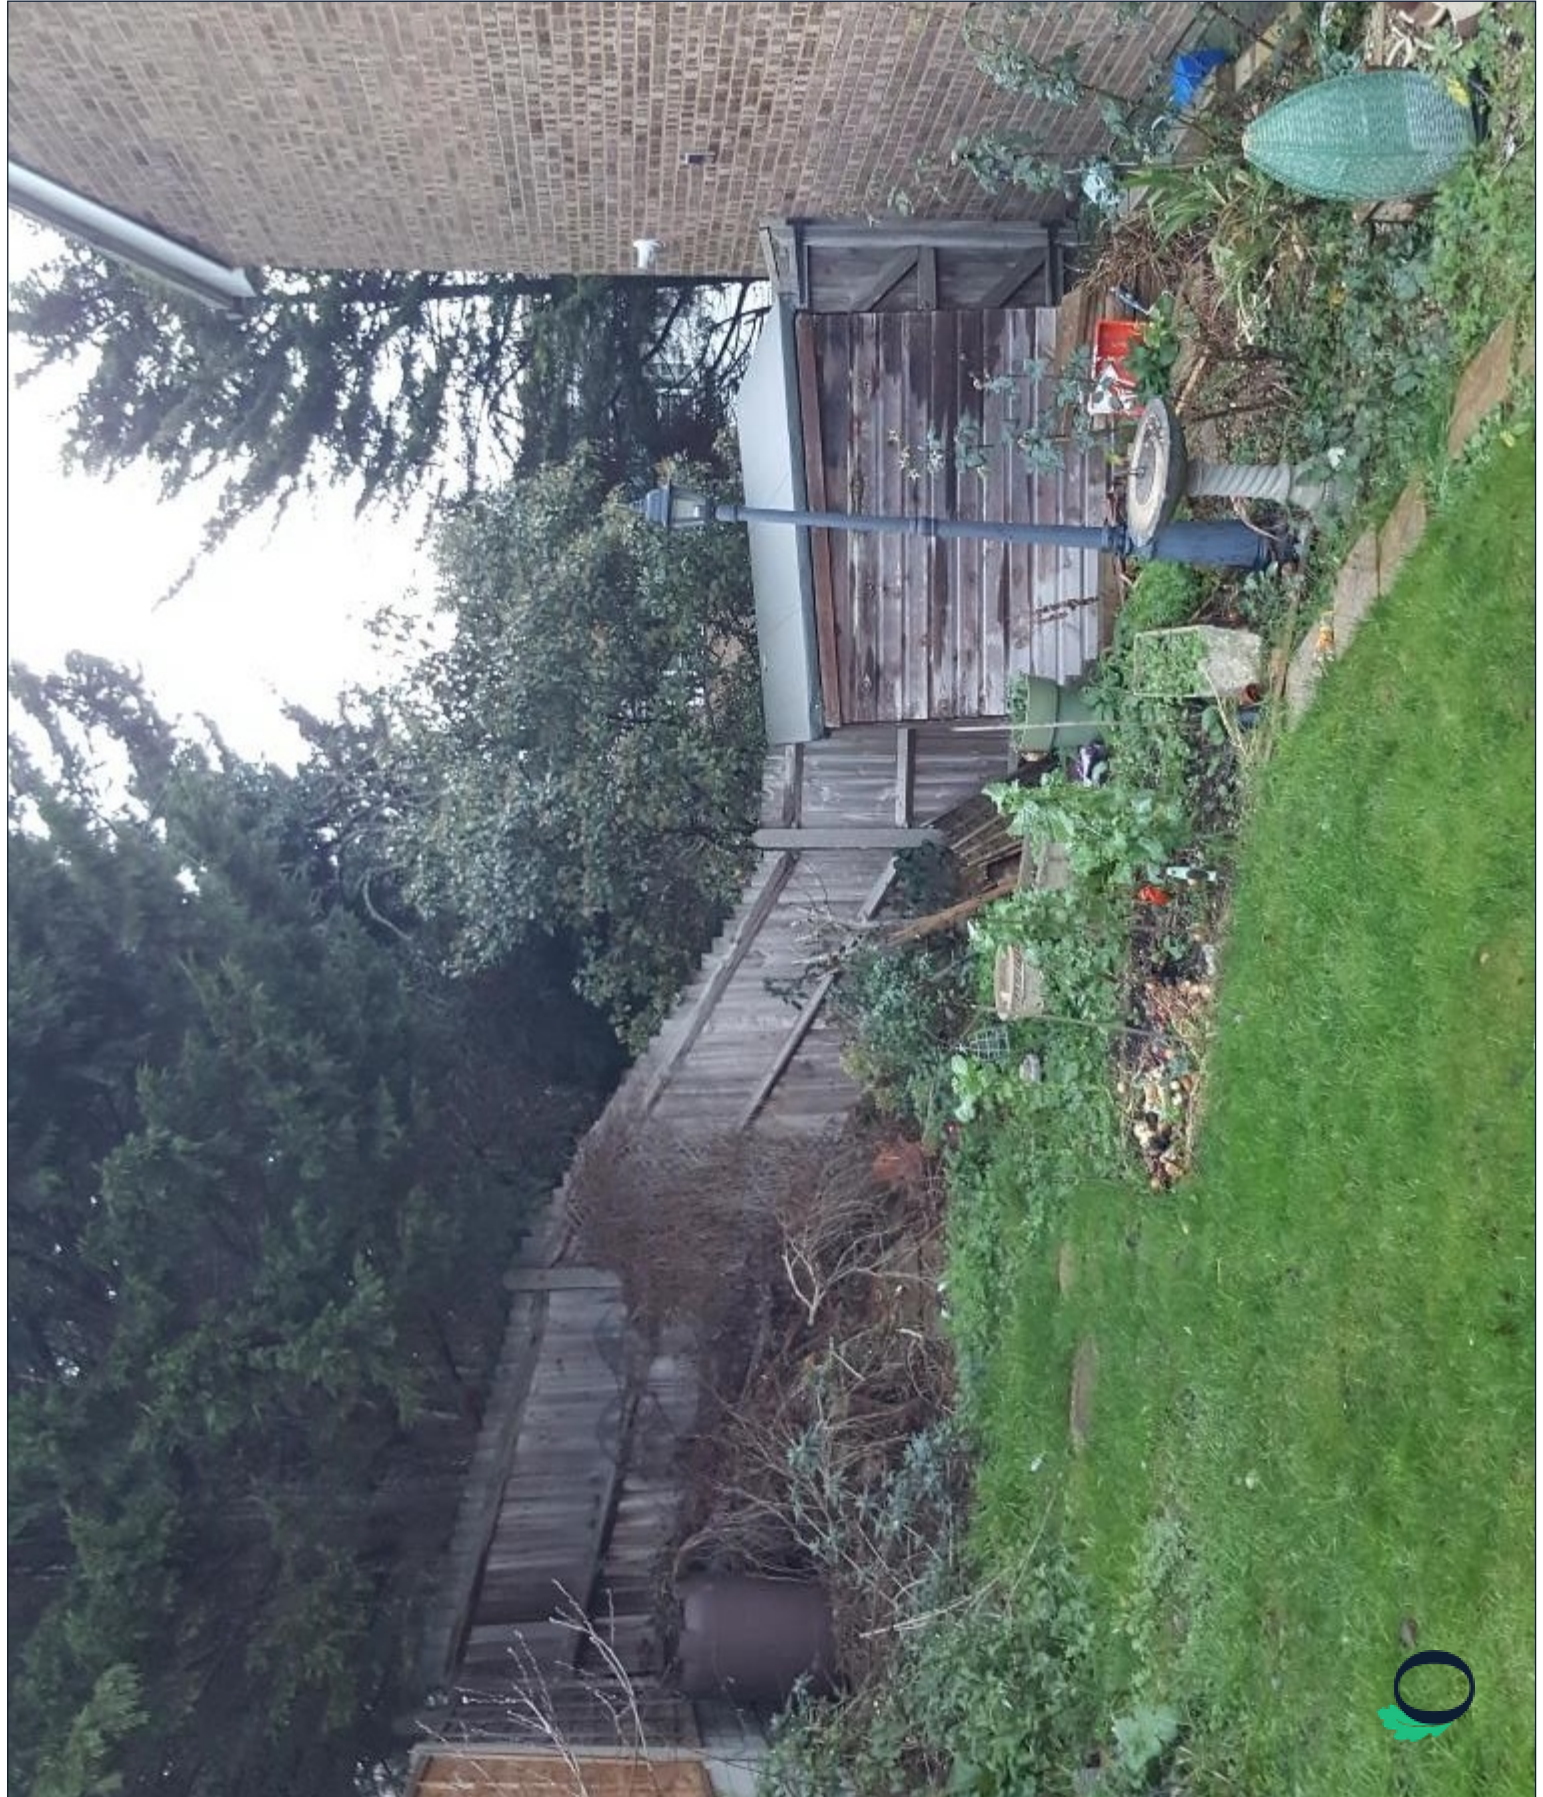
Figure 4

Photo of the grass and soft landscaping with retaining wall facing north

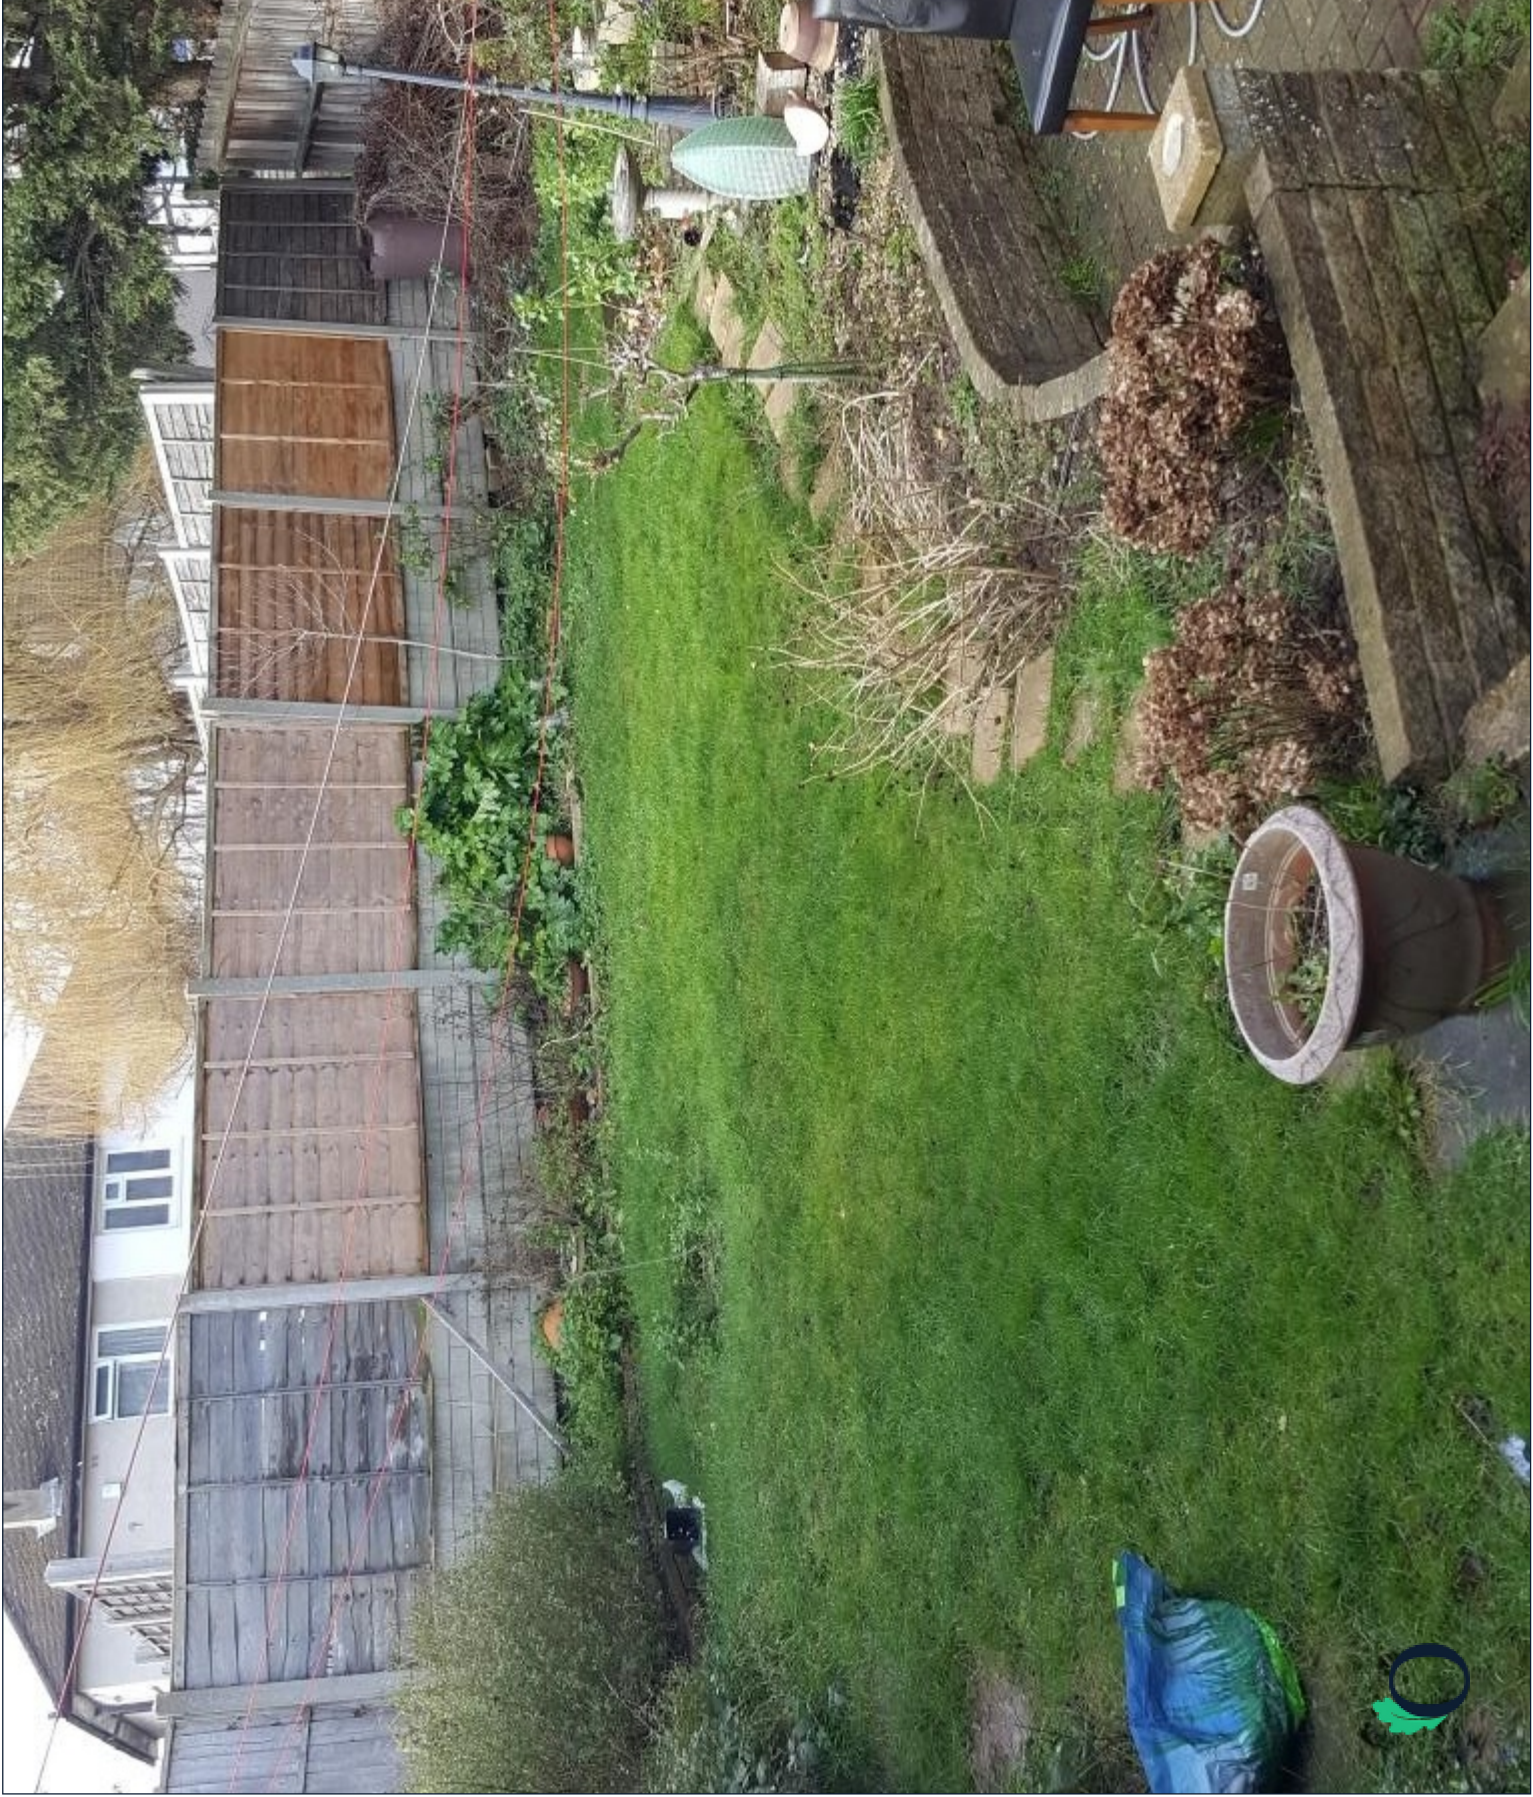
Figure 5

Photo of the grass area at the west and south of the site facing west

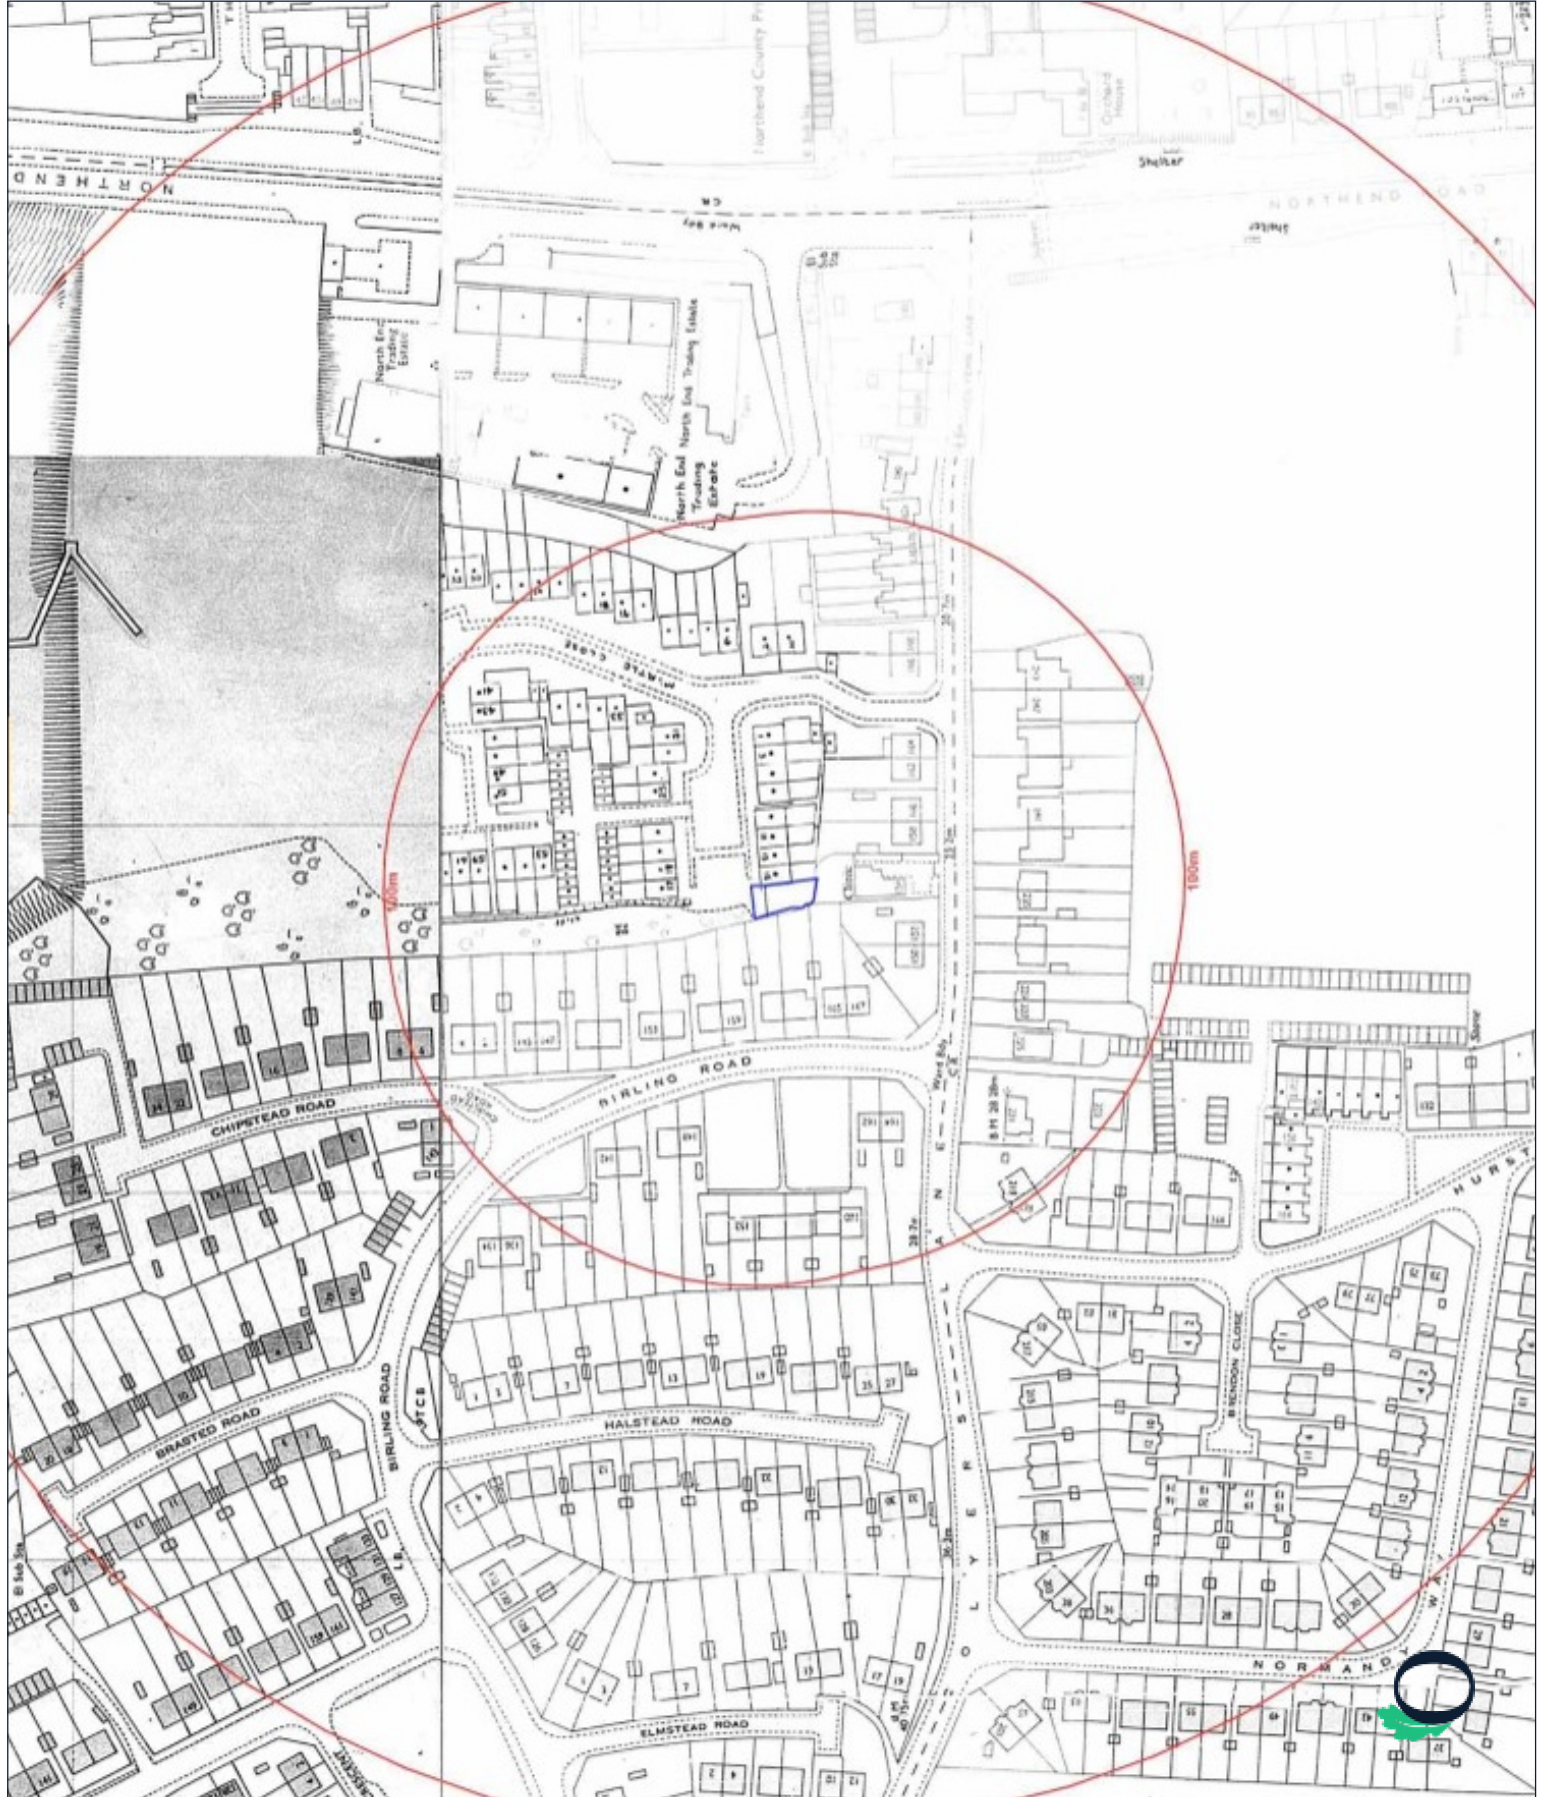
Figure 14

Historical map dated 1981 - 1985

1933		More buildings within clay pit 170m east and the engine house in the clay pit to the south is also no longer shown
1939		Additional buildings/extensions constructed in clay pit 100m east Allotment gardens 190m north east
1958 - 1961	Site forms part of the gardens of two residential dwellings and cuttings for clay pit no longer shown	Residential dwellings to the west and east and a clinic to the south Row of small attached buildings to the north (most likely storage garages) Depot 120m east and a garage 190m north east Large residential development to the west and south replacing old orchards
1969 - 1972		Additional garage to the north Depot to the east now labelled as a trading estate Long row of storage garages 100m south
1981 - 1985	Site forms part of the garden of a bordering end-terrace residential dwelling	Row of terraced houses adjacent to the site to the east Residential development including storage garages to the north on old clay pit (the site itself forms part of this development)

The site is situated at the edge of an old clay pit that was subsequently filled in between 1933 and 1957. A large residential development was then built on this landfill just after 1979, the site forms part of this development. Prior to this development the site formed part of the rear gardens of two previous dwellings that were demolished. It should be noted that the site was situated on the edge of this old clay pit and appears to be just south of the landfill boundary. BGS maps of artificial ground do, however, show infilled ground on the site. It is assumed that the residential development would have been subject to some ground investigation work and possibly some remediation, although there is no evidence of this in planning records. Given the age of the development, it is not likely that any potential contamination would have been identified or dealt with to existing standards, however, the time elapsed since this development occurred will also mean that it is unlikely that any volatile contaminants or ground gases will still be present. There has also been a newer residential development further north on the same landfill site that identified some contamination and carried out remediation and validation. This suggests that there is likely to have also been contamination present at the south of the landfill where the site is situated.

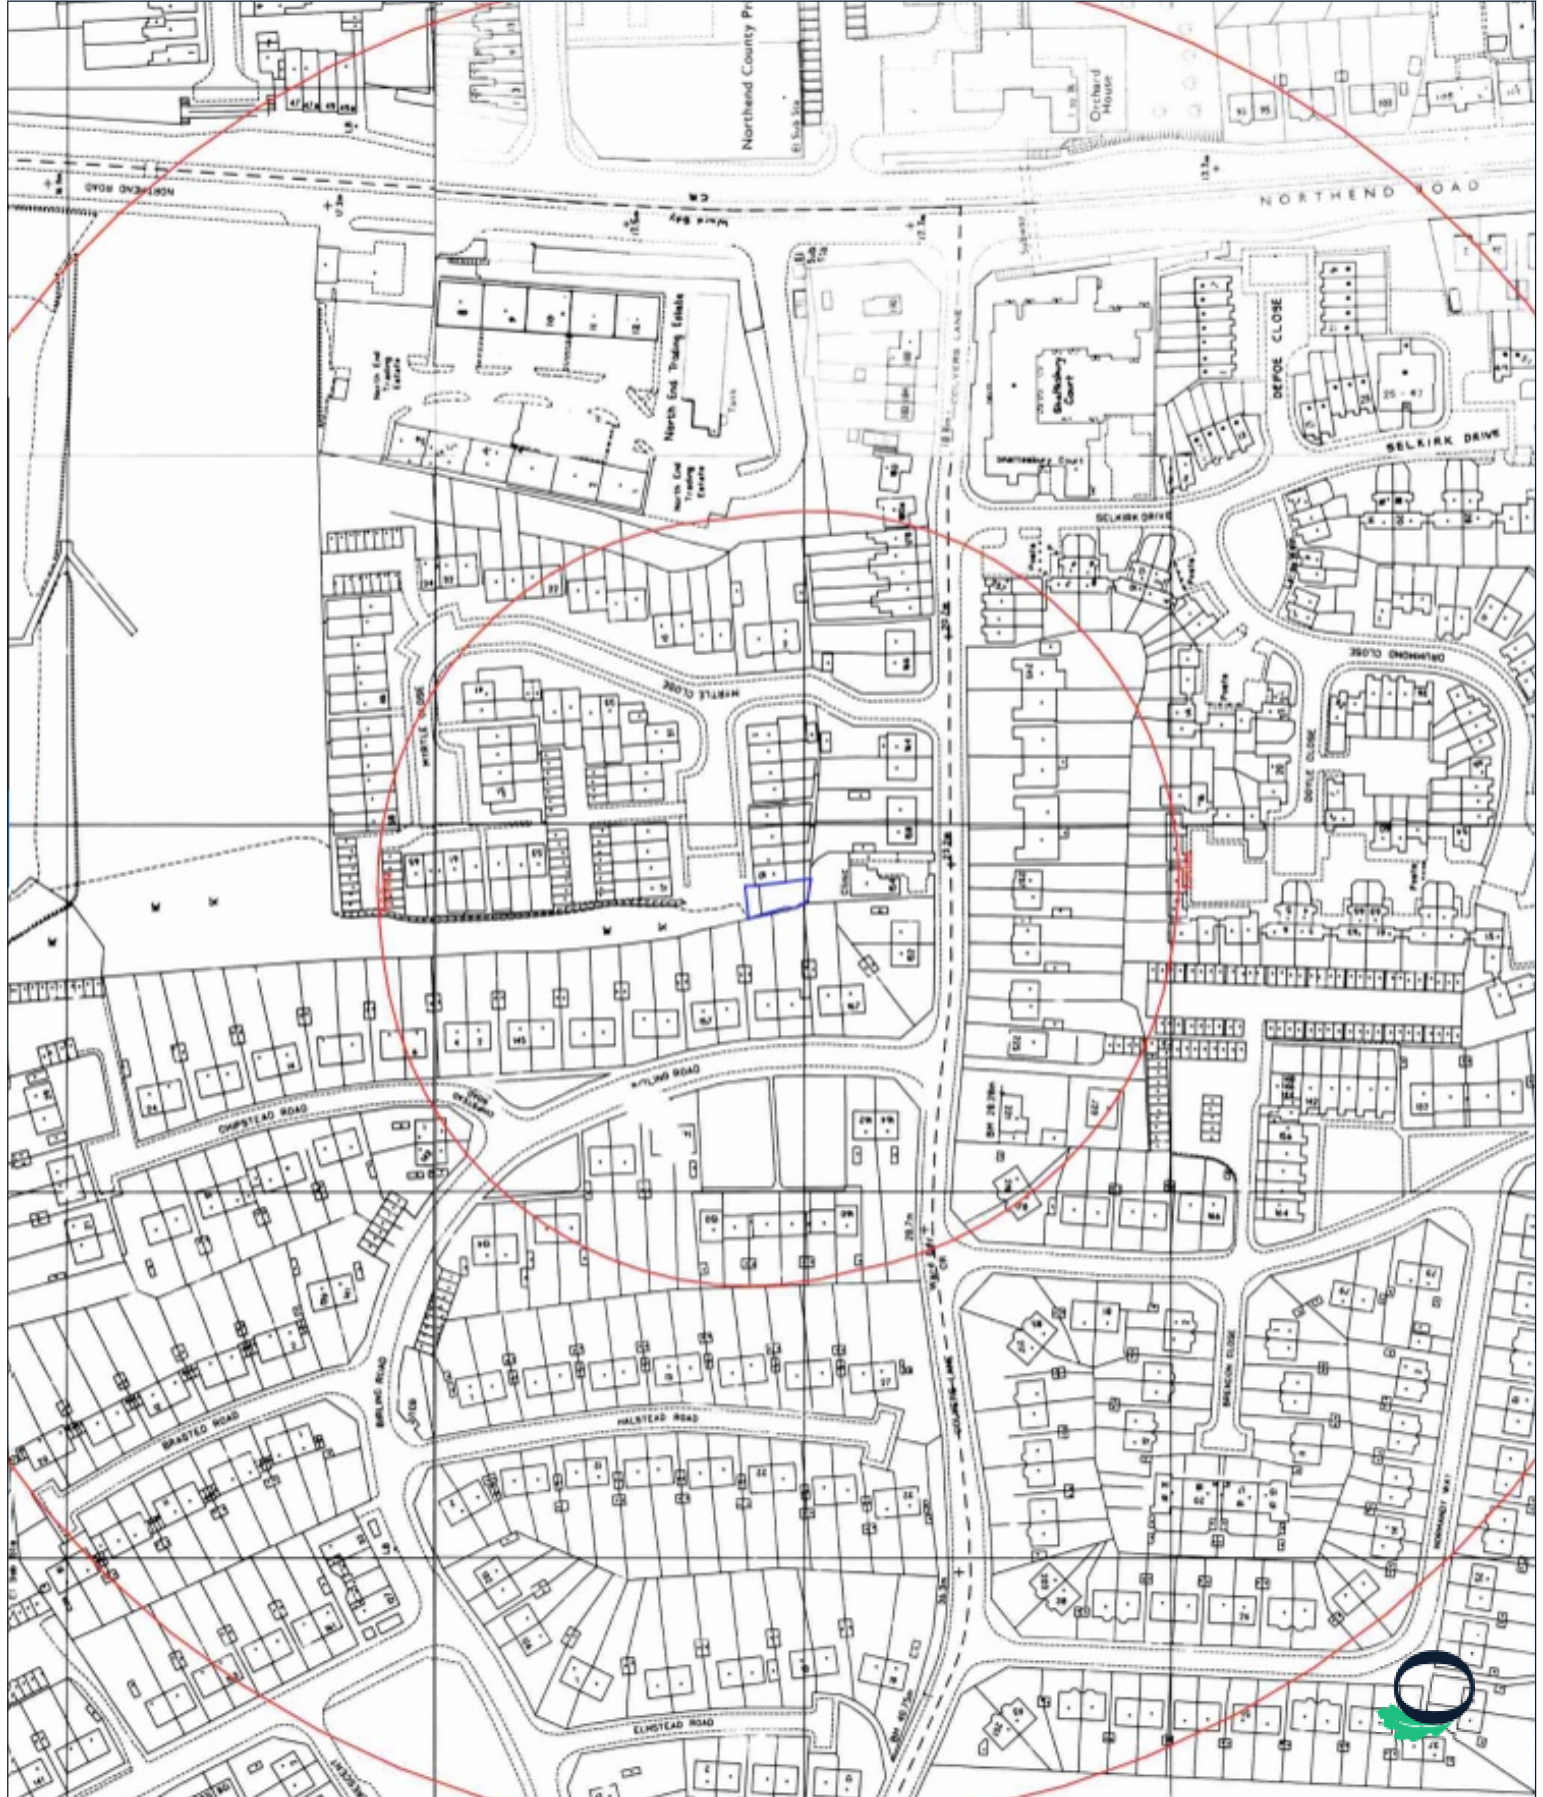
Description	Historical map dated 1990 - 1992 Map scale: 1:1,250 Printed at: 1:2,000
Sources	© Crown copyright and database rights 2018 Ordnance Survey 100035207
Key	Site boundary
Name	Figure 15

1990 - 1992		Residential development including storage garages to the south on old clay pit
2003		No change

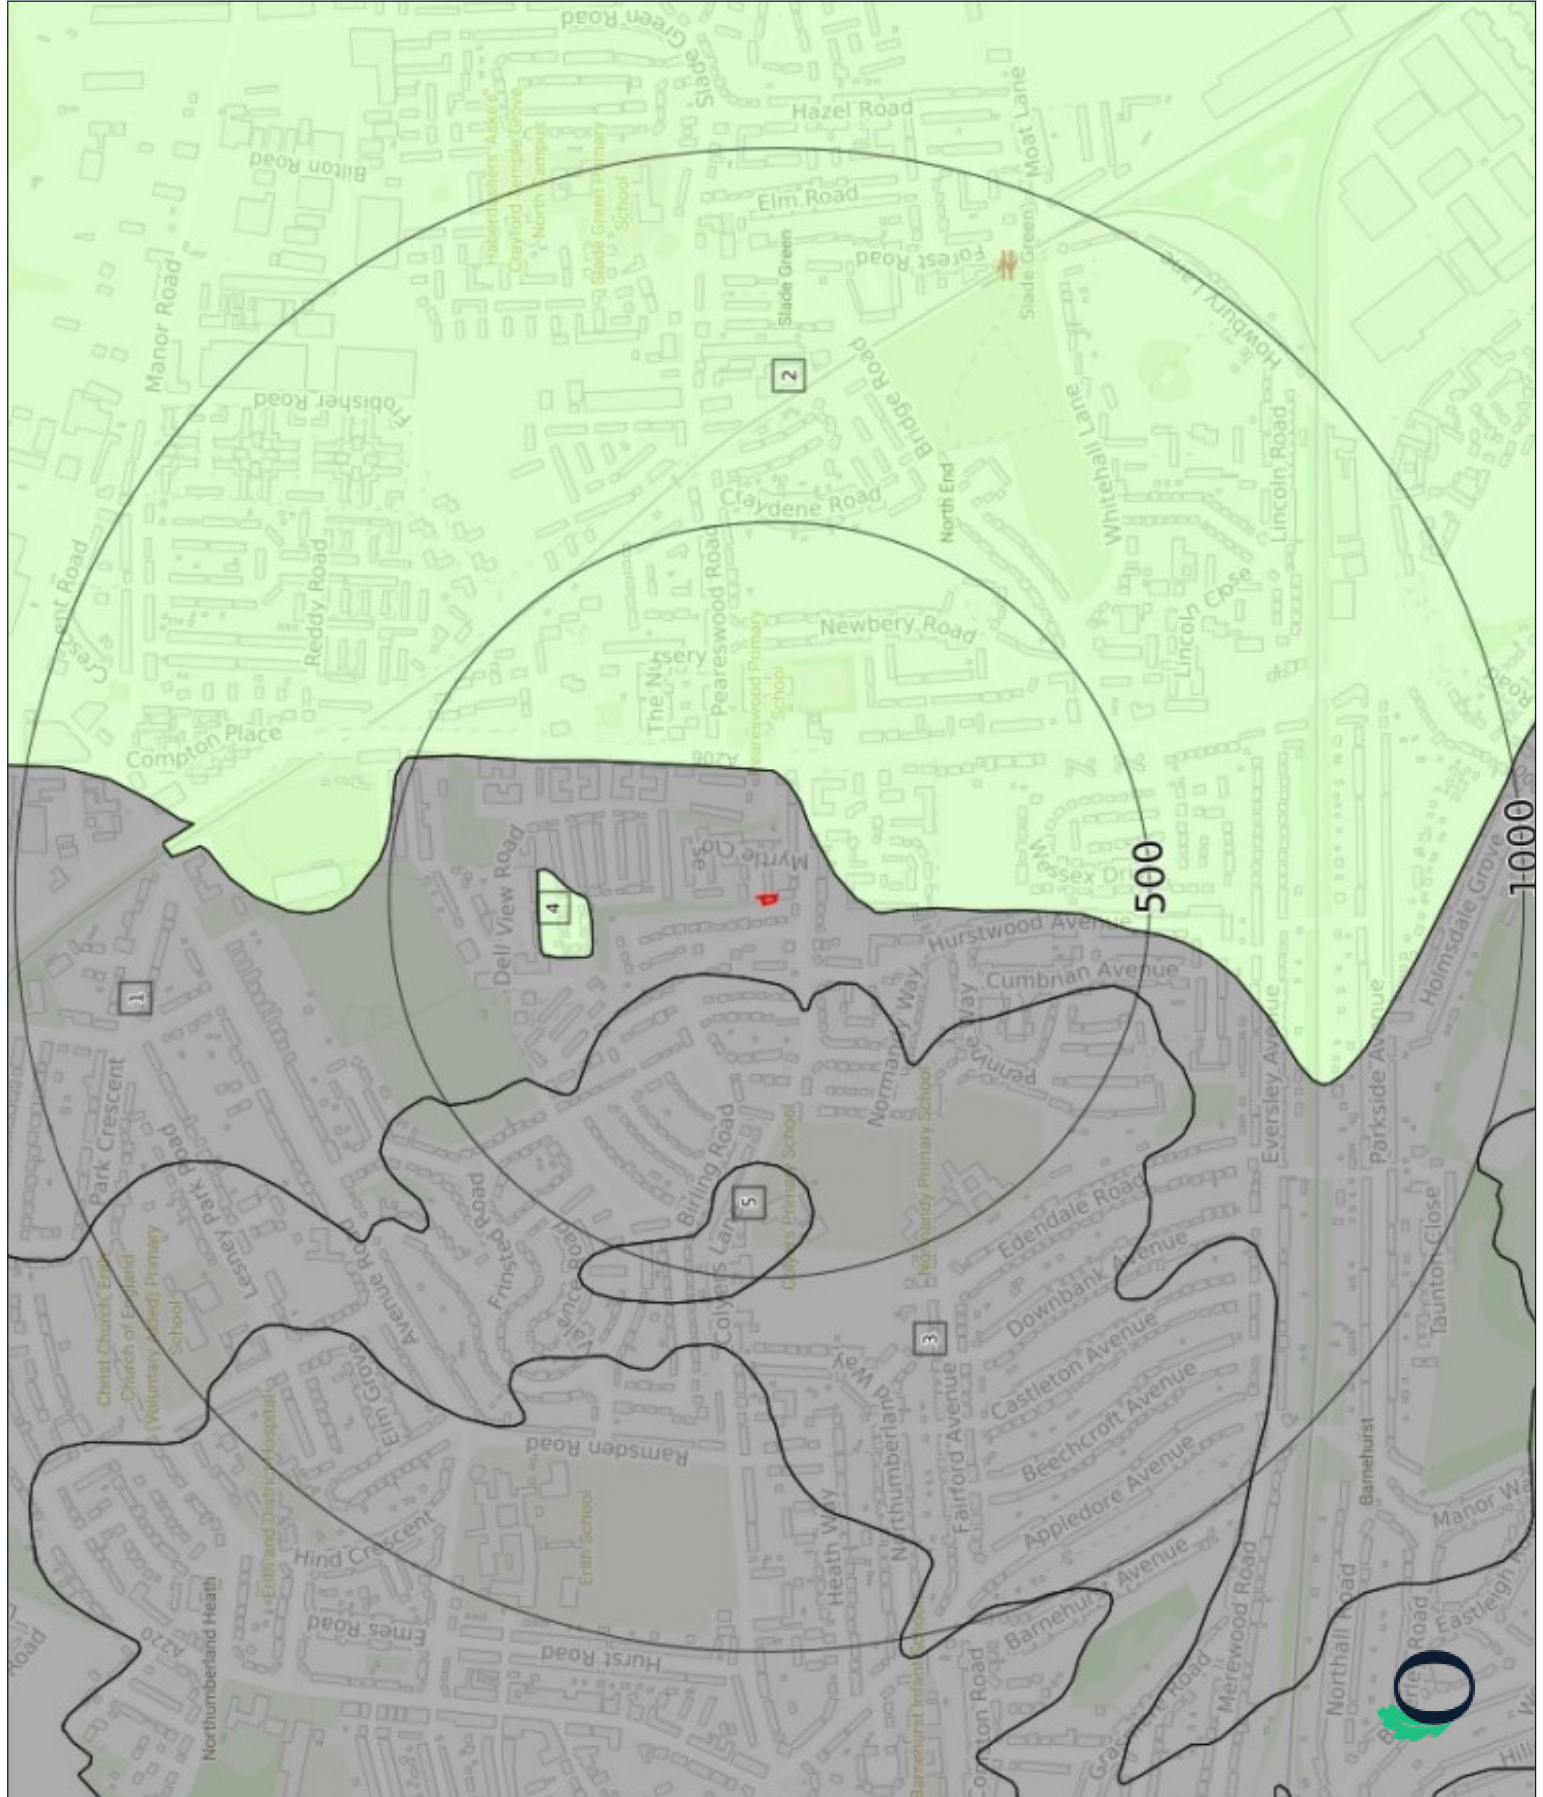
Description	
BGS map showing bedrock geology on site	
Sources	
British Geological Society (2021)	
Key	
Site boundary	
Thanet Sand Formation	
Seaford Chalk Formation	
Name	Figure 21

Bedrock Geology	Thanet Sand Formation - Sand	
	Artificial Ground permeability	Low to Very High (through mixed flow types)	
	Superficial Permeability	Very Low to Low (through mixed flow types) 3m south	
	Bedrock Permeability	High (through intergranular flow)	
	Borehole Records	Boreholes completed for the residential development to the south in 1974 identified made ground including brick and concrete rubble, glass, slag, ash and organic material to depths of >10m in some areas Groundwater encountered around 5m	
Workings	Mining and Ground Workings	'Normandy Farm Clay Pit' and 'Normandy Farm Clay Pit (south)' surface mineral workings 124m and 238m south (ceased) 'Larner Road Chalk Mine' underground working 259m north (ceased) 'Thanet Road Clay Pit' surface mineral working 265m north (ceased) - the site appears to form part of this clay pit 'Erith Clay Pit' surface mineral working 293m north (ceased) Additional underground chalk mines, surface clay pits and a brick works >300m
