Location:
**Raby Castle,
(Underground Services)**

Report Type:
**Arboricultural Method Statement
inc. Impact Assessment**

Ref:
ARB/CP/2585

Date:
August 2021

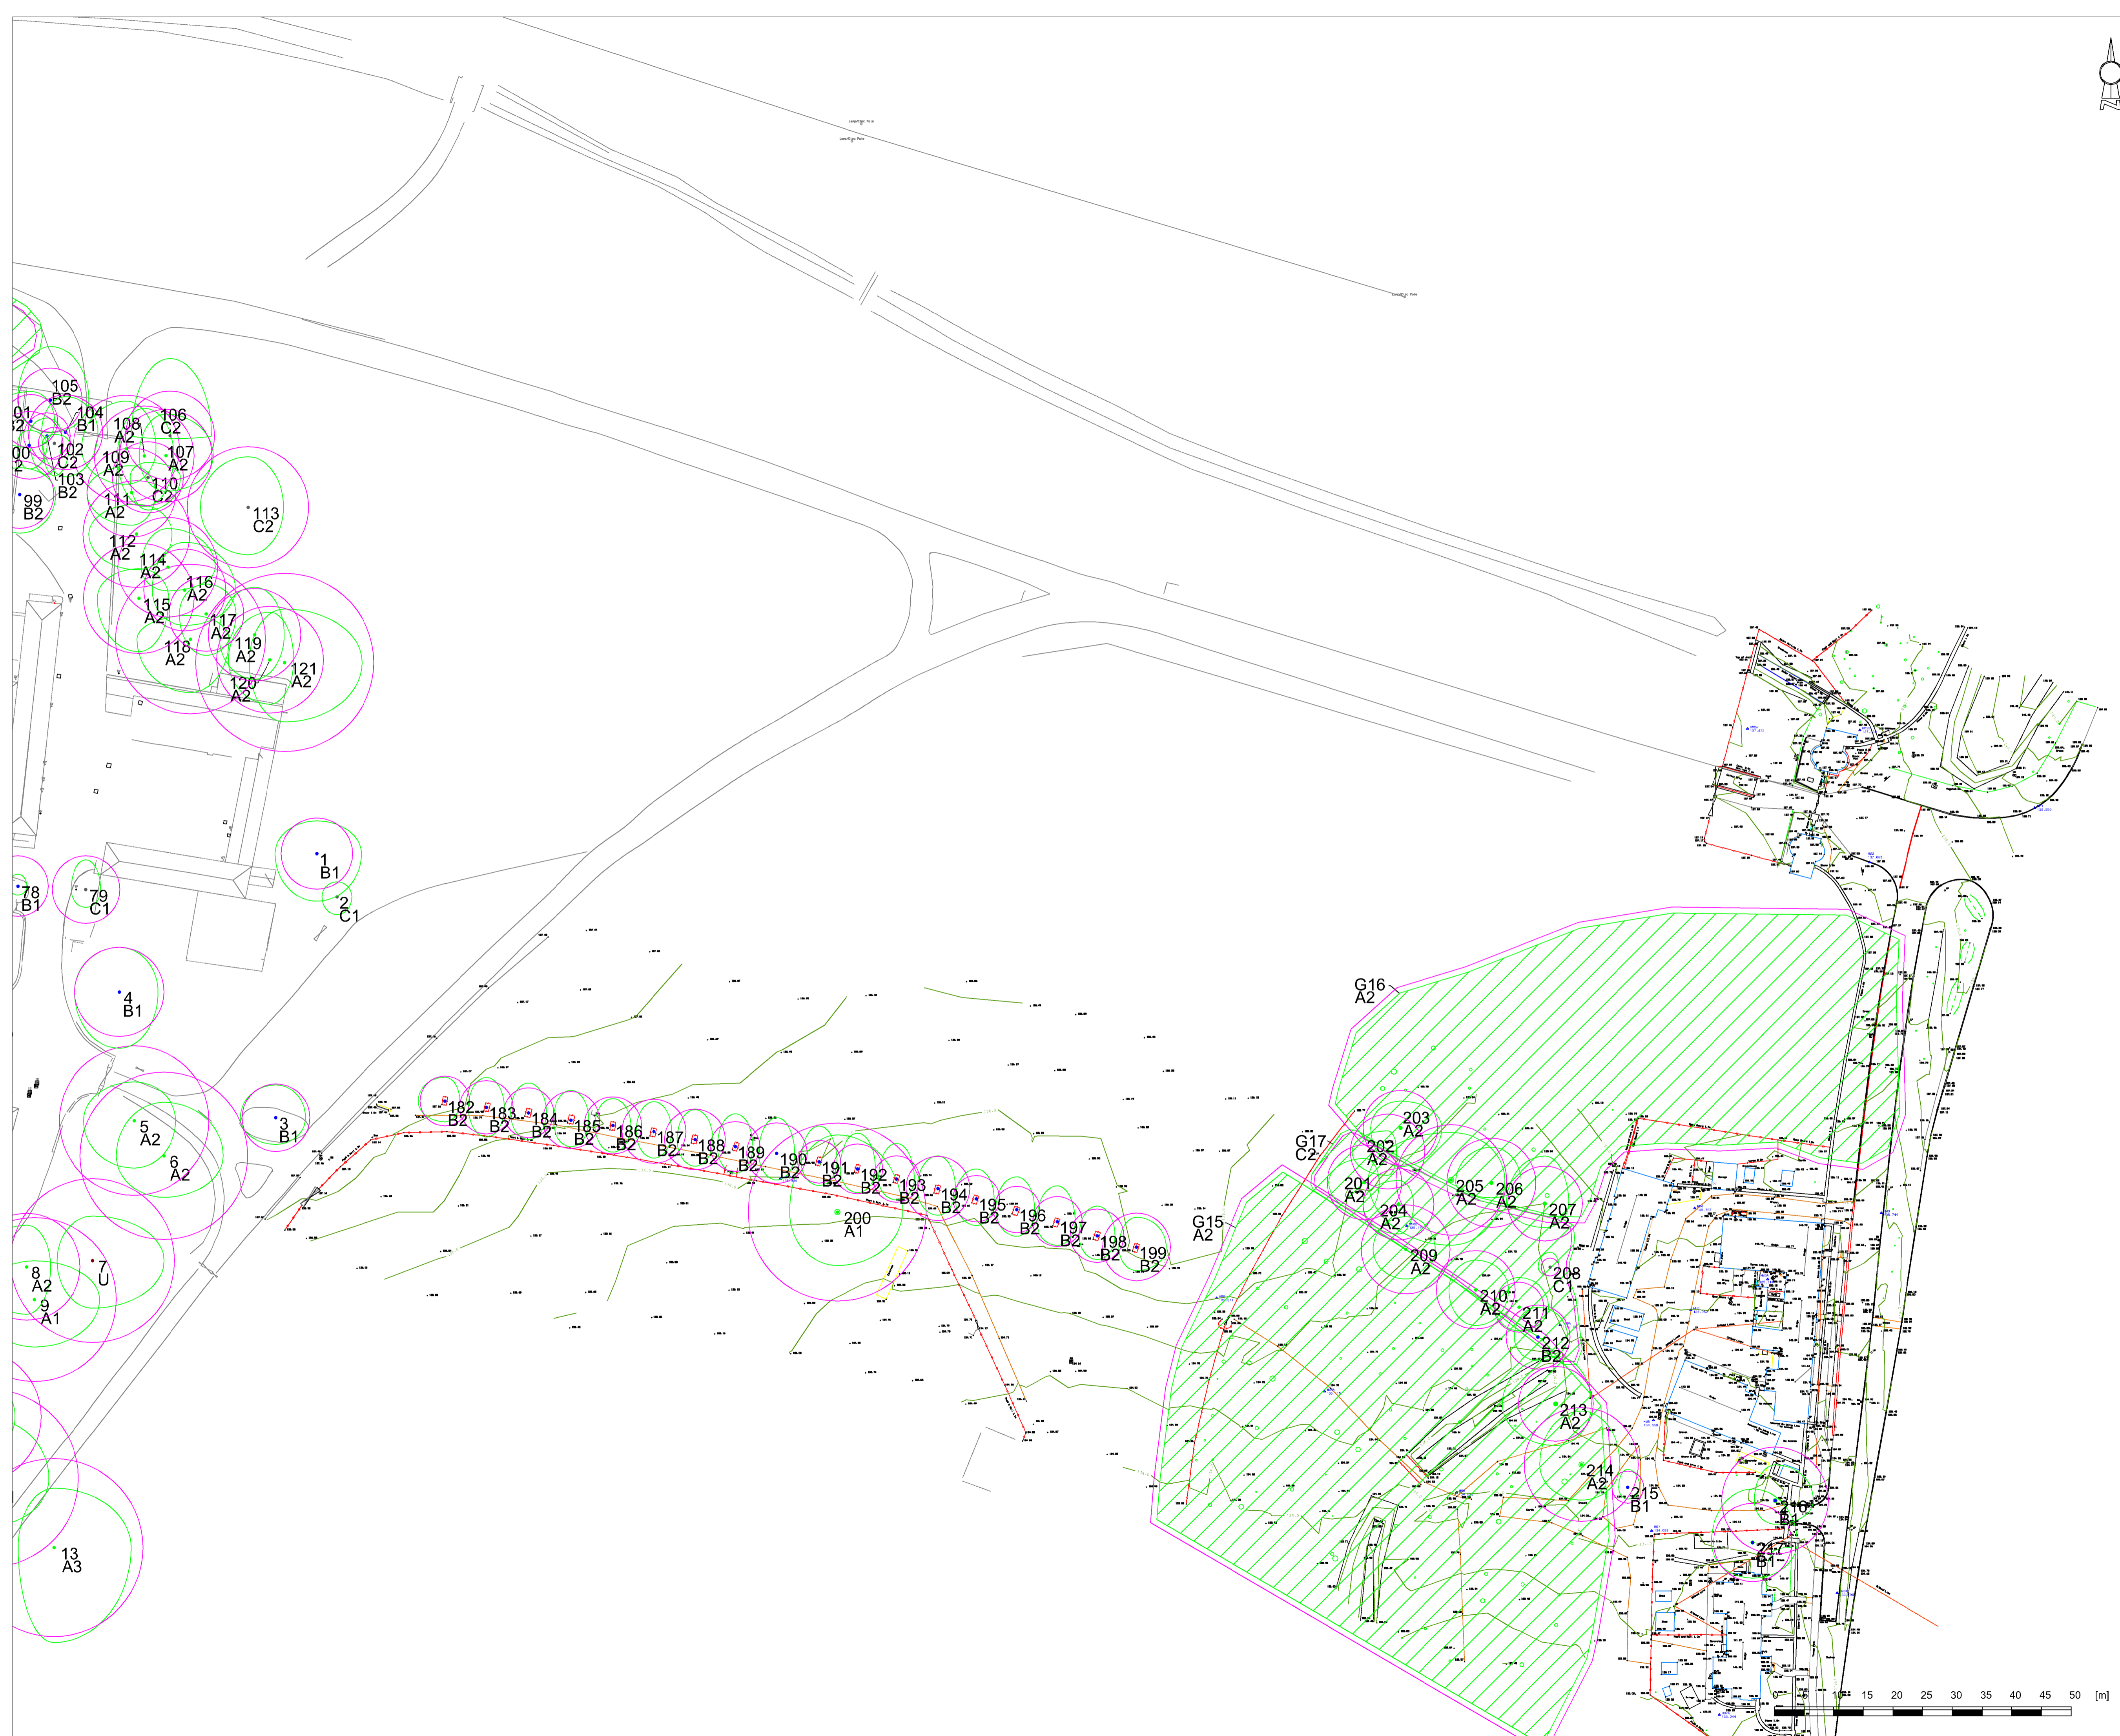
Drawing Title: Tree Constraints Plan

Project: Raby Castle Underground Services

Drawing Number: ARB/CP/2585/TCP
