Arboricultural Impact Assessment Method Statement & Tree Protection Plan (to BS:5837 2012)

Homewood, Farm Lane, Loudwater
WD3 4XJ

Ref: TH 3077

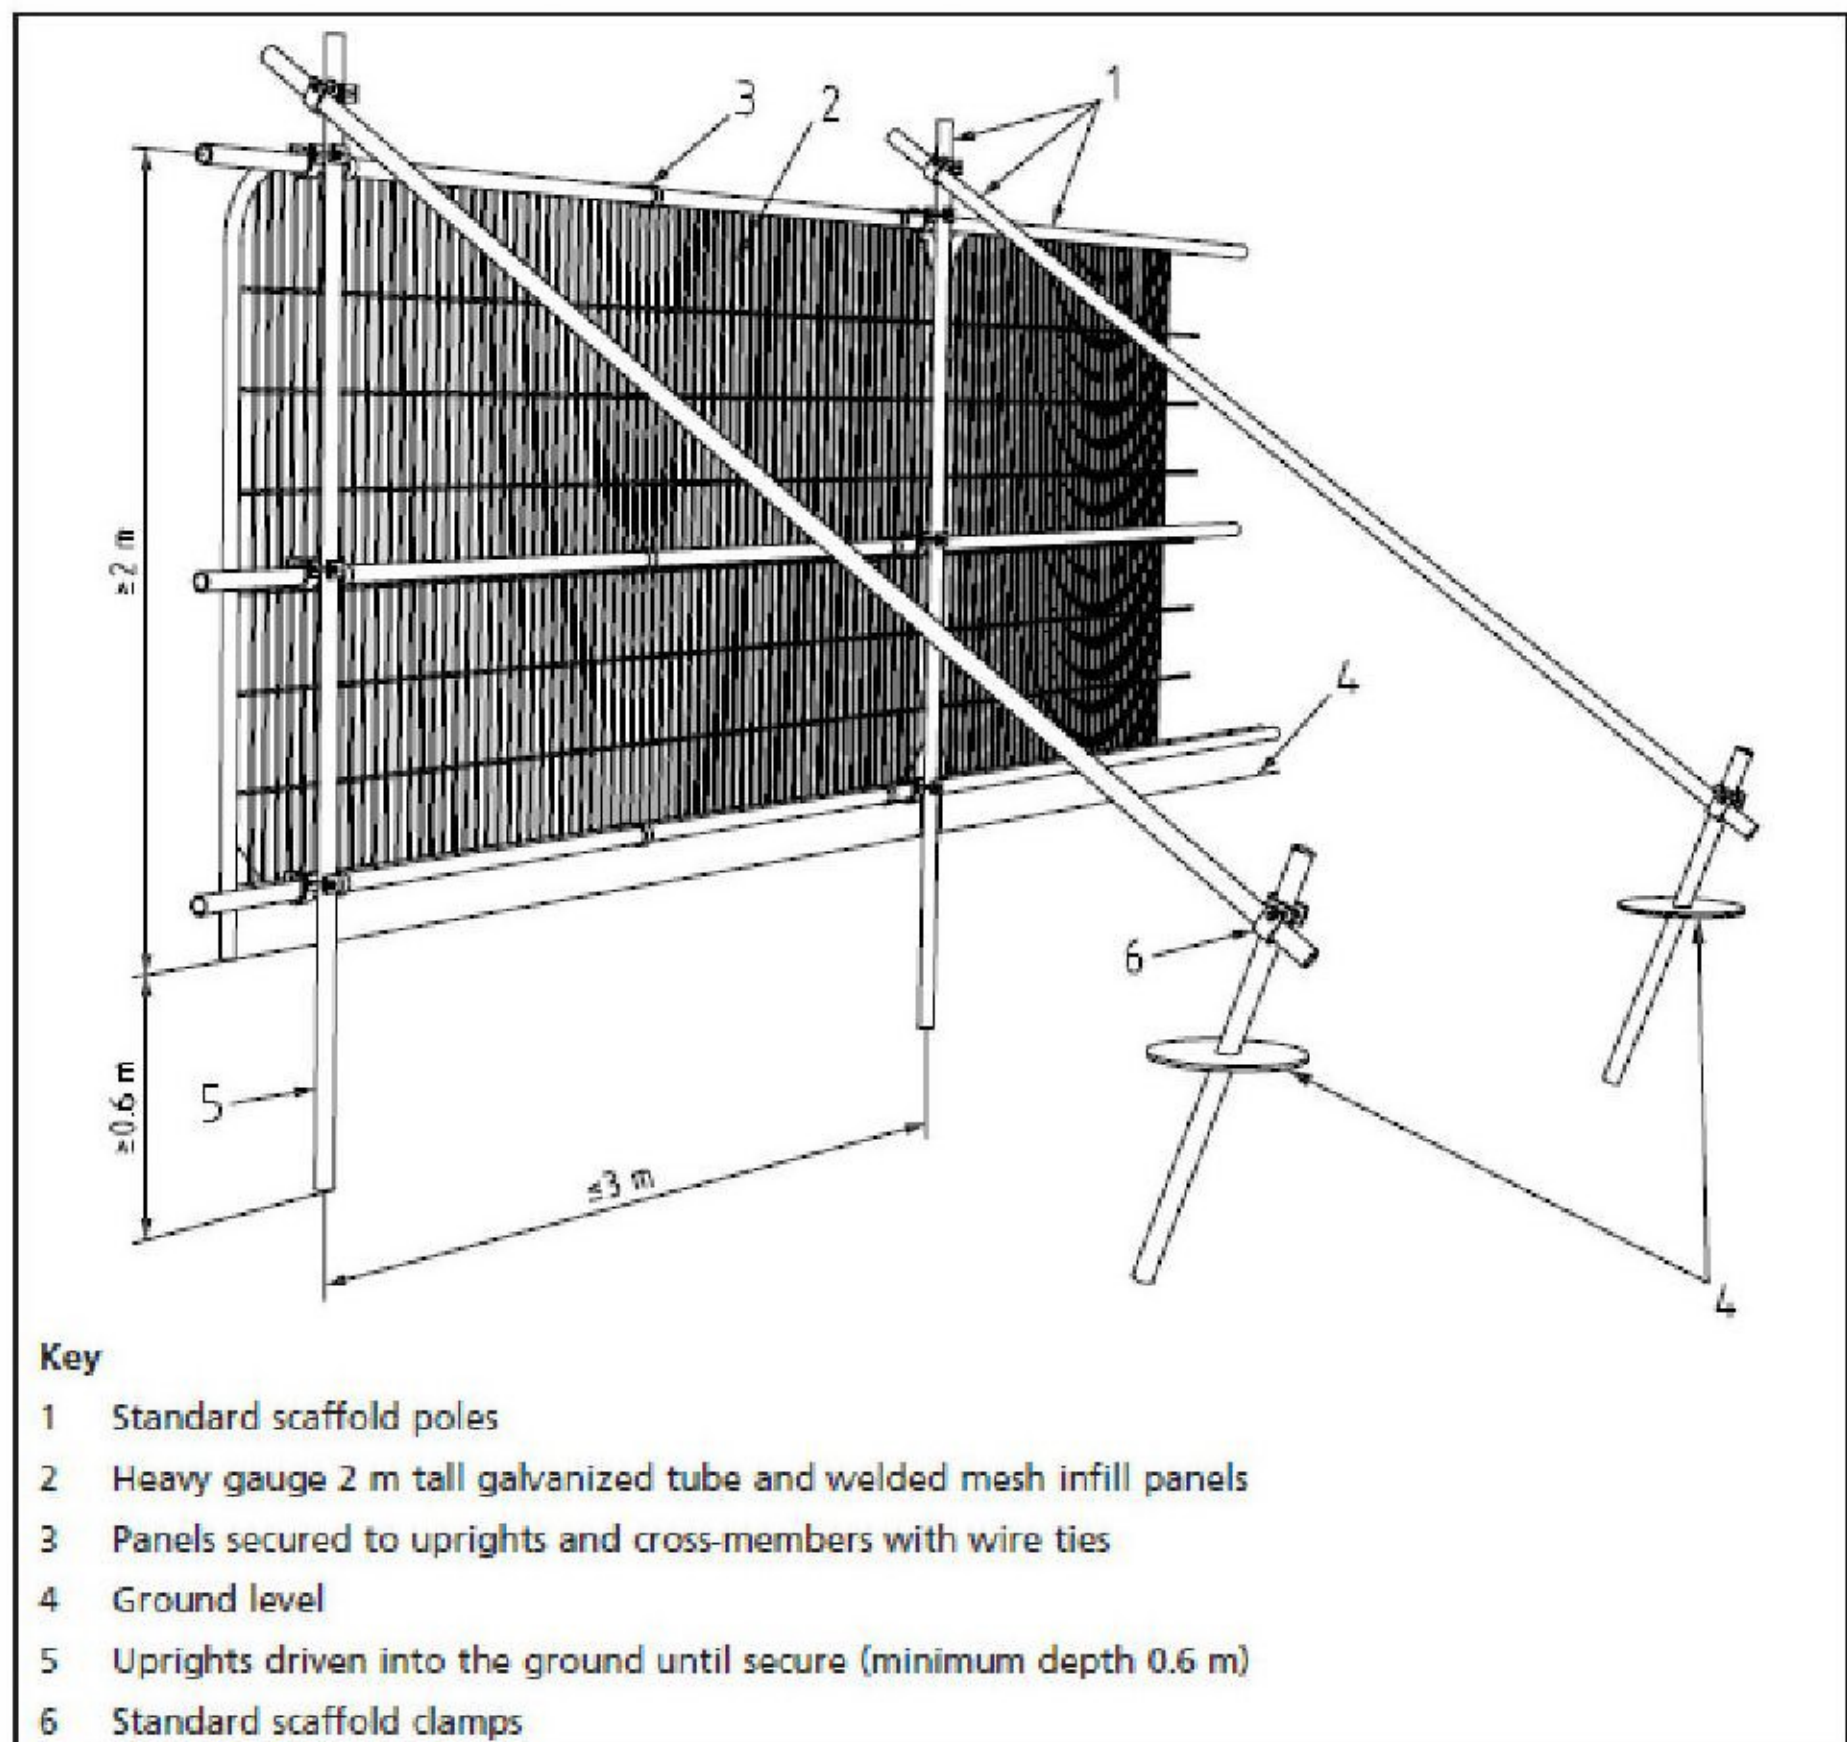
Figure 2: Default specification for protective barrier (BS 5837:2012)

The framework support (shown in Figure 2 and photo 1) is the usual method of support for ‘Heras’ fencing. Some variations are possible if site conditions are appropriate; i.e. support by wooden posts (75mm x 75mm x 2.75m) dug or concreted into the ground (dry mix concrete contained within a plastic bag), or if there is no pressure for access, a lighter form of netting on stakes.

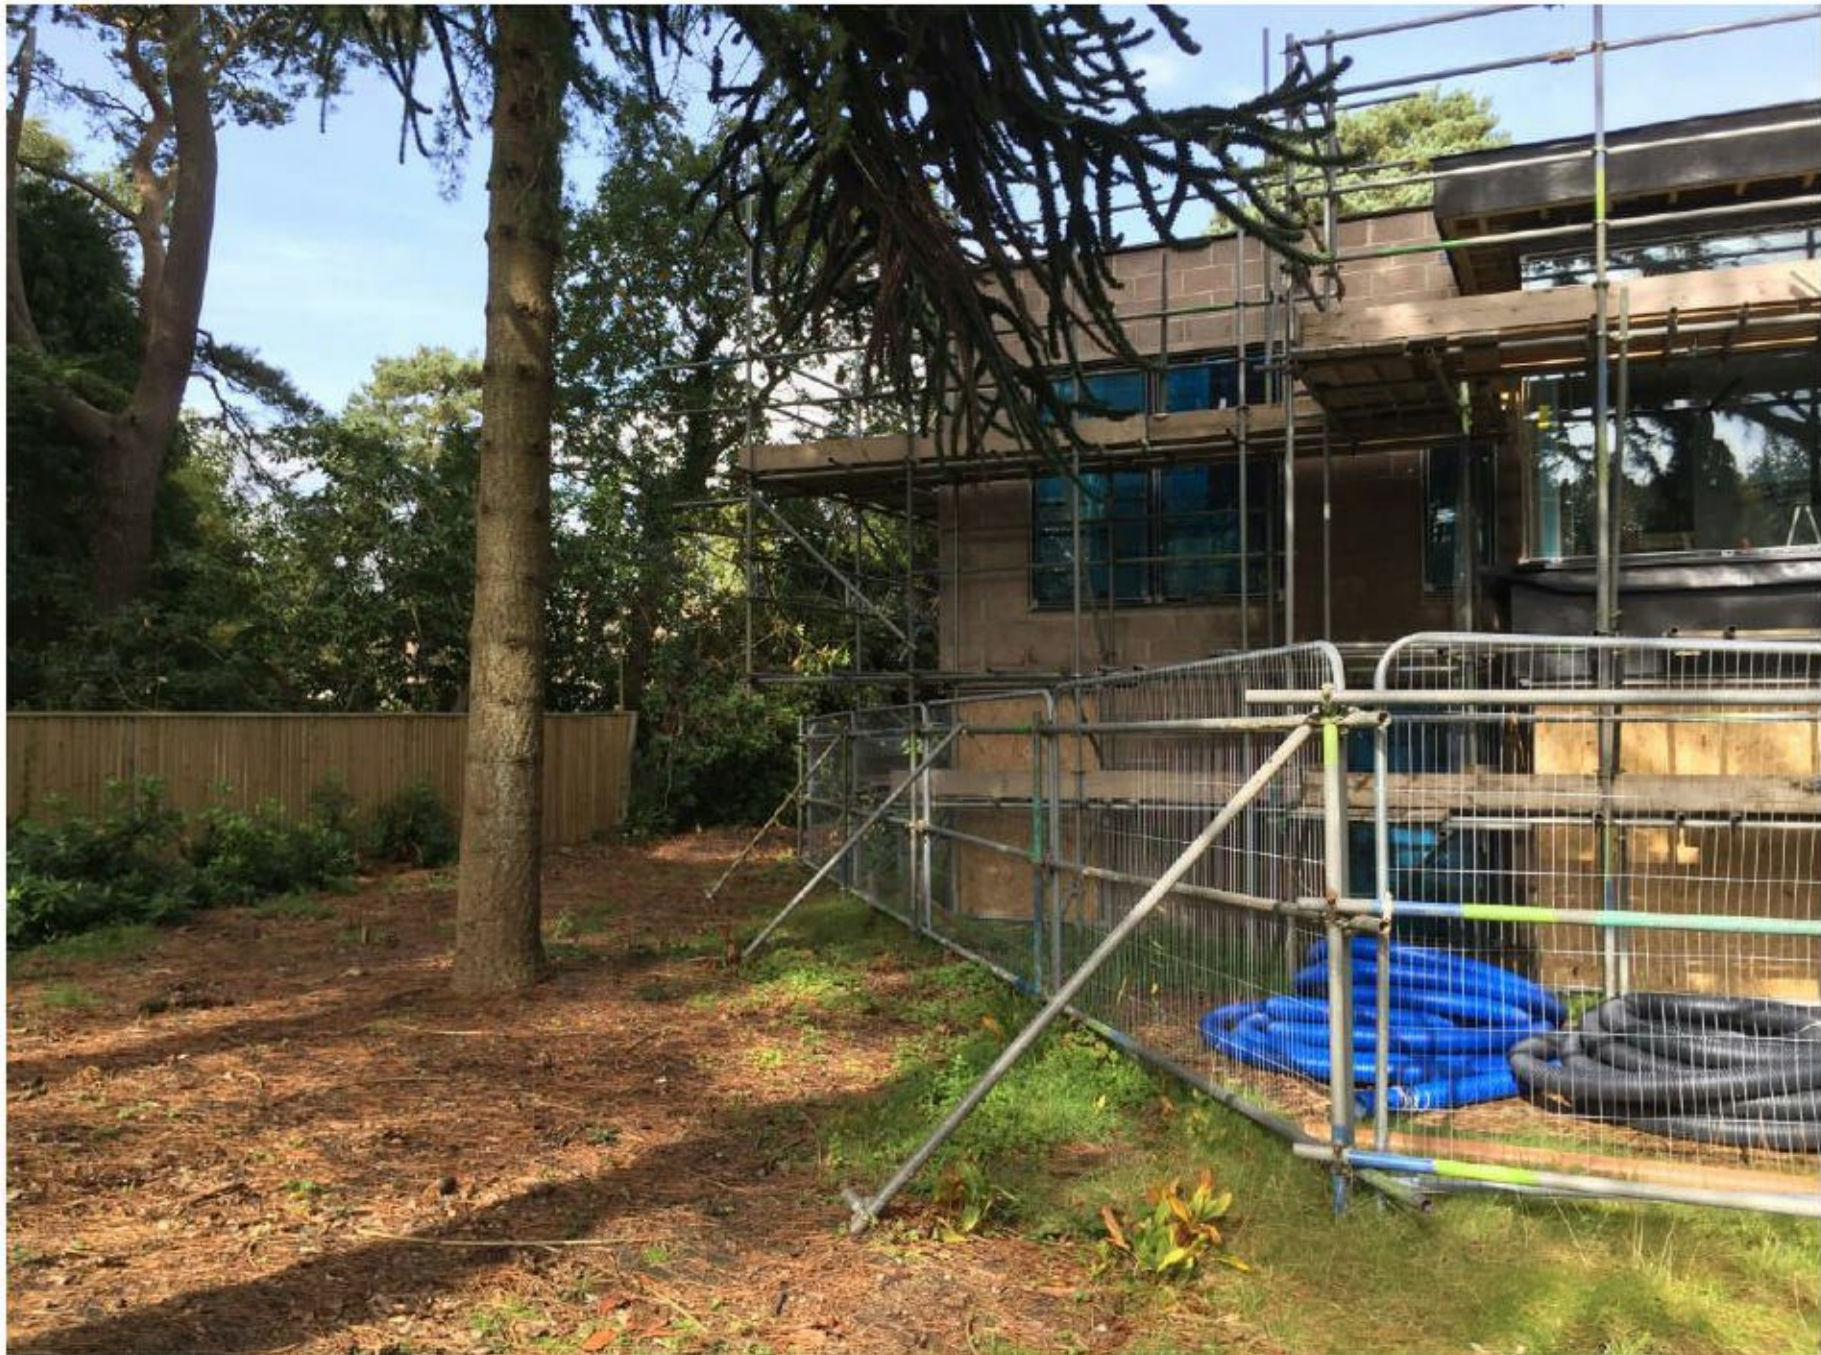
Photo 1: A worked example of the default specification for protective barrier (BS 837:2012)

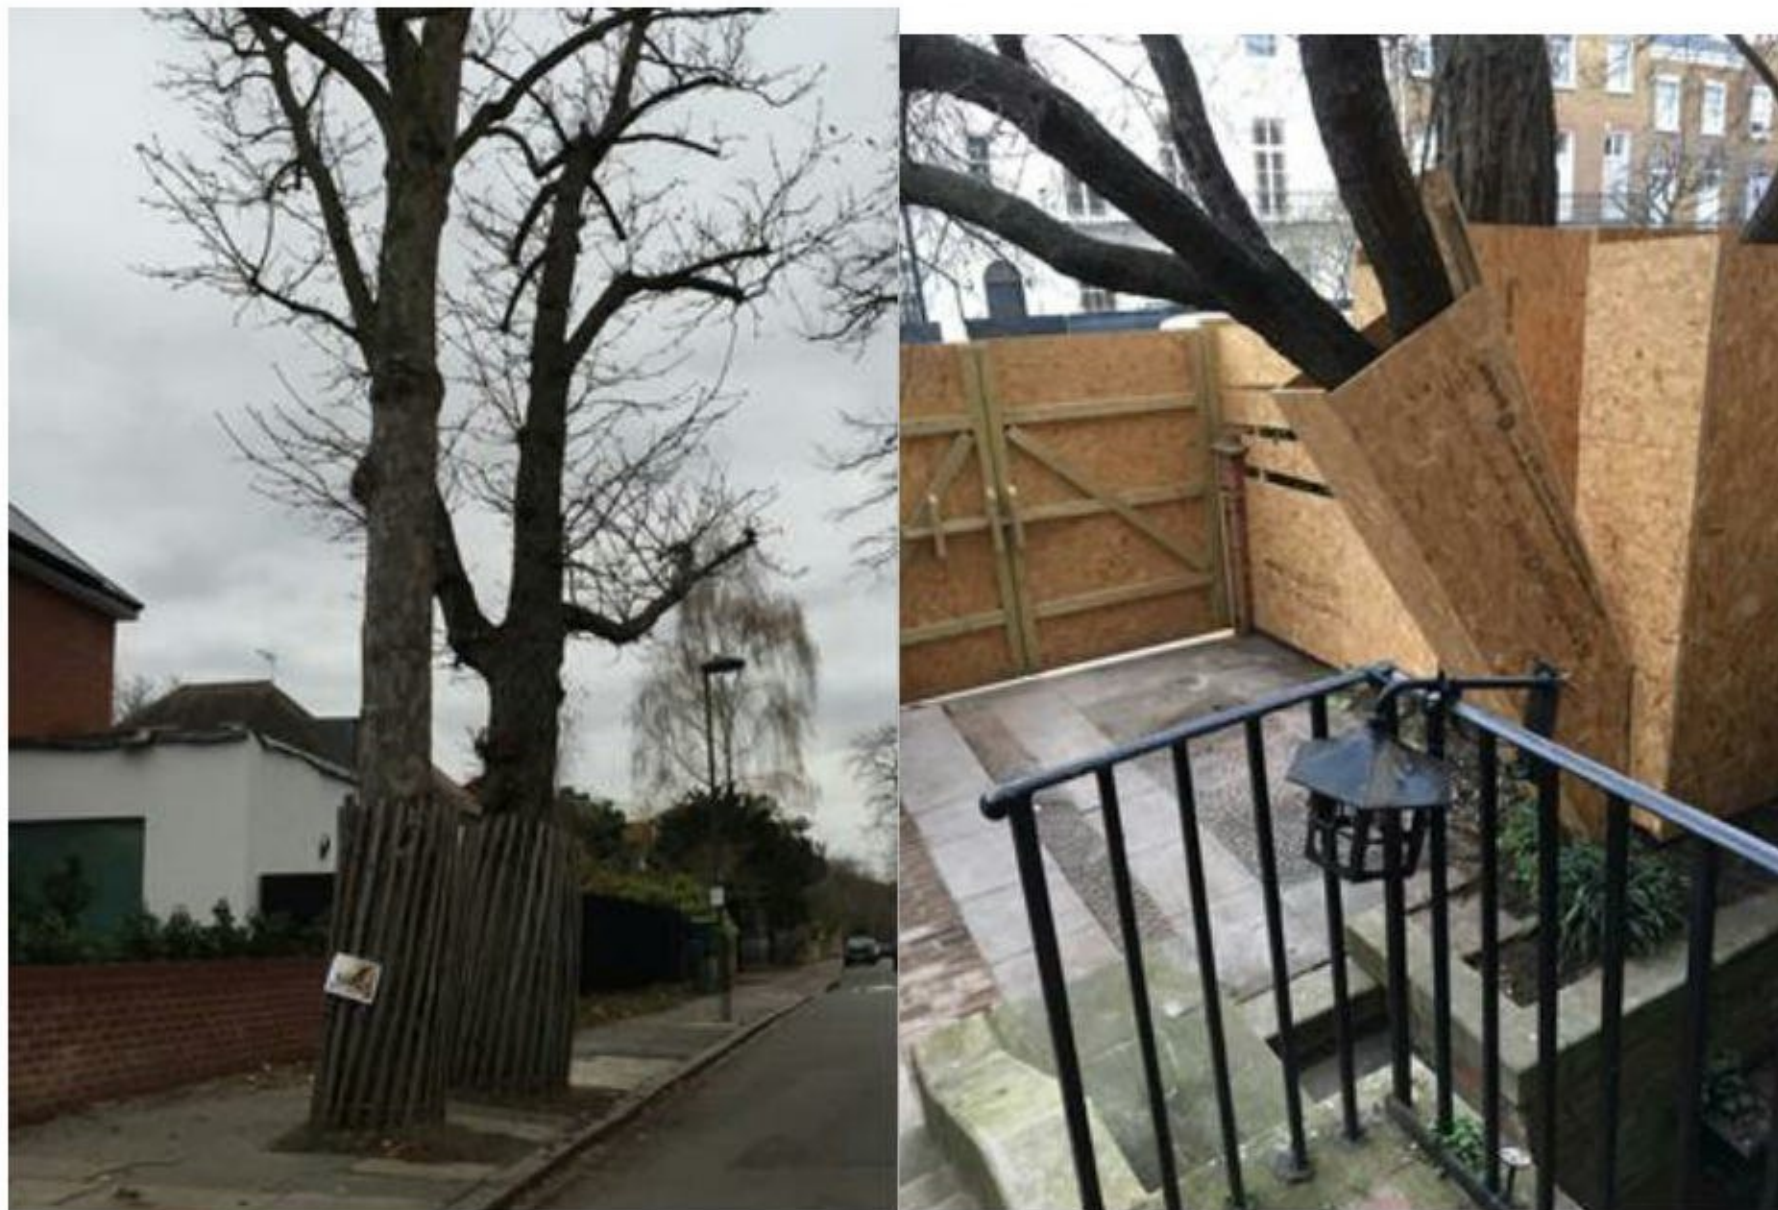
Photo 2: Trees protected by hessian & chestnut pale fencing / limbs protected by wooden boxing

Where specified in the AMS, the tree(s) stem/s shall be boxed off with wooden ply boards or wrapped in hessian and chestnut pale fencing. This will help avoid any direct damage to tree stems from passing machinery (see photo 2).

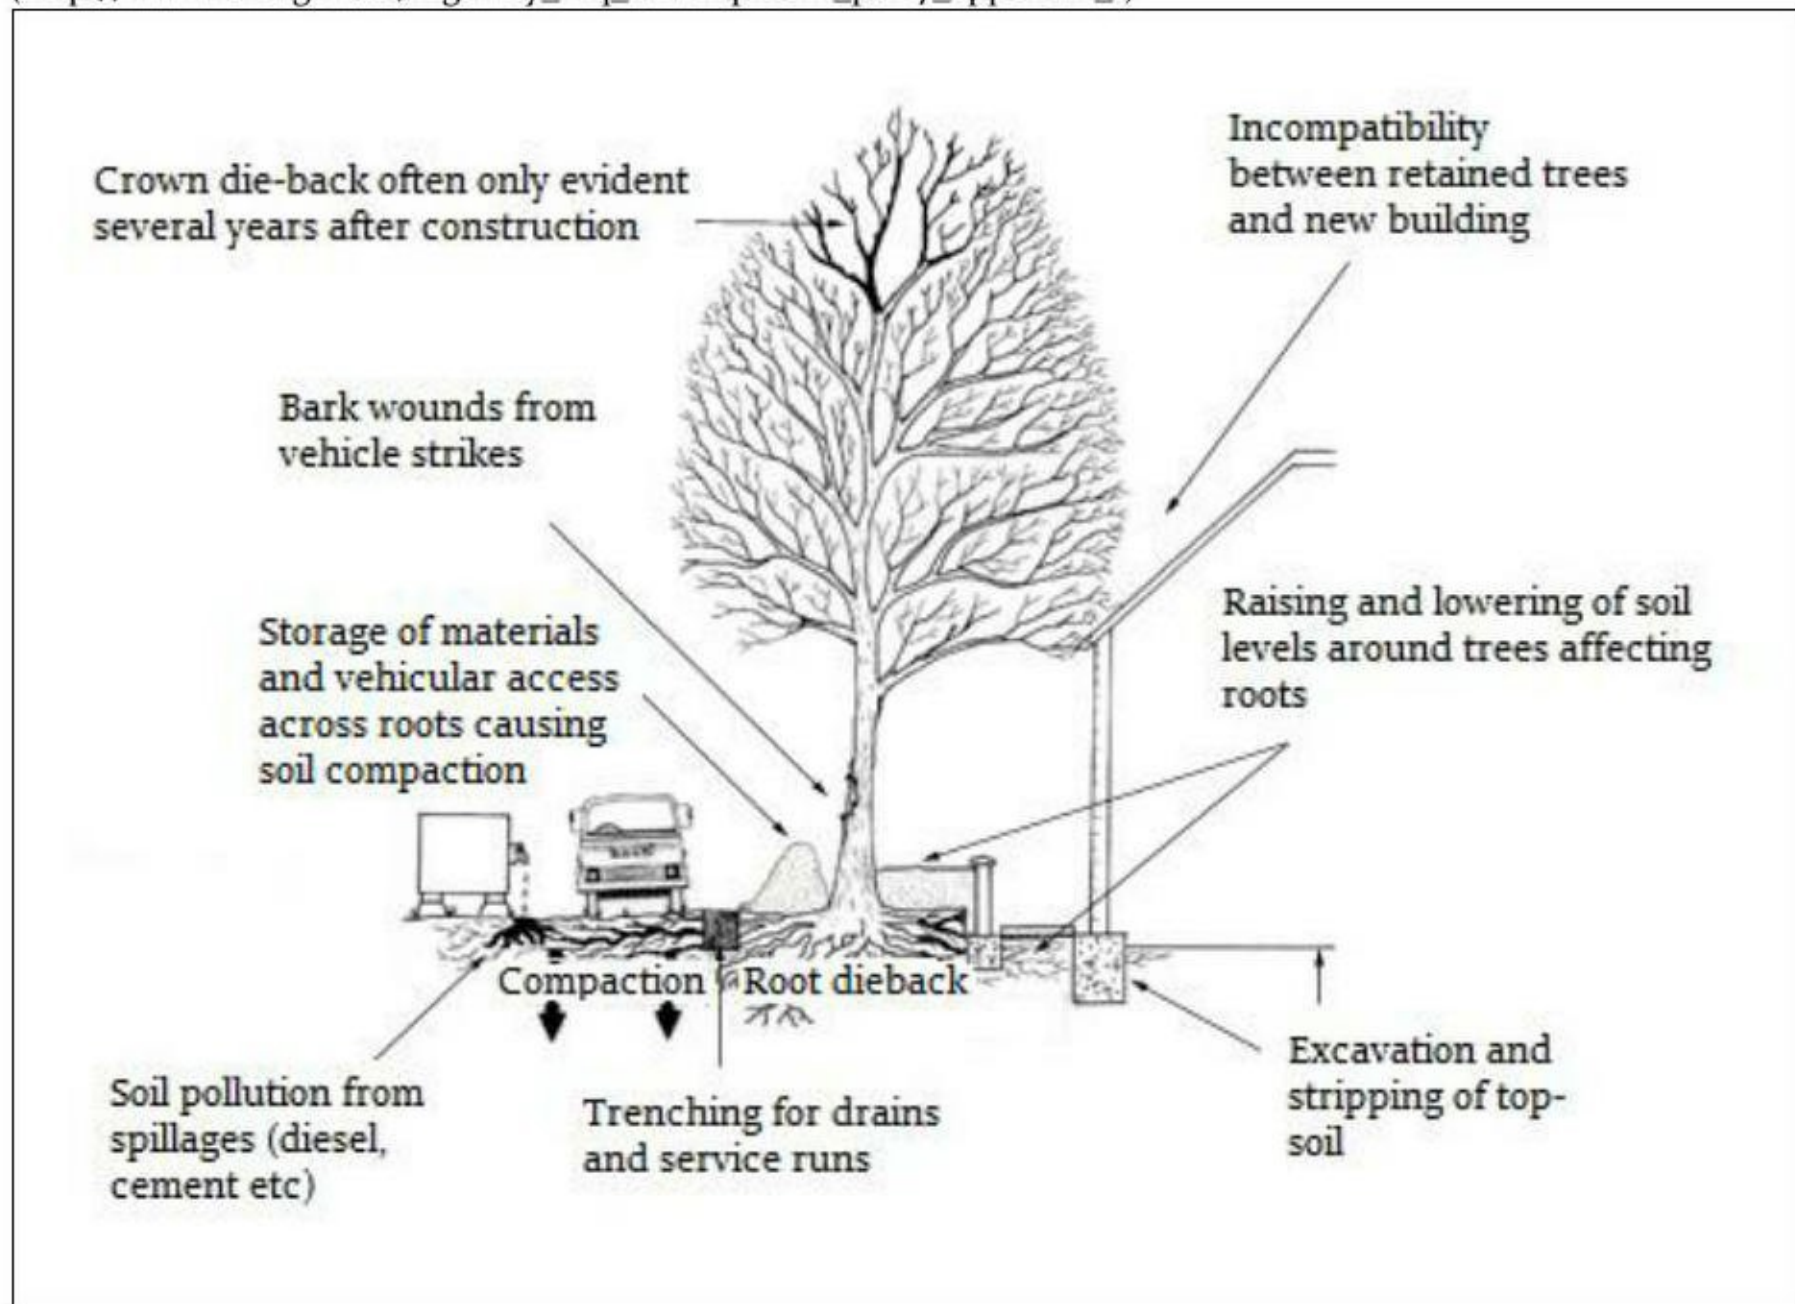
Figure 4: Common problems for trees on development sites
(http://www.leics.gov.uk/highway_req_development_part7_appendix_f)

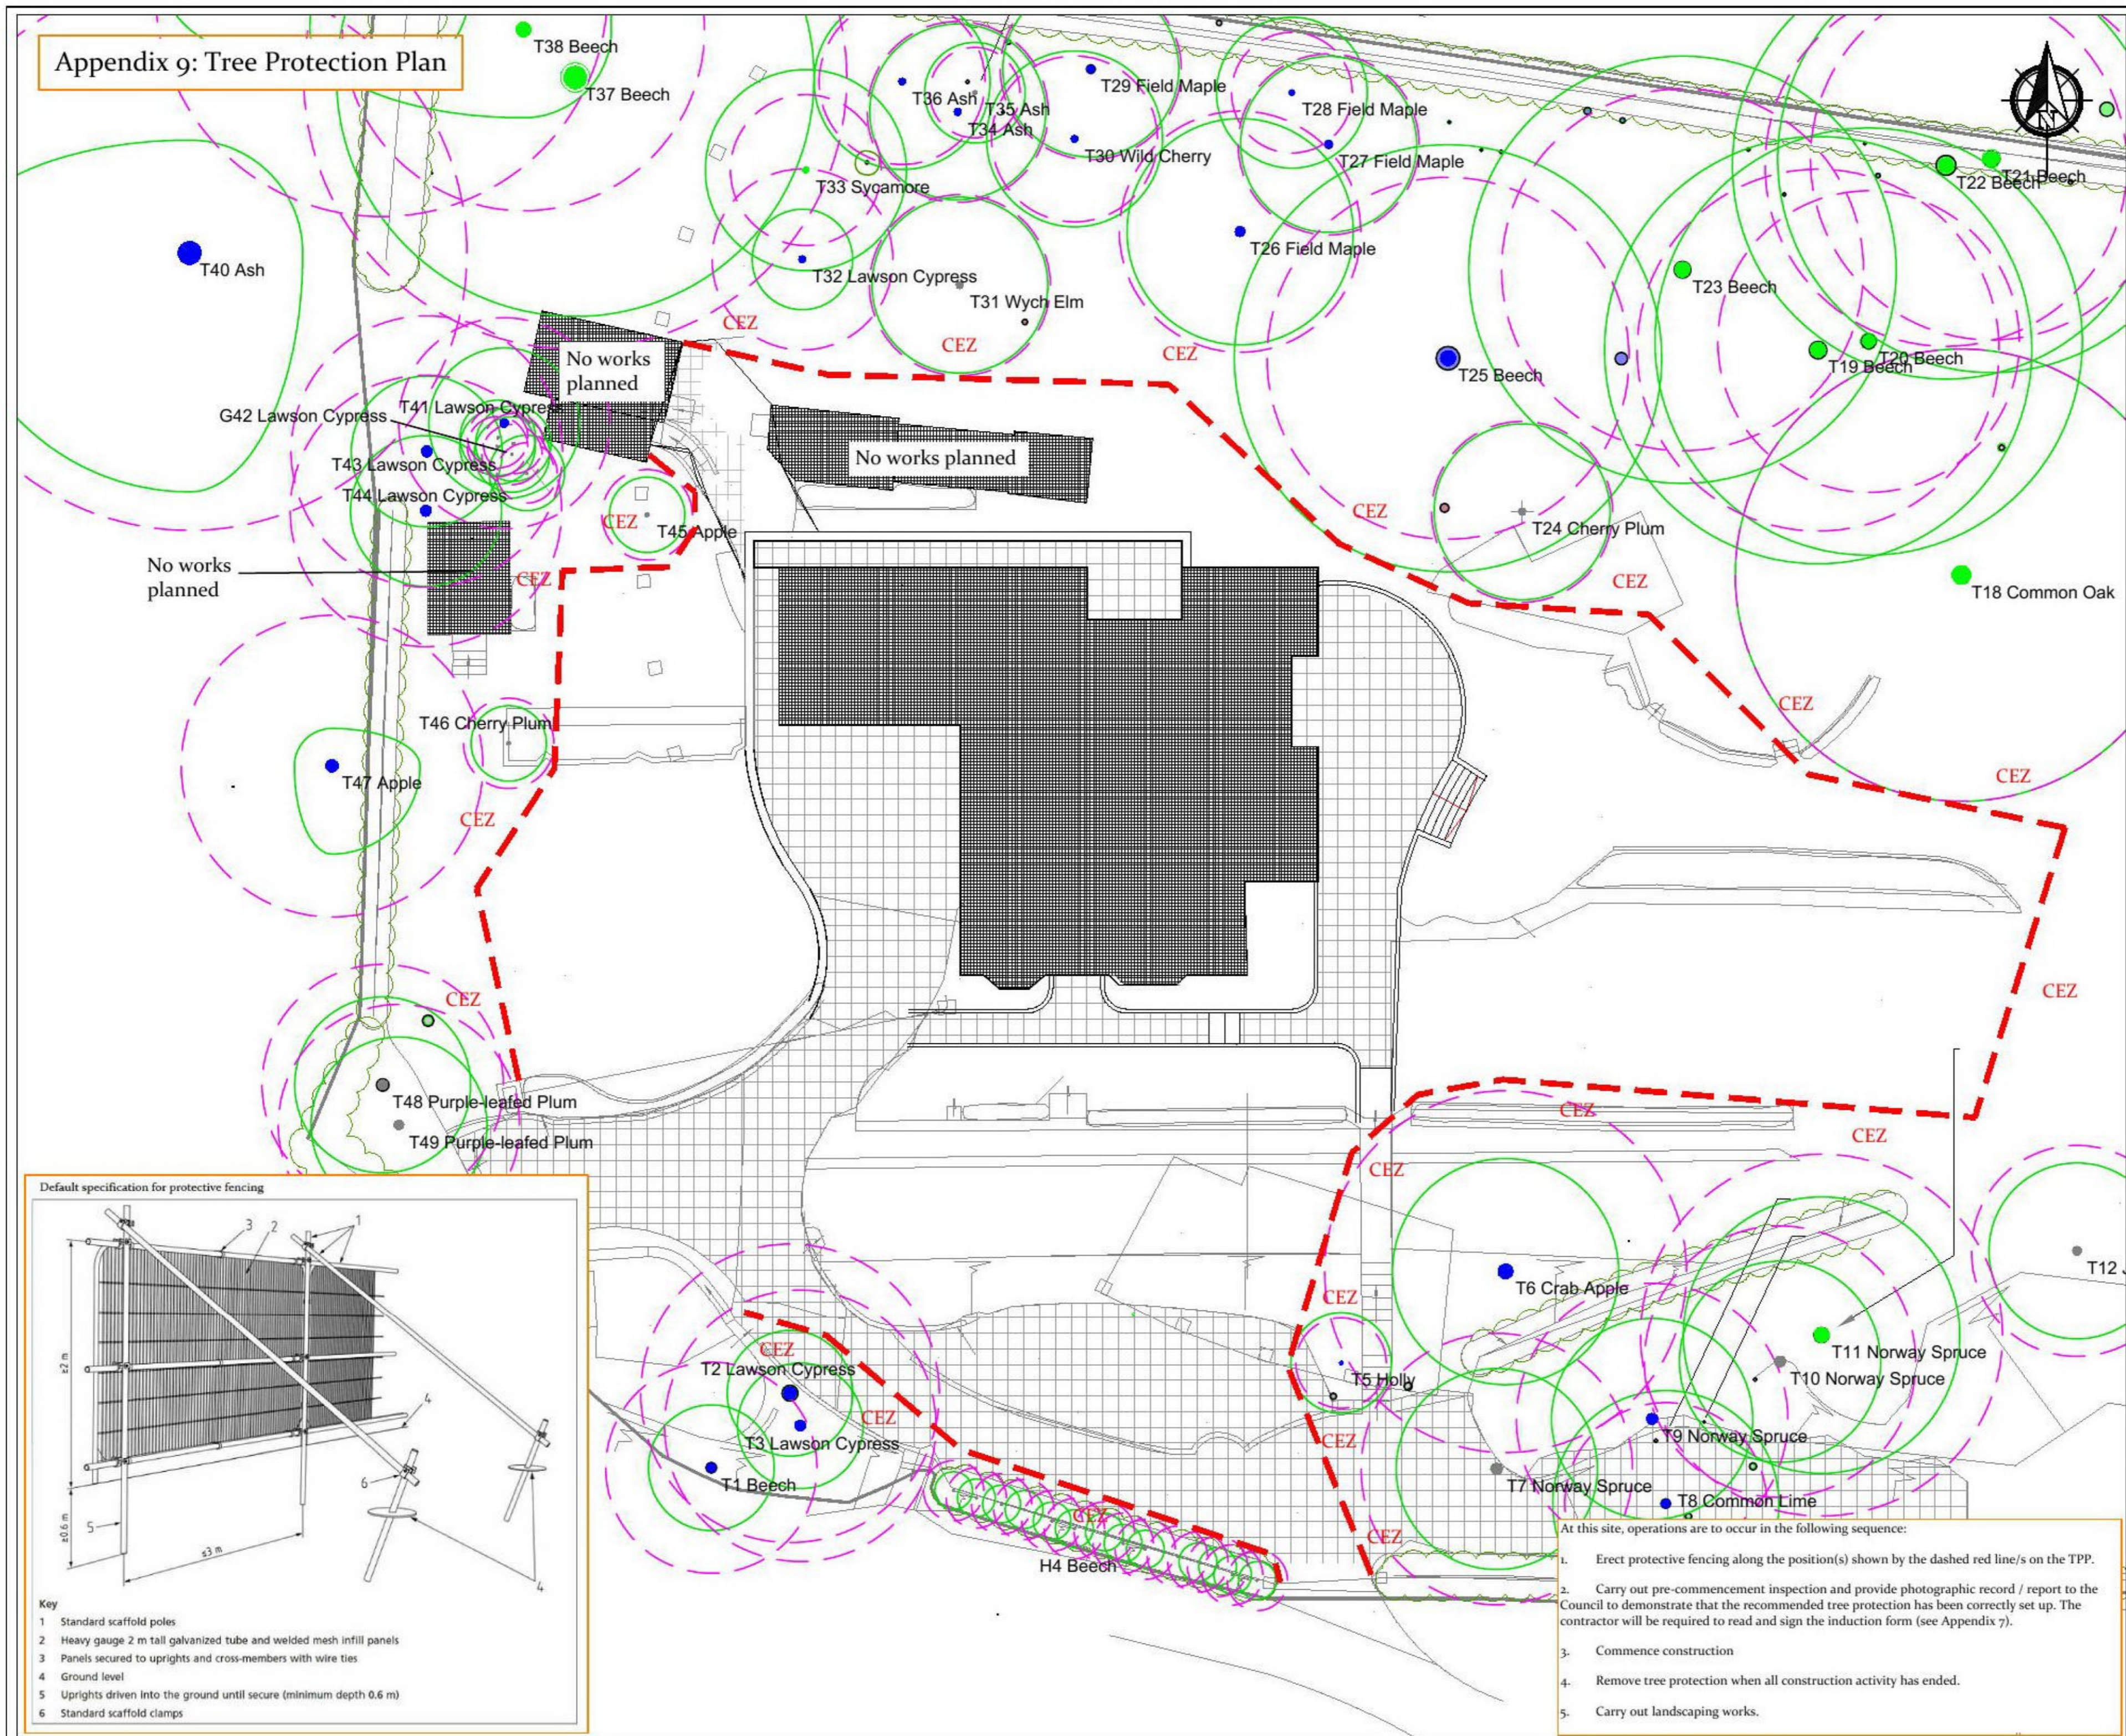
Appendix 9: Tree Protection Plan

- At this site, operations are to occur in the following sequence:
1. Erect protective fencing along the position(s) shown by the dashed red line/s on the TPP.
 2. Carry out pre-commencement inspection and provide photographic record / report to the Council to demonstrate that the recommended tree protection has been correctly set up. The contractor will be required to read and sign the induction form (see Appendix 7).
 3. Commence construction
 4. Remove tree protection when all construction activity has ended.
 5. Carry out landscaping works.

1. Erect protective fencing along the position(s) shown by the dashed red line/s on the TPP.
2. Carry out pre-commencement inspection and provide photographic record / report to the Council to demonstrate that the recommended tree protection has been correctly set up. The contractor will be required to read and sign the induction form (see Appendix 7).
3. Commence construction
4. Remove tree protection when all construction activity has ended.
5. Carry out landscaping works.
