## **Cromlet Hill Bat Survey**

**September 2021**

Envirocentre was commissioned by Ian Duncan Architects to undertake a Preliminary Roost Assessment (PRA) and late-season bat activity survey of a derelict residential outbuilding proposed for re-development into a Pool House at Cromlet Hill Guest House.

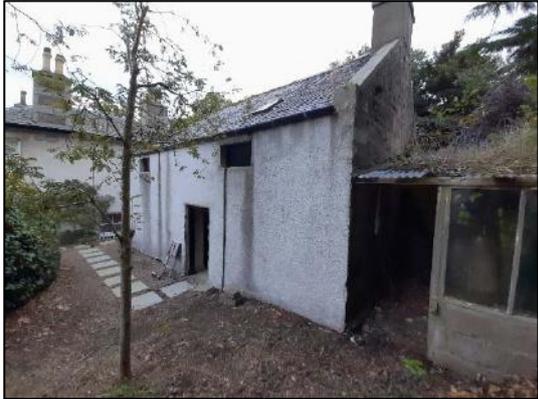
**Photo 1: North east viewpoints**

A dusk emergence survey was conducted on the outbuilding on the 14th September 2021. During the activity survey, surveyors were positioned at vantage points to gain visual and audible coverage of all PRFs. One covered the north and east aspects (Photo 1), the other covered the south and west aspects (Photo 2) where they also deployed the EMT & Anabat.

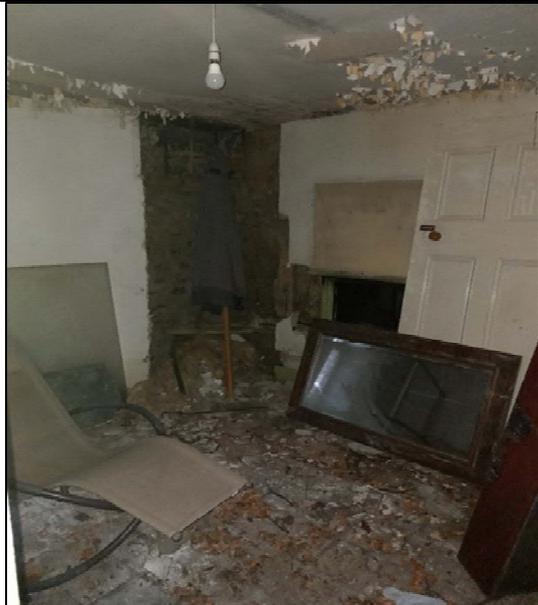
**Photo 3: Building interior**

Internally, the building presents a deteriorating plasterboard and wood panelled surround (Photo 3), with a fireplace present on both floors of the north aspect (Photo 4). There is a small heavily cobwebbed loft space extending the full length of the building (Photo 5). There were no obvious signs of daylight gaps in the roofing or at the wall heads. A former stable is present at the south of the building (Photo 6).

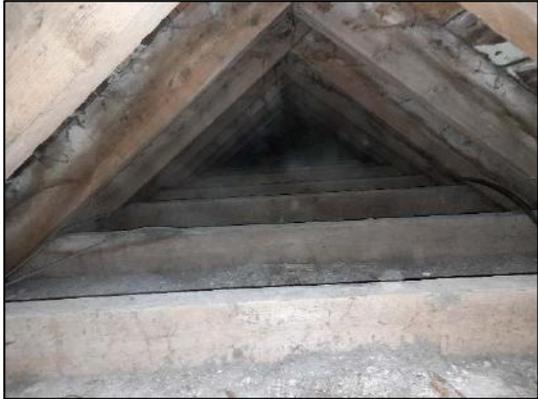
**Photo 5: Loft space**

The former stables and loft space structure have potential to host bats that require a void space (such as brown long eared bats), that are known to be present in the locale. However, the roof space is thick with spider's webs suggesting no internal flight by roosting bats and an open access hatch to the loft and the damaged wedged open door to the stables would cause thermal properties of the void space to fluctuate, all of these features are considered suboptimal for roosting bats.

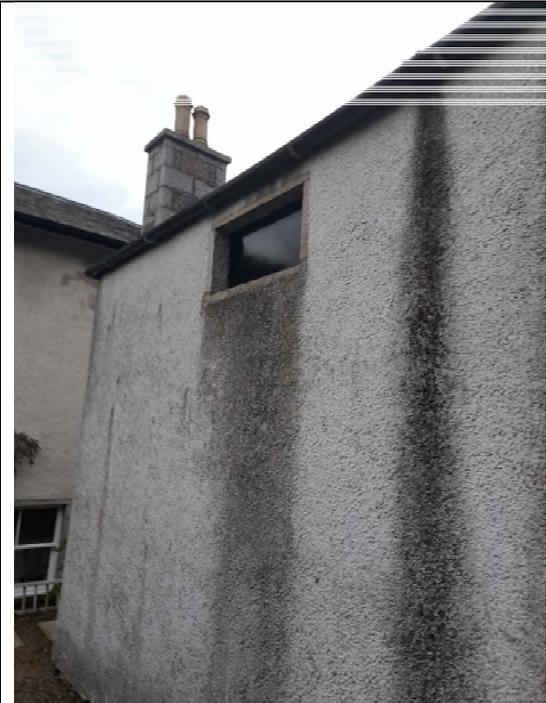
**Photo 7: Water staining**

The rendered exterior walls were largely intact and well-sealed, with water staining from drainage failure around the building's exterior (Photo 7). The wooden door and window frames were also intact and well-sealed (Photo 8 & 9). There were no noted gaps between the roof and the wall at the guttering.

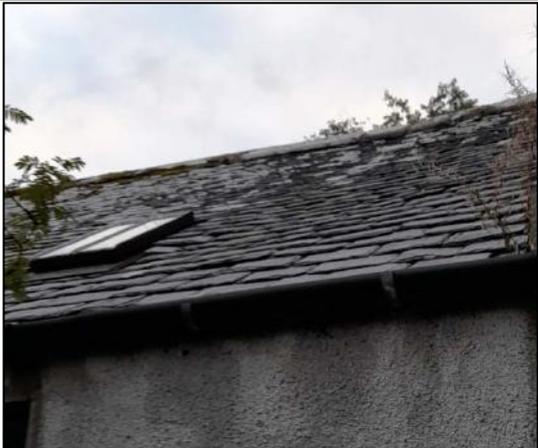
**Photo 10: Gaps in slate roof**

Some gaps were noted under and around the roof slates and ridge tiles (Photo 10), which are considered to present a roosting feature for opportunistic individual bats.

The loose slates and ridge tiles would be suitable for crevice dwelling bats such as common and soprano pipistrelle bats, known to be present in the locale and would most likely be utilised as a day roost by male or non-breeding females.
