Site/Building:	Semi-detached house	Date of survey:	23/06/21
Grid Reference:	SJ 21568 11567	Surveyor and report author:	Grace Dooley (NRW-licensed bat worker)
Site Address	41 Rhoslan, Guilsfield, Welshpool		
Customer Name	Mr Lee Andrew		
Reason for Survey	<p>Planning permission is sought for modification of the existing porch structure and the construction of a two-storey extension on the east elevation, to expand living space.</p> <p>Bats are a European Protected Species (EPS) and their presence or potential presence must be considered as a material part of any planning application; i.e. prior to the decision-making process.</p> <p>Initially, to determine likelihood of roosting bat presence at 41 Rhoslan, the suitability of the structure and its surrounding habitat was ranked according to the Bat Survey Guidelines (2016), shown in Table 1 below.</p>

Evaluation of building's suitability to support bats

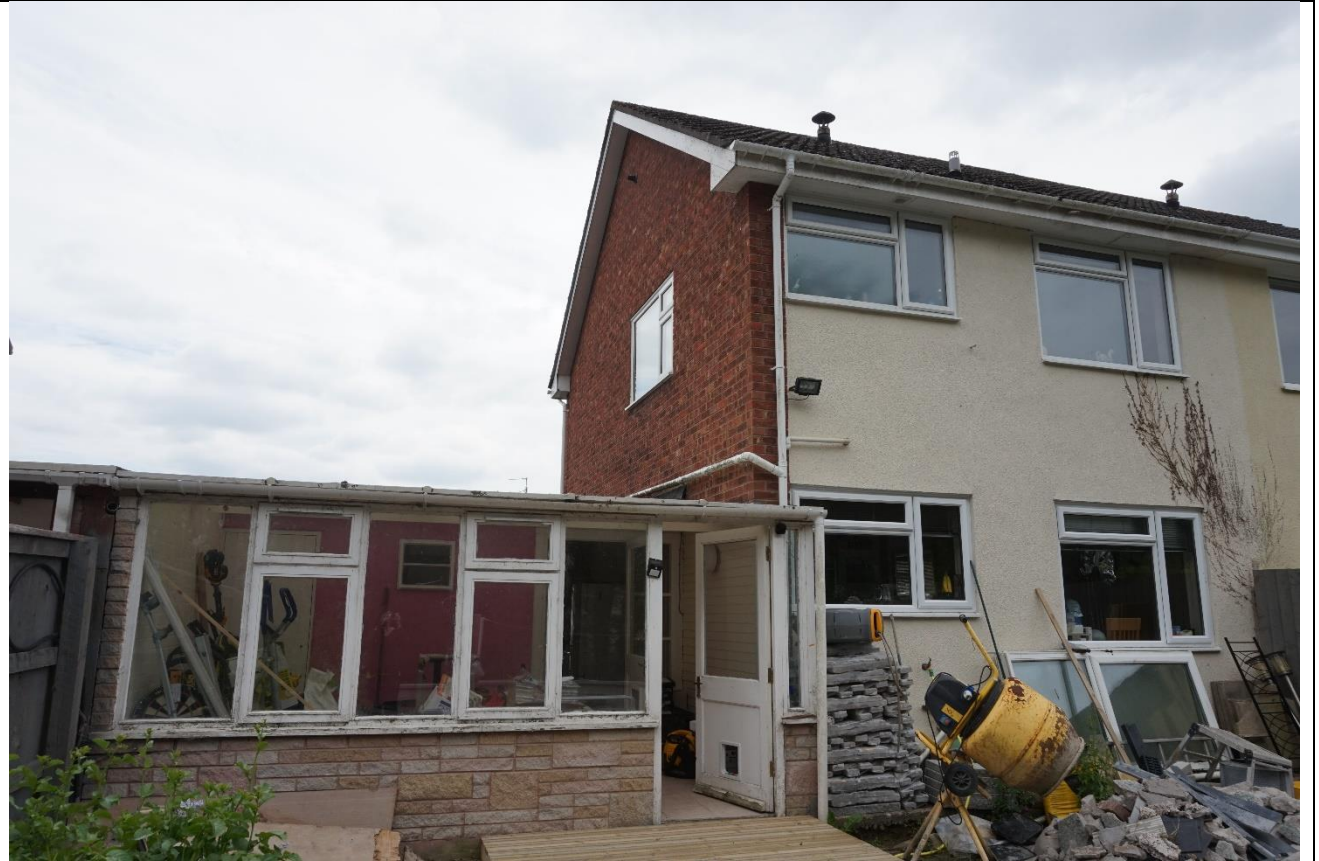
Figure 2: Rear of 41 Rhoslan

Presence/Absence			
Live/dead bats	×	Feeding remains	×
Droppings	×	Urine staining	×
Odour	×	Smudge marks	×
External Assessment (inc. presence/evidence of breeding birds): 41 Rhoslan is a semi-detached property with a pitched roof covered in interlocking concrete tiles. A small porch structure stands on the south elevation, which then extends between the neighbouring but separate semi-detached property, acting as a covered walkway to the rear of the property. A garage/interior storage area is also present here, which will be cleared to make way for the development. Barge boards, fascia boards and soffits comprise timber, and rainwater goods uPVC. Windows and doors are double-glazed and uPVC.			
<i>Dwelling</i> No live bats nor evidence of their presence was observed during the survey. No evidence of potential roost features (PRFs) were noted: the roof and its coverings appear to be well-sealed, with no gaps of an appropriate size noted between the wall and the soffits.

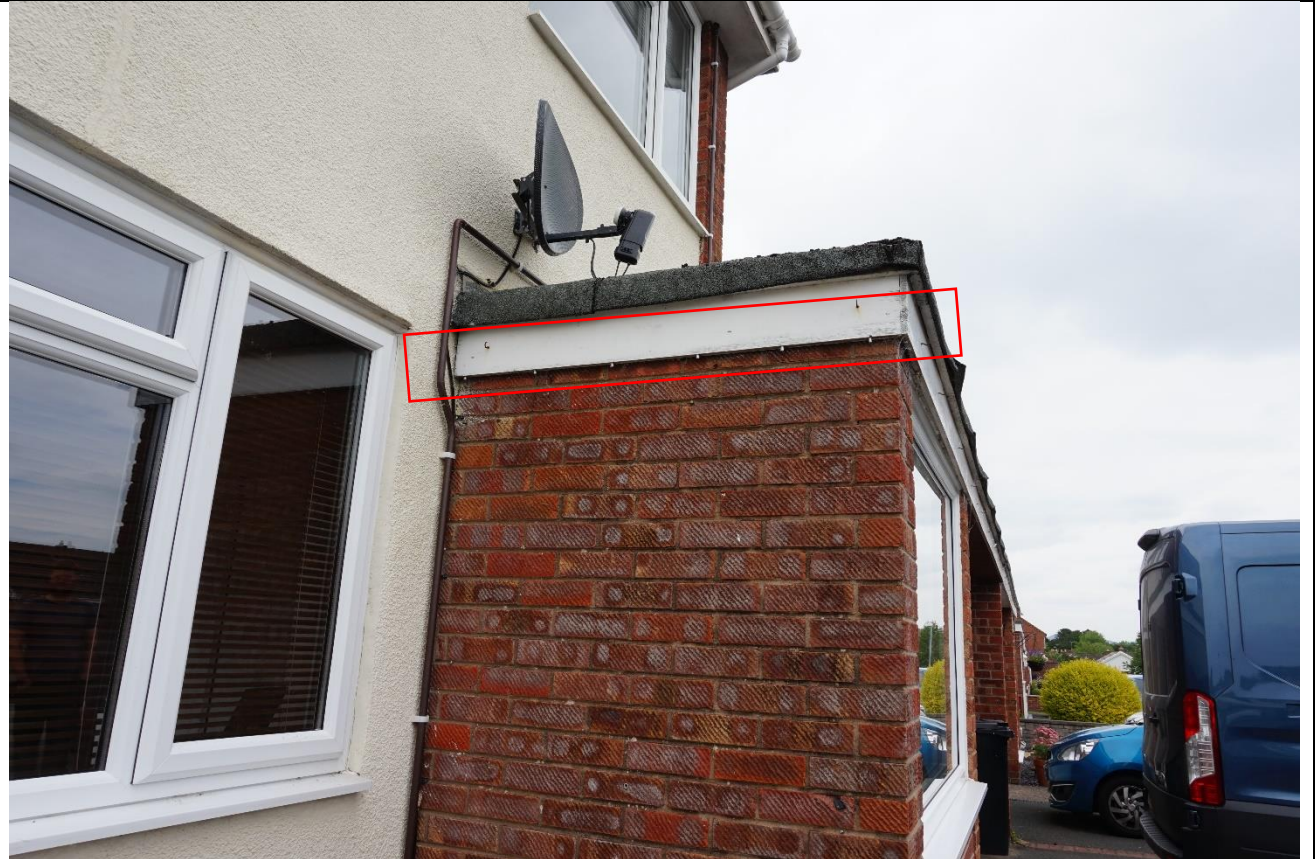
Figure 4: Gap on western edge of porch

<i>Porch</i> No live bats nor evidence of their presence was observed during the survey. However, a single gap was observed between the roofing felt, the fascia board and the wall at the western edge of the porch (Figure 4). Upon inspection with an endoscope this gap was noted to lead to a crevice between the ceiling boards and the roofing felt. No bat was present at the time of inspection.			
No evidence of nesting birds was observed.

A single gap was observed that may offer bats access to a potential roost at the western edge of the porch structure (Figure 4). It is of a size and nature that is likely to only support singular or low numbers of bats.

The porch at 41 Rhoslan is considered to have **Low** suitability to support a bat roost, on account of the single potential roosting feature and presence of ancient woodland in close proximity to the property.

Therefore, further survey work is required to identify any roosts present on the porch, as well as determine species present and characterise the roost (if present).

Based on criteria laid out in Table 2, a single observation survey will be required at 41 Rhoslan; a dusk survey is suitable for this purpose. Two observers are recommended to be employed in order to fully observe the building in its entirety.
