Preliminary Roost Assessment

Project	Terry's Lodge Farm, Wrotham, Kent TN15 7ED	Date	July 2021
Report No.	UE0454_Terry'sLodge_PRA_0_210721	Ref	UE0454
Author	Tim Lees BA (Hons) MSc MCIEEM	Page	1 of 7
Client	DHA Planning

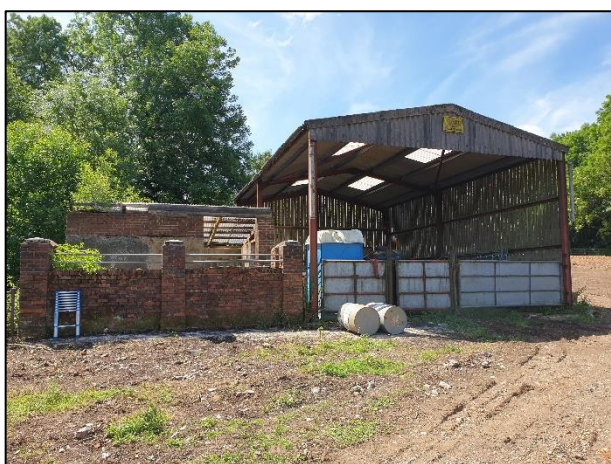
- 6.1 B1 comprised an open double height agricultural barn built upon a block base. The barn included a steel girder frame clad in timber panelling. Gaps were present between the panels as per the design. The building incorporated a pitched, suspected corrugated asbestos panel roof with four skylights. Two small open brick extensions were located along the north-eastern aspect with a timber framed corrugated plastic roof in places. Internally the barn was used for storing construction materials and logs, but was generally uncluttered.

Building B1 – view looking south

- 6.2 No PRFs were identified for bats and no evidence of bat use was recorded during either the external or internal inspection. Accordingly, B1 was assessed as providing Negligible suitability for roosting bats and no further survey is necessary

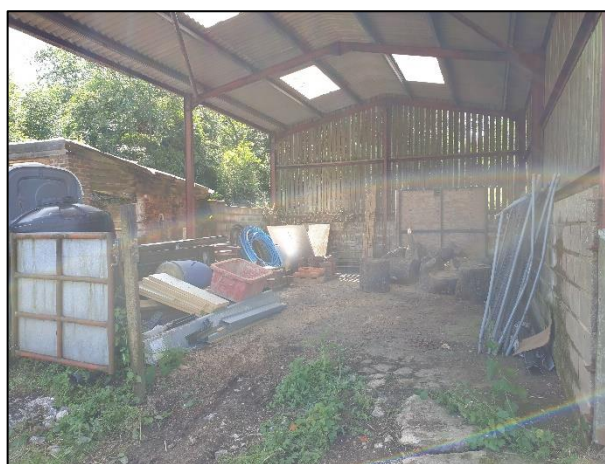
Building B1 (internal) – view looking south

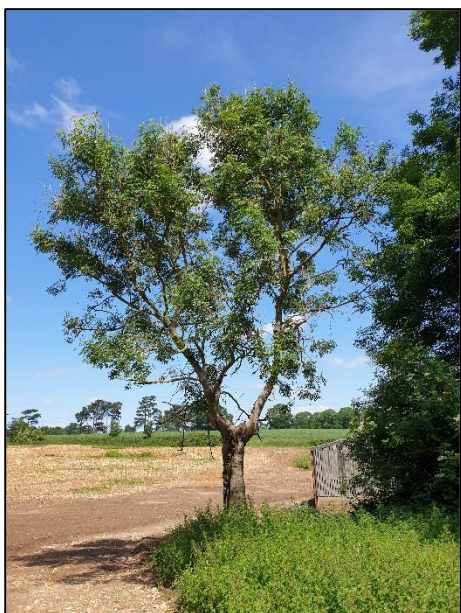
- 6.3 A single young ash *Fraxinus excelsior* tree was recorded adjacent to the site (T1), south of B1 – see Appendix I. The tree was considered to be of sufficient size to accommodate individual roosting bats and included a small area of flaking bark. Accordingly, T1 was assessed as providing Low suitability for roosting bats. It is anticipated that the tree will be retained and protected, and no further survey is required. However, in the event that is necessary to remove T1, this should be done using soft-felling techniques, as recommended at section 7.

Tree T1 – view looking north

#	Recommendations for ecological protection measures
R1	If works to fell or lop tree T1 are required, this should be done using soft-felling techniques. It is recommended that the areas of flaking bark should be removed by hand and any potential roosting features should be checked before works commence. If no bats are found felling should then proceed using section felling, then the trunk and removed limbs be left overnight, with cavities facing upwards, to allow any hidden bats present to escape. To avoid committing an offence, tree works must cease immediately if evidence of bat presence is found, while a suitably qualified ecologist is consulted.
R2	The use of external lighting should be avoided or reduced to the minimum required for its intended purpose, during both construction and operation. Where external lighting is to be provided, it will be low-level, directional lighting with minimal spill and glare, and consideration will be given to reduced hours of operation and/or a movement responsive system of control. Narrow-spectrum bulbs and light sources that emit minimal UV light, avoiding white and blue wavelengths of the spectrum should be utilised. Glass lantern covers should be used instead of plastic to filter UV light. Lighting should not be directed towards the adjacent tall ruderal vegetation and dense scrub with trees.
