14 September 2021

Preliminary Roost Assessment - Barn at Lodge Farm, Chaddesley Corbett, Kidderminster, DY10 4QB

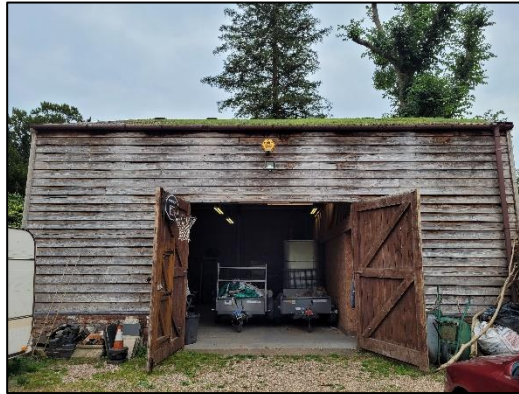
Area / Feature	Observations
Barn at Lodge Farm	<p><u>External Description:</u></p> <p>The external aspect of the building was found to be in a very similar state to that found in 2019.</p> <p>The building comprises a detached barn with a pitched corrugated fibreglass roof, which is covered in moss. The northern, southern and western elevations of the structure are constructed with wooden cladding, and the eastern elevation is brick-built. The brickwork pattern indicates no wall cavity is present. Large double doors are present on the front (west) aspect.</p> <p>The vast majority of the wooden cladding is fitted tightly with no suitable gaps for bats to exploit. Very occasional small, lifted gaps were noted, which were largely filled with cobwebs and/or debris on the day of the survey (as also noted in 2019). There are a couple of squirrel holes present on the southern elevation of the property. However, these have been filled in.</p> <p>The brickwork on the rear elevation is in excellent condition with no missing mortar or other crevices noted. Metal capping is present at the eaves which is fitted tightly to the walls.</p>

Plate 1: Showing a typical view of the barn. Photograph looking east.

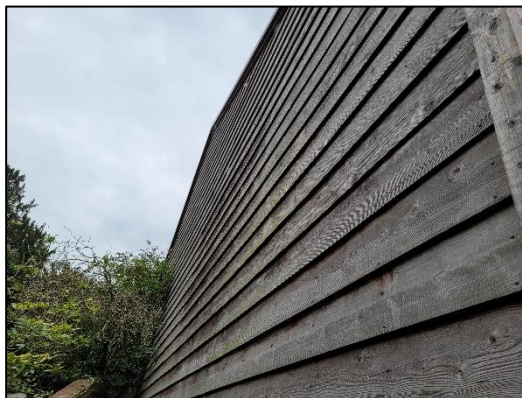
Plate 2: showing a typical view of the tight-fitting wooden cladding that covers three sides of the building.

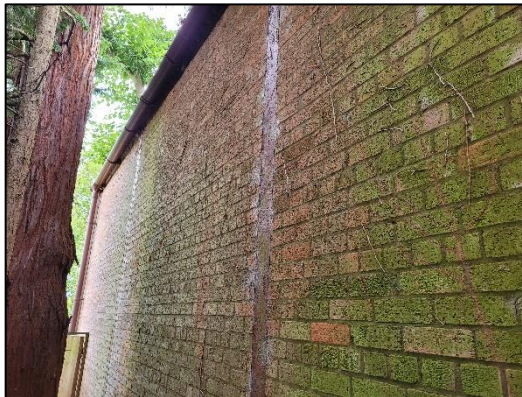
Plate 2: showing the brick wall that forms the rear (east) wall of the building.

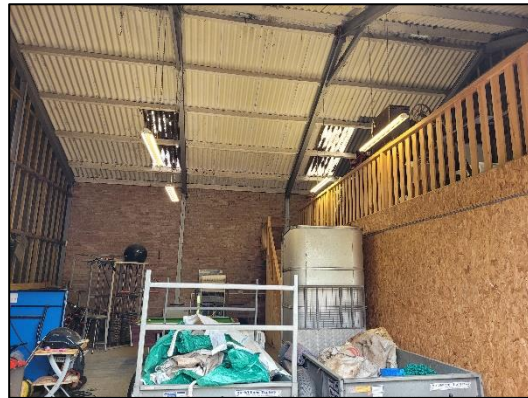
The internal aspect of the building was found to be in a similar condition to that found in 2019, although it is now more heavily cobwebbed.

No evidence and/or signs of bats was observed during the survey, and internal area is considered unsuitable for roosting bats.

Plate 3: Showing a typical internal view of the barn. Photograph looking west.

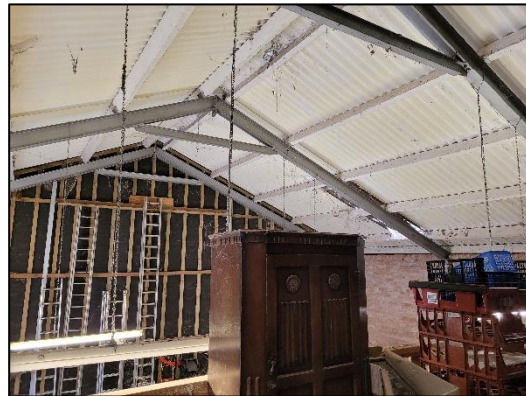
There are several skylights present within the roof of the barn, permitting light into the area. Electric lighting strips are also present. The roof is supported by metal beams. The wooden cladding is overlain with sarking felt and wooden batons in the internal area of the barn. The flooring of the barn comprises concrete. There is a wooden mezzanine present within the southern section of the barn. Numerous dead woodlice were noted over the mezzanine floor and stored objects, and items are covered in a layer of dust. Thick, old cobwebs cover much of the walls and hang from the metal ceiling beams. Several, old inactive bird nests were observed on the walls

Plate 4: Showing a view of the roof structure inside the barn.
