Ecological Impact Assessment and Bat Survey

DUNHOLME FARM, HALTWHISTLE, NORTHUMBERLAND

SUMMER 2021

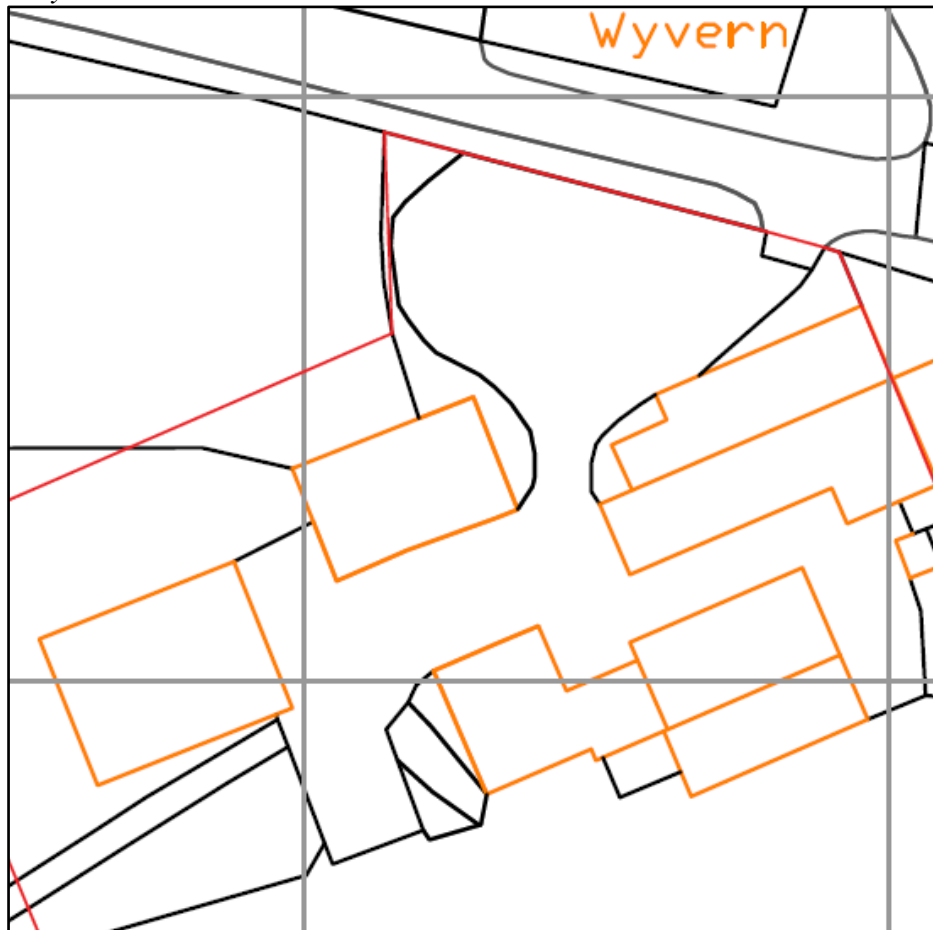
Figure 2. Survey area - within the redline

The survey area covered the buildings only within the red line boundary as shown within Figure 2 and included searching for signs of any wildlife using the site with the key aspects listed below.

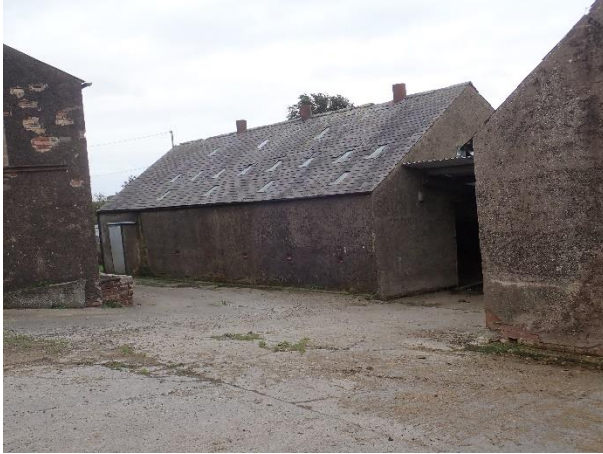
Building/ Section	Description	Comments
A	Brick built walls, pebbledashed, slate roof with old bitumen sarking, single storey. Roof vents, roof lights and missing ridges.	Moderate roost potential. Crevices below ridge tiles. Bat droppings present in two locations below the ridge. Single Pipistrelle 55kHz and Brown long-eared bats plus two Daubenton's bats were identified using the ridge
B	Lean-to against south aspect of Building A. Breezeblock base walls with profiled metal roof and corrugated metal upper walls. Single storey. Also profiled metal infill between Buildings A and C.	Low roost potential. No bat traces. Used by foraging bats.
C	Single storey, brick built, pitched profiled metal roof, open to east and large gaps at the eaves.	Low roost potential. No bat traces. Pigeons present. Used by foraging bats.
D	Two storey at west end only, corrugated asbestos roof and east gable wall, pebbledashed brick, corrugated metal roof with roof lights over main section and open access to north.	Low bat roost potential.

Building A from the northwest

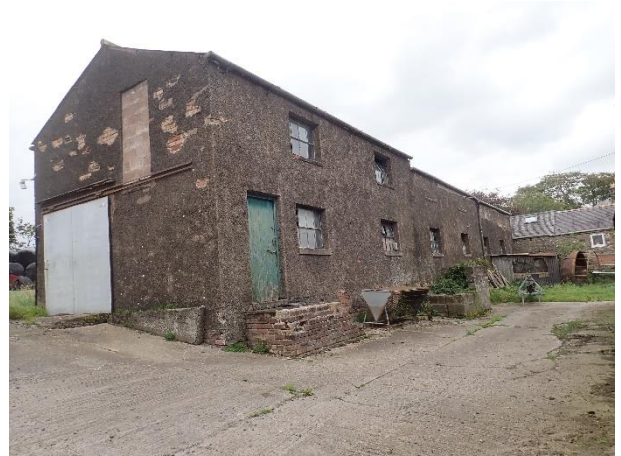
Building D from the southwest

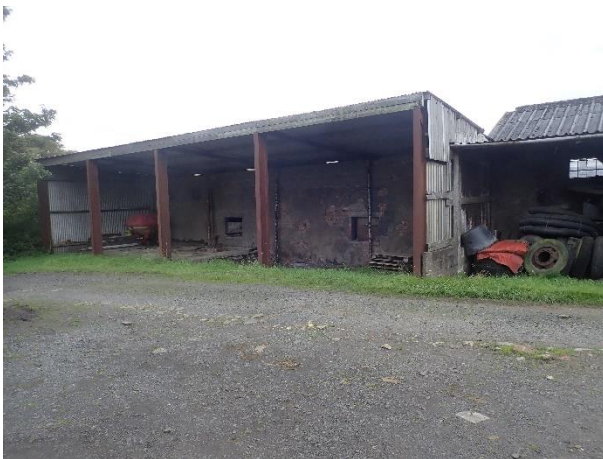
E	Profiled and corrugated metal clean-to.	Negligible bat roost potential.
F & G	Large agricultural barns, Building F with brick base walls and corrugated metal roofs. Building G has ventilated profiled metal walls and roof with 3m breezeblock base walls and corrugated metal roof	Negligible bat roost potential. No evidence of owls. Nesting swallows in Building F.

Building E from the north

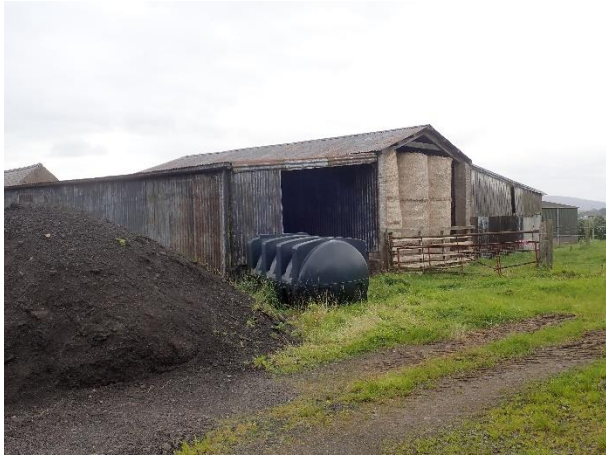
Nesting swallows were identified in Building F. Pigeons were present in Buildings C and old blackbird nests in Building D.

Building F from the southwest

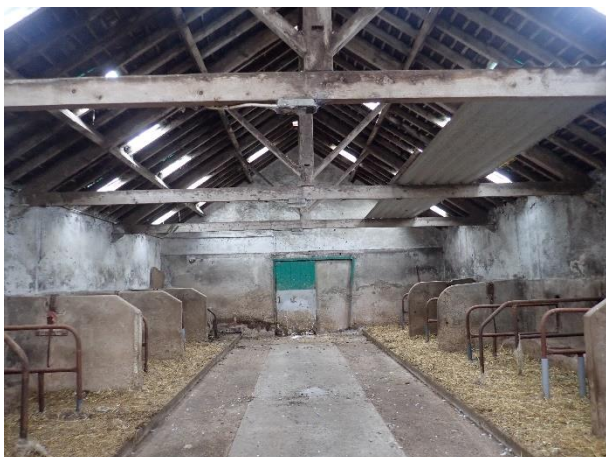
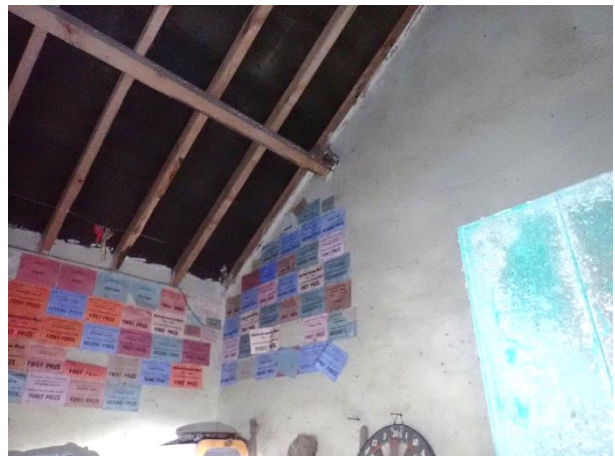
Interior of Building A

West end of Building A with small plastered room with bitumen felt sarking

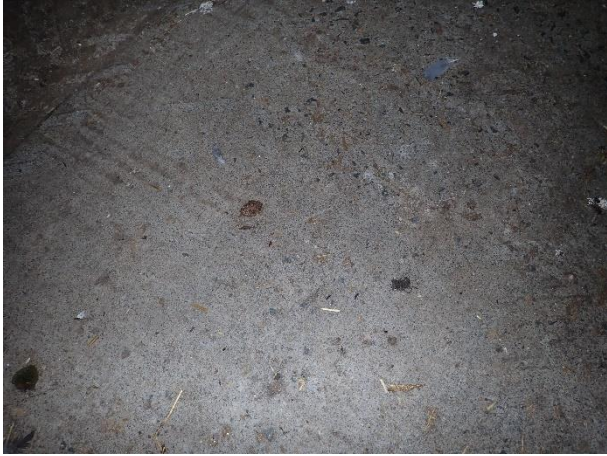
Bat droppings in Building A

As bat roosts are present which will be impacted, the site will require to be registered under a Natural England Mitigation Licence (Low Impact) before the works can proceed. This is applied for after any necessary consents are granted and can take up to 2 weeks (10 days). Surveys have to be current in the year of registration. The surveys reported in this report are current up to April 2022.

Bat access will also be created through the mortar fillet to beneath the ridge tiles and above the ridge/sarking board on Unit 2 in two locations by ensuring that the ridge tile is not totally filled with mortar. Access through the mortar fillet measuring 20x20+mm will be created leading to a larger gap measuring 400mm long below the ridge tile, a section of split pipe can be used to give access from ridge tile to ridge tile.

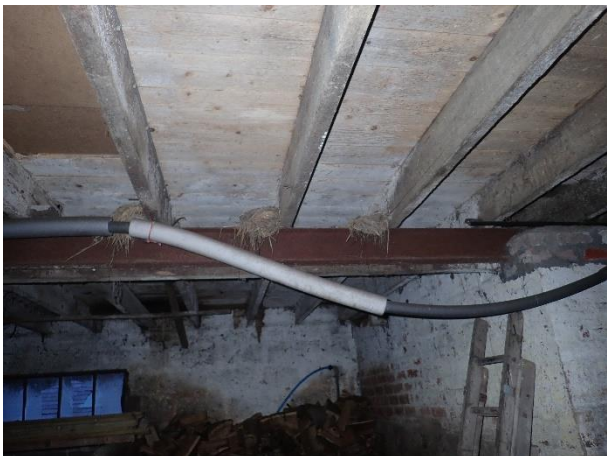
Blackbird nests in Building D

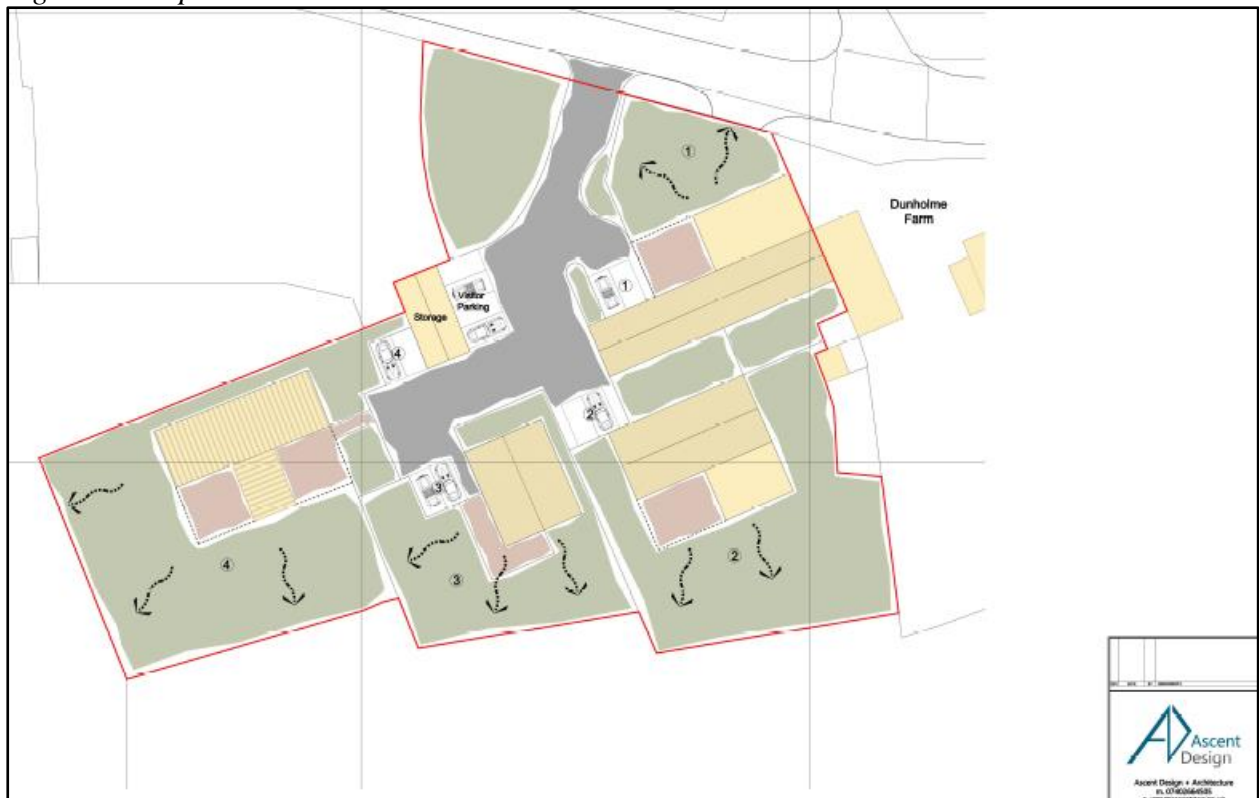
Figure 6. Proposed Works

The proposals are to convert the buildings to create four residential units.
