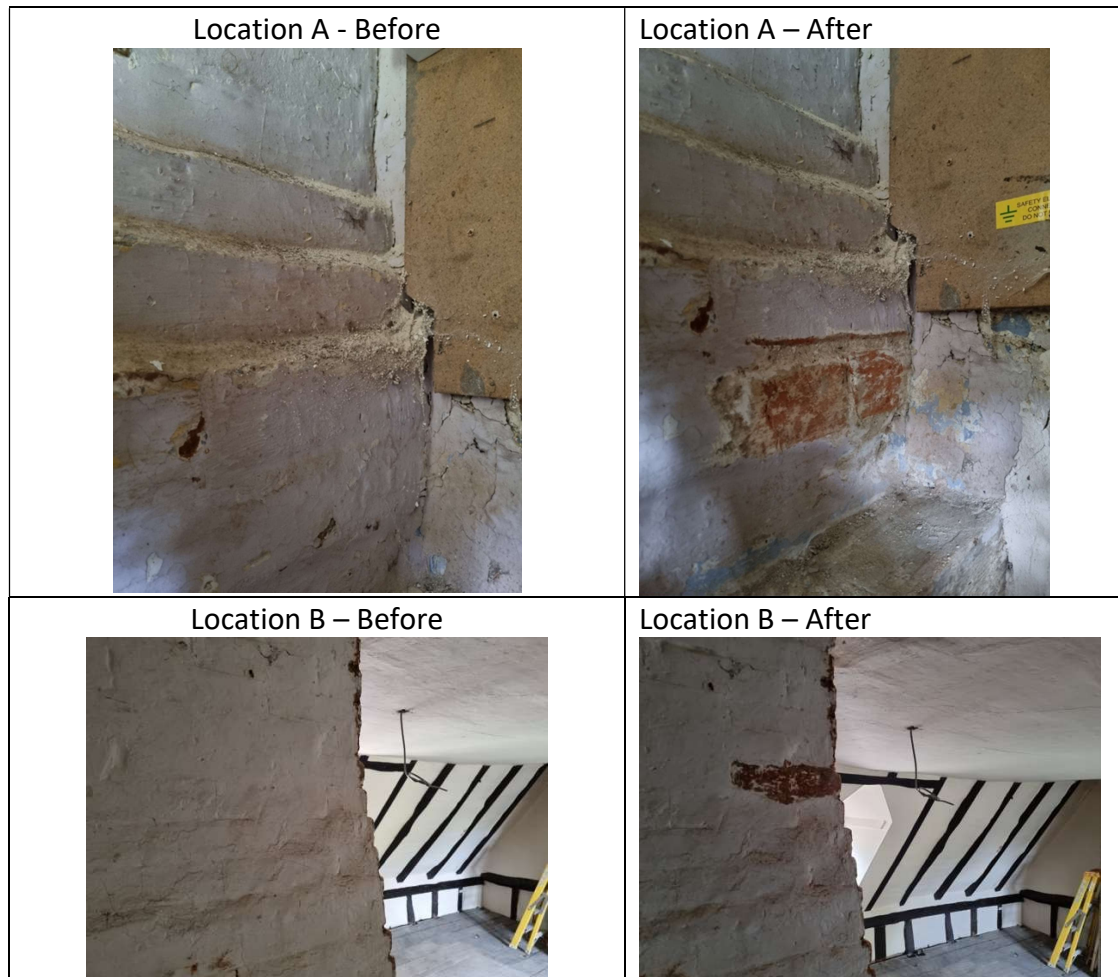
1. Work commencing October 2021
2. Work carried out according to plans submitted
3. Photos showing paint on fireplace to be removed and subsequent photos of paint removed. Locations on Floorplan A and B, on the side of each fireplace. Method used was a hand scraper with no chemicals etc. Paint is a flaky chalk which is easily removed. Brick beneath shows no marks, scrapes, scratches or damage.

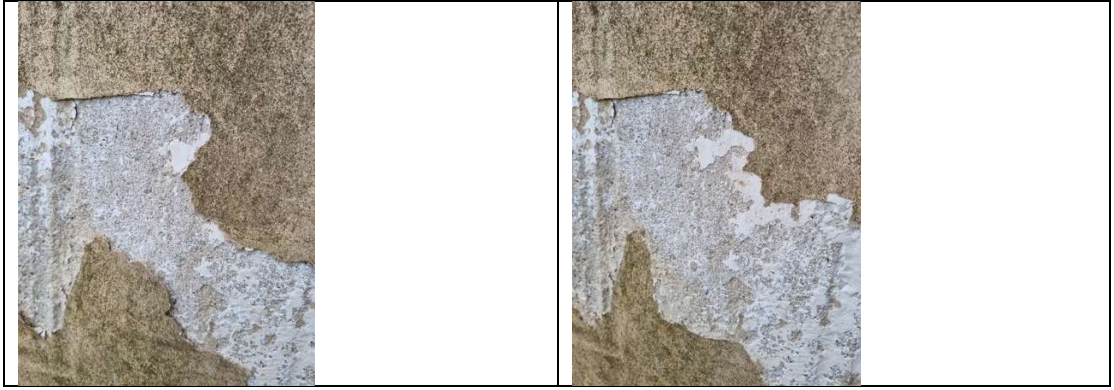
Existing masonry paint will only be removed from external render where it has become loose and detached from the render. No chemicals or manual scraping will be used to avoid damaging the existing lime render. The Pozilime limewash which will be used to paint is a breathable limewash that can cover different surfaces so can be overpainted on to the existing areas of lime, concrete and areas of remaining masonry paint. Area shown below of masonry paint that has lifted and so can be pulled from the surface. The Limewash can then cover the bare render beneath as well as the patches of remaining masonry paint that will not be removed.
