Jon Sloan  
Ecological Consultants

The Barns  
Rhyd-y-carw Mill  
Trefeglwys  
Powys  
SY17 5PU  
Ecological Survey

August 2020

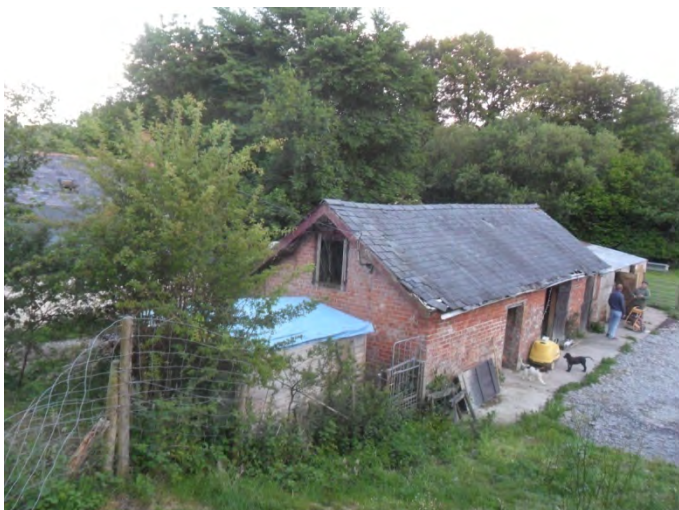
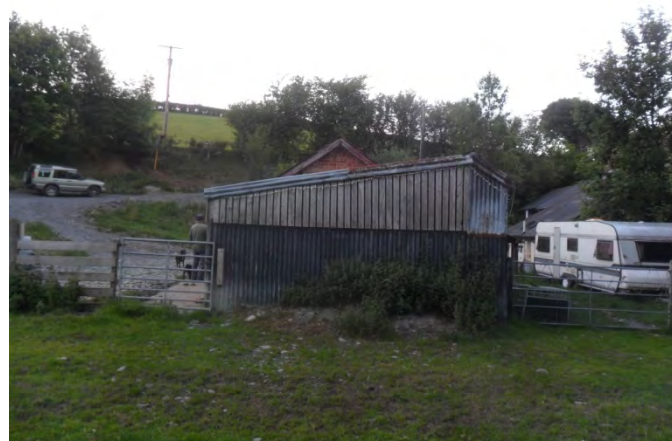
### Areas of potential for Bats – Barn 1

- 4.4 **Barn 1**- the structure of this barn is in good condition, however there are several areas of potential for bats to access/roost, i.e. missing/displaced roof slates, gaps at intersection of rafters/wallplates, gaps under ridge tiles, open doorways, gaps in vertical wooden boarding on block-work extension & gaps under slates to gable end verges/bargeboards (see photographs "Areas of potential for bats – Barn 1"). All brickwork was well pointed/sound with no crevices & the timber work is a softwood construction with no open mortise/tenon joints.

Open windows/doorways, missing slates, under ridge

Vertical timber boarding

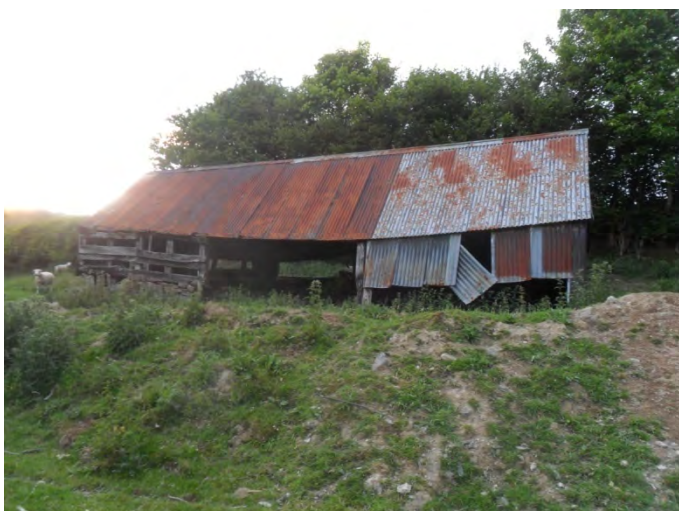
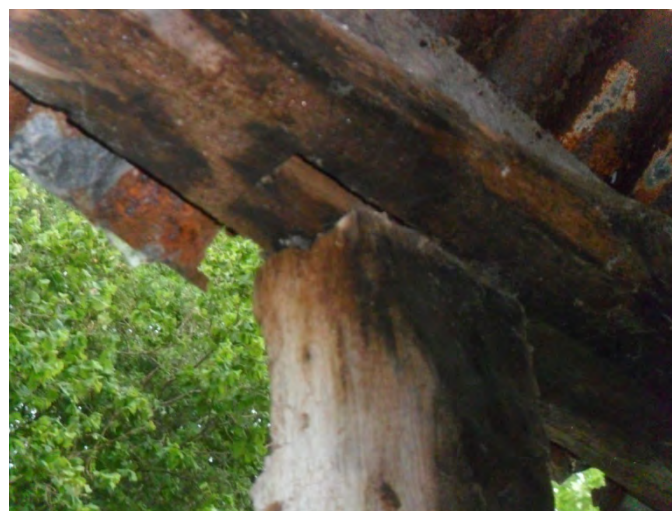
### Areas of potential for Bats – Barn 2

- 4.5 **Barn 2** – the structure of this barn is in a very poor condition & close to collapse with many areas of potential for bats to access/roost i.e. missing/displaced tin sheeting to

all elevations, under ridge capping, open frontage & open mortise/tenon joints in oak timberwork. Many of the oak timbers were rotting due to the ingress of rainwater (see photographs “Areas of potential for bats – Barn 2”).

Missing/displaced tin sheeting, open front, ridge capping

Open mortise/tenon joints

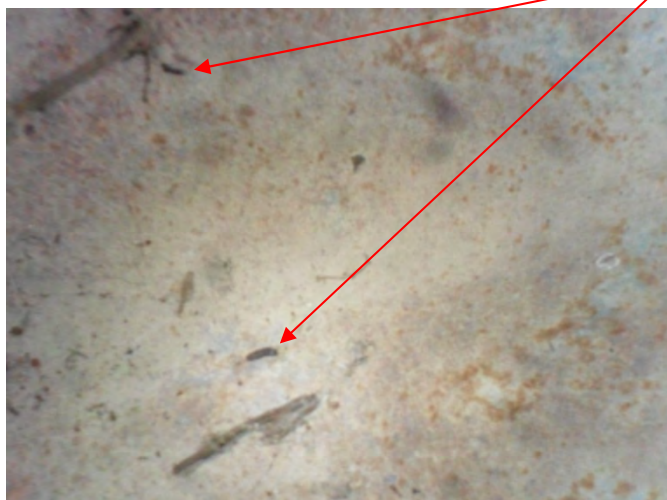
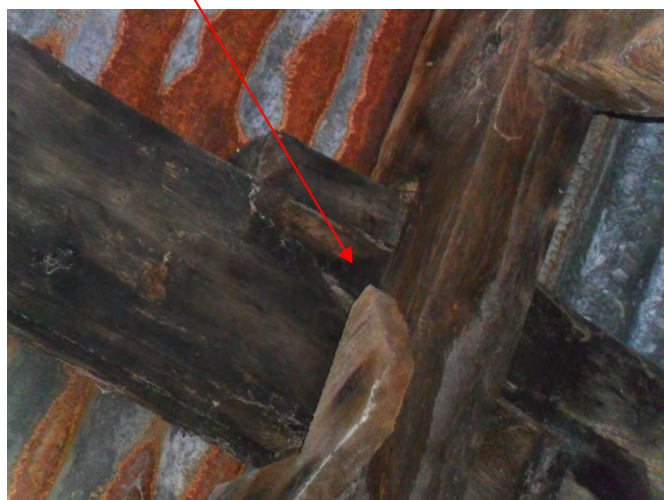
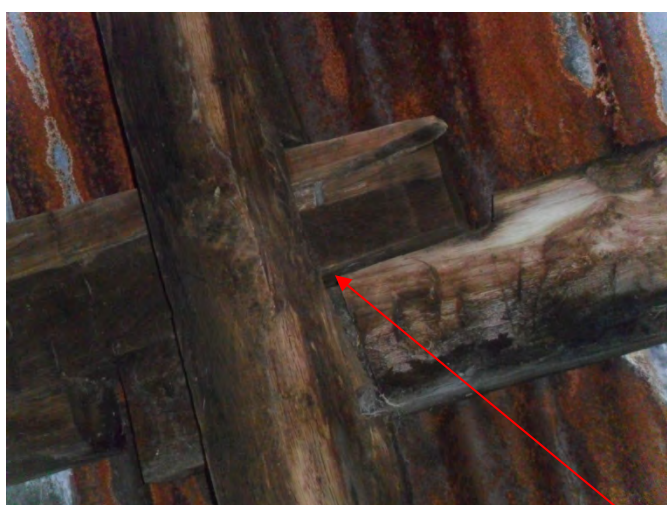
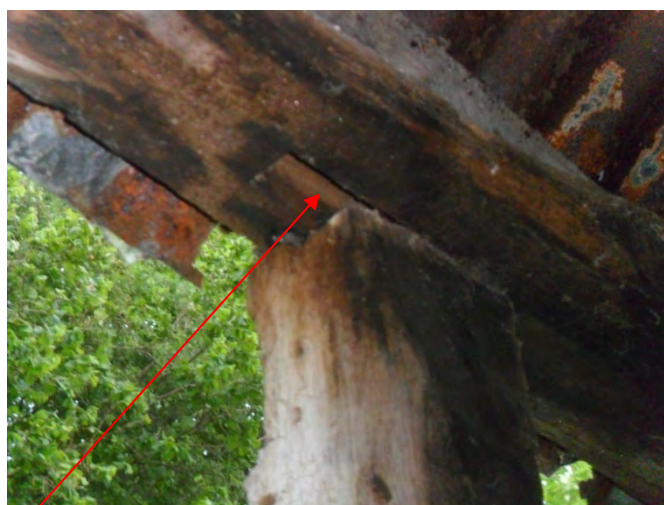
### Examples of bat droppings & clear joints

**Barn 2** – there are several open mortise/tenon joints within the timber structure of this barn, some of which were clear. On inspection with endoscopes no evidence of bats roosting within these joints was noted at this time; however 2 bat droppings were observed on sheeting beneath one of the joints within the barn. The floors were covered in current & historical animal detritus therefore locating further droppings was difficult.

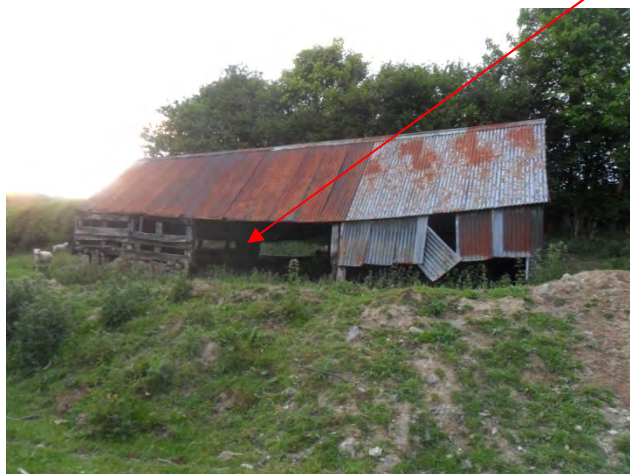
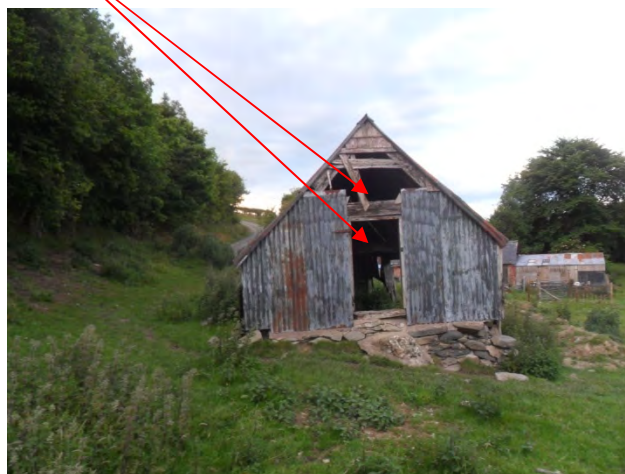
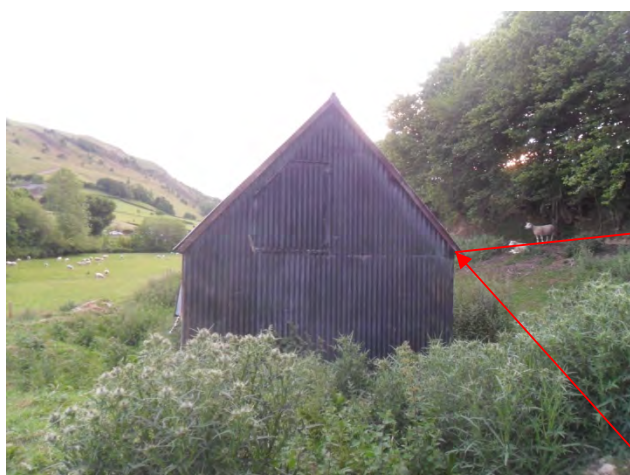
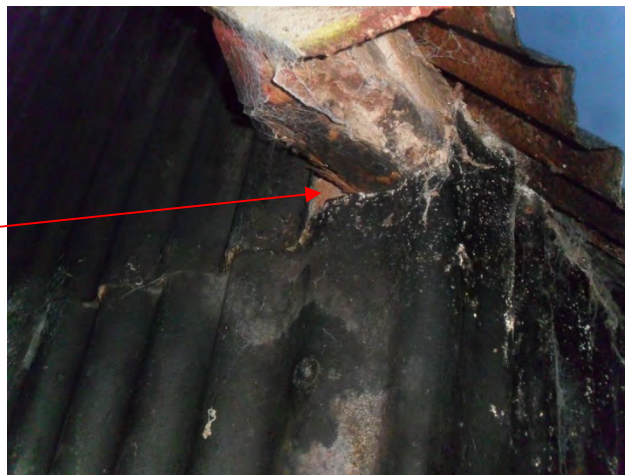
## Bat emergence / access points Barn 2

**13.6.20** – during the 1<sup>st</sup> evening emergence survey at 21.28hrs a Common Pipistrelle bat was observed emerging from the area of the missing boarding on the western gable apex of the barn & a second Common Pipistrelle bat emerged from the open frontage on the southern elevation at the same time. At 21.43hrs a third Common Pipistrelle bat accessed the open frontage on the southern elevation & emerged from the open doorway in the western gable at 21.46hrs. These bats continued to forage along the hedgerow/tree line to the north of the barn & over the roof from the direction of the river corridor to the south of the barn. An occasional pass of a Noctule bat was also detected high above the hedgerow. No further bats were observed/detected during this survey. A Tawny Owl (*Strix aluco*) was observed at 22.22hrs landing on the roof at the eastern gable before flying off towards the east. This survey commenced at 21.20hrs and ended at 23.00hrs, sunset was at 21.38hrs.

Southern elevation

Western gable

Eastern gable

- c) The preferred time for the removal of any roof covering to Barn 2 or any conversion works would be mid-September – April when bats are less active. During the removal of the roof covering to Barn 2 it will be necessary for a licensed ecologist to be on site to undertake a watching brief when areas of potential are being removed (i.e. ridge cappings, gable end tin sheeting). If any bats are found these should be removed and relocated on site (by ecologist). The ecologist will also give a tool box talk to contractors to explain bat legislation & guidelines and explain the bat mitigation strategy for the new development.

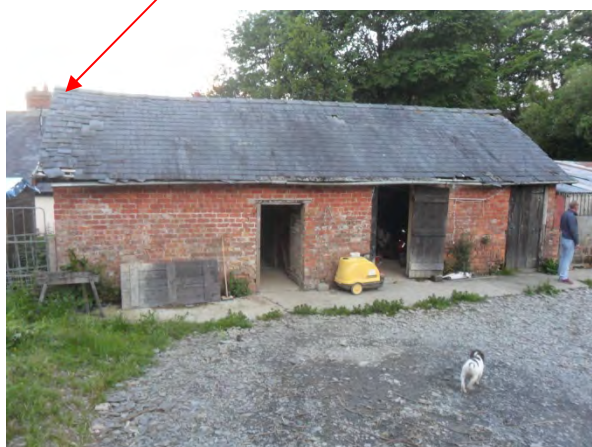
Wren access point

- a) The surveyors examined the outside of both barns. The purpose of this search was to locate any possible Barn owl (*Tyto alba*) access/egress points and to note any barn owl splashing (white faeces splashing) or discarded pellets (regurgitated fur and bones of small mammals, e.g. voles). or any other nesting birds.
- b) There was no evidence of Barn Owls in either barn however during the evening survey 13/6/20 a Tawny Owl (*Strix aluco*) was observed at 22.22hrs. landing on the eastern gable of Barn 2 before flying off in an easterly direction & on 14/6/20 at 21.36hrs a Wren (*Troglodytes troglodytes*) accessed beneath the ridge on the northern aspect of the western elevation of Barn 1. The nest of a Swallows was noted on the interior southern gable of Barn 1.

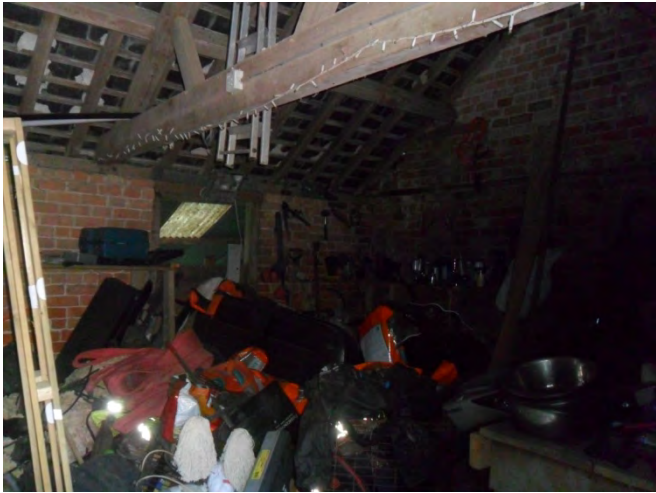
**Interior centre**

**Barn 1** - on inspection there were no clear areas to the ridge beam these being cobwebby throughout the length of the building. There was no under-slating felt i.e. the underside of the slates being visible from the ground. This barn is power washed every day given it is used constantly as kennelling for at least 10 dogs. No evidence of any bats or roosts was noted in any areas, i.e. no bat droppings, fur oil staining, feeding remains or actual bats.
