## **Former Piggery Bedingfield House Farm**

**Preliminary Roost  
Appraisal**

Reference: 25-2101-GE-BC

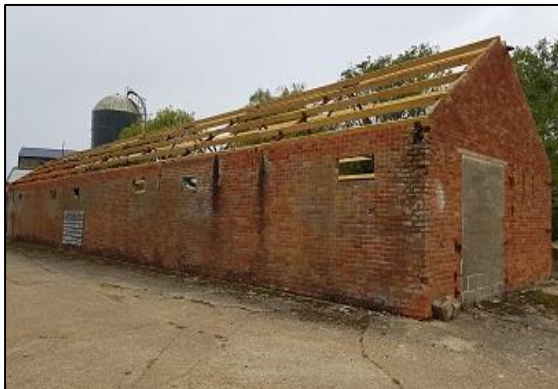
Figure 1: Western aspect.

5.2.2 The piggery was on hardstanding in a farmyard and was of brick and breezeblock construction. The roof had recently been removed due to storm damage and the roof structure was exposed (Figures 1 and 2).

5.2.4 There were some gaps on the brickwork on the western aspect but these were wide and gave access into the building rather than offering sheltering opportunities.

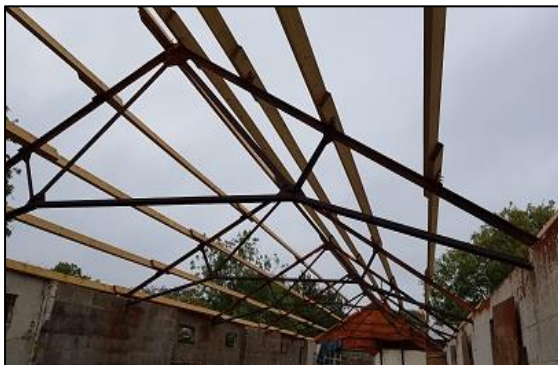
Figure 3: Tightly sealed roof tiles.

5.2.3 The wooden beams were narrow and machine cut with other metals beams for support (Figure 3).

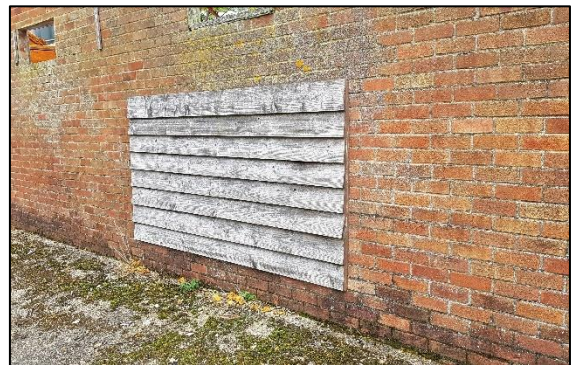
Figure 4: Small area of weatherboarding.

5.2.6 There was a small amount of weatherboarding on the western aspect (Figure 4). This was well single-skin and well-sealed.

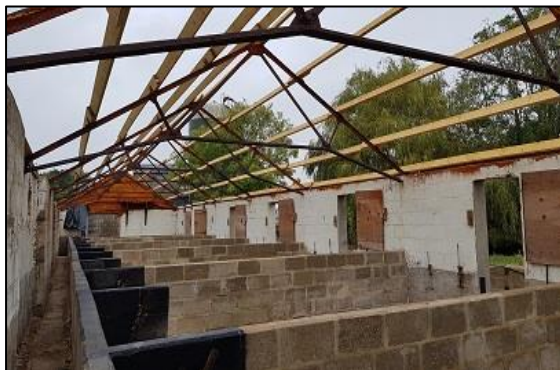
Figure 5: Internal view

5.2.7 Internally the space was clear of stored items and all areas were available for survey (Figure 5).

5.2.8 There were some cracks in the internal walls but these appeared shallow and full of mortar debris when inspected.

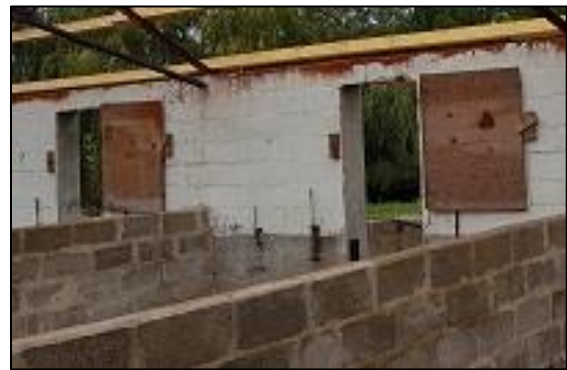
Figure 6: Pinned back wooden doors on eastern aspect.

5.2.9 The wooden doors on the eastern aspect were all pinned back to the inside wall creating potential sheltered areas (Figure 6). However, on inspection the inside of the doors were all heavily cobwebbed with no bat droppings on the ledges or the woodwork.
