Jon Sloan
Ecological Consultants

The Barns
Rhyd-y-carw Mill
Trefeglwys
Powys
SY17 5PU
Ecological Survey

August 2020

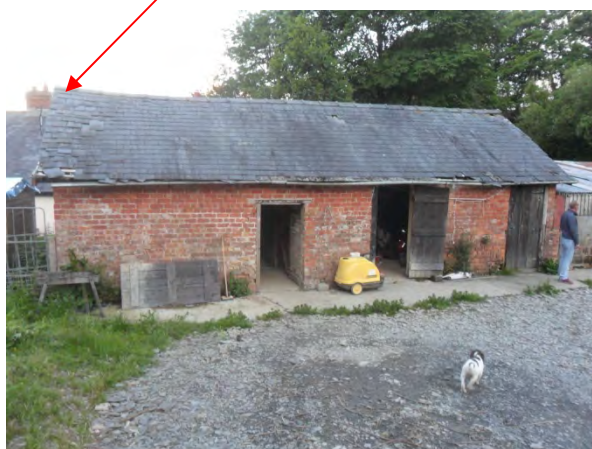
Wren access point

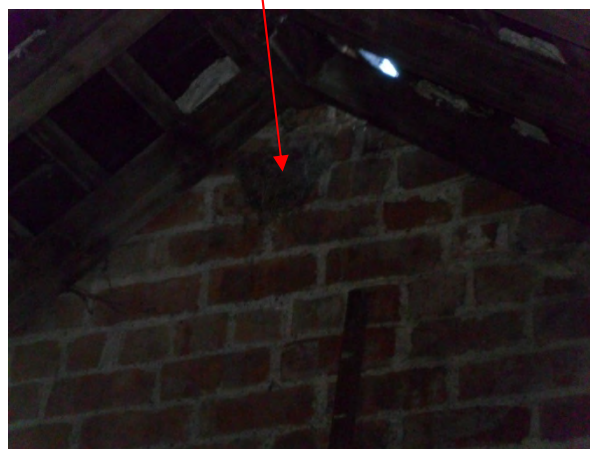
- a) The surveyors examined the outside of both barns. The purpose of this search was to locate any possible Barn owl (*Tyto alba*) access/egress points and to note any barn owl splashing (white faeces splashing) or discarded pellets (regurgitated fur and bones of small mammals, e.g. voles). or any other nesting birds.
- b) There was no evidence of Barn Owls in either barn however during the evening survey 13/6/20 a Tawny Owl (*Strix aluco*) was observed at 22.22hrs. landing on the eastern gable of Barn 2 before flying off in an easterly direction & on 14/6/20 at 21.36hrs a Wren (*Troglodytes troglodytes*) accessed beneath the ridge on the northern aspect of the western elevation of Barn 1. The nest of a Swallows was noted on the interior southern gable of Barn 1.

Swallows' nest

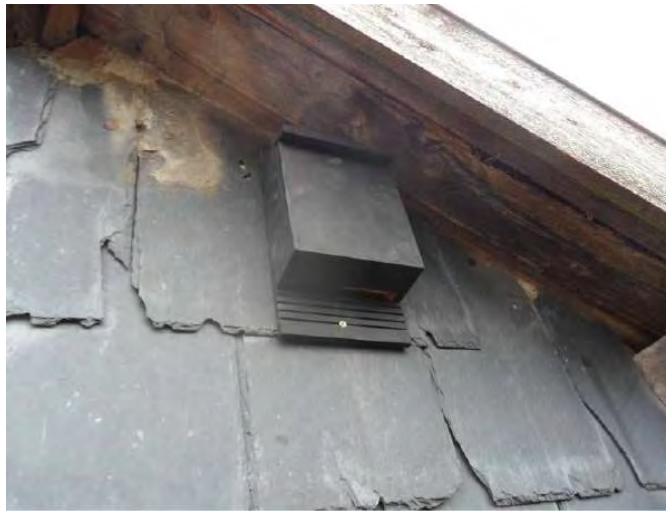
DIAGRAM 1 “Example of a double crevice bat box”

- a) 4 Double crevice bat boxes will be erected on the exterior of buildings/adjacent trees prior to any works commencing. These boxes will be positioned approximately 12ft above ground level with the entrances facing south-east or south-west (see Diagram 1 "Example of a Double crevice bat box"). Advice on positioning will be given by ecologist.

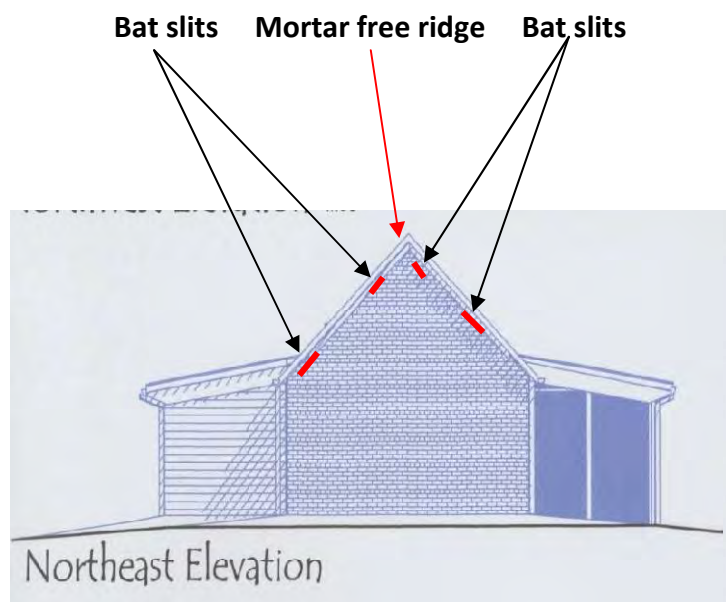
DRAWING 1 “Bat Mitigation Barn 1”

- b) All gable end ridge tiles on the converted barns will have a mortar free access cavity for bats to utilize. This will be created by a wooden slug insert (15mm x 25mm) positioned within the end mortar bedding and can be removed when the mortar has gone off/green. This will ensure an access point for bats to the cavity above the ridge beam (see Drawing 1-'Bat Mitigation Barn 1' and Drawing 2- 'Bat Mitigation Barn 2').

- c) In order to provide potential roosting areas for crevice seeking bats 4 bat slits will be created at the intersection of the brickwork/stonework/shiplap & soffits/bargeboards on the eastern & western gables of Barn 2 & the north-eastern
