# LUSTRE

**BARN AT 2 HARTLEY WOOD CORNER  
COTTAGE, MANOR DRIVE, HARTLEY  
PHASE 1 DESK STUDY**

PROJECT RECORD				
PROJECT NAME	BARN AT 2 HARTLEY WOOD CORNER COTTAGE, MANOR DRIVE, HARTLEY, LONGFIELD, KENT			
CLIENT	ANDREW GOODWIN			
REPORT DETAILS				
TYPE	PHASE 1 DESK STUDY			
REFERENCE	4033 - 210812 - ML			
ISSUE DATE	AUGUST 2021			
AUTHOR	MEGAN PARKER SEAL ASSOCIATE			
REVIEWER	MATTHEW LARKIN BSc (Hons) MSc MCIWEM C.WEM CSci RSoBRA ASSOCIATE DIRECTOR			
REGISTRATION OF AMENDMENTS				
REVISION	DATE	AMENDMENT DETAILS	REVISION AUTHOR	REVISION REVIEWER

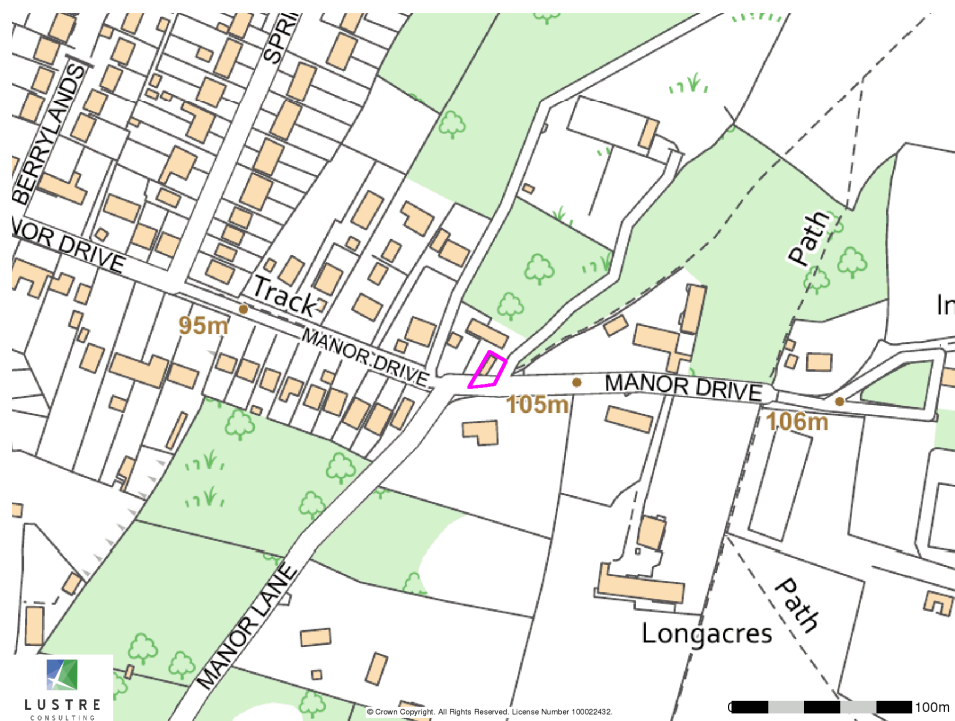
Figure 1: Site Location Plan

- 1.2 The site, roughly rectangular in plan, is centered at National Grid Reference 561270, 167350, and occupies an approximate area of 0.03ha as shown in Figure 1. The site currently comprises a derelict, former barn and Hop Kiln and is located within a primarily residential land use area within the eastern area of the village of Hartley. The Client requires this Phase 1 Desk Study to support redevelopment works at the site. It is understood that current development proposals for the site involve the refurbishment of the existing agricultural barn on site to create a residential scheme. The proposed development will comprise a two-bedroom low-rise residential dwelling, containing a ground and first floor, with a private garden. The property will be independent of 2 Hartley Wood Corner Cottage and will have its own access and parking area. Figure 2 illustrates the proposed development scheme.

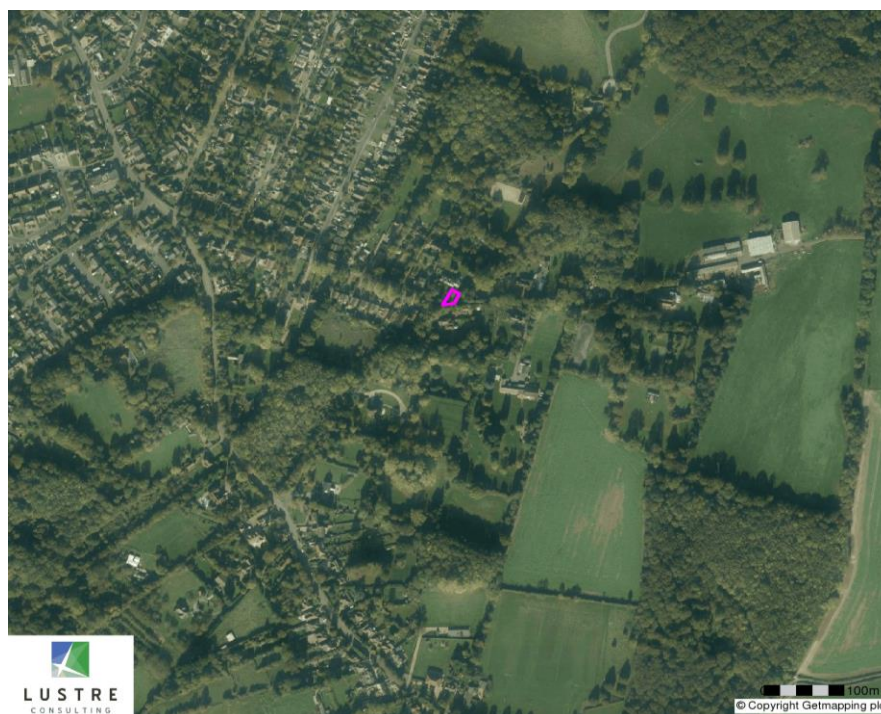
Figure 3: Site Aerial Photograph

- 2.3 The site comprises the building footprint of a single-storey 18<sup>th</sup> Century agricultural barn and former Hop Kiln. The site itself is generally flat and level. The building was vacant and unused at the time of the site walkover and appeared to have not been used in a long time. The building

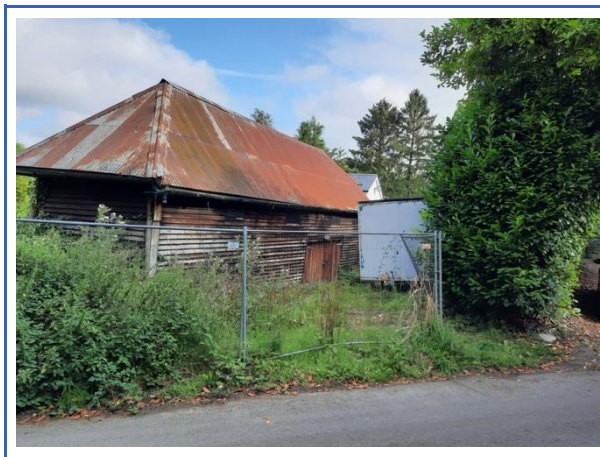
- 2.4 The building itself was a wooden structure with a pitched corrugated metal roof that was noted to be rusty. The building remained intact though the roof was slightly delapidated and the guttering on the building was dipped and broken in several places. The wooden doors of the building were locked, and no windows were present. A trailer was parked in front of the barn building and a series of heras fence panels were present along the northern side of Manor Drive separating the site from the roadway.

*View of the barn on site and adjacent parked trailer*

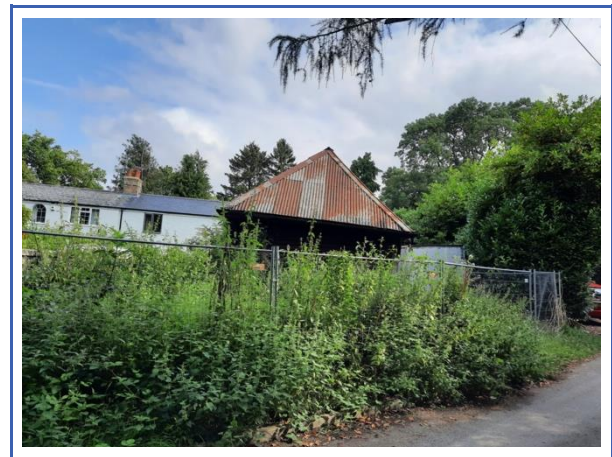
*View of the barn on site with 1 & 2 Hartley Wood Corner Cottages to the north*

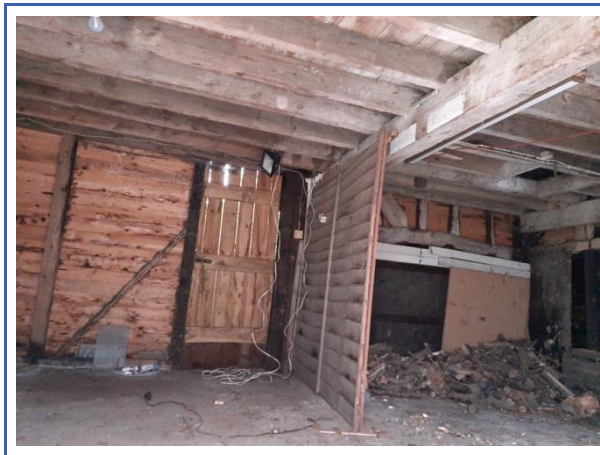
was mainly empty, except for the storage of a pile of logs and electric cables. Some wind-blown litter was noted to be present within the building.

*Internal view of the barn and log pile on site*

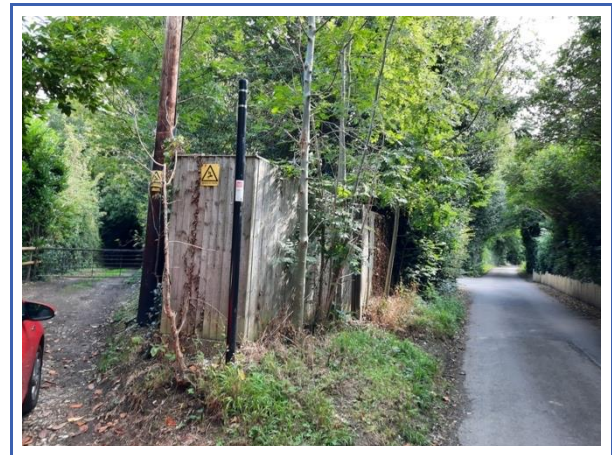
*View of the electrical sub-station to the east*

- 2.15 An electricity sub-station was noted to be present during the site walkover directly east of the site boundary, on the northern side of Manor Lane. Access into the sub-station was restricted and a wooden fence was present around the sub-station perimeter. Warning signage was visible around the sub-station.

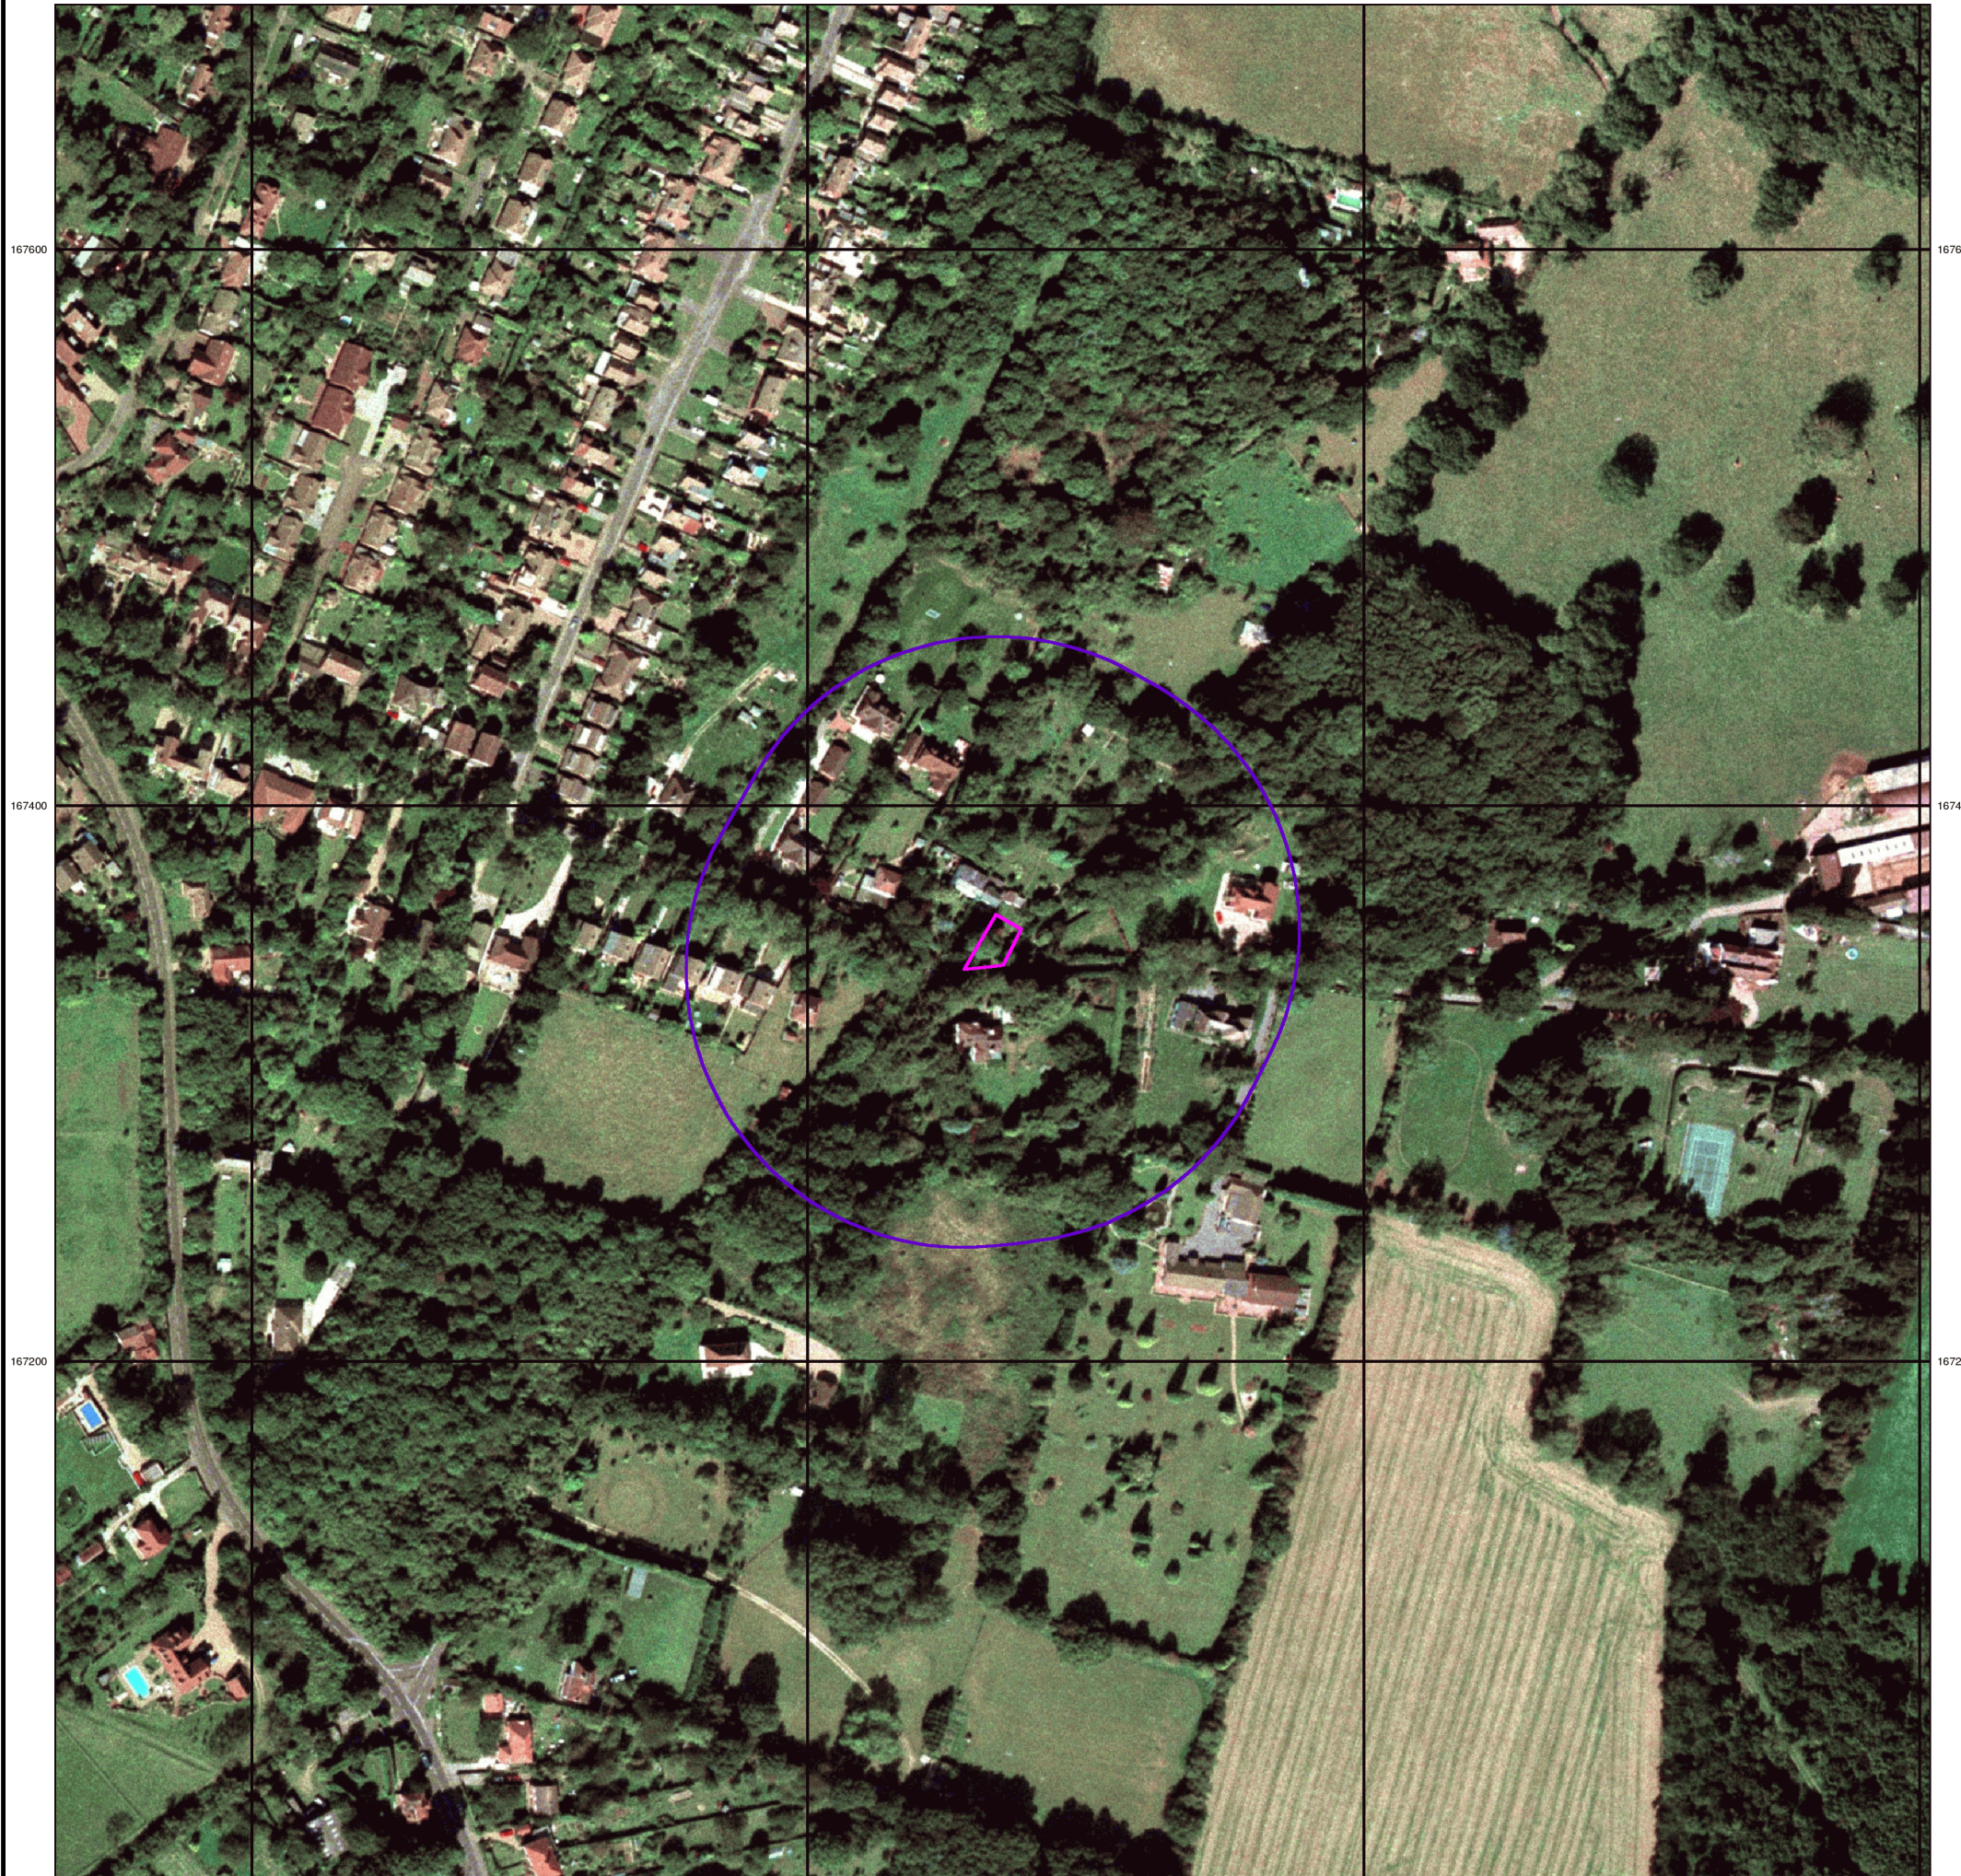
### Historical Aerial Photography - Segment A13

This aerial photography was produced by Getmapping, these vertical aerial photographs provide a seamless, full colour survey of the whole of Great Britain
