**LOWER BARN FARM
LOWER STREET, BAYLHAM
SUFFOLK**

**AN ARCHAEOLOGICAL
EVALUATION**

**PLANNING APPLICATION NUMBER:
DC/19/02401**

**PARISH/SITE CODE: BAY 081
OASIS NO: preconst1-385436
REPORT NO: R14113**

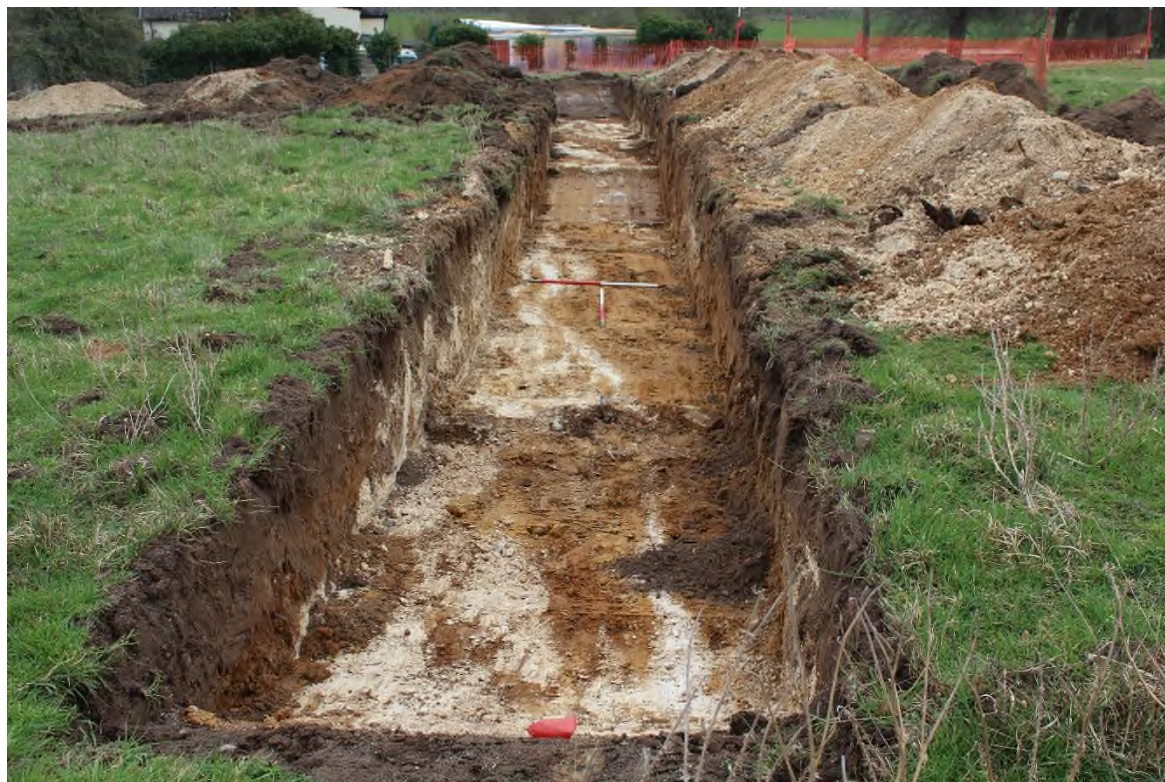
- 6.3.1 Trench 1 was located in the northern part of the site (Fig. 3; Plate 1). The original ground surface had been truncated to a depth of over 1.2m along the full length of this trench and the depression backfilled with a mixture of loose chalk and sand that contained modern rubbish such as glass bottles, wires and bonfire waste. A residual sherd of Roman pottery was recovered from the redeposited topsoil.

Plate 1: Trench 1, looking east-northeast

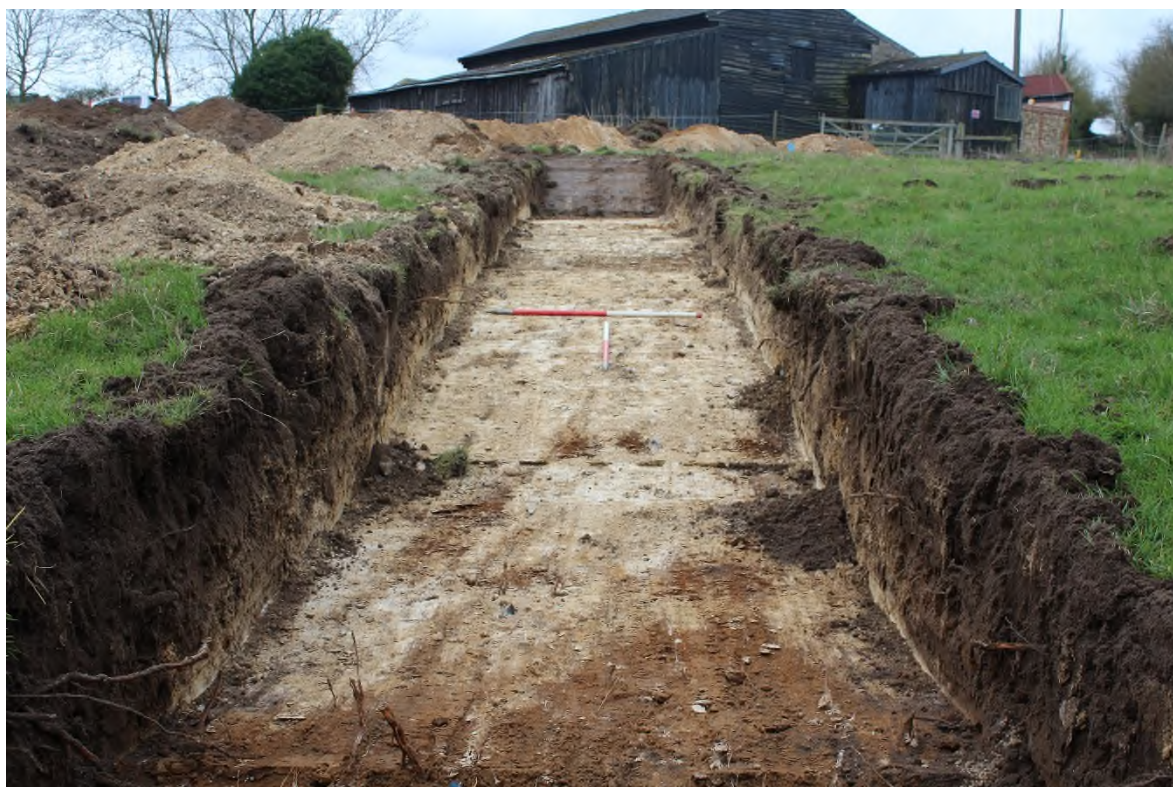
- 6.4.1 Trench 2 was located in the northern part of the site (Fig. 3; Plate 2). It contained a ditch [107] that was aligned northeast to southwest and measured 0.52m wide by 0.12m deep (Fig. 3, Section 2; Plate 3). Its fill (106) was a friable, mid brownish-grey silty sand. There was no dating evidence in the ditch but its position corresponds with a boundary shown on the 1905 Ordnance Survey map of the area.
- 6.4.2 Modern backfill up to 1.0m thick filled a large depression at the southern end of the

Plate 2: Trench 2, looking south

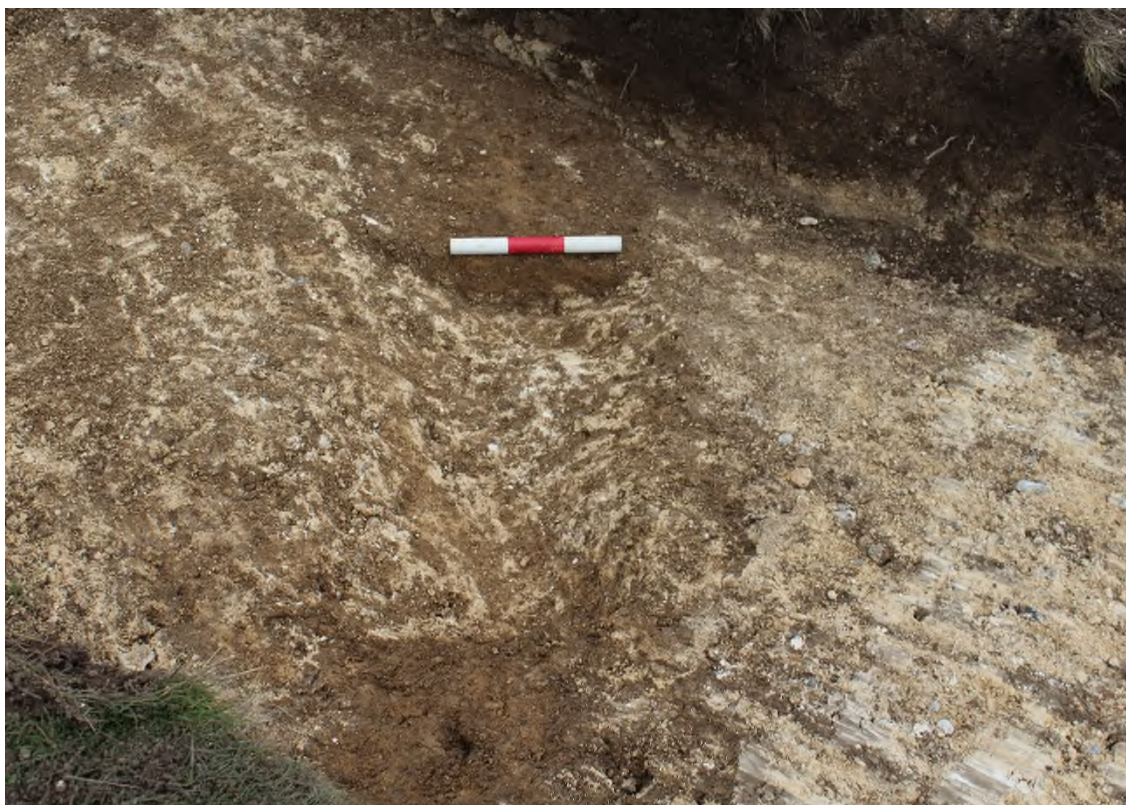
Plate 3: Ditch [107], Trench 2, looking east

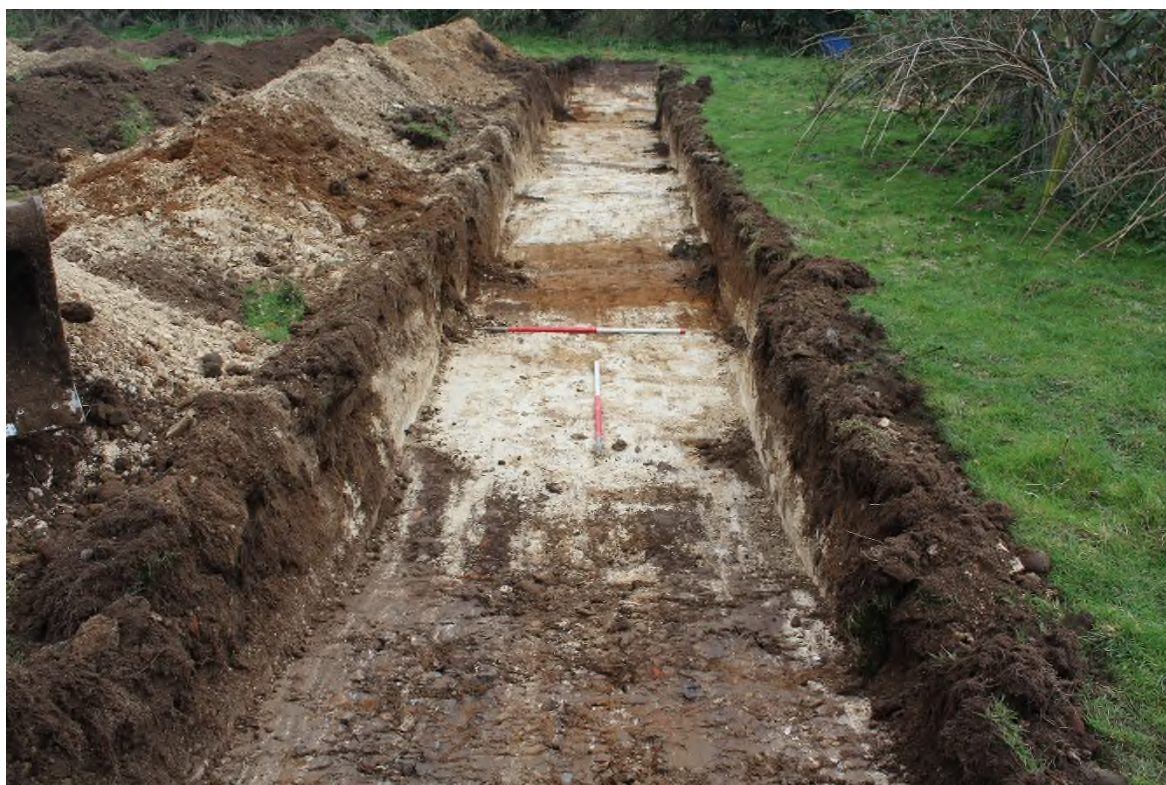
6.5.1 Trench 3 was located in the northeastern part of the site (Fig. 3; Plate 4). It contained an undated hollow [109] that was sub-circular in plan, measuring over 1.9m long, 1.15m wide and 0.18m deep (Fig. 3, Section 3; Plate 5). It had gently sloping sides and an uneven base. Its fill (108) was a friable, mid greyish-brown silty sand.

6.5.2 Modern backfill was identified at the northeast end of the trench. It was up to 0.8m thick, extended for approximately 5m and was a mixture of loose chalk and sand.

Plate 4: Trench 3, looking east-northeast

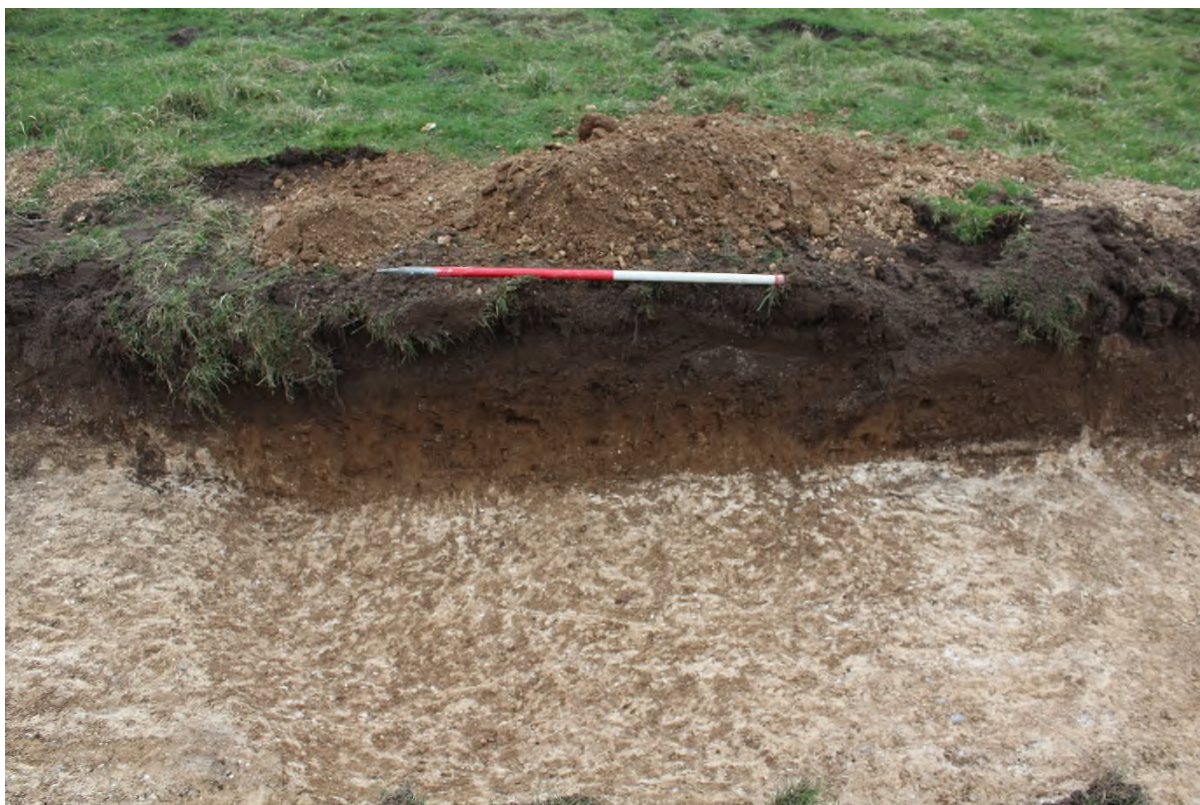
Plate 5: Hollow [109], Trench 3, looking north

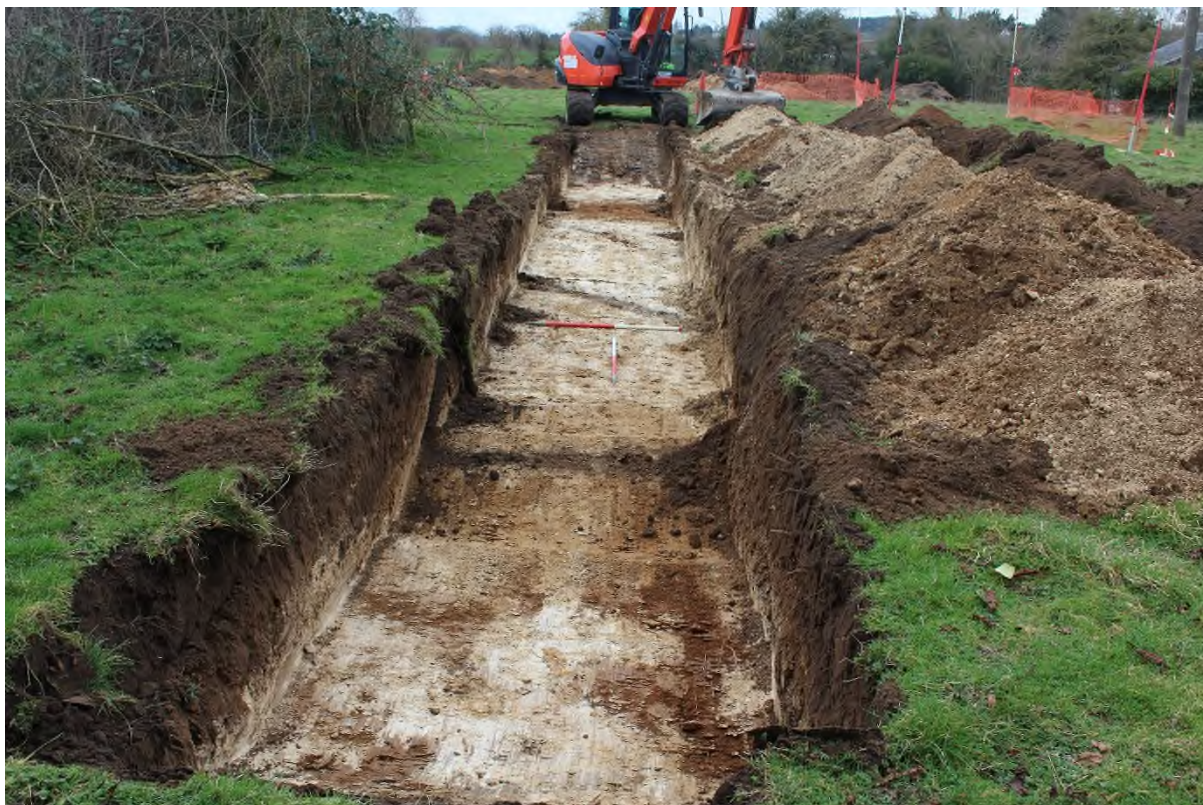
6.6.1 Trench 4, which was located in the southern part of the site, contained no archaeologically remains (Fig. 3; Plate 6).

Plate 6: Trench 4, looking northwest

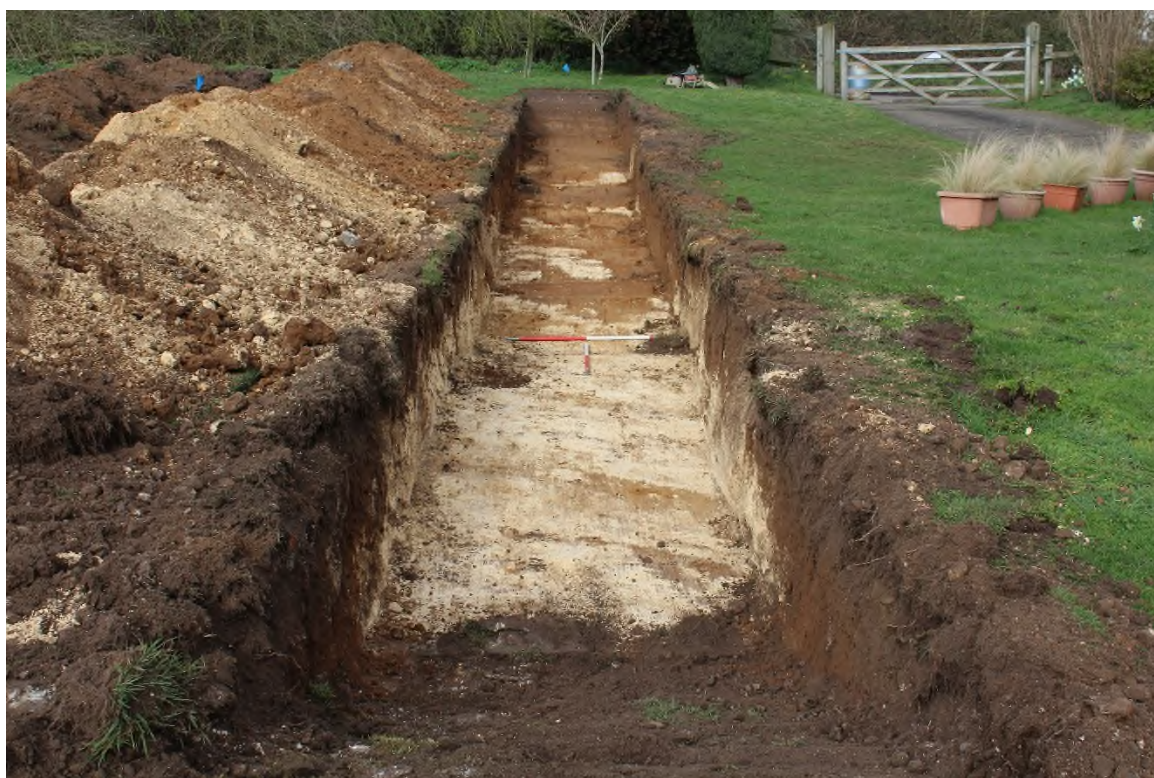
6.7.1 Trench 5 was located in the southern part of the site (Fig. 3; Plate 7). The original ground surface had been truncated and the depression entirely backfilled with a mixture of loose chalk and sand.

6.7.2 A modern pit [104] was cut into the backfill. It was elongated in plan, measuring over 1m long, 0.9m wide and 0.29m deep, and was backfilled with loose, mid yellowish-brown silty sand (103) and (105). A residual flint blade was recovered from its fill.

Plate 7: Trench 5, looking northwest

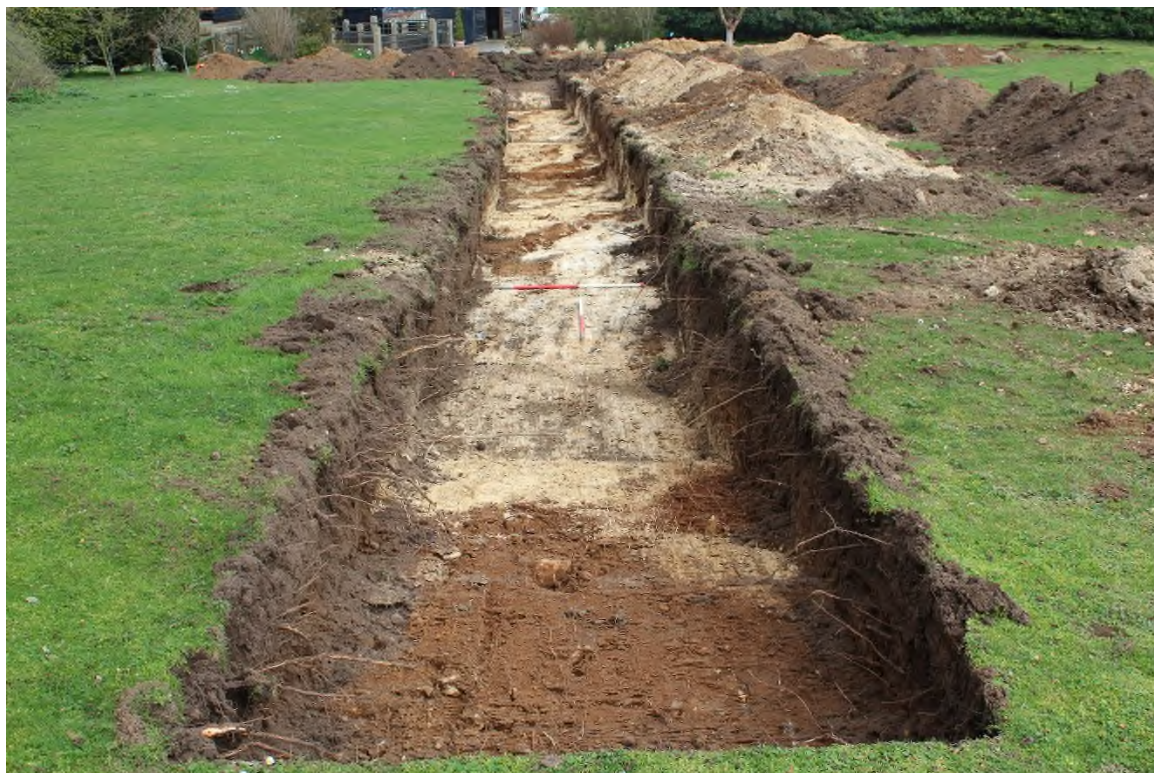
6.8.1 Trench 6 was located in the southern part of the site (Fig. 3; Plate 8). Modern features were mainly identified in the south-western part of the trench. This included a modern rubbish dump of wires, pipes, cans and glass. A modern service ditch containing a metal pipe was also identified in the central part of the trench.

Plate 8: Trench 6, looking northeast
