Preliminary Ecological Appraisal and Bat Survey Report

Villa Farm, Folly Lane, Norton Disney

Presented to T R Holmes (Farms) Ltd

Delta-Simons Project No. 21-1575.02

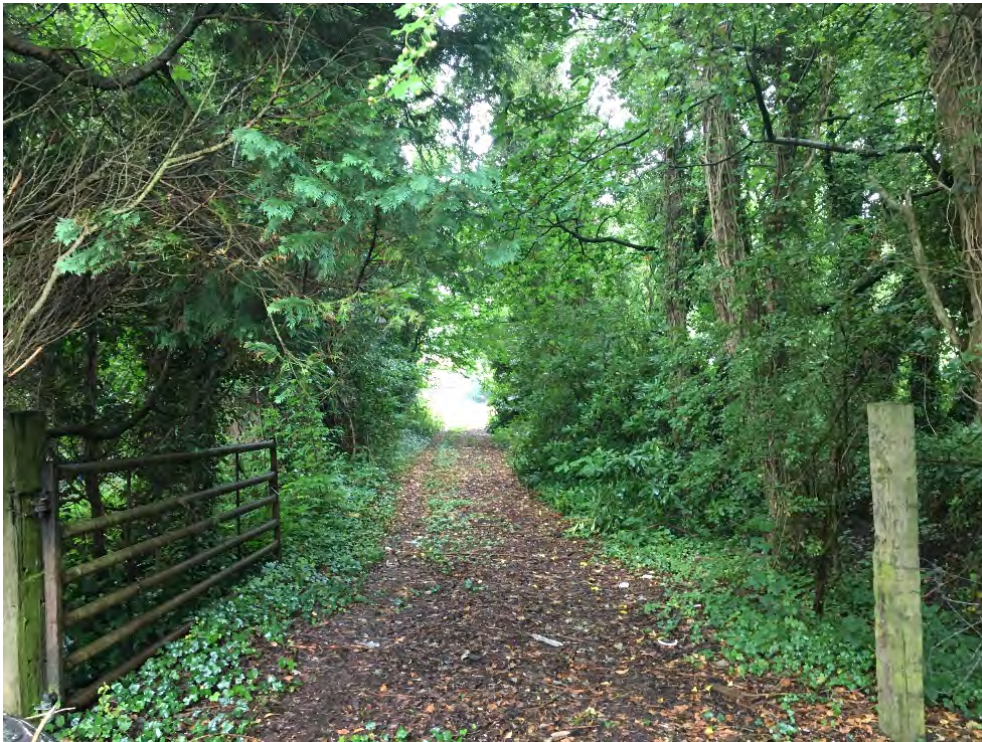
Photograph 1 – Woodland bordering the access track at the northern extent of the Site

The Site was dominated by mixed plantation woodland comprising Leyland cypress *Cupressus x leylandii*, pedunculate oak *Quercus robur*, aspen *populus tremula*, silver birch *Betula pendula*, hybrid black poplar *Populus x canadensis*, Scot's pine *Pinus sylvastris*, sycamore *Acer pseudoplatanus*, cherry *Prunus* sp., hawthorn *Crataegus mongyna*, white poplar *Populus alba*, Norway spruce *Picea abies*, elder *Sambucus nigra*, atlas cedar *Cedrus atlantica*, horse chestnut *Aesculus hippocastanum*, Lombardy poplar *Populus nigra*, apple *Malus* sp., ash *Fraxinus excelsior*, false acacia *Robinia pseudoacacia*, laurel *Laurus nobilis* and, hazel *Corylus avellana*. Some of the trees supported varying levels of ivy *Hedera helix*, which also formed the ground cover along with common nettle *Urtica dioica* and occasional evening primrose *Oenothera biennis* beneath more open areas of the canopy (Photographs 1 and 2).

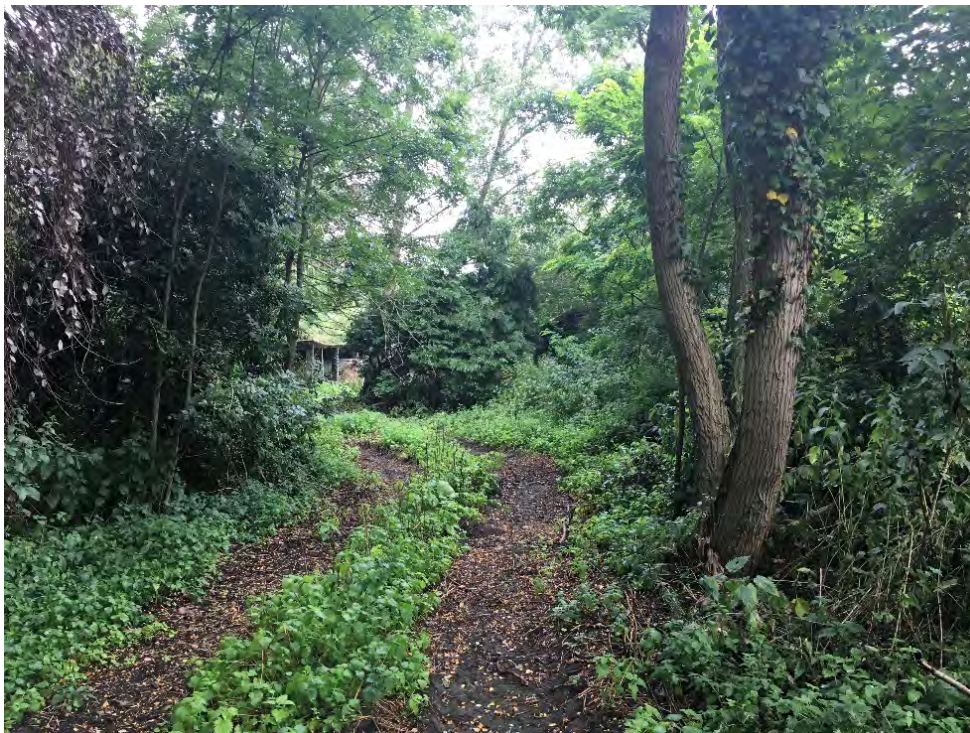
Photograph 2 – Woodland within the centre of the Site

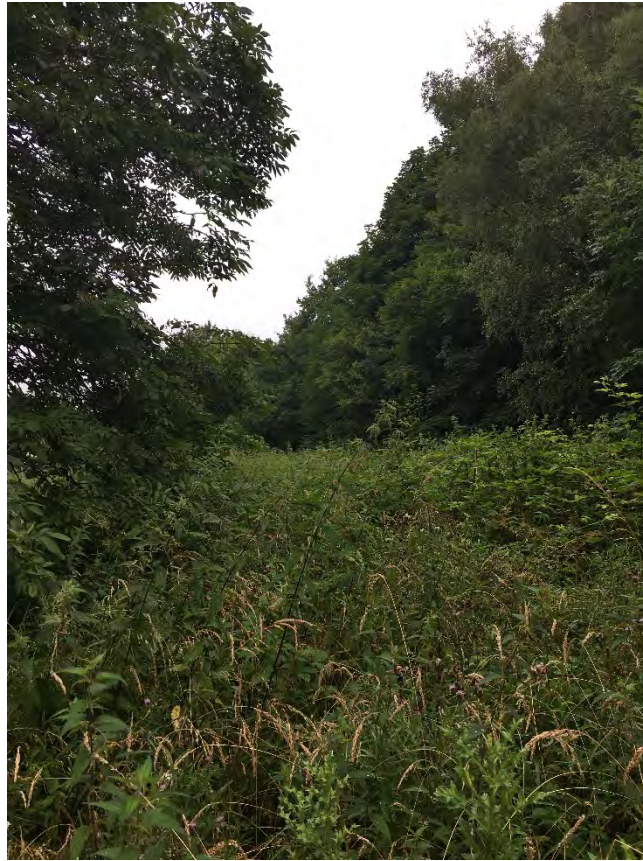
Photograph 3 – Dense scrub and tall ruderals in the northern extent of the Site

Bramble *Rubus fruticosus* agg. scrub colonised areas around the derelict buildings at the Site and formed dense patches at the woodland edge in the northern (Photograph 3) and southern areas of the Site, as well as along the roadside verge at the eastern Site boundary.

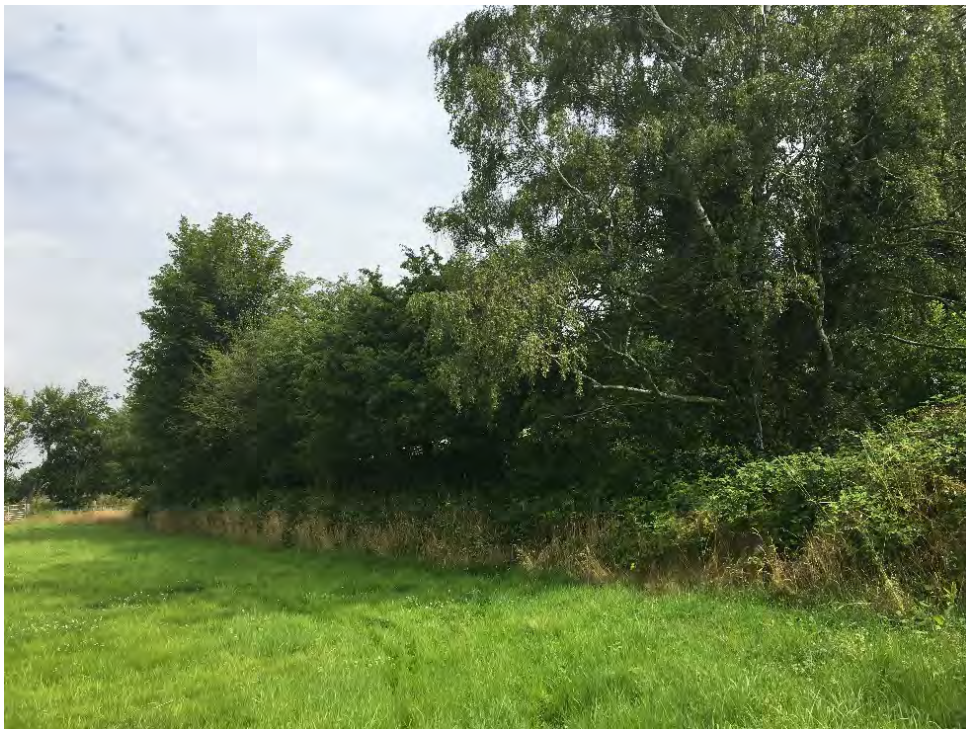
Photograph 4 – Scattered trees at the western Site boundary

Scattered broadleaved trees were present at the western Site boundary, comprising young and semi-mature hybrid black poplar, sycamore, rowan *Sorbus aucuparia*, ash, silver birch, hawthorn, pedunculate oak and cherry (Photograph 4).

Common nettle and willowherb *Chamaenerion angustifolium* had colonised an unmanaged area of former grassland in the northern area of the Site (Photograph 4) and formed patches, adjacent to the dense scrub in the south. Further nettles colonised areas around the buildings at the Site, including an area to the west of the residential property which had been recently cleared of shrubs and small number of trees to enable better access to the building. This area also supported creeping thistle *Cirsium arvense*.

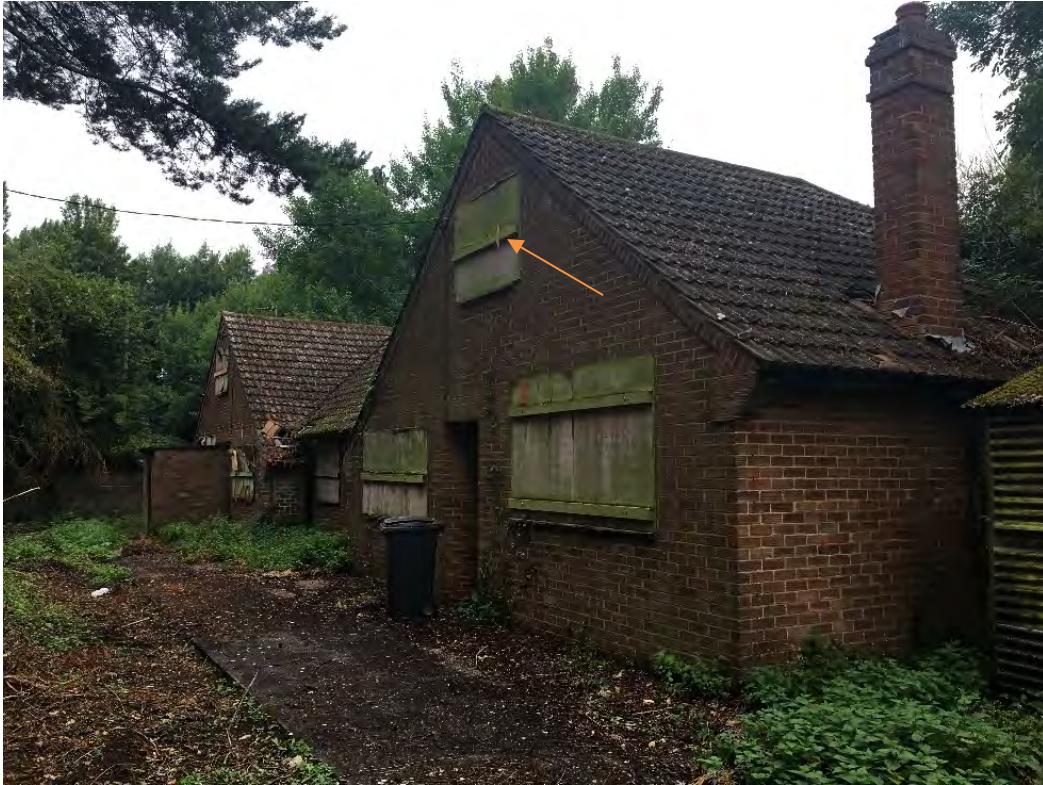
Building 1 has previously been found to support a small number of hibernating BLE bats, although its suitability has been decreased as a result of vandalism, and supports up to three small summer day roosts of common pipistrelle bat(s). The proposed demolition of the building will result in the permanent loss of the roost(s) as well as the potential to kill or injure individual bats if present. A EPSL is required to facilitate the demolition and ensure appropriate mitigation and compensation measures are applied. Depending on timescales to full planning consent and commencement of works on-Site, the EPSL application may require updated surveys should more than one season (12 months) pass from the date of this Report.

Photograph 5 – Western aspect of Building 1 with roost location behind wooden boarding

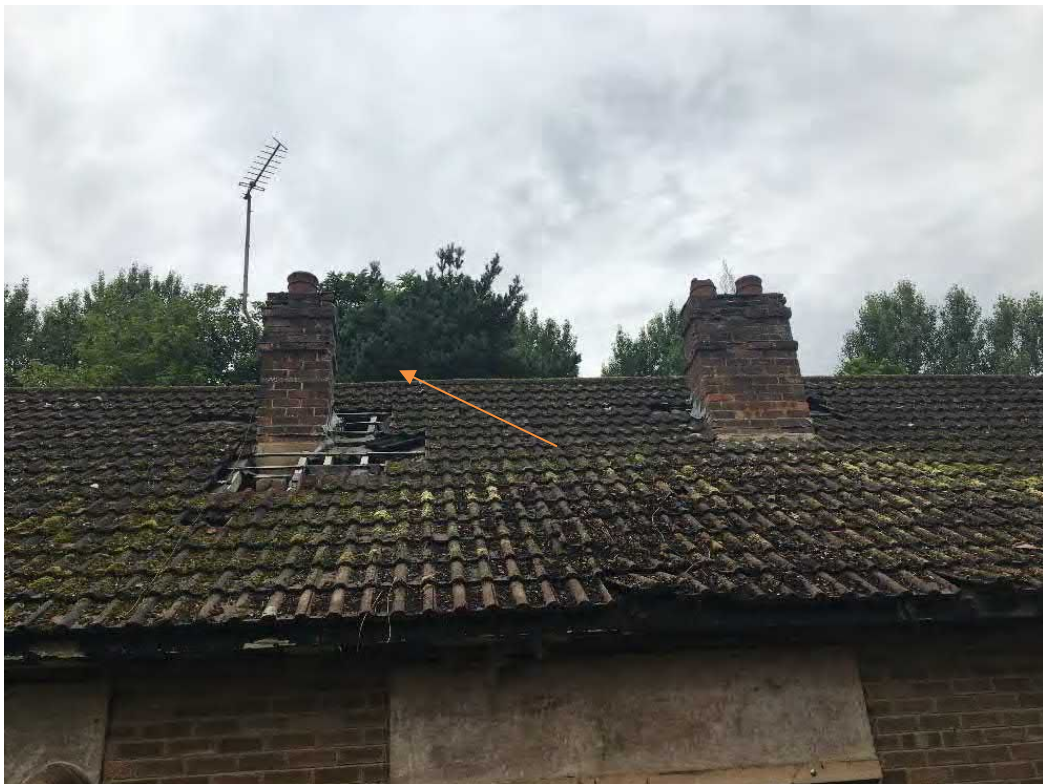
Photograph 6 – Eastern roof elevation of Building 1 with roost access point in roof structure

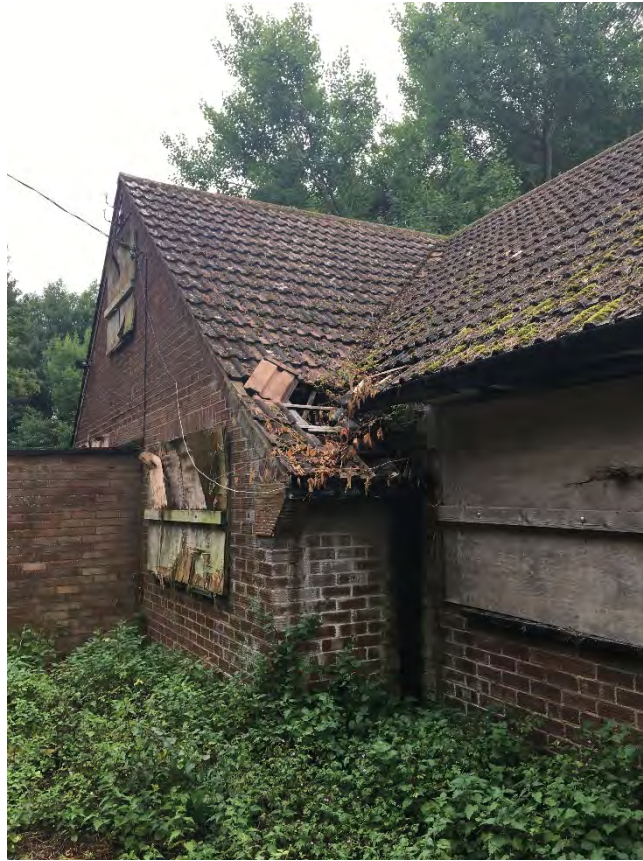
- ▲ The residential building was also recorded to support two hibernating BLE bats during the 2017/2018 hibernation season. However, vandalism and removal of lead flashing and roof tiles during 2018 was considered to have altered the internal climatic conditions of the roof void and, therefore, reduced the suitability of the building to support hibernating bats.

Photograph 7 – Missing roof tiles and warped boarding on Building 1

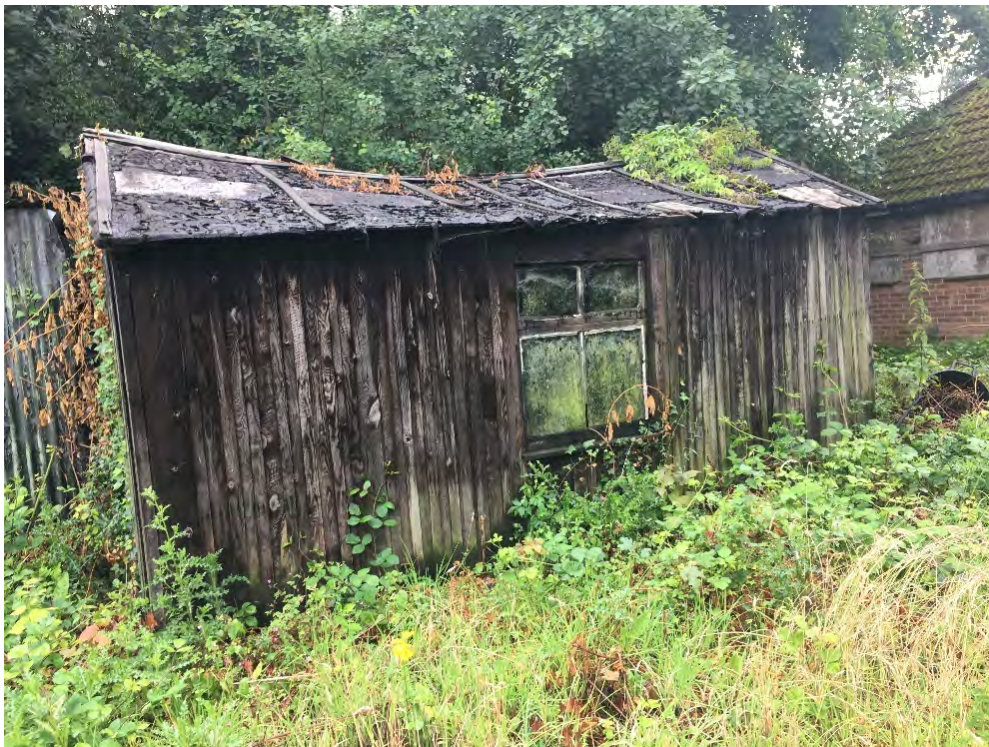
Photograph 8 – Building 2

Building 2 comprised a wooden shed/ garage with a pitched felt roof (Photograph 8) and an adjacent flat roof structure comprising wooden boarding and corrugated gently sloped roof. Windows and open doorways made both building sections internally light and draughty. The building was in poor condition with evidence of roof collapse, and a gap along the length of the ridge.

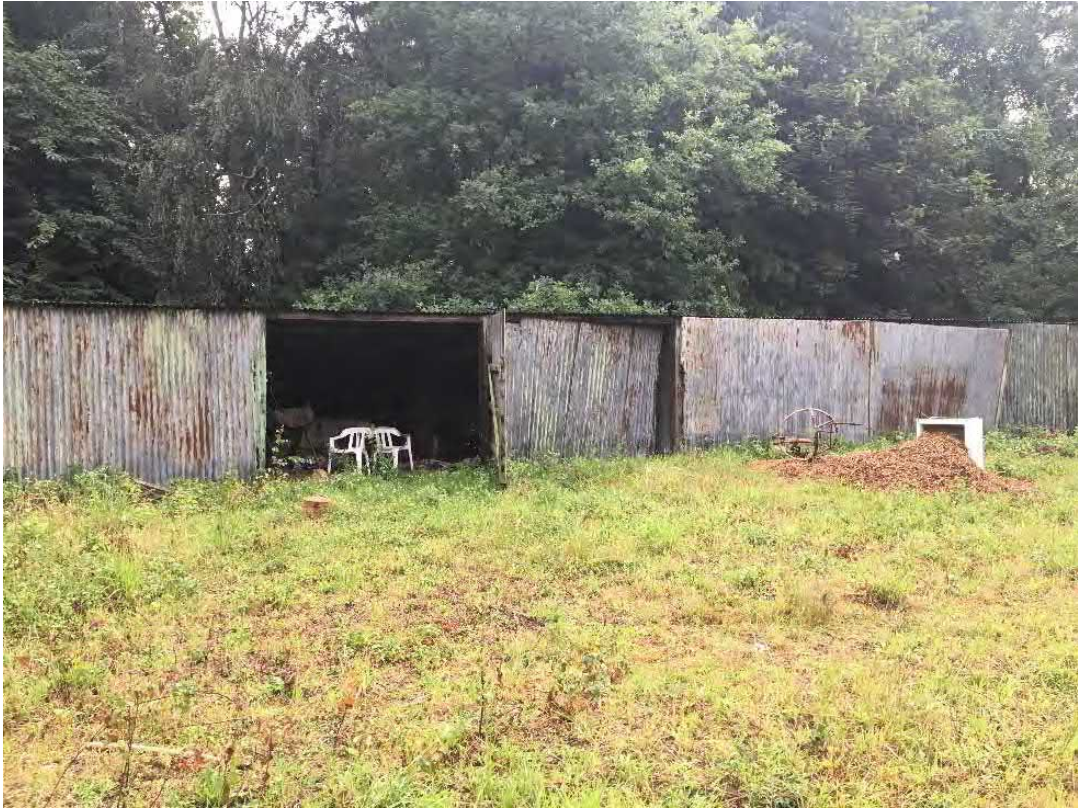
Photograph 9 – Building 3

Building 3 comprised a row of garages constructed of corrugated metal sheeting (Photograph 9), whilst Building 4 comprised a further metal garage that was open on the southern aspect and featured missing panels on the western elevation (Photograph 10). Both buildings were in a poor state of repair.

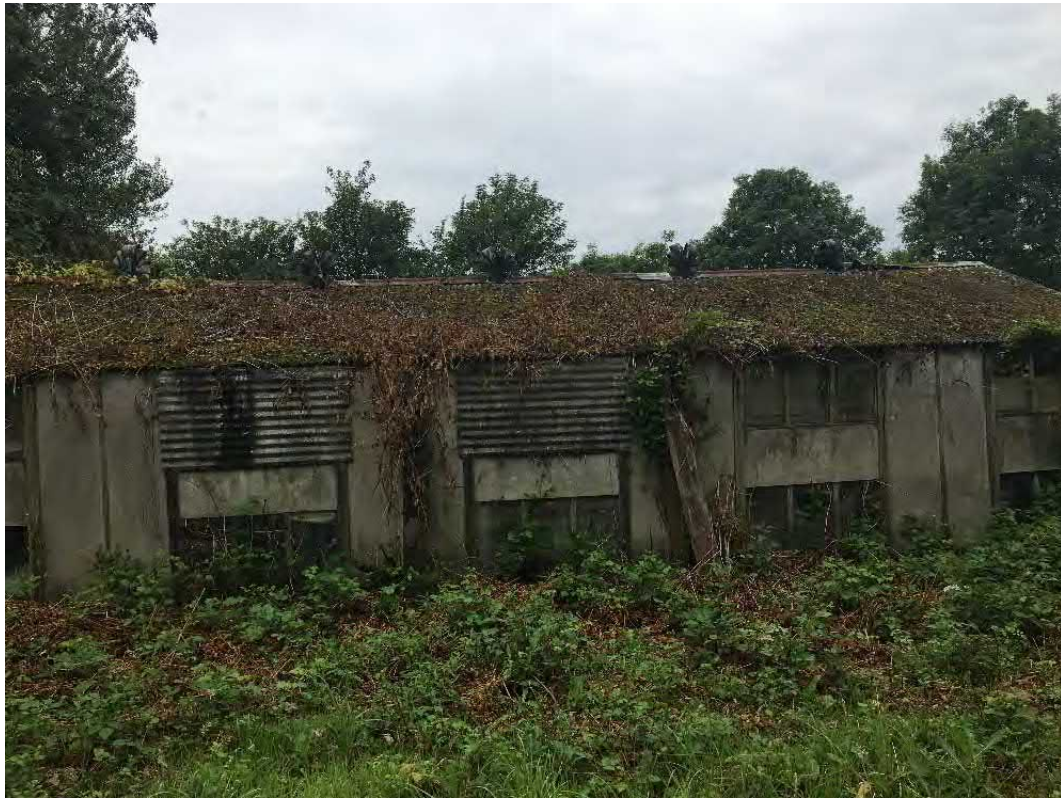
Photograph 11 – Building 7

Building 5 was a wooden structure that had partially collapsed at the time of the survey and Building 6 was a small wooden horse box in poor condition. Building 7 comprised a single storey structure constructed of a combination of metal and suspected asbestos cement sheets, with a pitched roof and ventilation pipes at the ridge (Photograph 11). Windows on the eastern aspect exposed the internal space to natural light and the building was noted to be draughty with no insulation Daylight was visible along the length of the ridge.

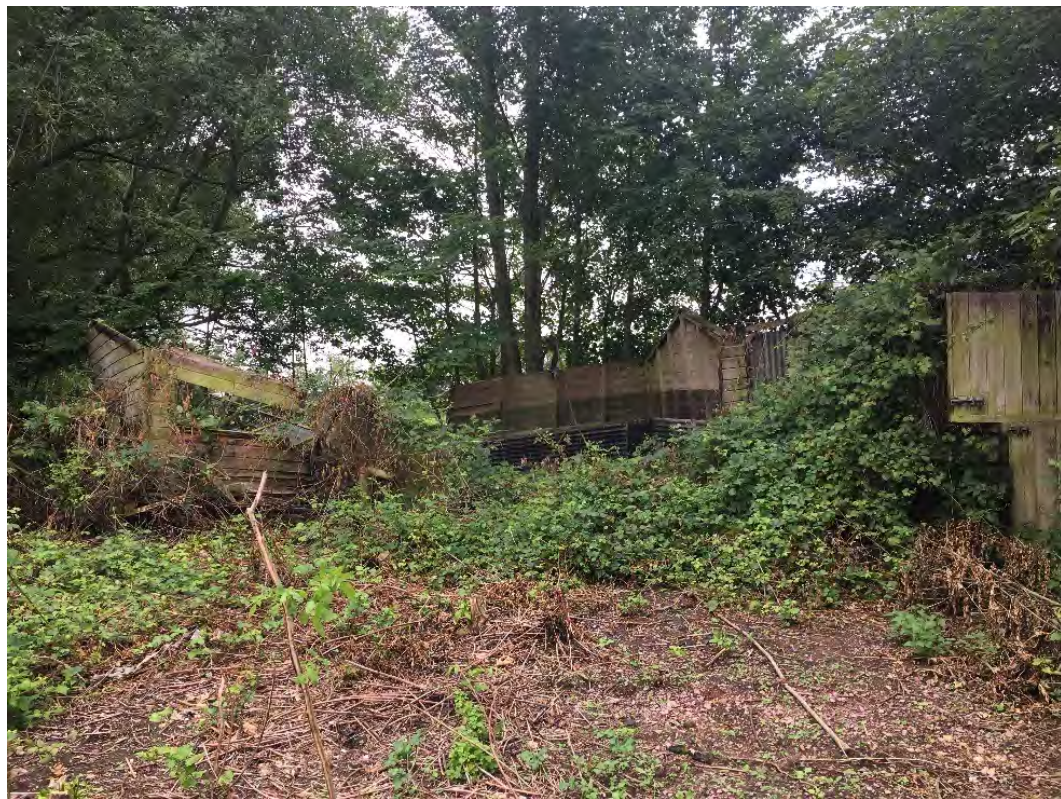
Photograph 12 – Building 9a and b

Building 8 was a wooden, open sided cart shed with a gently sloped suspected asbestos cement and metal sheet roof which was used for storage at the time of the survey. Building 9a and b comprised collapsed wooden structures with no roofs present (Photograph 12), whilst Building 9c comprised a further open sided structure of corrugated metal sheeting which was in a poor state of repair.

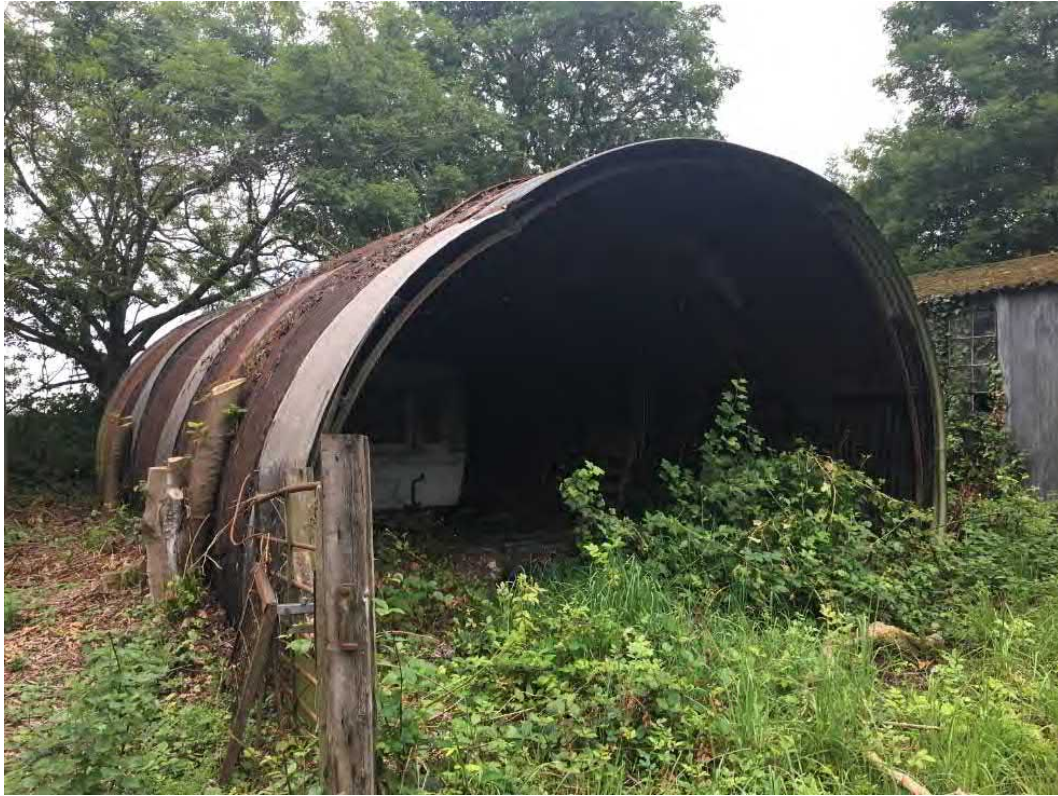
Photograph 13 – Building 10

Buildings 10 and 15 comprised Nissen huts made from prefabricated steel. Building 10 was open ended (Photograph 13), whilst Building 15 featured wooden doors on the ends and windows set within the western aspect (Photograph 15). Both buildings were single skinned and in a poor state of repair.

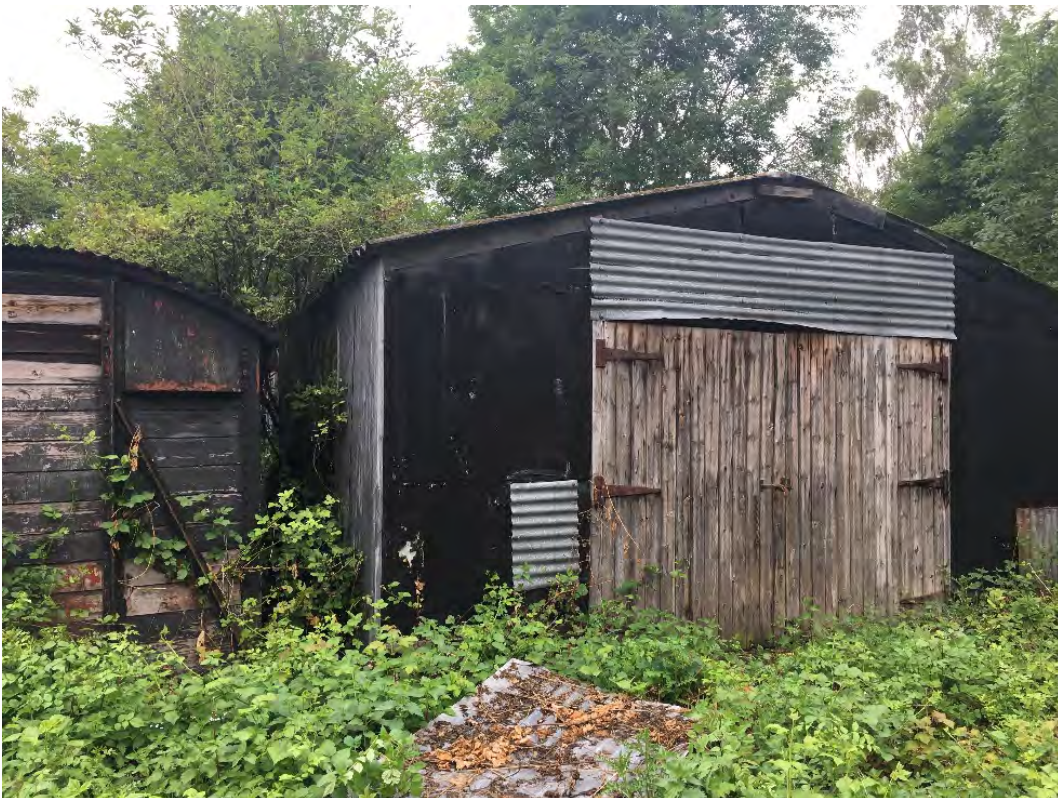
Building 11 appeared to be a temporary wooden structure situated adjacent to Building 12, which was a large wooden shed with corrugated metal sheeting and a pitched roof (Photograph 14). Internally Building 12 supported occasional wooden boarding that was in poor condition with evidence of damp and warping. Building 13 was a small wooden and metal storage structure. Buildings 14 comprised an open sided metal barn, whilst Building 16 comprised a wooden, open ended garage and adjacent wooden structure with a partially collapsed roof.

Photograph 14 – Buildings 11 (left) and 12 (right)
