Bat Survey Report

Keelham Farm, Old Town, Hebden Bridge

22nd September 2021

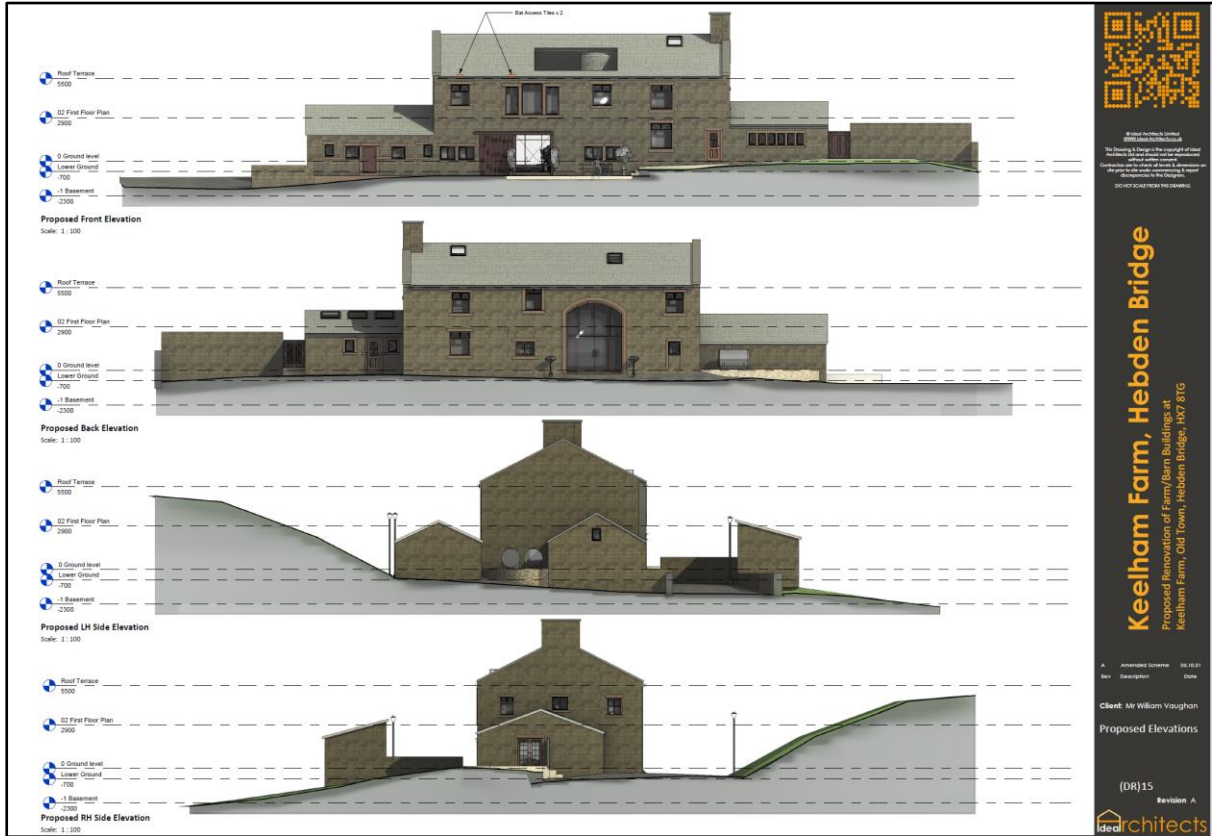
Figure 1.2: Post construction visuals for the proposal.

Post construction visuals for the proposal are shown as Figure 1.2. The outbuildings will be internally and externally modified to link into the existing farmhouse dwelling. This shall involve removal and reconstruction of the roof structures, integrating new windows and constructing loft living space.

The proposal integrates built in bat mitigation as part of its design, including two lifted tiles at the building's front elevation. This proposed mitigation aligns with the bat survey result and will be developed further to ensure an adequate internal loft void for bats.

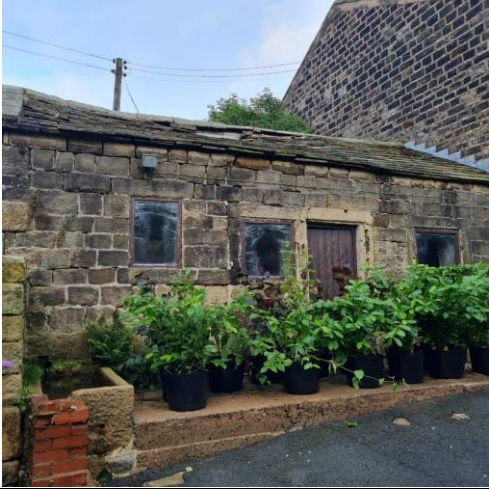
PRF	Description of PRF	Photograph	Resulting Value
1	<p>South facing aspect of building B1, gaps under stone tiles and roof overhang. Part collapsed roof c. 3x3m and exposed to rain fall and increased light levels.</p>

Moderate
2	<p>External features of B1, PRF on gable end. Gap beneath cement and gritstone.</p>

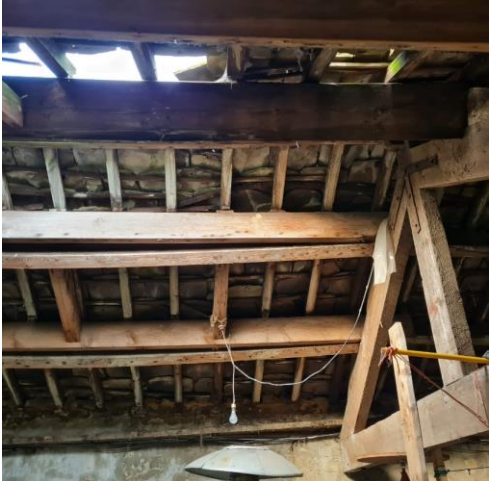
Moderate
3	<p>Internal view of B1 revealing part collapsed roof and original joists and beams with the original stone tiles. PRF under joists and beams.</p> <p>Internal walls were well-sealed and there was no evidence of bat droppings or feeding.</p>

Moderate

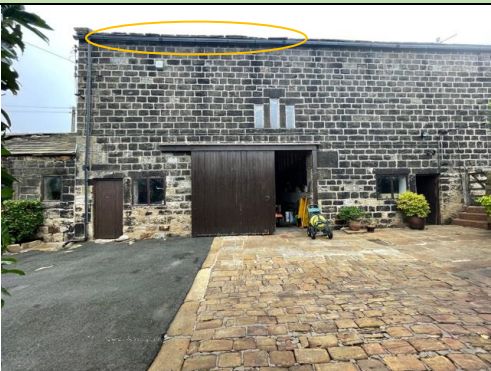
PRF	Description of PRF	Photograph	Resulting Value
4	<p>PRF along the overhang of stone tiles on south facing aspect of building B2. The tiles are slightly lifted to provide access and egress for bats.</p> <p>Rear north facing aspect of barn has consistent well sealed tiles and brick work.</p> <p>The ridge tiles along the length of the B2 are well sealed with cement.</p>

Moderate
4	<p>Internal view of B2 with traditional beams, although joists have been replaced and there is an underlay between the roof joists and stone tiles.</p> <p>Common pipistrelle bat droppings were located on furniture within the building.</p>

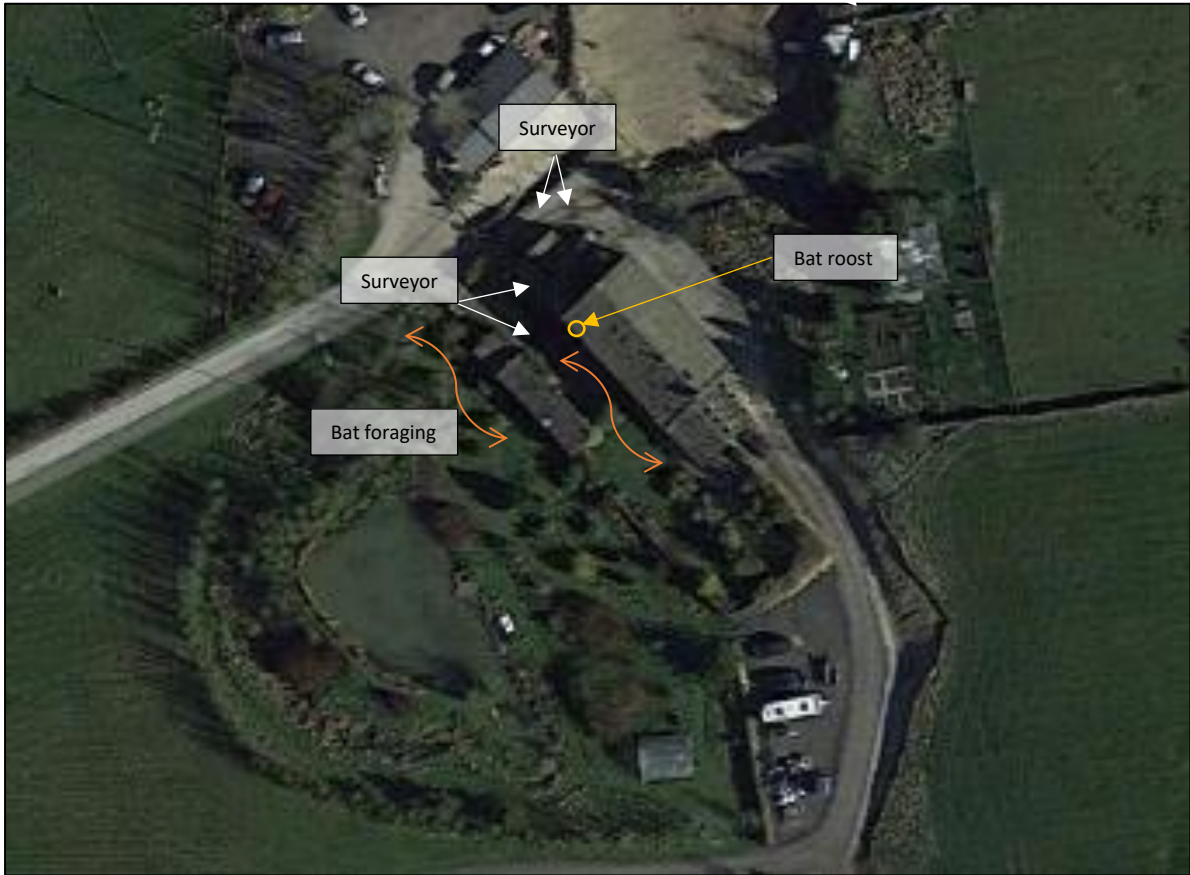
Figure 3.1: Bat Survey Findings

During the dawn survey, there were two common pipistrelle frequently foraging within the same location and a third pipistrelle was foraging intermittently. Two bats were observed swarming and entering beneath a stone tile on the south facing aspect of building B2, see PRF 4 of Figure 3.1.

To mitigate the loss of a common pipistrelle roost two bat access tiles are incorporated into the development design, sighted in the same location for where bats were observed entering. In addition, the roof void of the buildings should be lined with bituminous roofing felt which does not contain polypropylene filaments. Under no circumstances should breathable roofing membrane be used. Breathable roofing membrane contains spun bond filaments which can entangle bats feet and wings, resulting in bats becoming immobilised and eventually dying, in addition to reducing the functionality of the roofing membrane.
