BAT SURVEYS AND ASSESSMENT

**Woolaston Methodist Church, Netherend
Woolaston, Gloucester GL15 6NT**

**Report
20th September 2021**

Report reference:
C2752-1

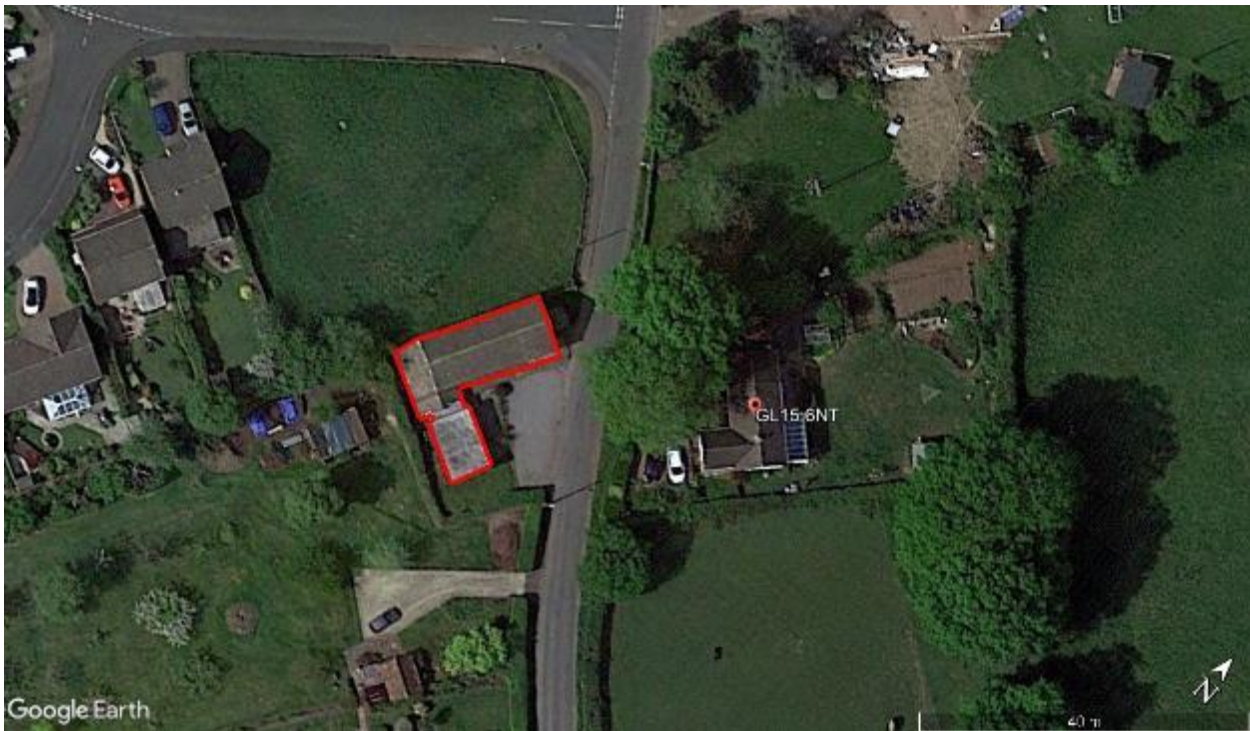
Figure 1.1: The location of Woolaston Methodist Church, with the building surveyed outlined in red.

The preliminary survey was undertaken on 26th May 2021 by Nick Underhill-Day and Rhiannon Taylor of Swift Ecology Ltd. Weather conditions at the time of the survey are shown in Table 2.1. The survey covered the church, as shown in Figure 1.1, Section 1.

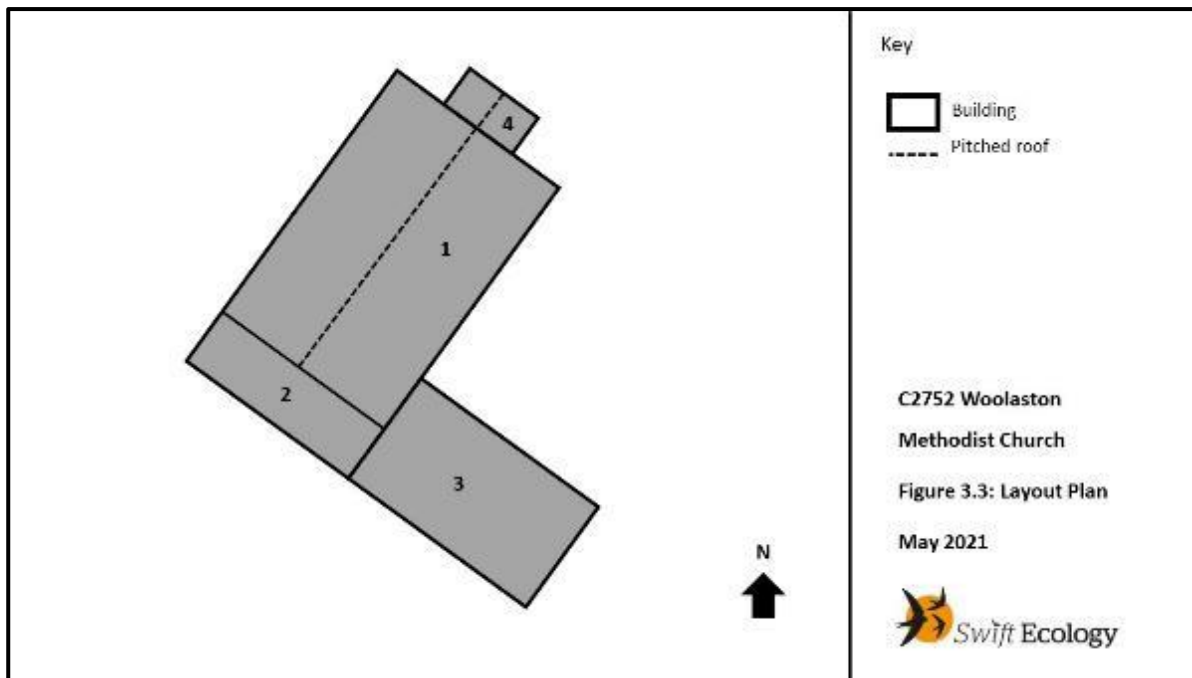
Figure 3.1: Woolaston Methodist Church layout plan

Woolaston Methodist Church was built in 1867 (sections 1 and 4). It was enlarged in 1893 with a single storey sloped roof extension (section 2) and a Sunday School room with a flat roof added in 1967 (section 3); the layout is shown in Figure 3.1 below. The church was used as a place of worship up until December 2020. The church and extension are constructed of stone walls and modern concrete interlocking roof tiles; the Sunday School extension is constructed of modern brick with a bituminous felt flat roof.

The church comprises four main parts (Figure 3.1; Plates 1 and 2): an original rectangular stone-built building with a pitched roof (section 1), a stone-built extension with sloping roof on the southwest elevation (section 2, Plate 3), a flat roofed brick-built Sunday School room extension (section 3, Plate 4) and a small stone porch with a pitched roof (section 4) located on the northern roadside elevation.

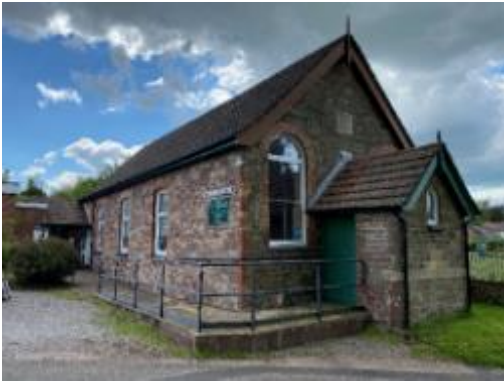
Plate 1: North-east elevation showing the original Church (section 1) and front porch (section 4).

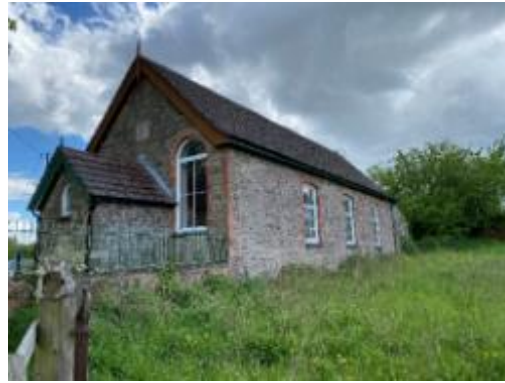
Plate 2: Western elevation and adjacent pasture field.

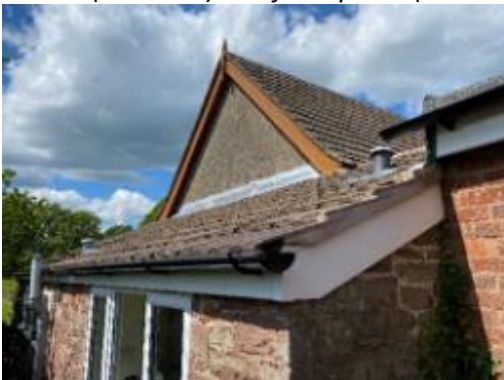
Plate 3: Rear of the Church showing the single storey sloped roof extension from 1893 (section 2) and the joins of sections 1 -3.

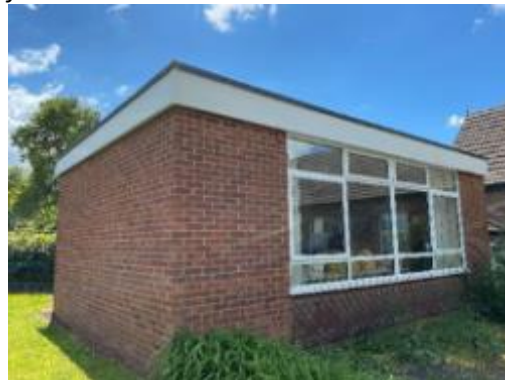
Plate 4: Sunday School room extension (section 3).

The stone walls of sections 1, 2 and 4 are generally in good condition although there are several gaps in the pointing which might offer potential for roosting bats (Plate 5). A house sparrow *Passer domesticus* was noted nesting in a gap on the eastern elevation of the main building where mortar was missing. The brick walls of Section 3 are tightly sealed with no gaps in the pointing noted.

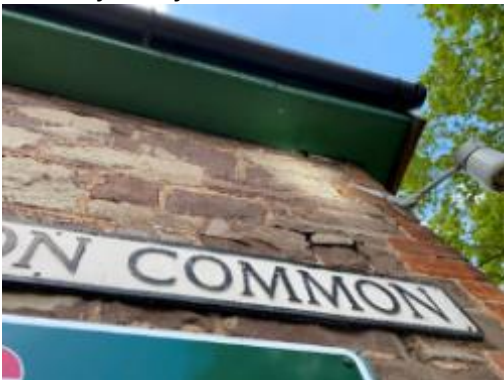
Plate 5: Gaps in the pointing of section 1.

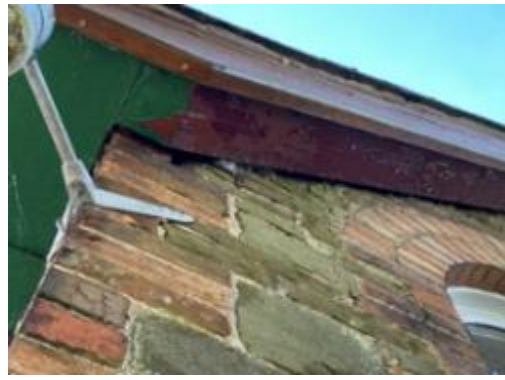
The main roof of the church (section 1) supports modern, interlocking concrete roof tiles and concrete ridge tiles. These are in good condition and well-sealed with no visible gaps for roosting bats, except for several small gaps noted under a few of the ridge tiles. There are several cracks along the tile verges of section 1. There are wooden soffits covering the eaves on section 1 with numerous gaps between the soffit and brick work that could offer bats access into the roof void of the original church (Plate 6), and frequent gaps between the gable end render and soffits. The lead flashing at the rear of the building has some lifting and there is potential for crevice dwelling bat species to roost around the rear of the single storey extension (section 2) between the render and the wooden barge boards. The modern extension (section 3) is flat roofed and is tightly sealed, offering very limited potential for roosting bats, except for occasional or opportunistic roosting within gaps behind the plastic fascia boards; however, these gaps contained extensive cobwebbing, suggestive of no recent bat use.

Plate 6: Gaps under the soffits.

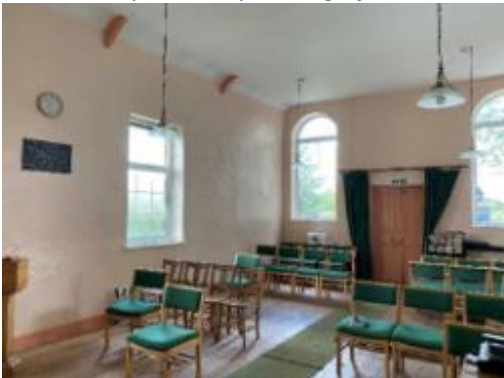
Plate 7: Interior of the nave (section 1).

Internally the church comprises the main church with nave and alter (Plate 7), accessed via a porch (section 4, Plate 8) on the north-eastern elevation or internally through the sloped roof extension (section 2; Plate 9) which consists of a small kitchen, two lavatories and a hallway with another pedestrian entrance with access into the Sunday School extension (section 3; Plate 10).

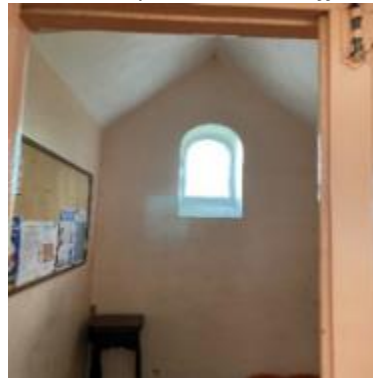
Plate 8: Interior of the porch (section 4).

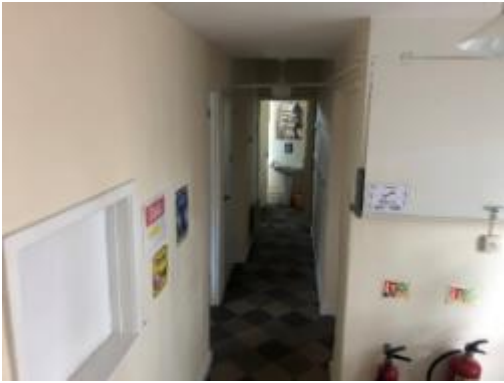
Plate 9: Interior of section 2- corridor and lavatory with kitchen door on the left-hand side.

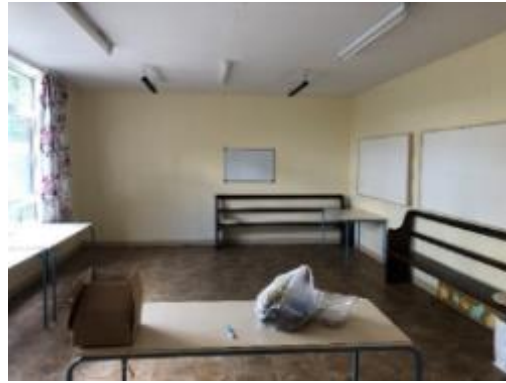
Plate 10: Interior of the Sunday School room (section 3).

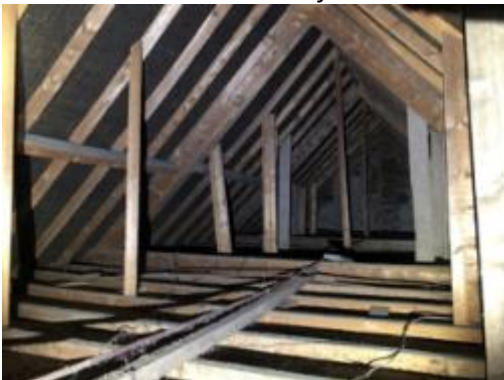
There is a large single void accessed through a hatch in the ceiling of the main church (Plate 11). The void is approximately 12 – 14 m in length by 4 m in width, and approximately 2.2 – 2.4 m in height at the apex. There is a ridge board along the apex with purlins at a third height; the timbers are square cut and in good condition (Plate 12). The internal gable stonework is roughly mortared, and thus there may be gaps and cracks providing suitable roosting opportunities for crevice-dwelling bats (Plate 13). The void is relatively dark, although some daylight is visible through the eaves, which is likely to provide access for bats into the loft. The void provides good protection from wind and adverse weather. The roof is lined with traditional bitumastic felt, mostly in good condition with few holes, tears or sags which would provide easy access for bats into the void from the spaces above, although there is one area of sagging felt above a section of the ridge board; the lining appears to have been replaced within the last 20 years (Plate 14). Levels of human disturbance are likely to be very low.

The void contained a small number (~30) of bat droppings localised around the access hatch; these were relatively fresh and were of a size and shape characteristic of a pipistrelle bat species. A number (~50) of droppings from a large bat species were also present beneath the ridge board where the felt is damaged. The void floor also contained an extensive covering of dust along its entire length, directly below the roof apex; on closer inspection there were some very pale and crumbled medium-sized bat droppings within the dust, which was considered to represent the remnant evidence of an historical bat roost of a medium-sized bat species, such as brown long-eared bat. Dropping samples were collected and sent for DNA analysis to confirm species.

Plate 11: Large loft void above the main Church building (section 1).

Because bat roosts are confirmed as present, a comprehensive mitigation plan will be required if roof structures or the roof void are to be affected as a result of the development of the church (e.g. conversion of the roof void, re-roofing or replacements of soffits/fascia). The mitigation plan should be designed to accommodate the species of roosting bat present and to ensure that bats are not harmed during works and that there are no negative effects on bat populations. Detailed mitigation measures for bats should be designed into the scheme and incorporated into a method statement/mitigation plan; this can be conditioned upon approval or supplied as part of the planning application.

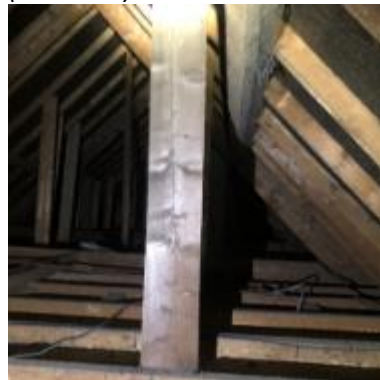
Plate 12: Square cut timbers in good condition in the loft void.

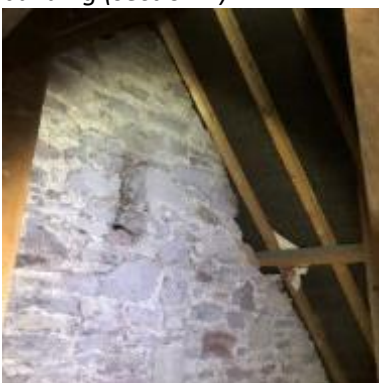
Plate 13: Internal stonework of the west gable.

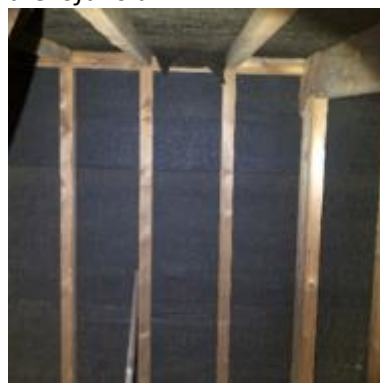
Plate 14: Bitumen felt roof lining of the loft void.

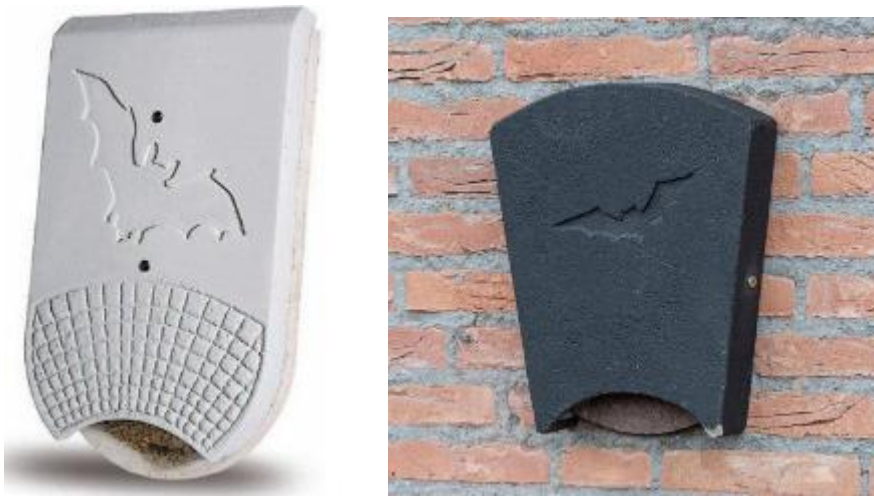
Figure A5.1: Schwegler 1FQ bat box (left) and Beaumaris Woodstone bat box (right)

Examples of suitable bat boxes to be installed on flat walls of the converted church building include:

- Schwegler 1WQ summer and winter roost
- Schwegler 1FQ bat box

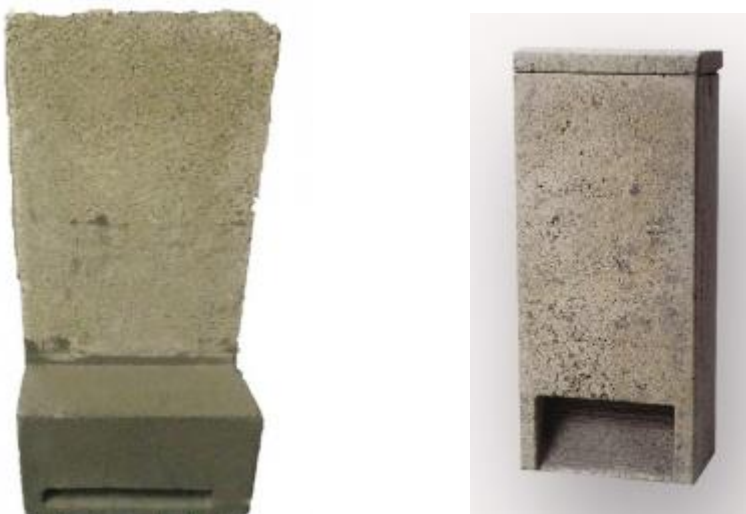
Figure A5.2: Segovia Build-in Woodstone bat box (left) and Schwegler 2FR Bat Tube (right)

Suitable bat box products to be installed integral to the walling of the converted church building include:

- Segovia Build-in Woodstone bat box
- Schwegler 2FR Bat Tube

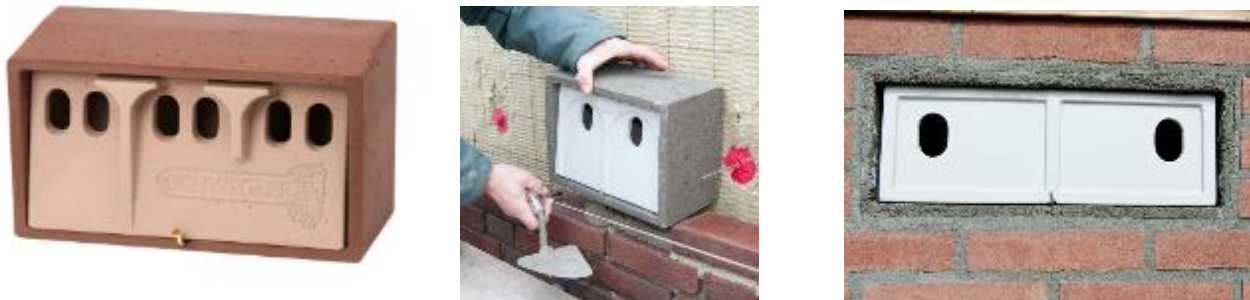
Figure A5.3: Schwegler 1SP sparrow terrace (left), Vivara Pro WoodStone house sparrow nest box (middle) and WoodStone Build-in house sparrow nest box (right)

Suitable bird box products to be installed on suitable walls of the converted church building could include:

- Schwegler 1SP sparrow terrace
- Vivara Pro WoodStone House Sparrow Nest Box
- WoodStone Build-in House Sparrow Nest Box
- Schwegler 9a house martin nests
- Schwegler slide-out house martin nest
- Schwegler swift box No. 17
- Schwegler 16s swift box

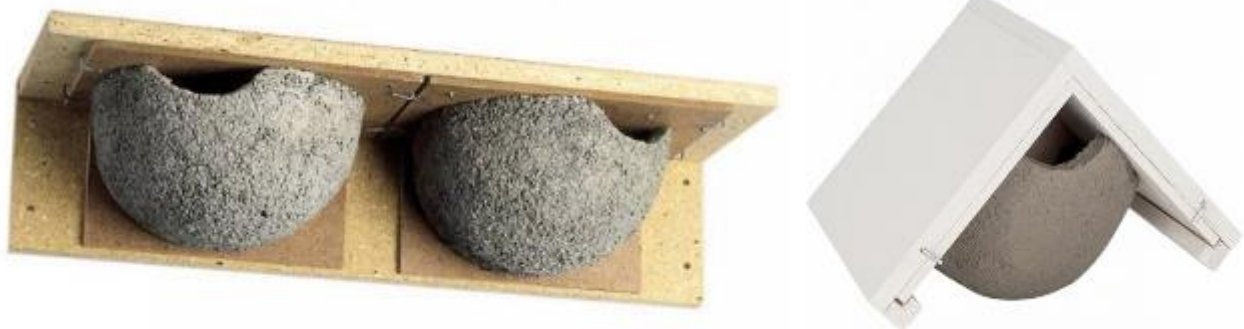
Figure A5.4: Schwegler 9A house martin nests (left) and slide-out house martin apex nest (right)

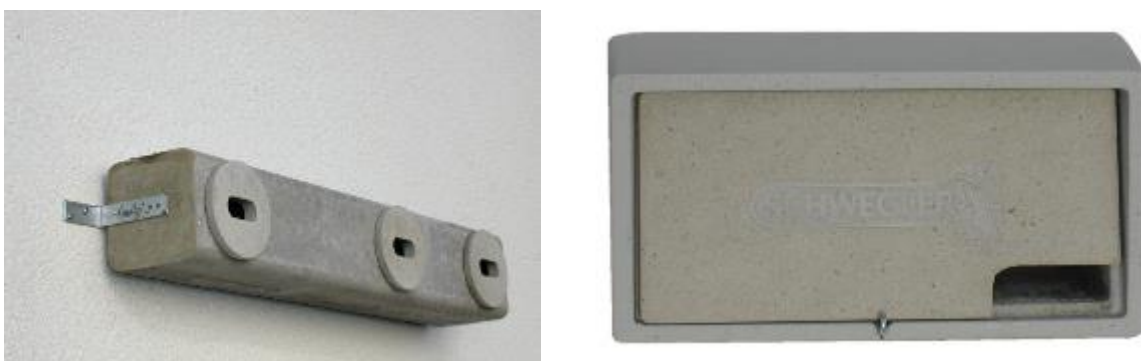
Figure A5.5: Schwegler swift box No. 17 (left) and 16S Schwegler swift box (right)
