**Bat Survey Report for
Lemell Hooks Buildings at
North Rye House, Donnington,
Moreton-in-Marsh, GL56 0XU**

Cotswold Wildlife Surveys

13th July and 4th August 2021

Lemell Hooks Buildings, North Rye House, Donnington – Bat Survey Report

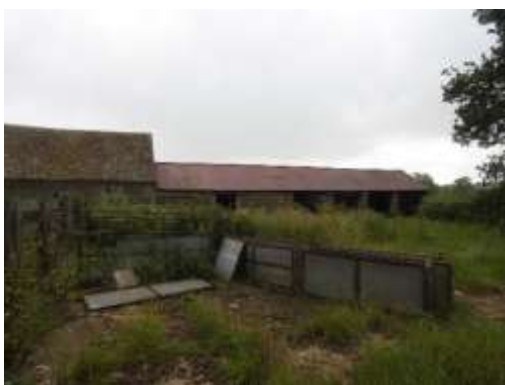
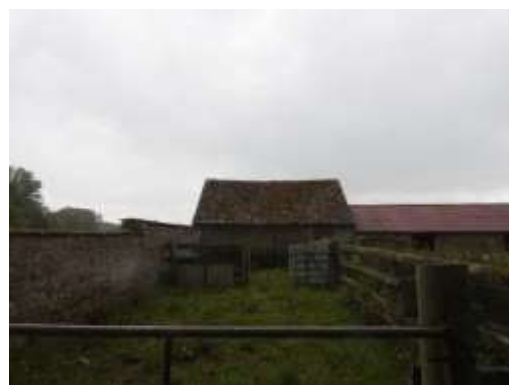
Figs. 1 & 2 Lemell Hook Buildings

The survey site comprised a set of redundant agricultural buildings, these consisting of a stone barn with pitched stone tiled roof, a single storey, open fronted cart-hovel with pitched corrugated steel roof, and a partly walled courtyard on the west side of the buildings (Figs. 1 and 2).

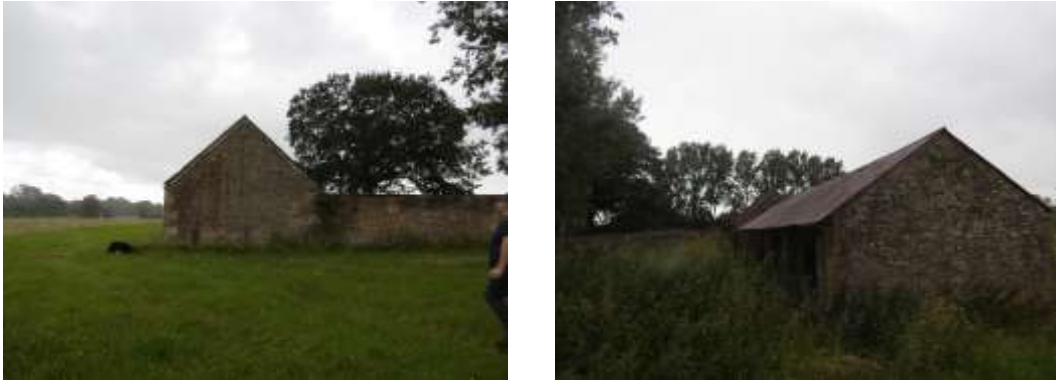
Figs. 3 & 4 Lemell Hooks buildings

The buildings (Figs. 3 and 4) lay approximately 350m to the west-northwest of North Rye House.

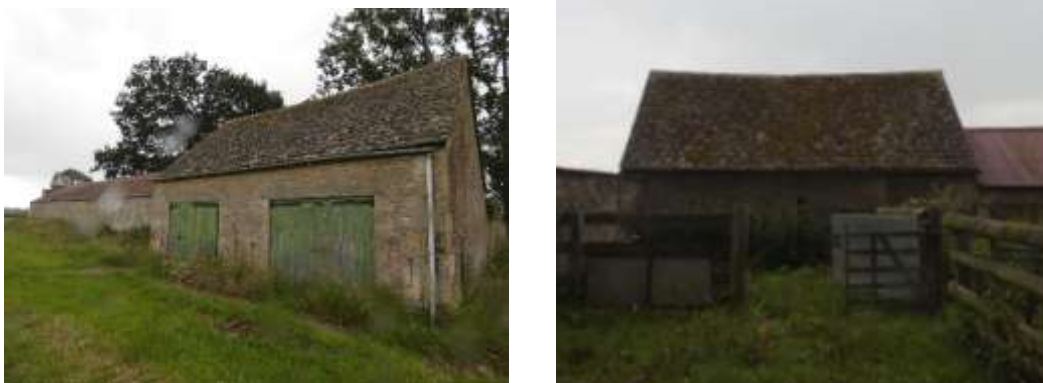
Figs. 5 & 6 Roof of stone barn

The ridge and roof tiles of the pitched stone roof were fully intact, although some small gaps were noted under a few tiles on the slopes where they were slightly raised or dislodged (Figs. 5 and 6).

This was considered to be low, as there were a few gaps under stone roof tiles and there were a few areas of missing mortar in the stonework of the walls.

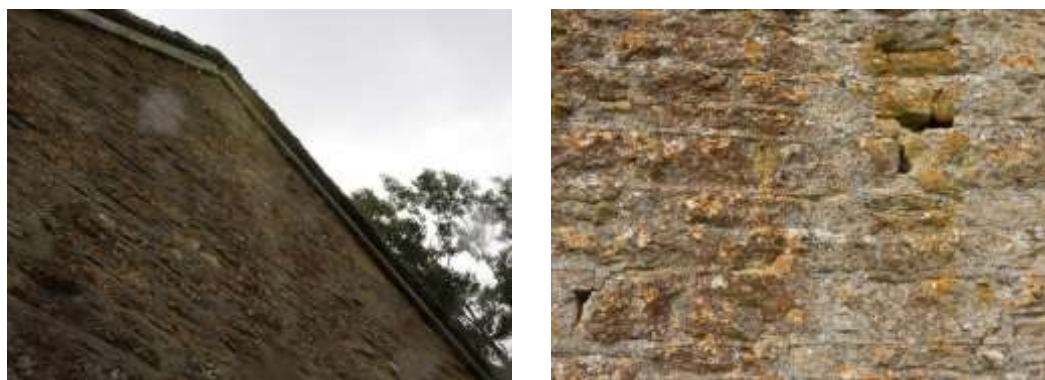
Figs. 7 & 8 Verges (L) and stone wall showing cavities in the pointing (R)

There were also a few cavities created by some missing mortar in the stonework, and gaps behind the gable barge boards, although the latter were choked with cobwebs. The verges were tight (Figs. 7 and 8).

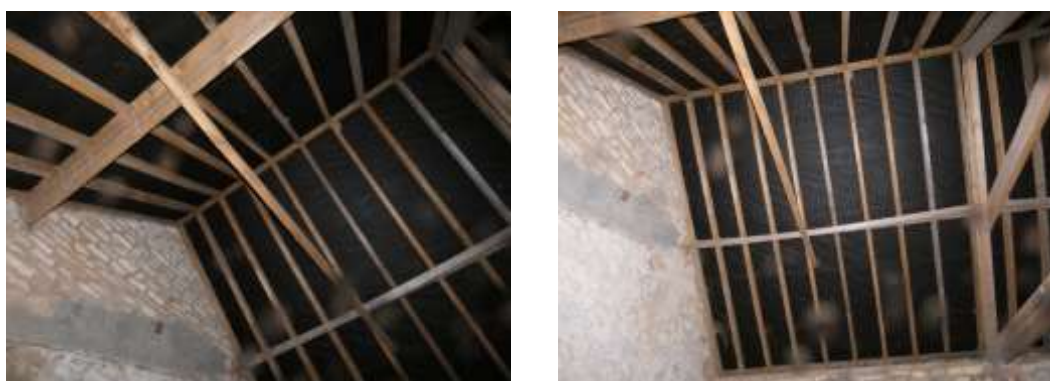
Figs. 9 & 10 Interior of stone barn

Internally the roof was lined with intact bitumen felt and there was no light penetration to the interior through the roof slopes (Figs. 9 and 10).

No evidence of bat occupation was discovered inside the barn.

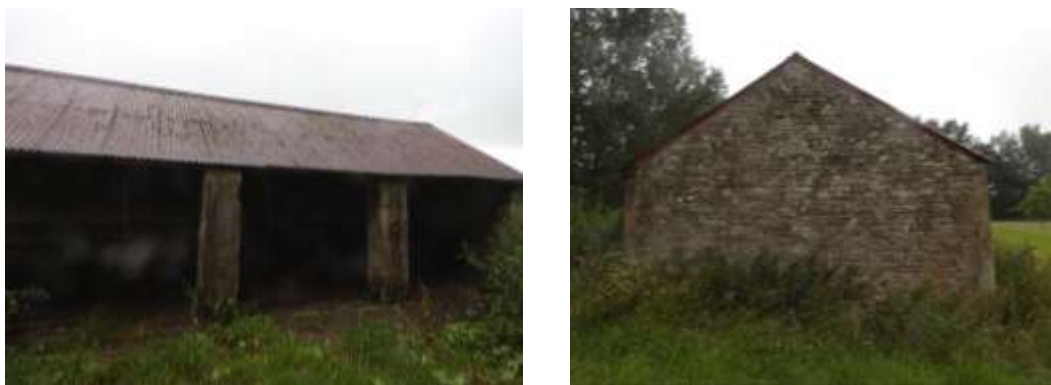
Figs. 11 & 12 Cart-hovel

Adjoining the barn was a fairly long, single storey building with a pitched roof covered by corrugated metal sheets (Fig. 11). These were all intact and the ridge was sealed by metal flashing, although there were gaps under the corrugations.

There were gaps under the roof sheets at the gable end (Fig. 12), but the eaves were clipped on the east side and the metal sheets were tight against timber wall plates.

The west elevation of the building was open-fronted and supported by stone pillars (Ref. Fig. 11). These were fully pointed, as was the east elevation and south gable end (Fig. 12).

The interior was open to the roof, this unlined and unsuitable for bat roosting.

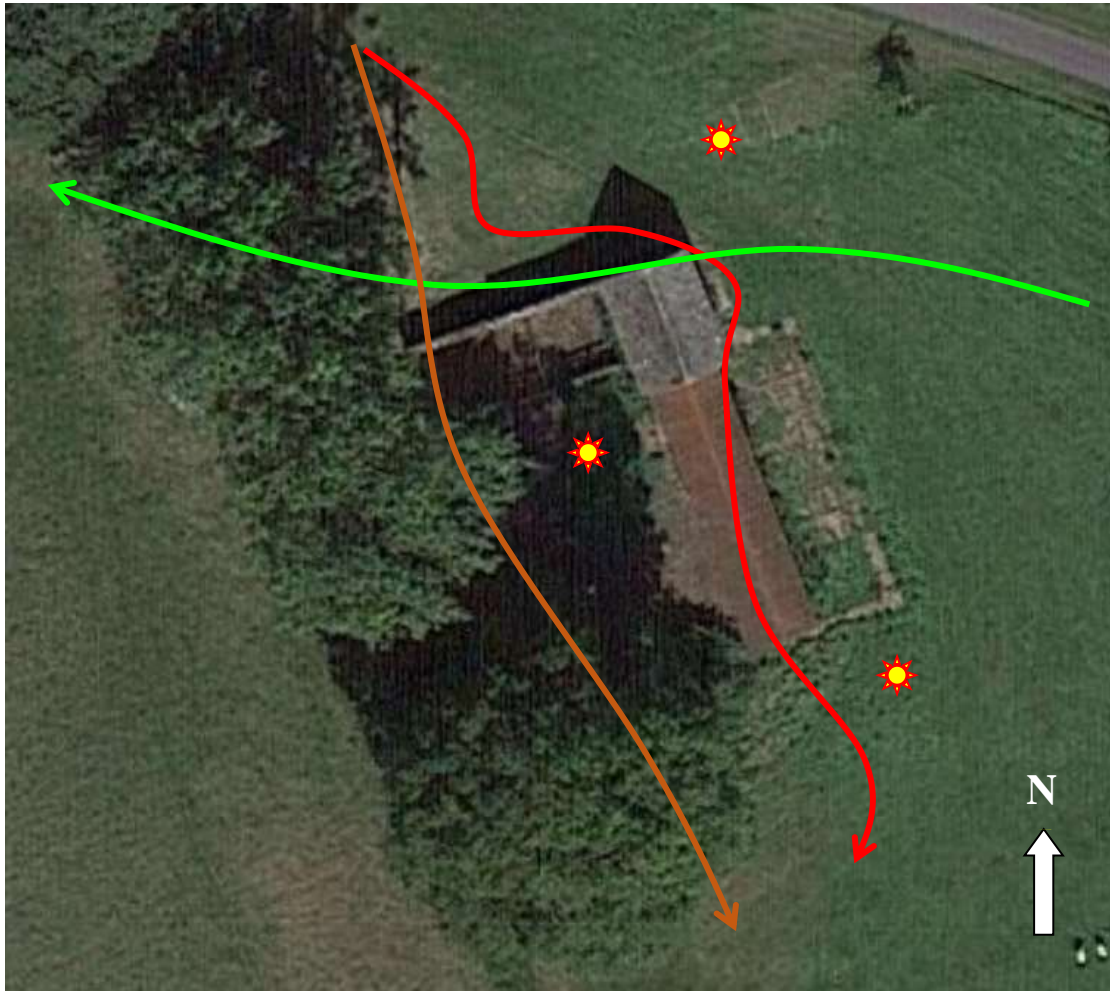
Appendix 3: Bat flight paths at emergence on 4th August 2021

The survey revealed very low levels of bat activity. A single Common Pipistrelle flew past the buildings, with a single Barbastelle detected later in the survey. A Noctule Bat was also noted flying overhead. No bats emerged from the buildings.

Time	Observation
21:02	Noctule flew over
21:16	Common Pipistrelle flew past
21:53	Barbastelle Bat flew past
22:20	No more detections or observations and the survey ended
