Heritage Statement for The Old Joiners Shop, Lartington Hall

Co. Durham

For Lartington Estates

October 2021

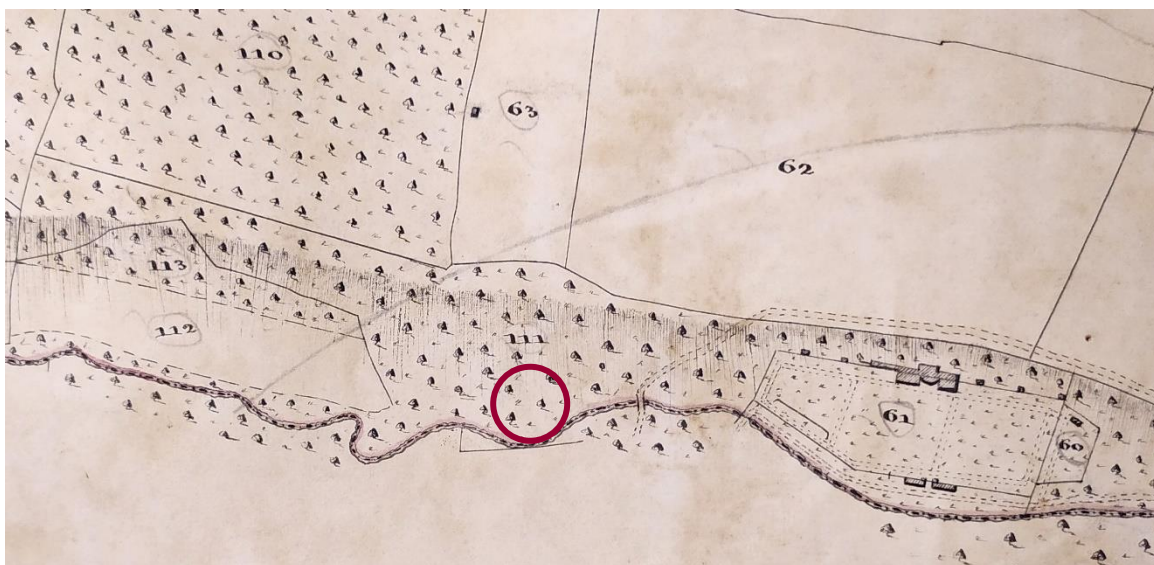
Figure 4. The Romal Kirk tithe map of 1838. The walled gardens and carriage drive over the bridge can be seen, but the workshops are not present in field 111, marked as woodland on the tithe apportionment. The kennels have not been built yet either. The future railway has been pencilled in, presumably at a later date. (R D/RT/60 and R D/RT/61)

The workshops date to the second half of the 19th century. They were not shown on the tithe map of 1838,⁷ nor were they shown on the OS maps surveyed in 1854. They first appeared on the subsequent OS editions surveyed in 1892. They were therefore built between 1854 and 1892 and so constructed while Thomas Witham was the squire.

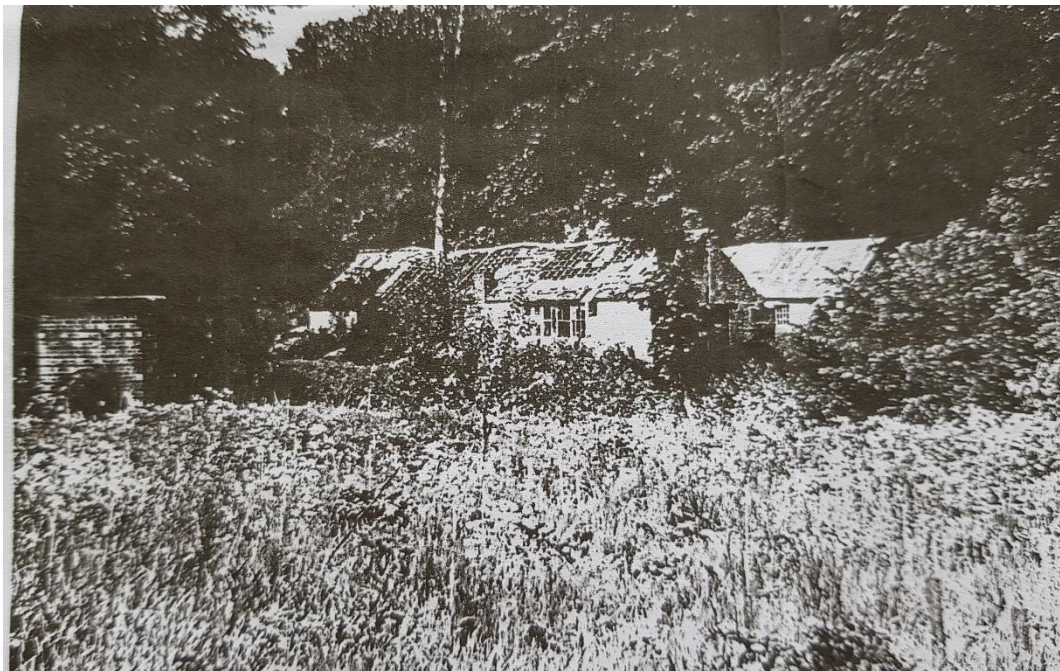
Figure 9. The site 'as existing' in 1995. The building in the foreground has mostly been demolished; only the N range survives to the rear.

Photographs and plans from 1995 show that the building had a chimney halfway along its S wall (see figs 9 and 10); this was associated with a corner fireplace internally. The ‘as existing’ plans dating to 1995 confirm that the surviving window openings were Yorkshire sliding sashes and with two narrow doors facing the courtyard. Large double doors faced the east, suitable for cart access. The E gable also had a narrow attic vent.

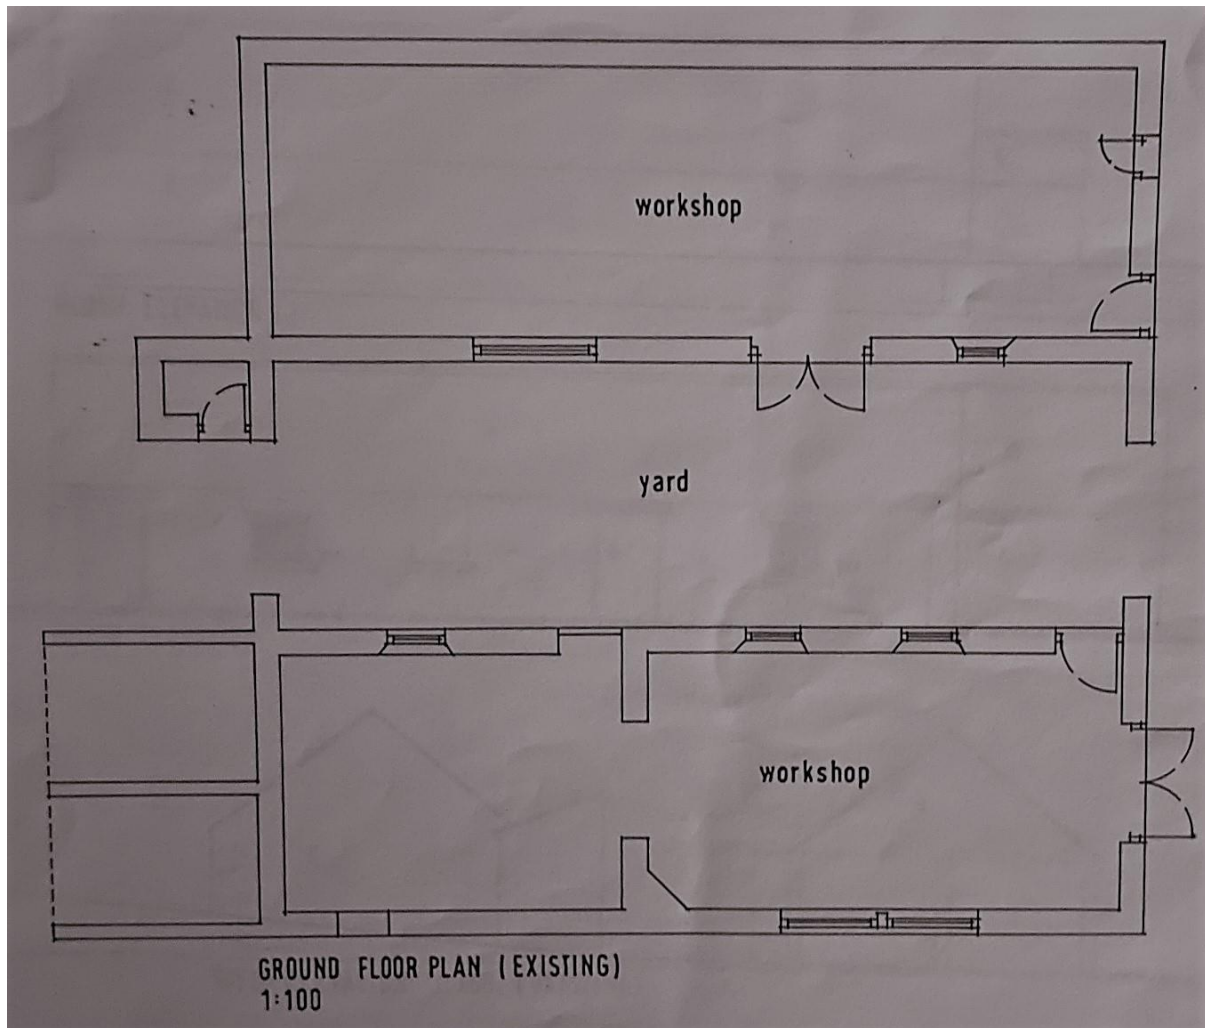
Figure 10. The floorplans of both ranges 'as existing' in 1995

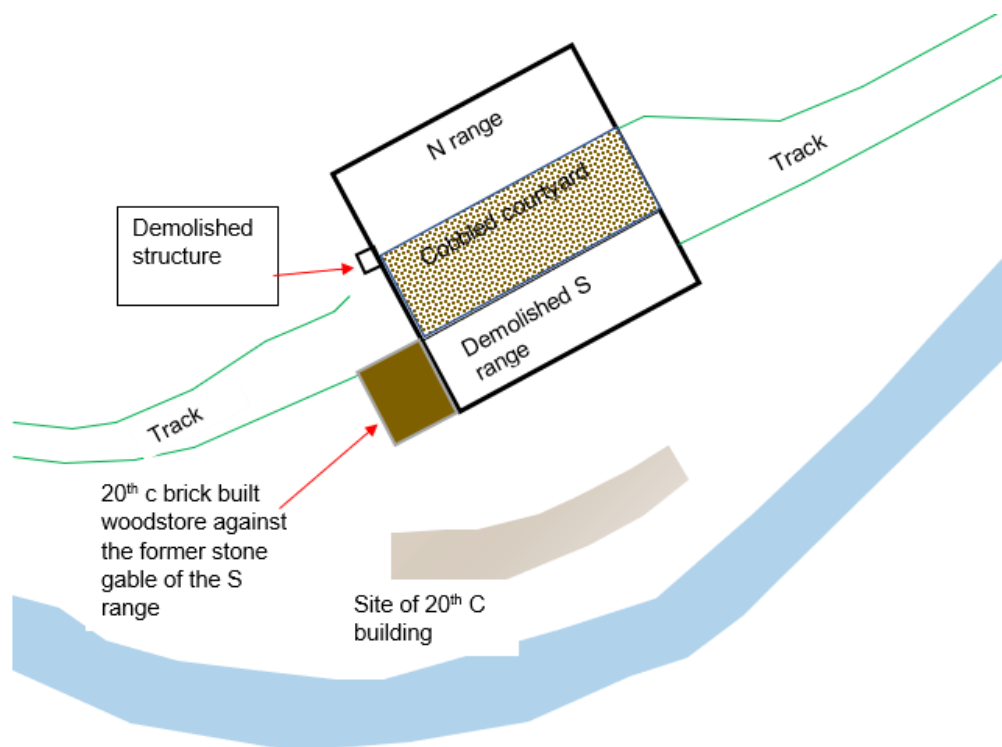
Figure 12. The layout of the site today including the locations of demolished structures

Of the original two linear buildings and central courtyard, only the N range survives intact. The S building has mostly been demolished, but its W gable end survives as the E wall of a 20th century brick lean-to structure currently used as a woodstore.

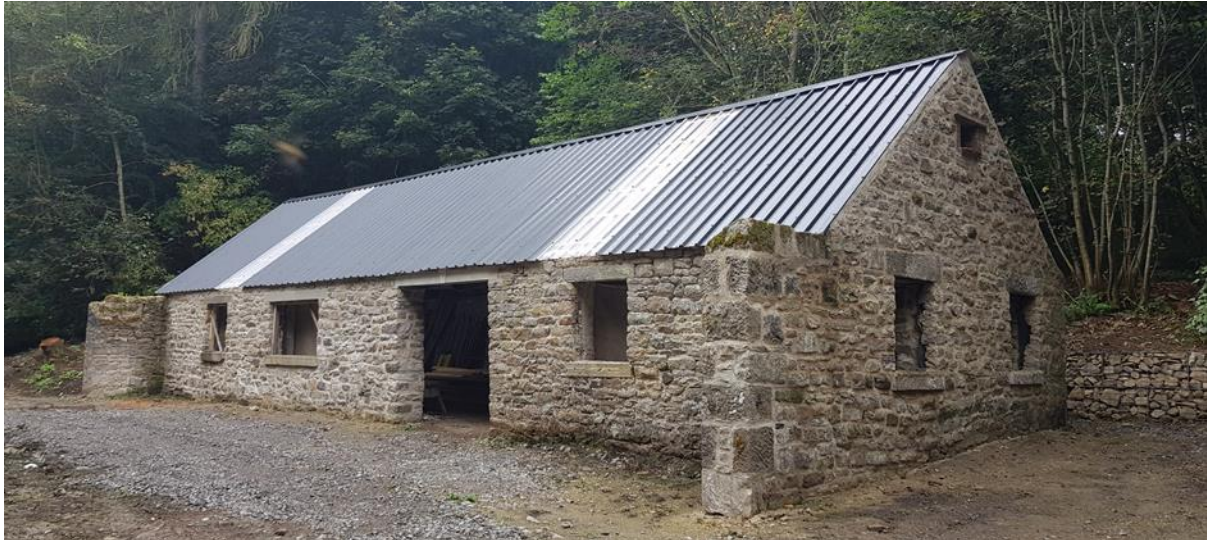
Figure 13. The North Building

The N building is a single storey stone-built structure dating to the second half of the 19th century with a modern replacement roof dating to 2021.

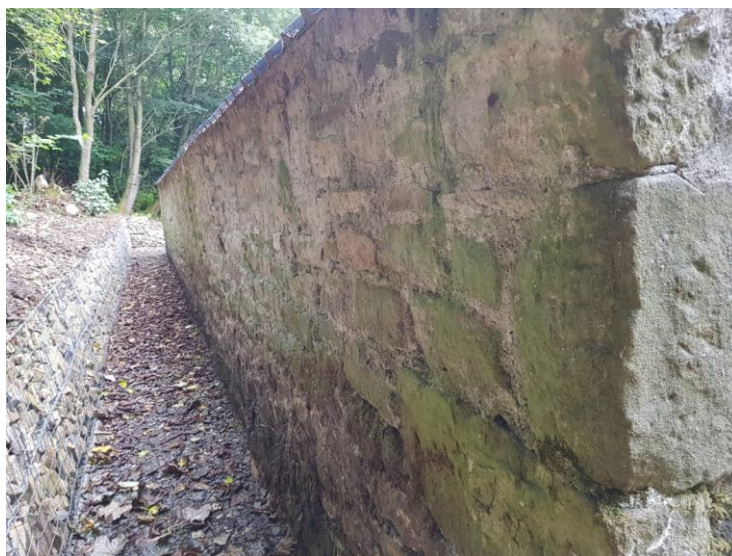
The N rear wall was built at the foot of a sloping wooded bank; it has no openings. It has a slight lean on it facing towards the bank. The stone is coursed and roughly dressed and the walls terminate with dressed stone quoins. In 2021 the soil which had slipped and covered the base of the wall was removed and a retaining wall built to create a space allowing the wall to dry out.

Figure 14. The rear wall of the N building. The earth was cut away from the wall in 2021 to allow it to dry out. It had previously slipped down the bank to cover the bottom four courses.

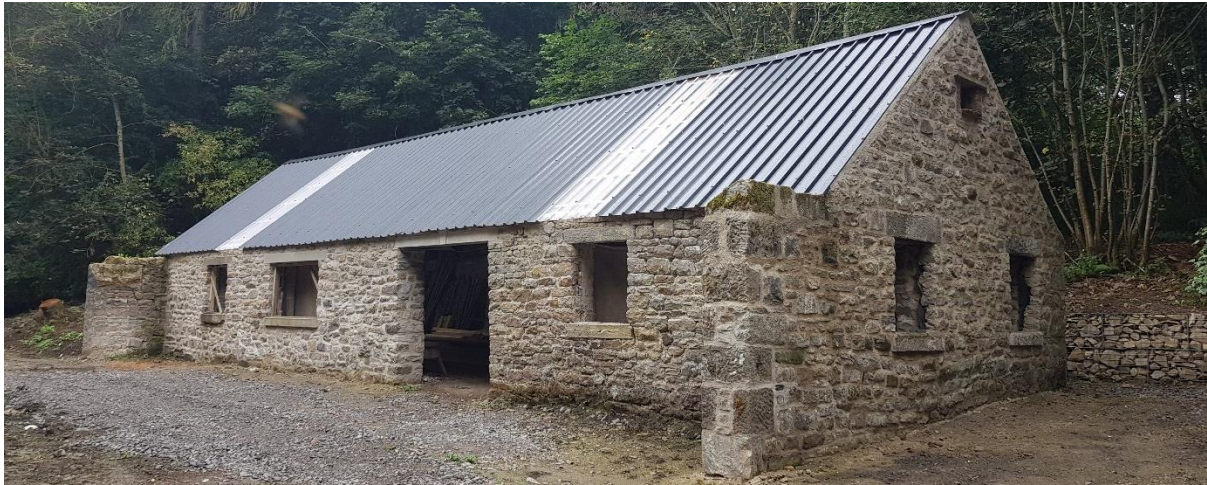
The front S wall consists of one wide central opening; this has been rebuilt along with a section of the S wall to the W of the door. The lintel is a new replacement.

Figure 15. The front S elevation in 2021

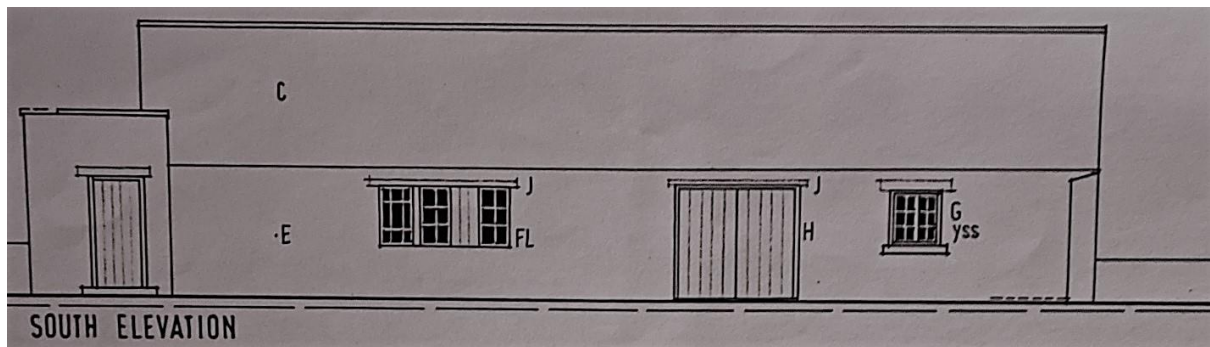
Figure 16. As existing drawings in 1995 with an assortment of window styles and the large central opening. The structure on the SW corner survived at this time.

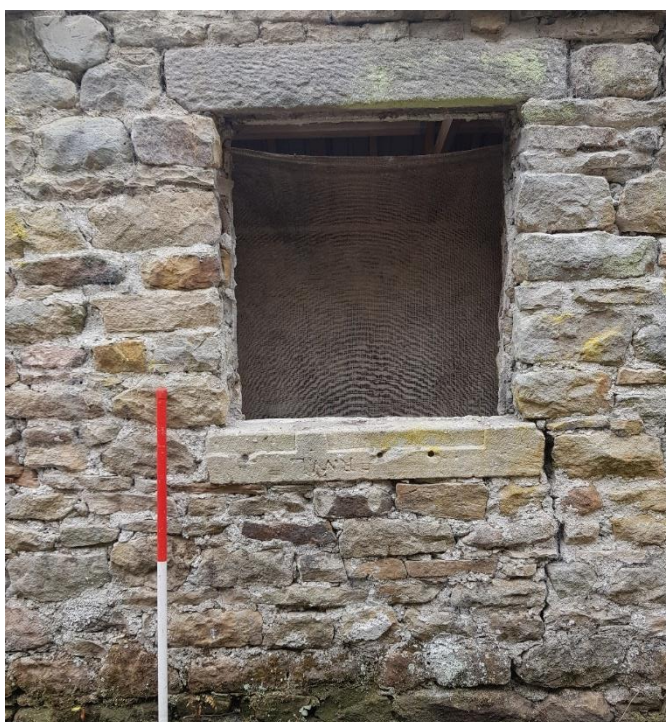
Figure 17. The E window with a reused 17th c window sill (or possibly a lintel) with graffiti reading R.W.L and a small square shape.

To the E of this opening is a square window opening with original lintel and sill. This window still had its Yorkshire sliding sash window in 1995 (see fig 16). The sill is a reused window lintel or sill possibly dating to the 17th century and from a mullioned window. It may have been taken from the Hall (which has similar windows on its S elevation cellars) when Hansom carried out the rebuilding of the servants' quarters between 1860-63 on behalf of Thomas Witham. An engraved set of initials must date to the earlier use at the Hall as they are now upside down. They read R.W.L and a small square shape, thus:

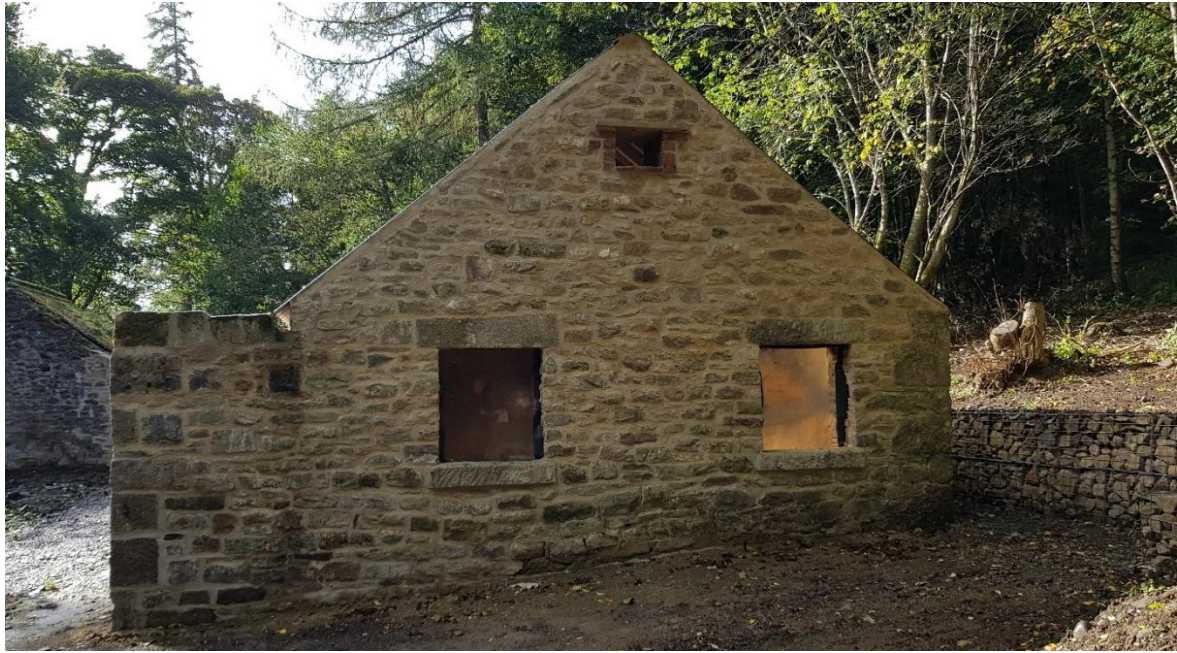
Figure 18. The rebuilt E gable end featuring two square windows and an attic vent opening at the pinnacle of the gable. This elevation was taken down to the bottom five courses and rebuilt in 2021 due to structural issues.

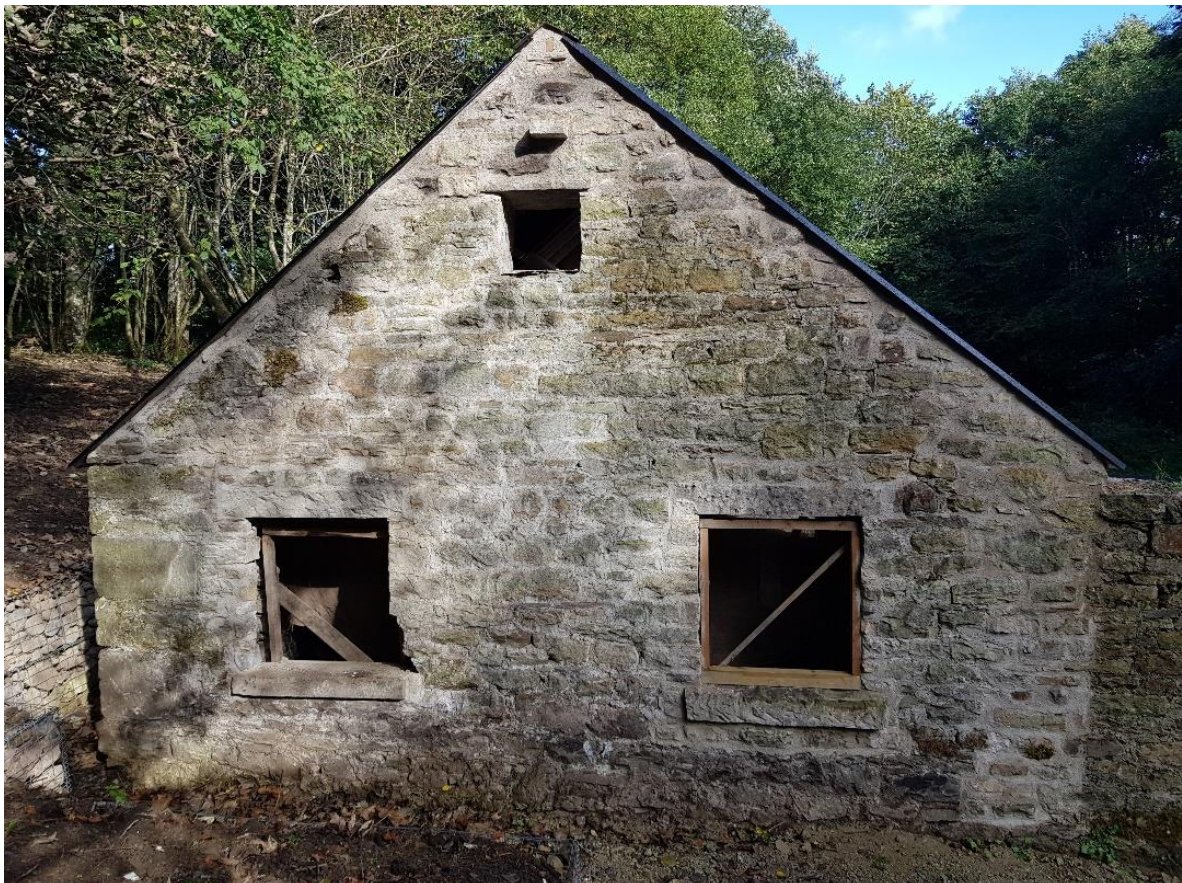
Figure 19. The W gable end in 2021. The repointed whiter area on the right suggests some rebuilding. It is also the location of an adjoining former square building, now demolished.

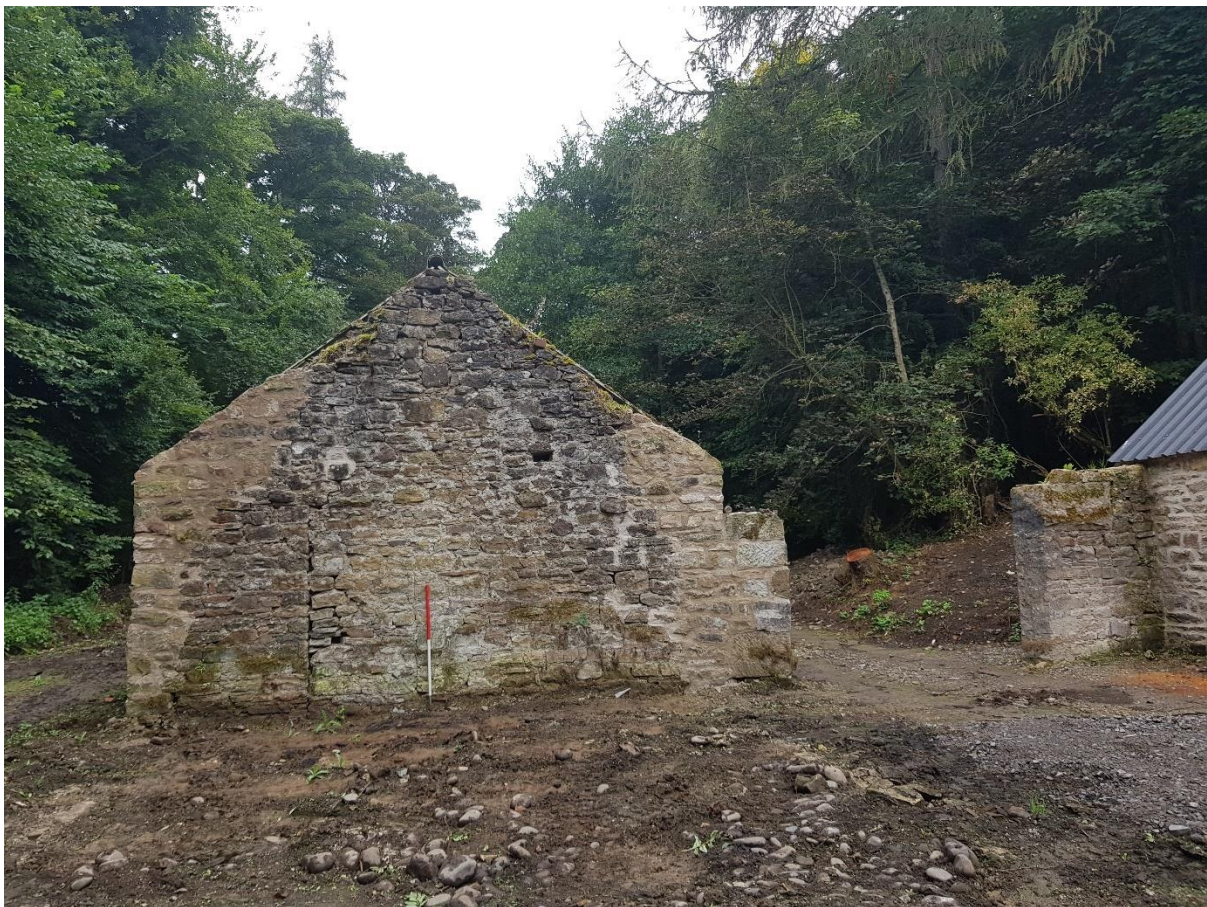
Figure 20. The surviving W gable of the S building. A blocked doorway is located to the left of the ranging pole

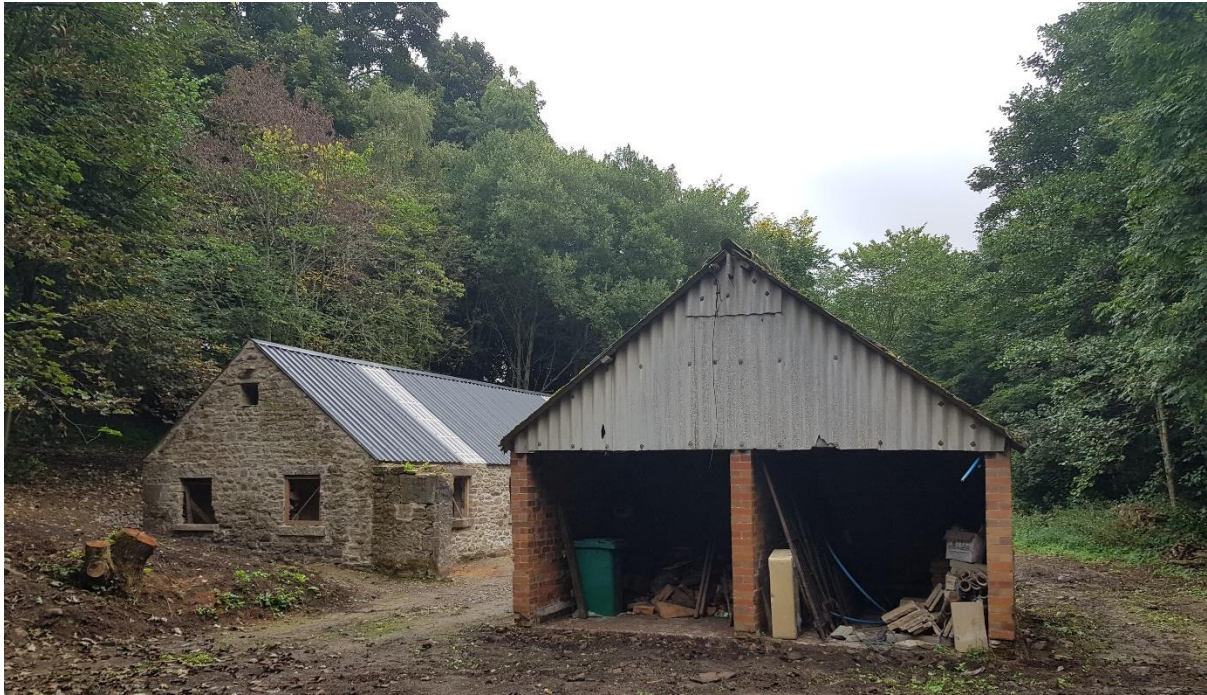
Figure 21. The 20th c woodstore on the W side of the surviving stone gable

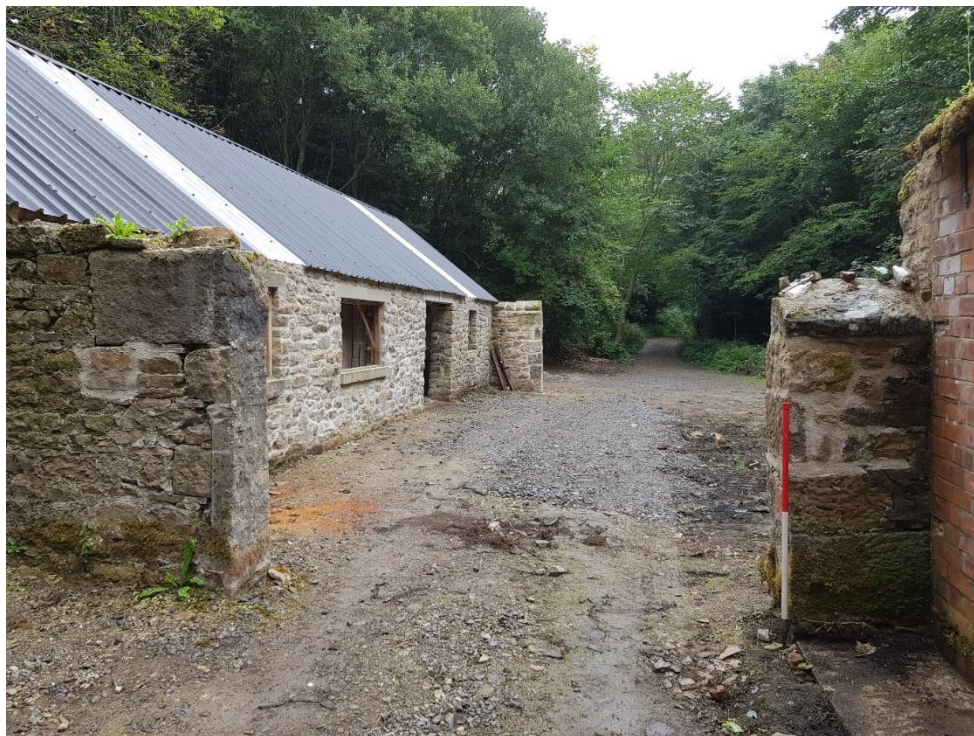
Three wall stubs that joined the two original buildings forming an enclosed courtyard have survived. One of the S walls was lost when the S range was demolished. Access into the courtyard was controlled as evidenced by a gate hinge on the E wall.

Figure 22 The three surviving courtyard walls.

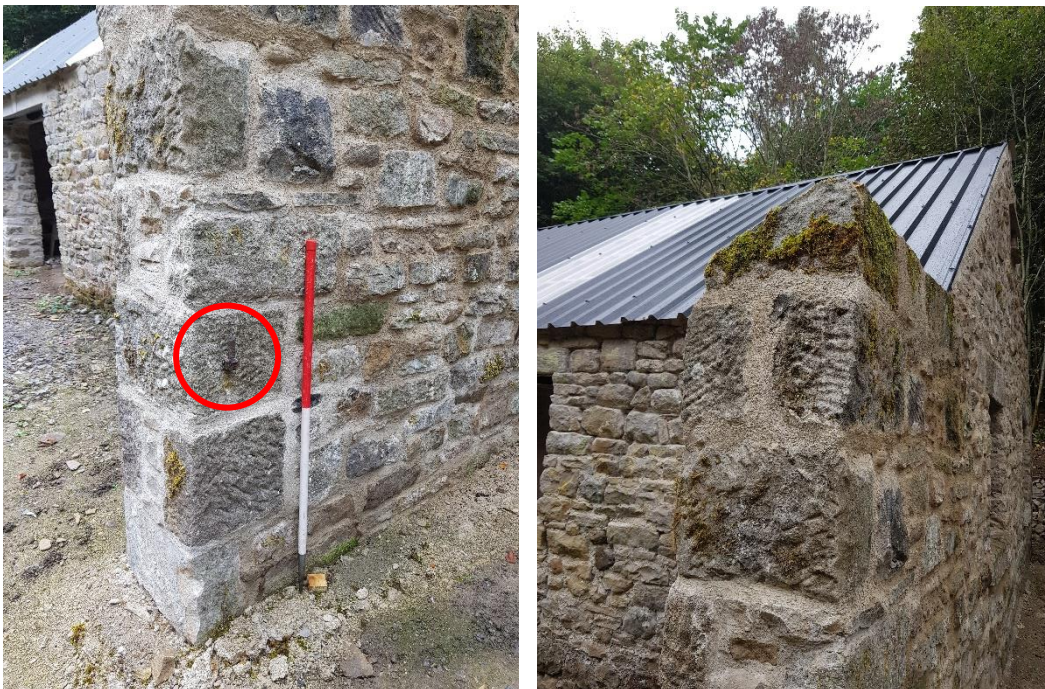
Figure 23. Left: An iron gate hinge on the E courtyard wall Right: sloping coping to the courtyard walls

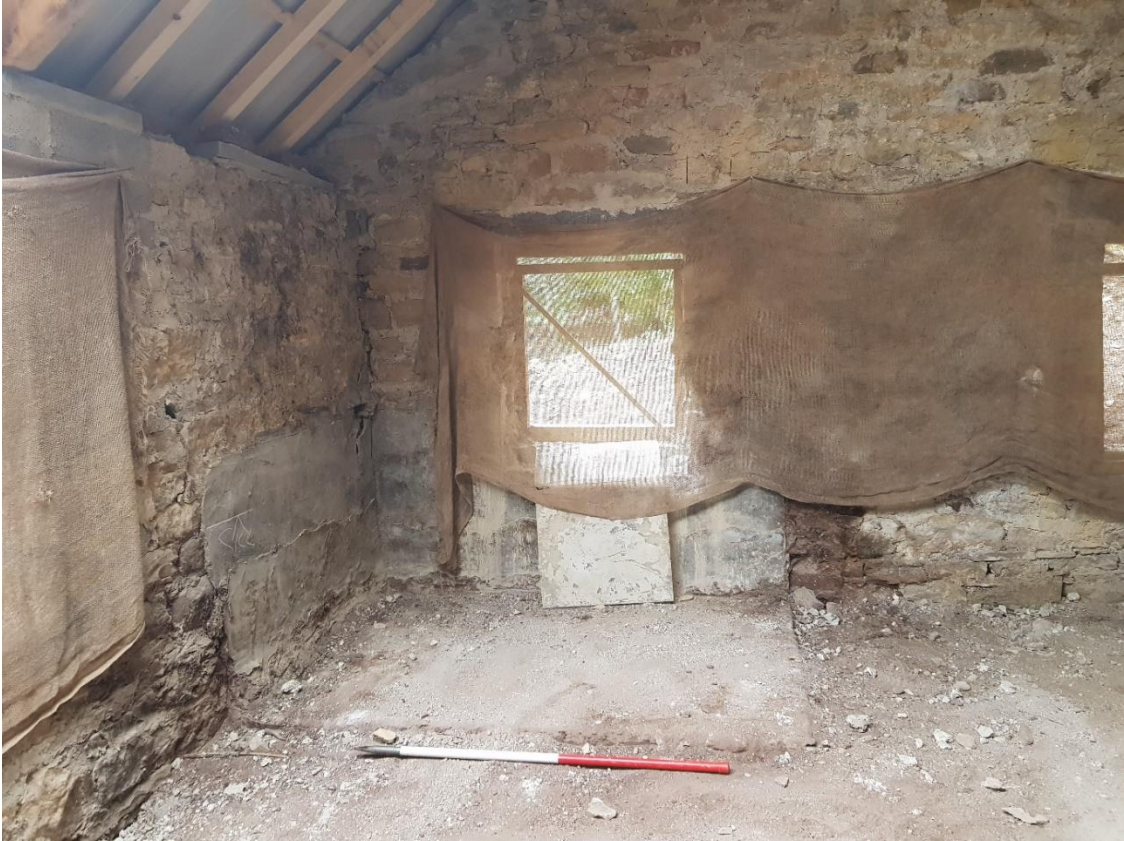
Figure 24. Concrete hardstanding in the SW corner. The window is a modern insertion

The SW corner has a small area of concrete hard standing with the two adjacent walls having a concrete skim half way up. This may have been the location of some heavy machinery or a forge, but there is no evidence of burning or heat on the adjacent walls. The walls here have been modified however with the insertion of a new window opening and some repointing externally.

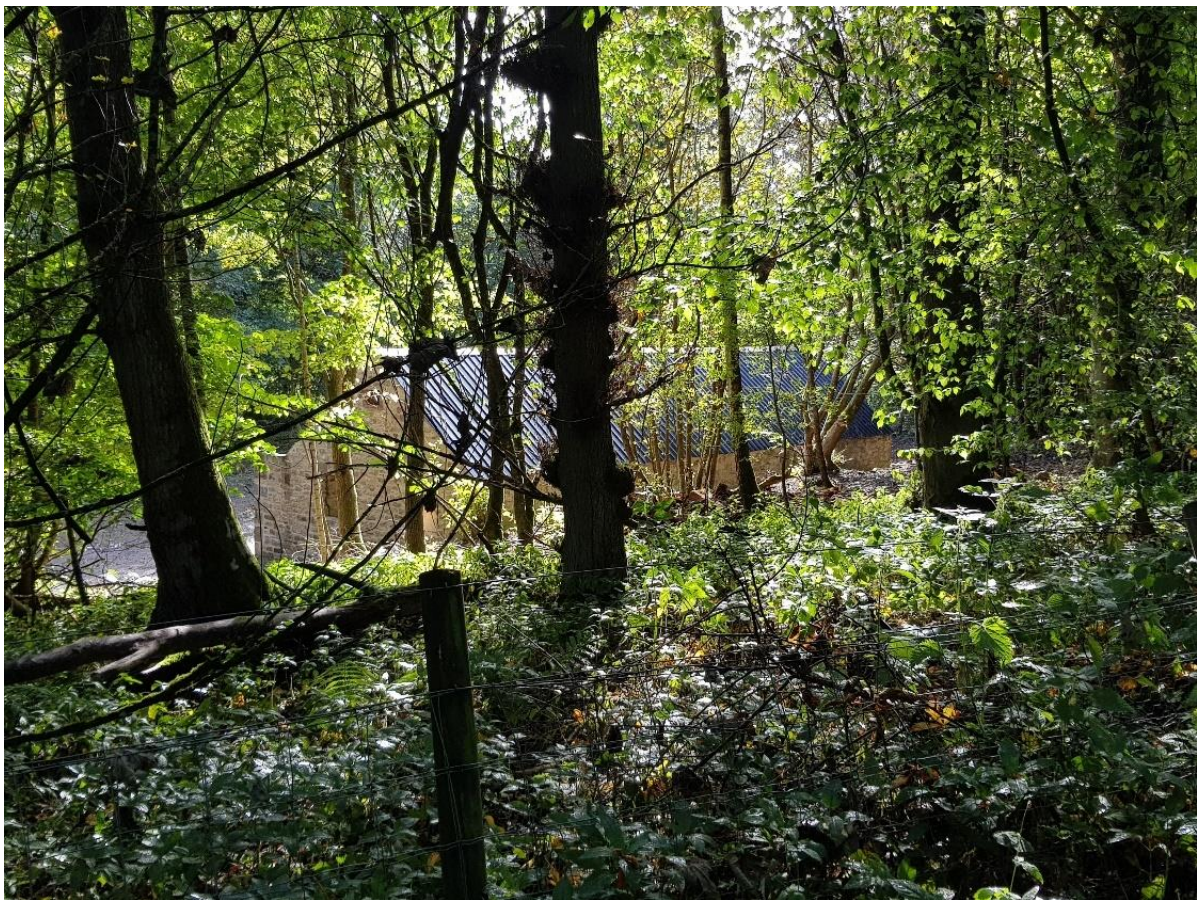
Figure 27. The present day (October 2021) view of the workshops from the former Pleasure Walks to the N. The workshop's low-lying location within a woodland made them visually unobtrusive

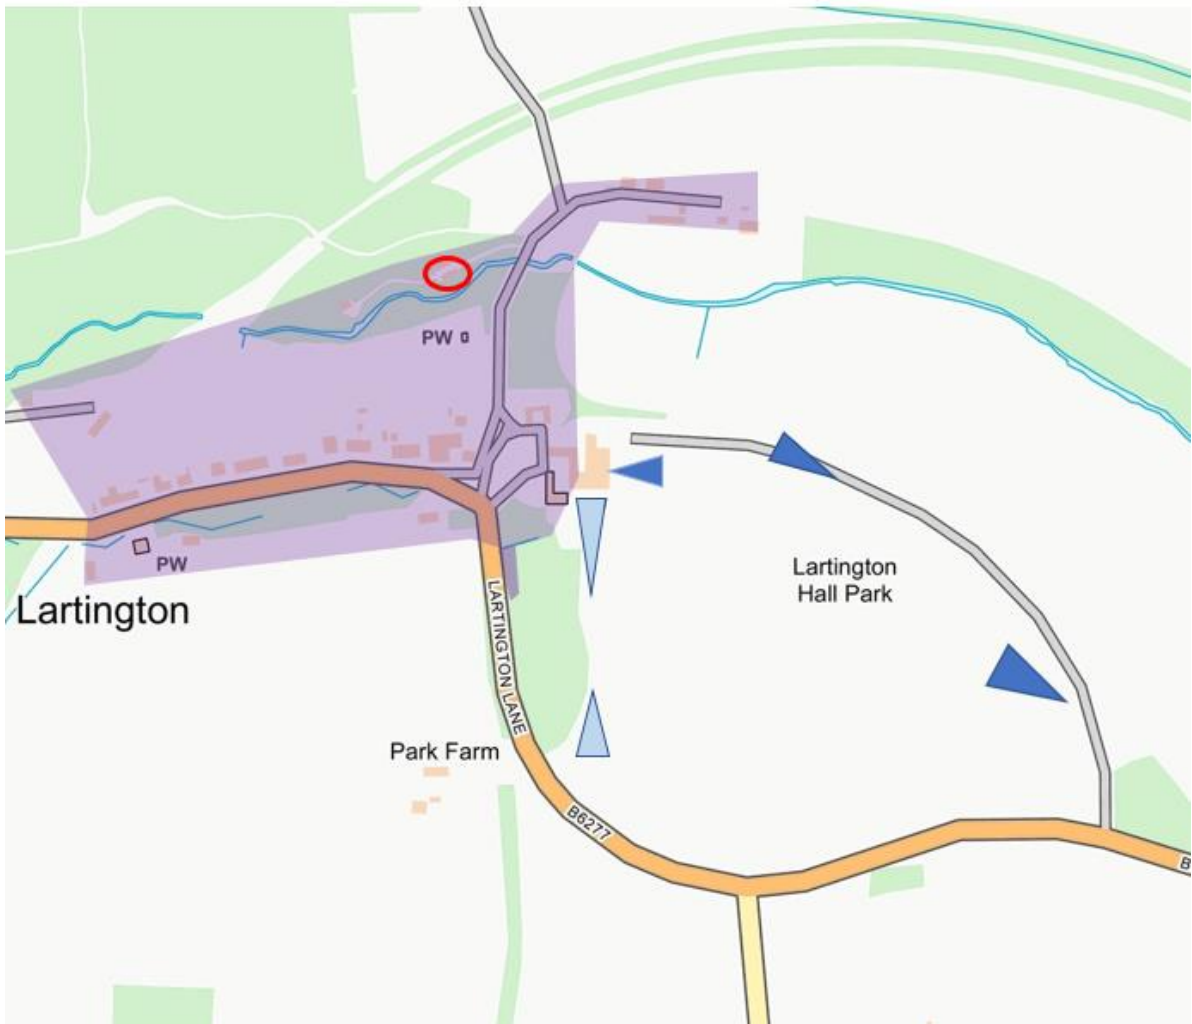
Figure 28. The setting of the Hall varied throughout history, but generally the picturesque set pieces of the 18th century parkland were to the E where views (dark blue) to and from the Hall and within the park were managed by design. Earlier the principal elevation was southwards controlling views (light blue) from the approach into the village. This left the darker and cooler aspects to the north and west for the servants' quarters, the village which housed support staff such as footmen, teachers, the pub landlords and part time farmers and other Estate maintenance workshops, kennels, kitchen functions etc all within a NW zone (purple).

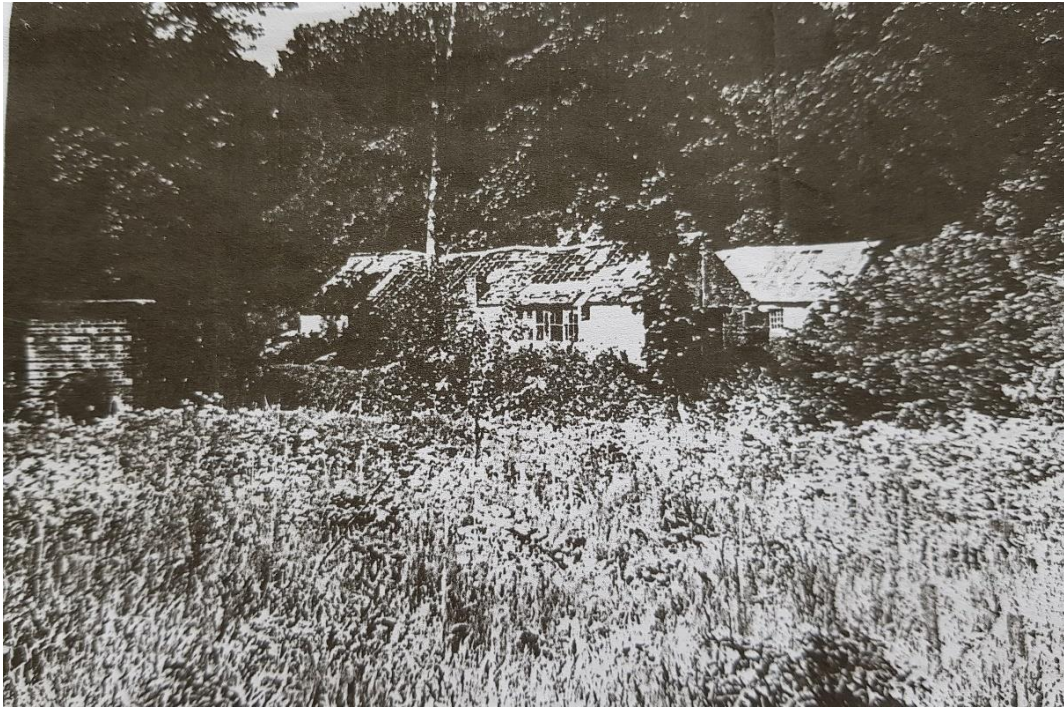
Figure 29. A photo dating to 1995 and taken from near the icehouse.

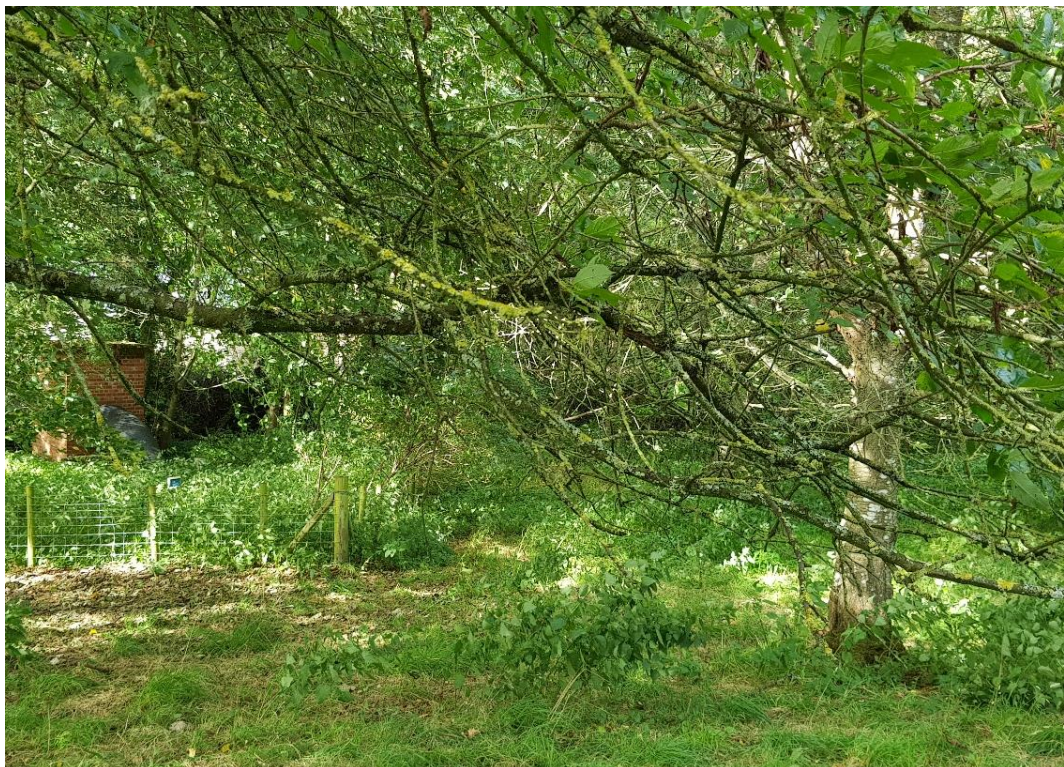
Figure 30. The same view in 2021 (photo taken 1st October 2021)

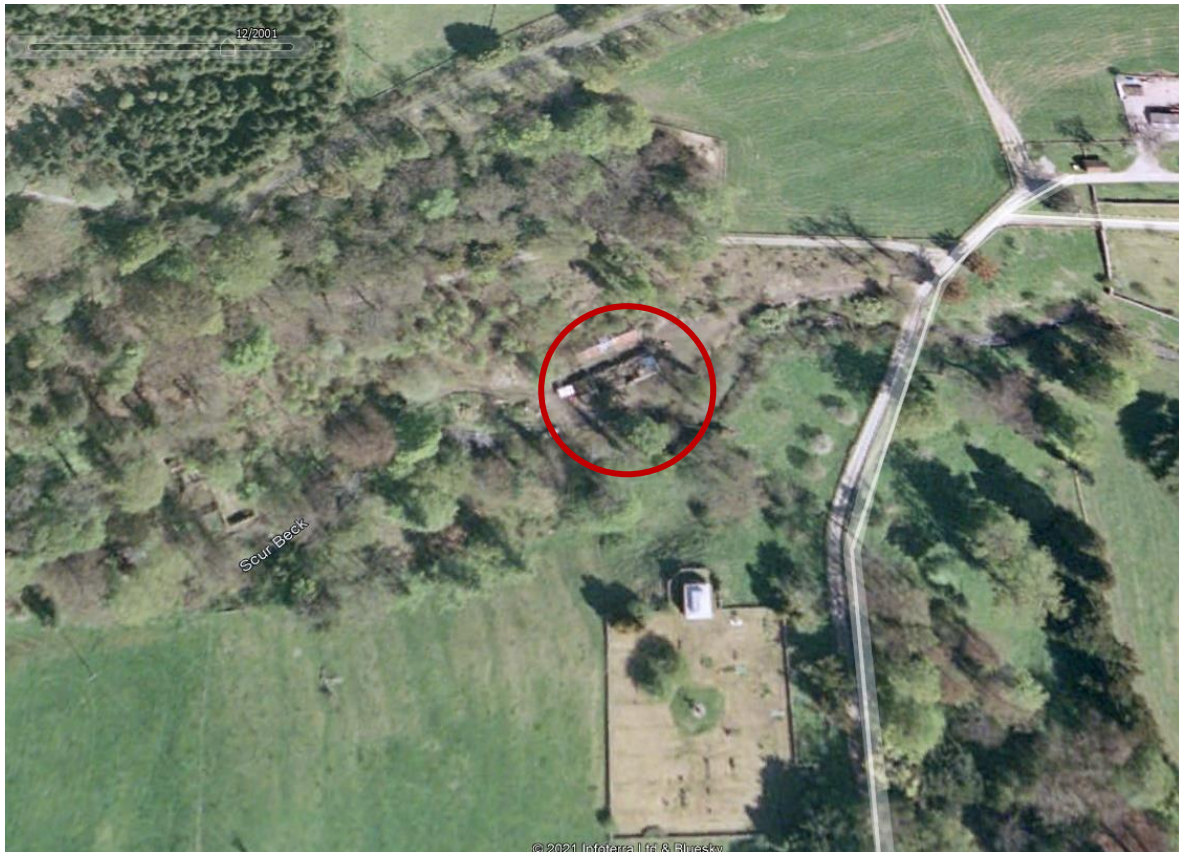
Figure 31. The former workshops in 2001 (Google Earth imagery) when there was less tree cover

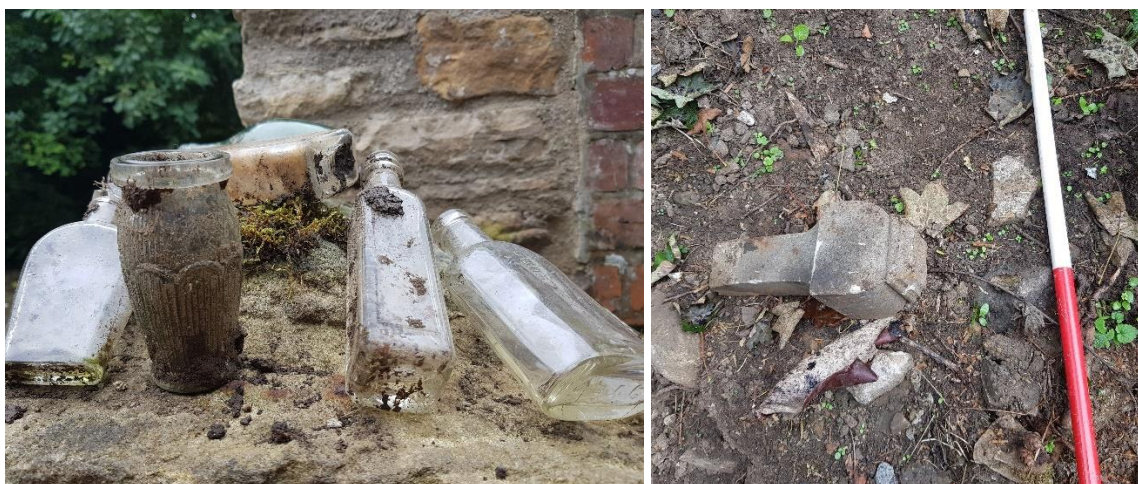
Figure 33. Some of the artefacts scattered around the site or uncovered during the 2021 works

The sub-surface remains have the potential to reveal additional information about what the site was used for over time, however works to date have only uncovered a varied selection of glass bottles.³⁴ These are mostly domestic in nature and include food and drink bottles from the early 20th century to the 1970s. One ornate architectural fragment – a stone pinnacle has been uncovered from amongst building debris.

There is considerable demolition debris around the site and so the original context for these finds has been lost but the nature of the finds suggests that the site has been used as a midden rather than the finds relating to the functions of the workshops. There may be below ground evidence for the short-lived 20th century building that ran parallel to the Scur Beck,
