Preliminary Ecological Survey

Old Joiners Shop, Lartington

July 2021

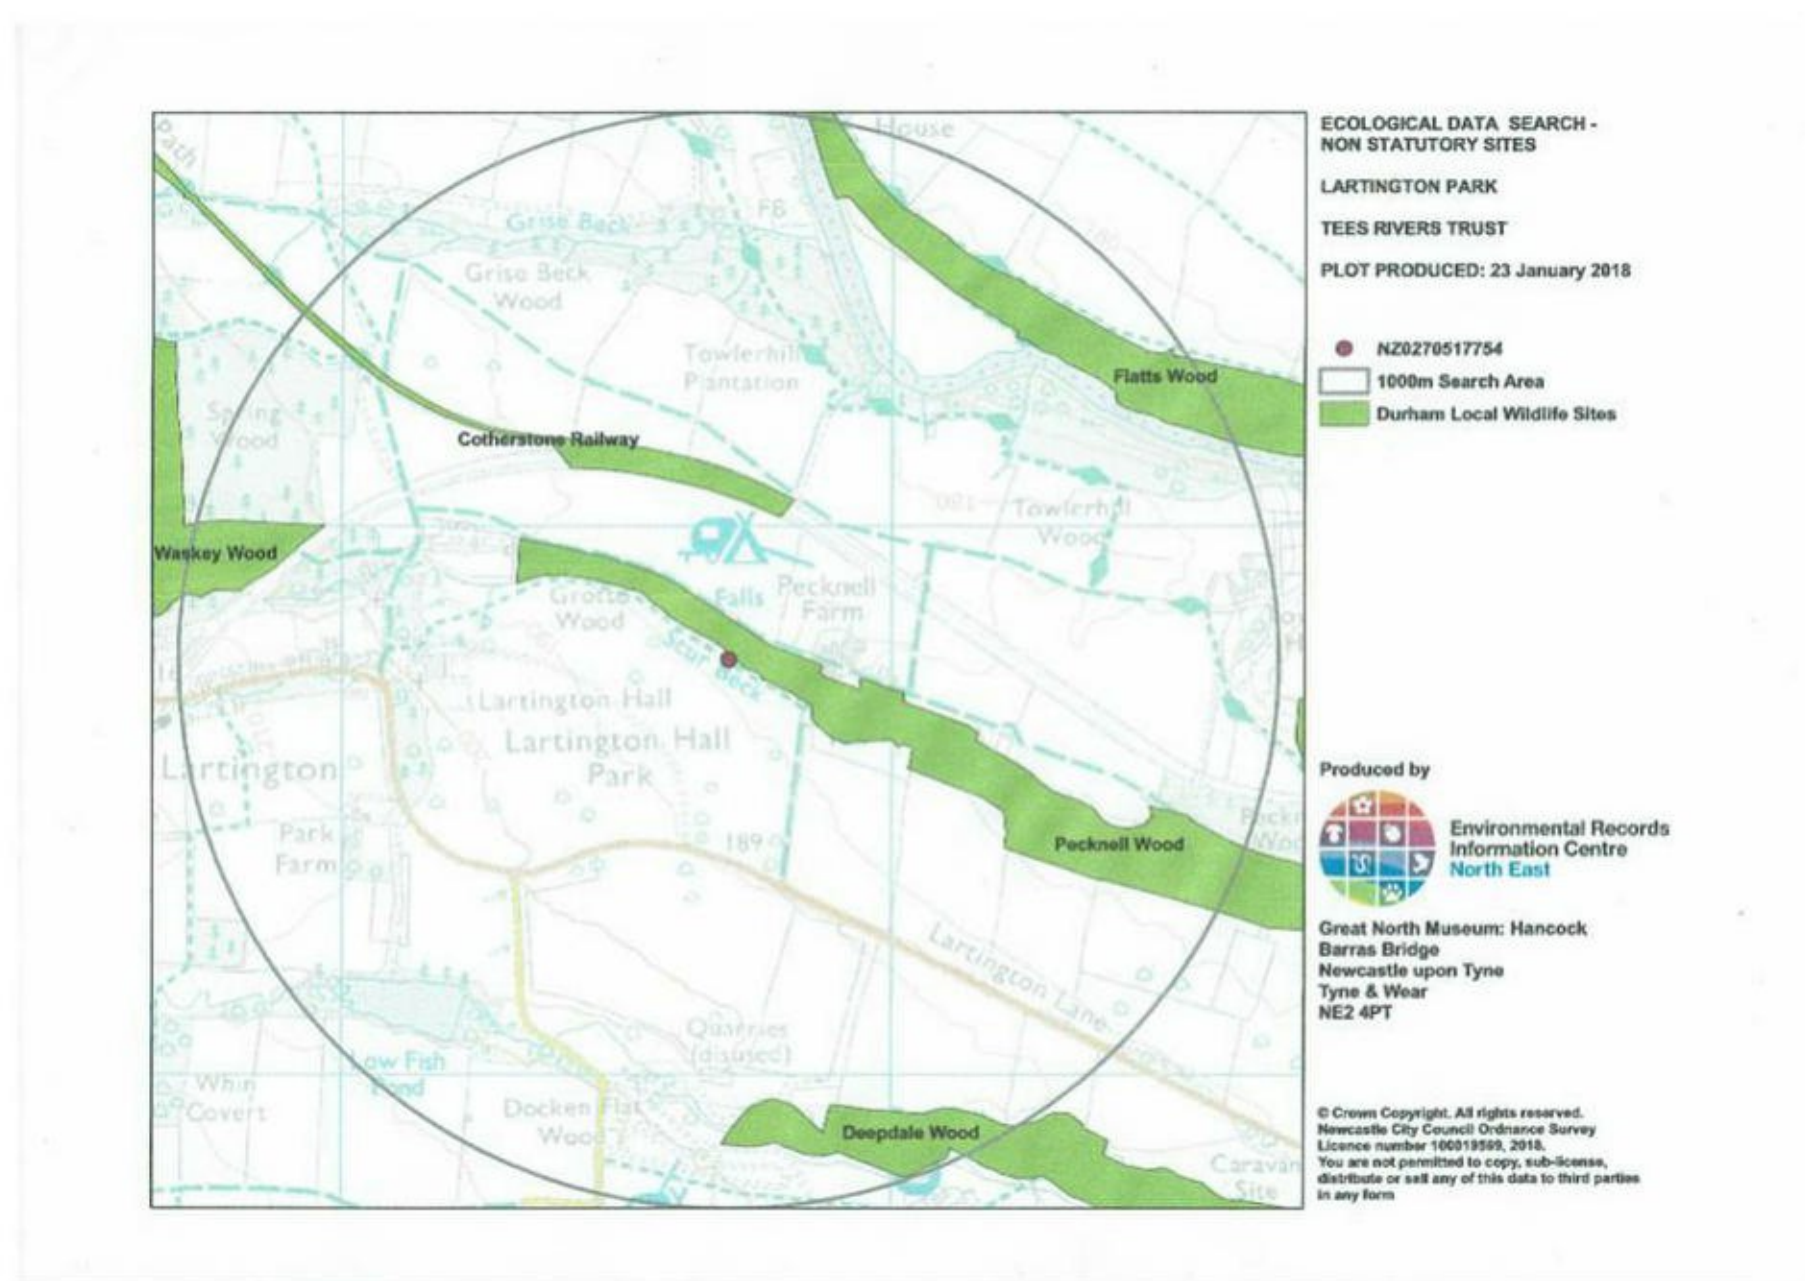
Figure 2, nearby Local wildlife Sites

Waskey Wood Local Wildlife Site, a woodland area, is almost adjacent to the site to the west. Pecknell Wood Local Wildlife Site is 300 metres to the east, connected by the Scur Beck, and Cotherstone Railway Local Wildlife Site, a mixed habitat former railway line, is 300 metres to the north. These sites are illustrated in Figure 2.

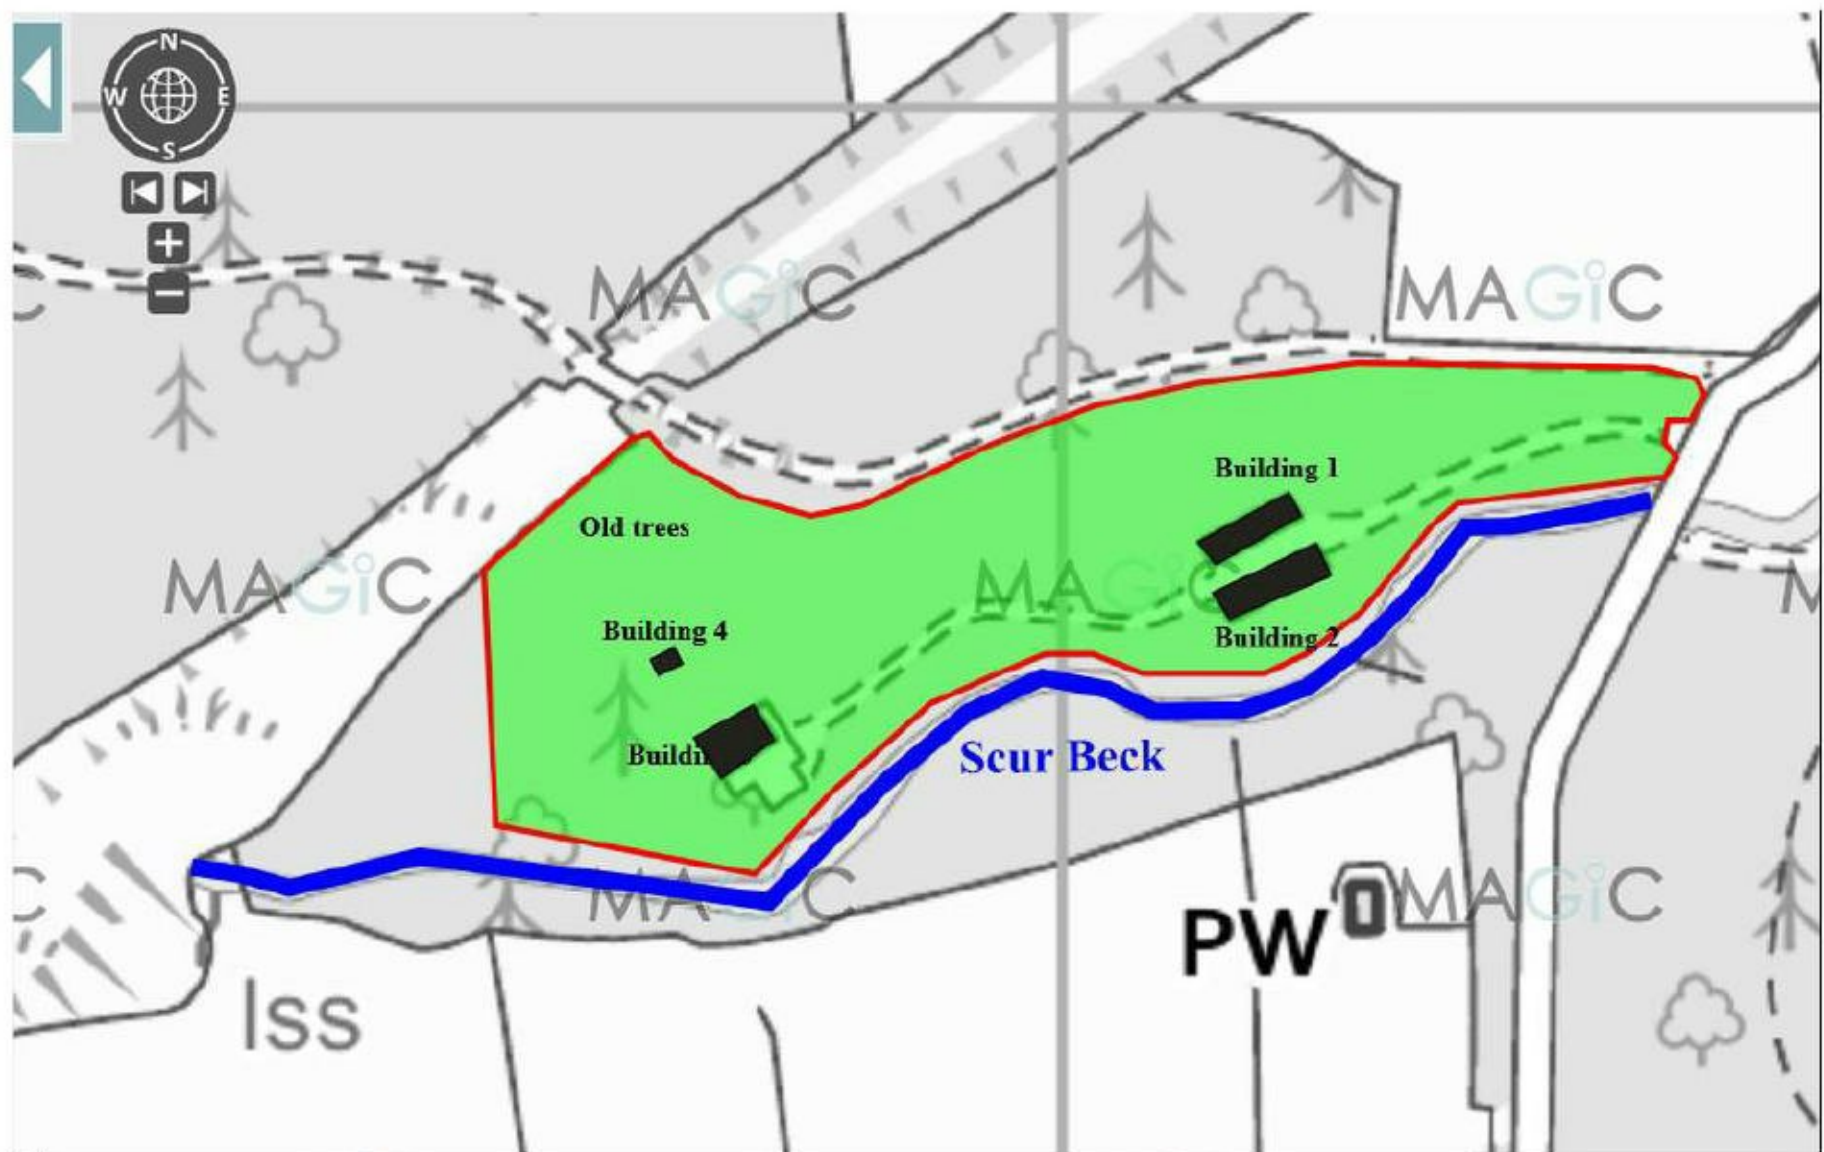
Figure 1, habitats

The site is predominantly woodland, with a central track from a bridge over the Scur Beck at the east end of the site, and the remains of several old buildings along the track. The habitats are shown in Figure 1, and illustrated in the photographs below.

There are 4 buildings, two by the track in the centre of the site, one at the western end of the track, and a fourth just north of this in the woodland. These are numbered in the Figure x and illustrated in the photographs below.

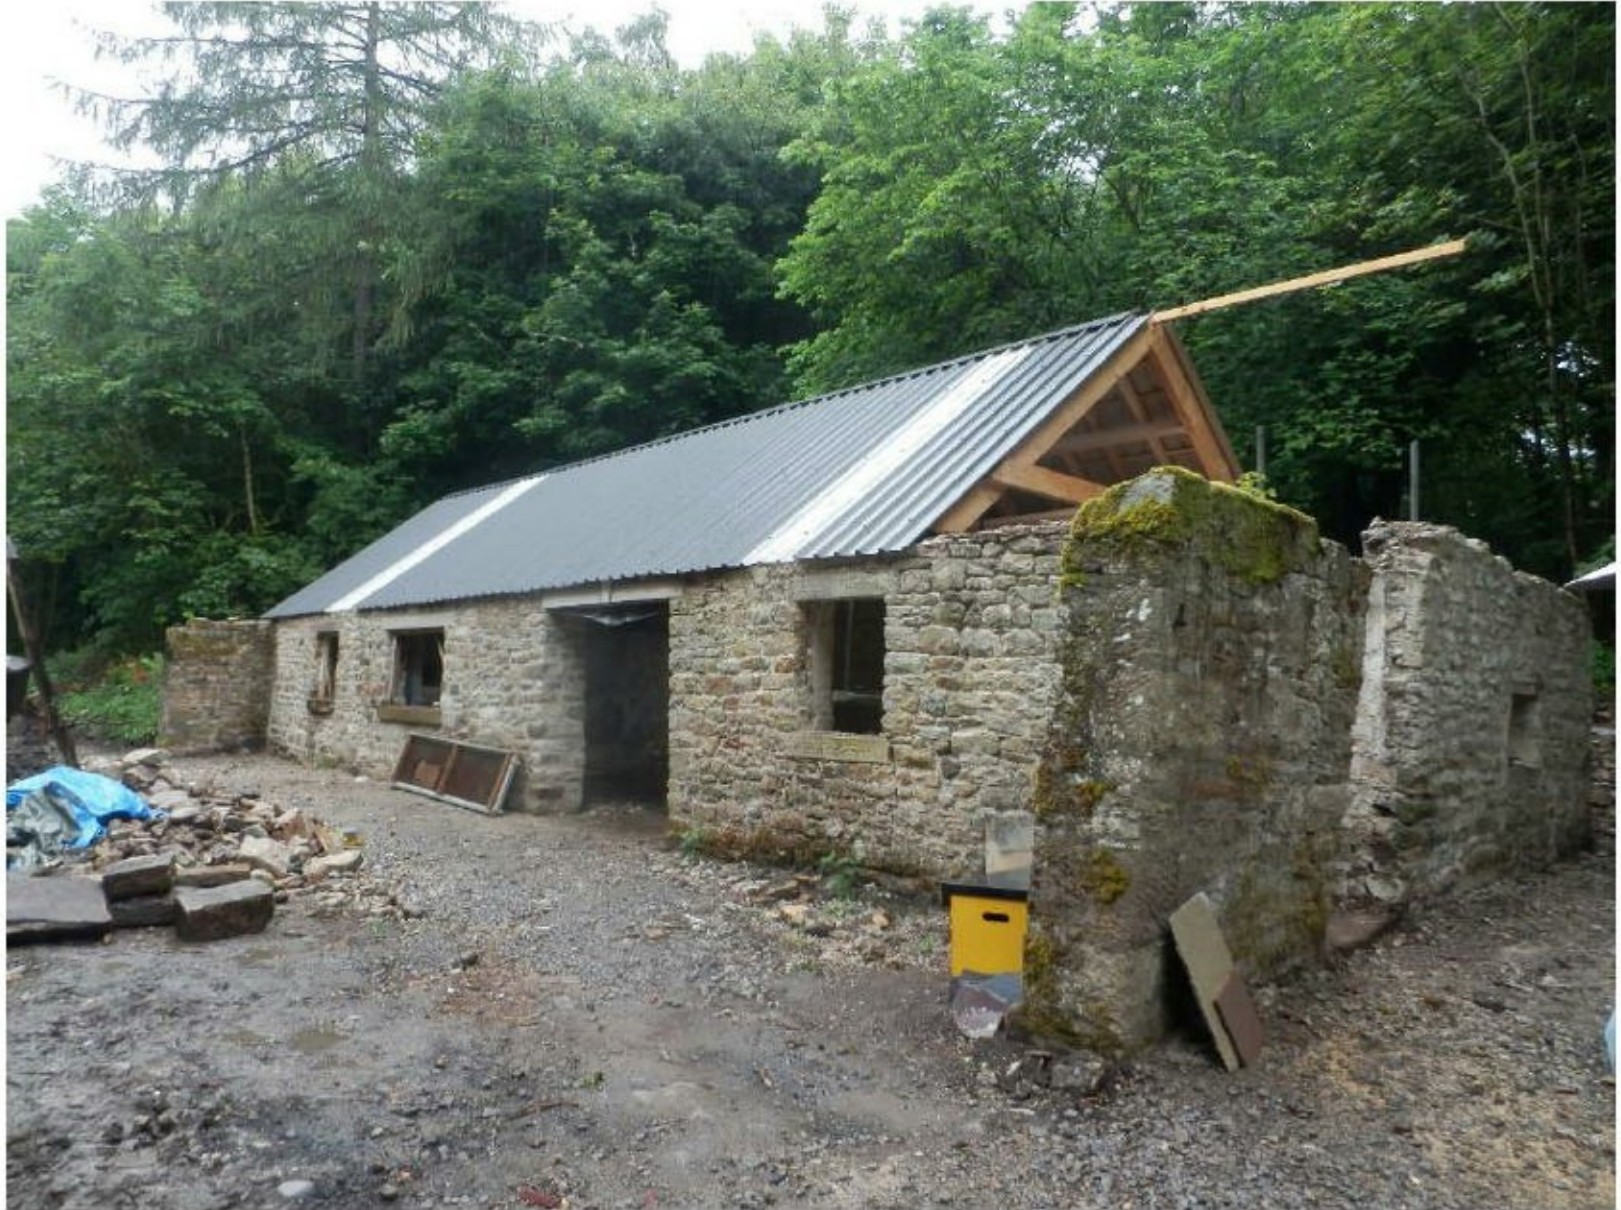
Building 1 Exterior

Building 1. This is the main building, with stone-built walls, no doors or windows and no roof space. At the time of survey it was in the process of being re-roofed. There was no roof space or wall cavities suitable for a bat roost.

Biodiversity losses here are negligible, amounting to a few square metres of ruderal plants and scrub. The requirement for biodiversity gain can be met by installing artificial bat roosting facilities into the dwelling, either as “bat tiles” or “bat bricks”.

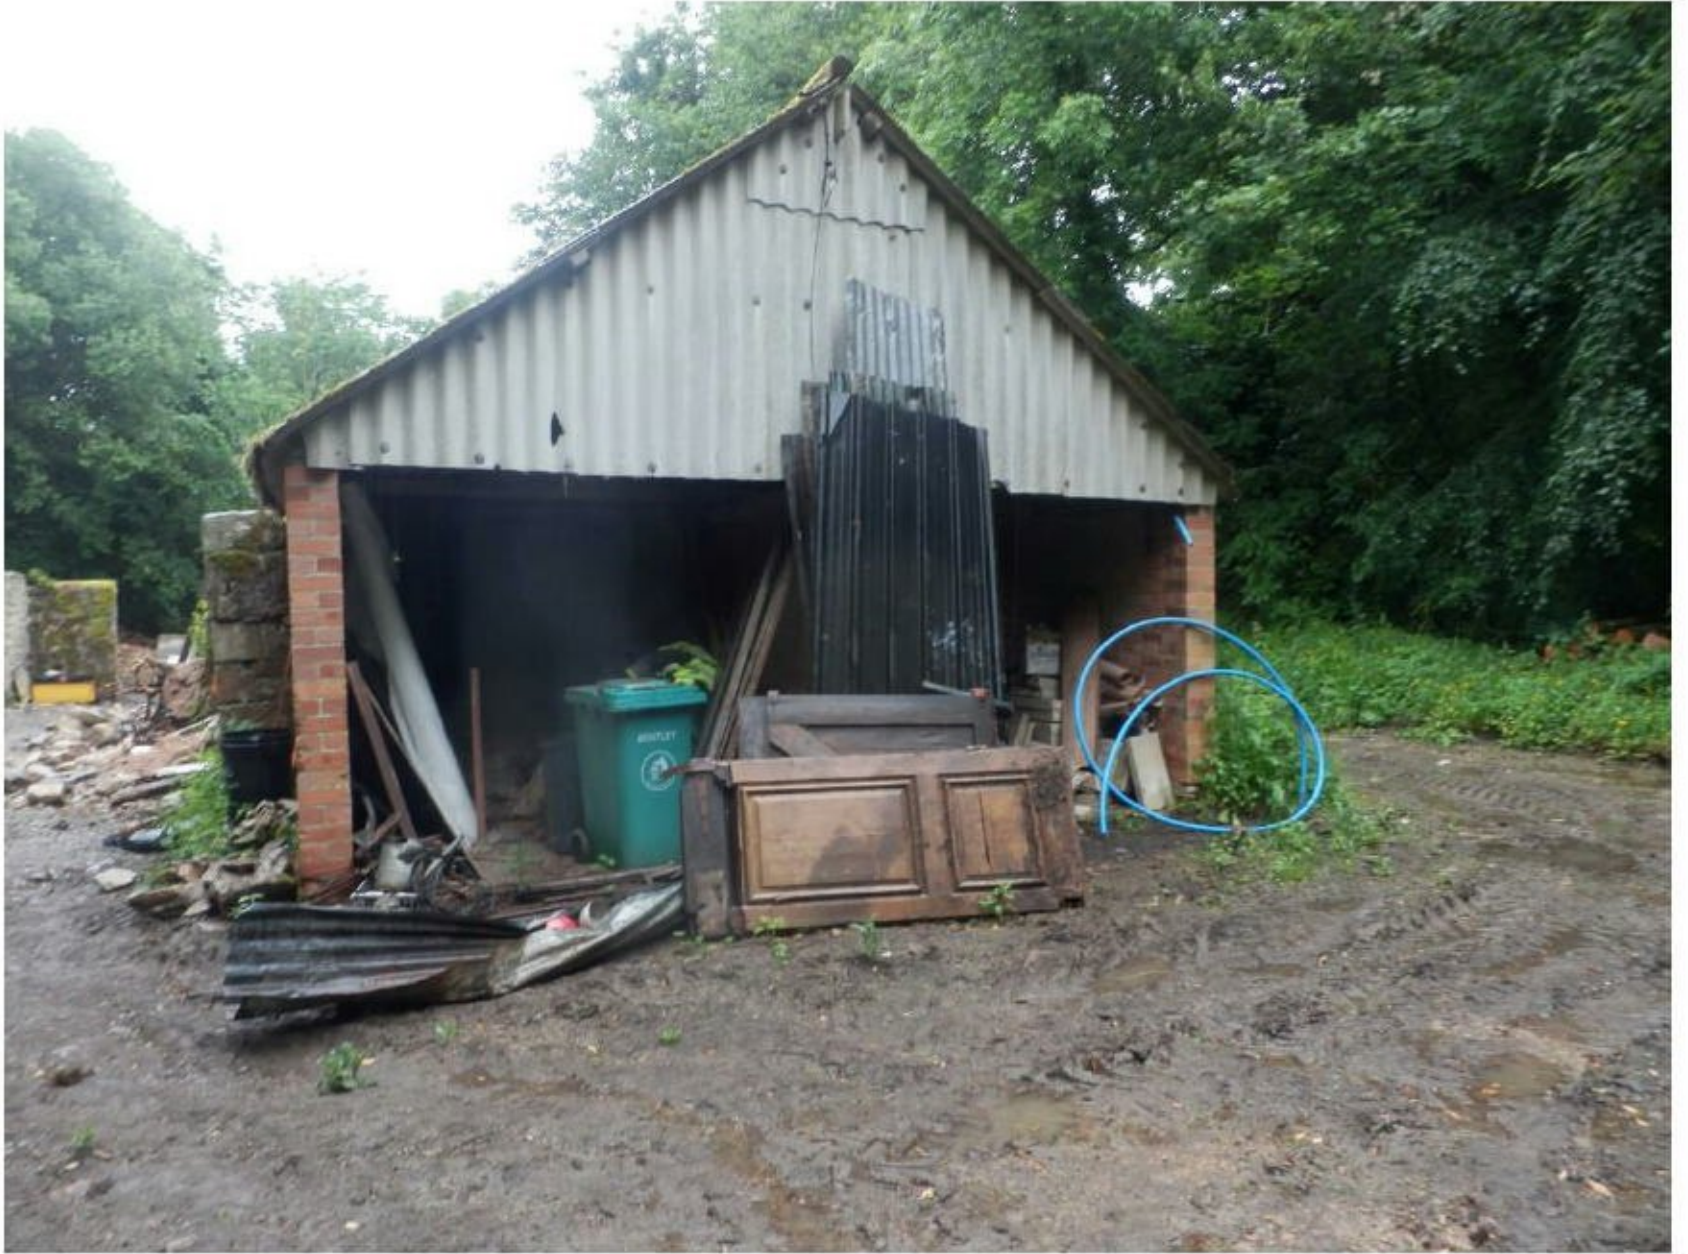
Building 2 Exterior

Building 2. Adjacent and to the south of Building 1, a stone and brick building roofed with metal sheeting, with no enclosed roof space. Parts of this building had fallen down.

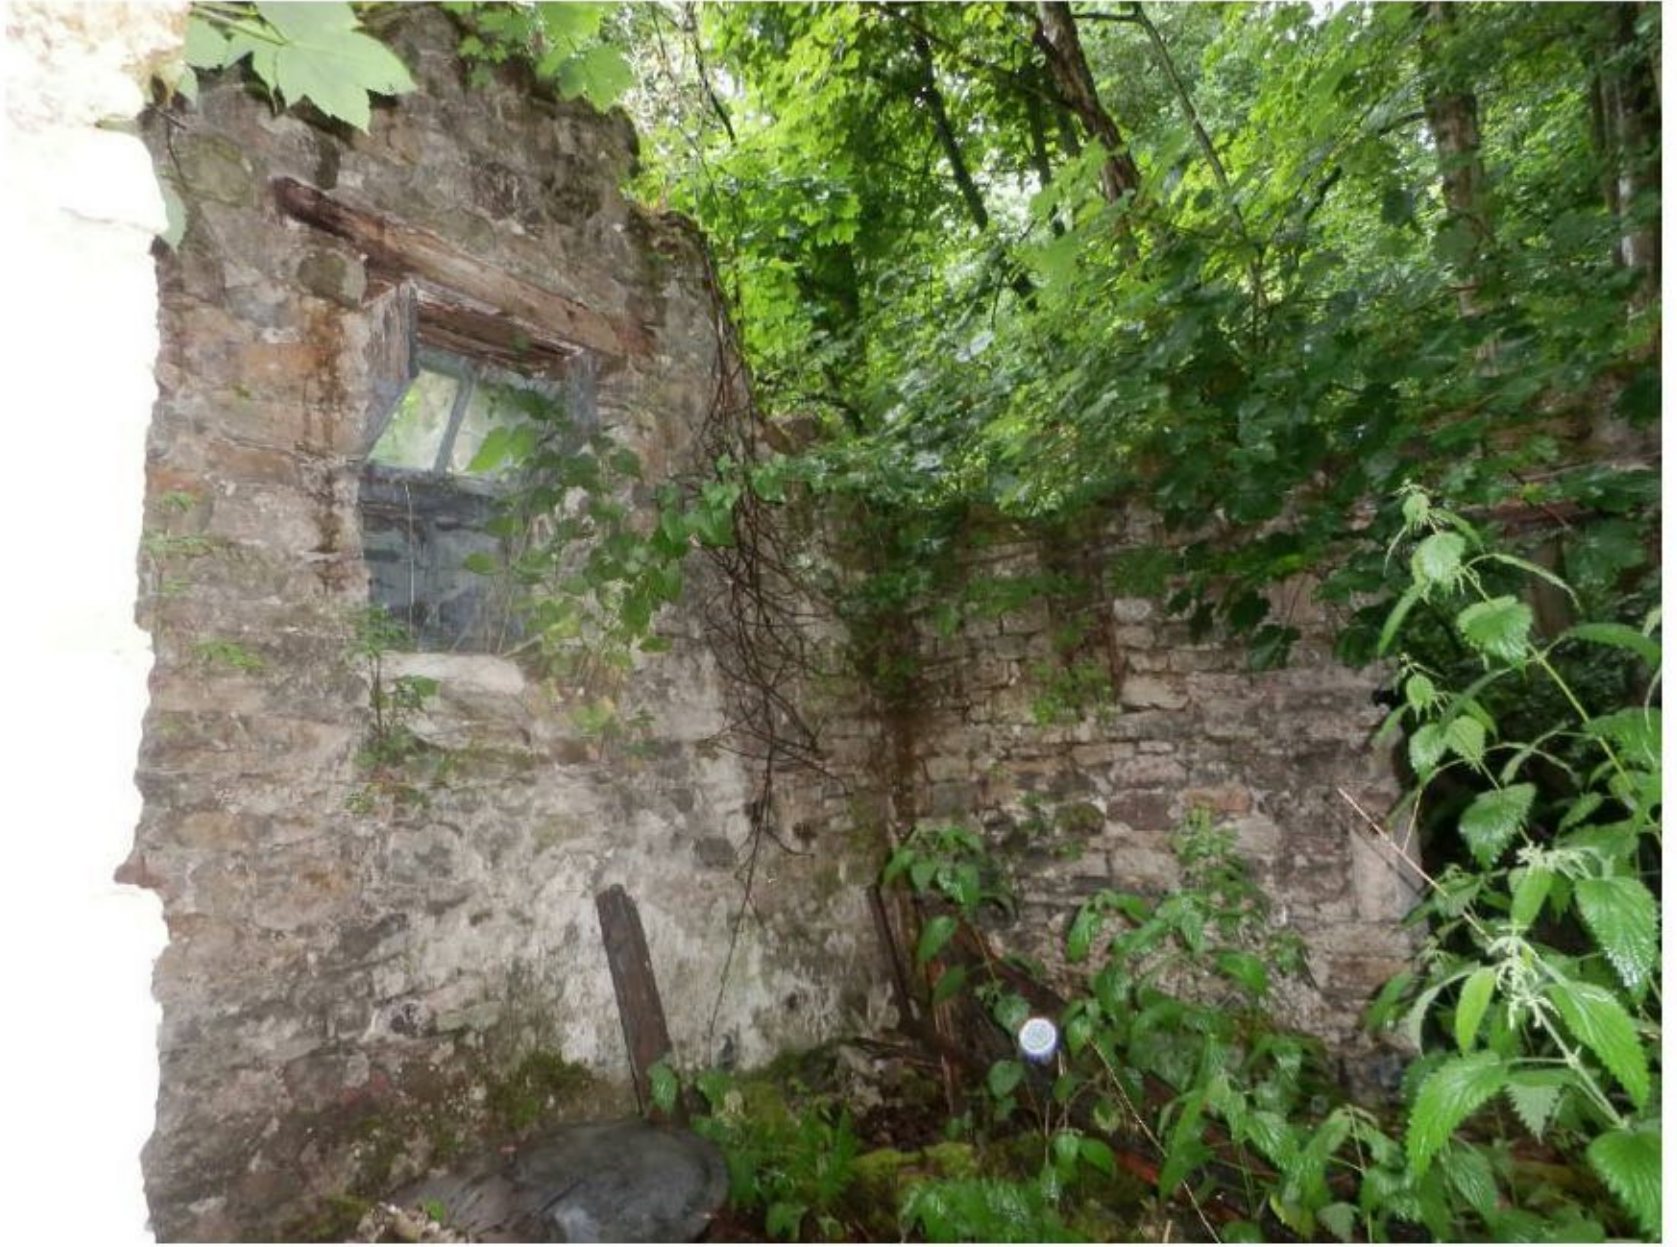
Building 3

Building 3. To the west of Buildings 1 and 2, this building consisted of roofless brick walls and had no suitability for bat roosts.

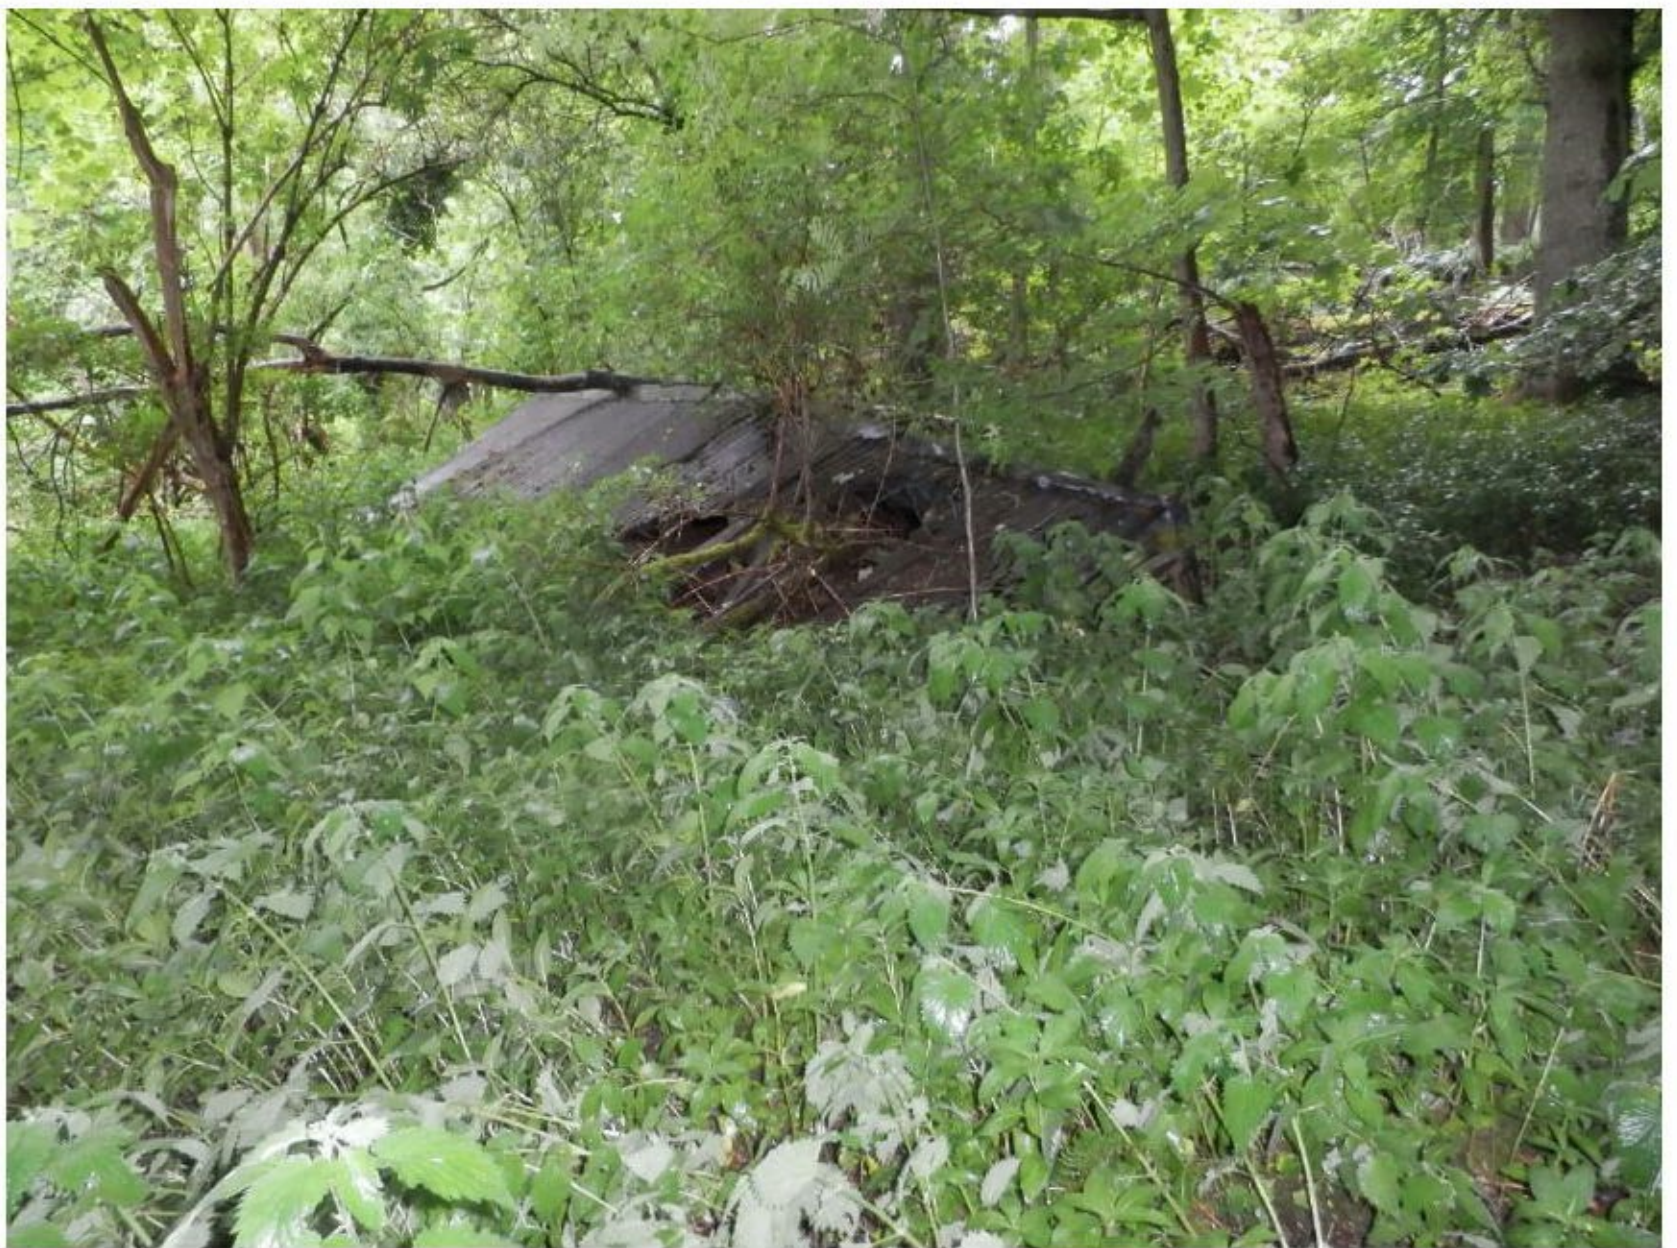
Building 4

Building 4. To the north of Building 3, this building had fallen down and consisted of debris and part of the roof, lying on the ground.

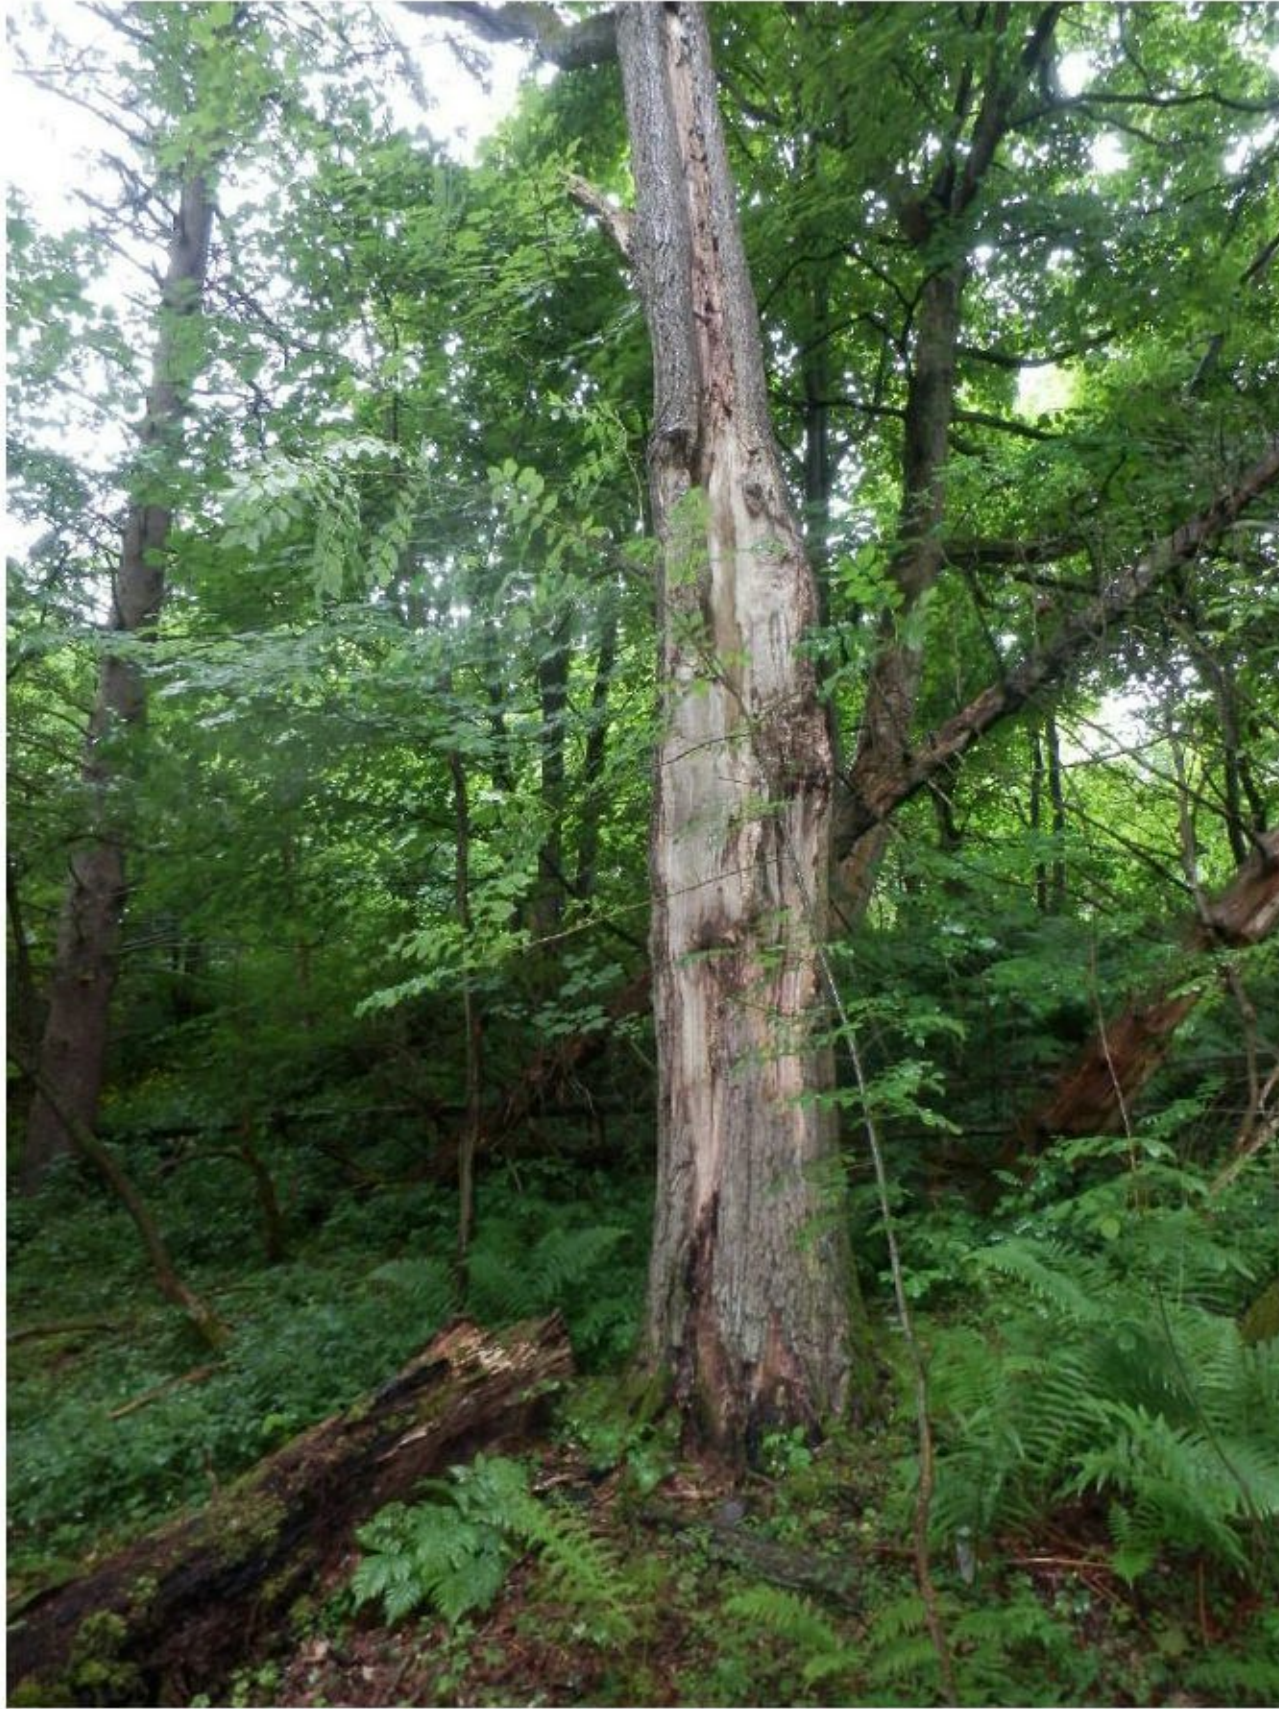
Several trees in the north west part of the site were large and had holes and defects potentially suitable for bat roosts. These should be surveyed if the trees are to be removed. None of the trees along the access track or around the buildings had features suitable for bat roosts.

Potential bat roost tree, example.

There are no trees suitable as bat roosts close to the buildings or the access track, only in the north west area of the site. If it is necessary to fell in this area, then bat roost emergence surveys would be required.

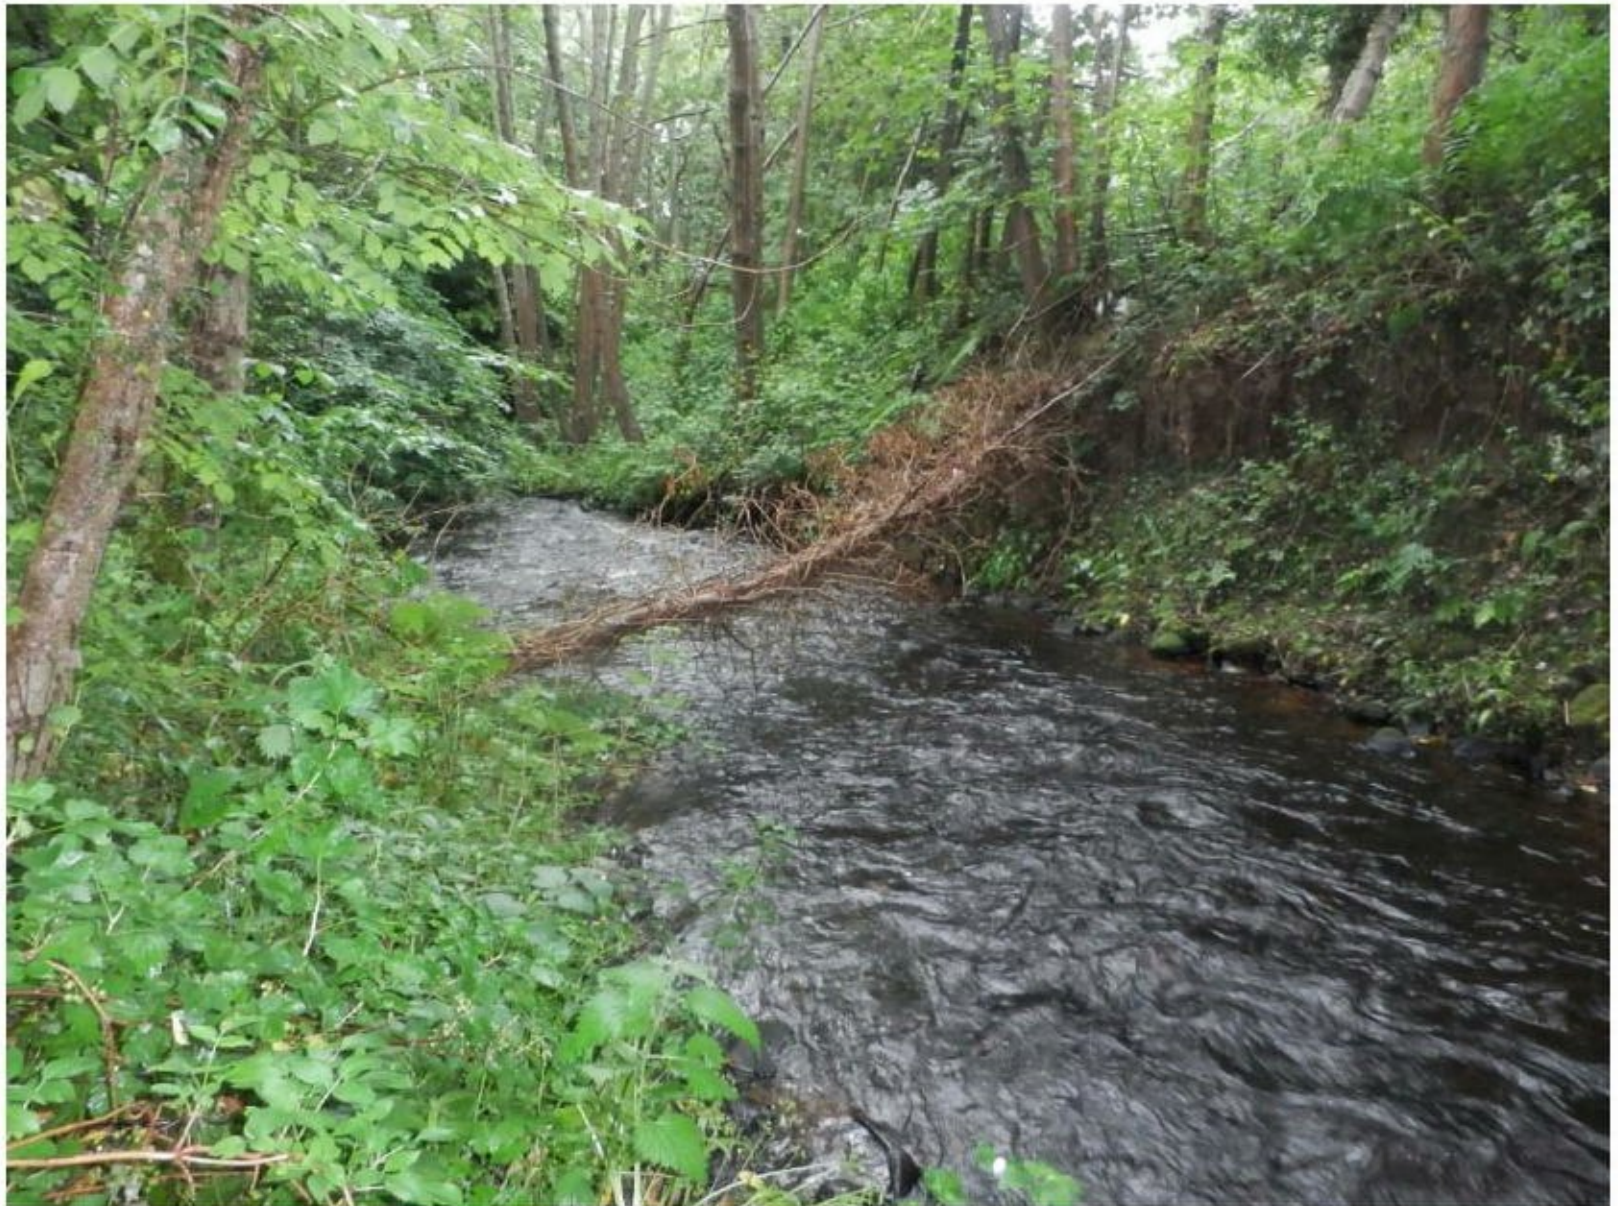
The banks of the Scur Beck, which are just outside the application area, were searched for signs of Otters, including holts, tracks, spraint and feeding signs. None were found.

Scur Beck, typical view

The Scur Beck is nearby and is known to be used by Otters. Design and development should take account of this and avoid physical or light disturbance to the stream.
